# Evolution of three streambanks before and after stabilization and record flooding

Published in *Ecological Engineering* 170 (2021) 106357

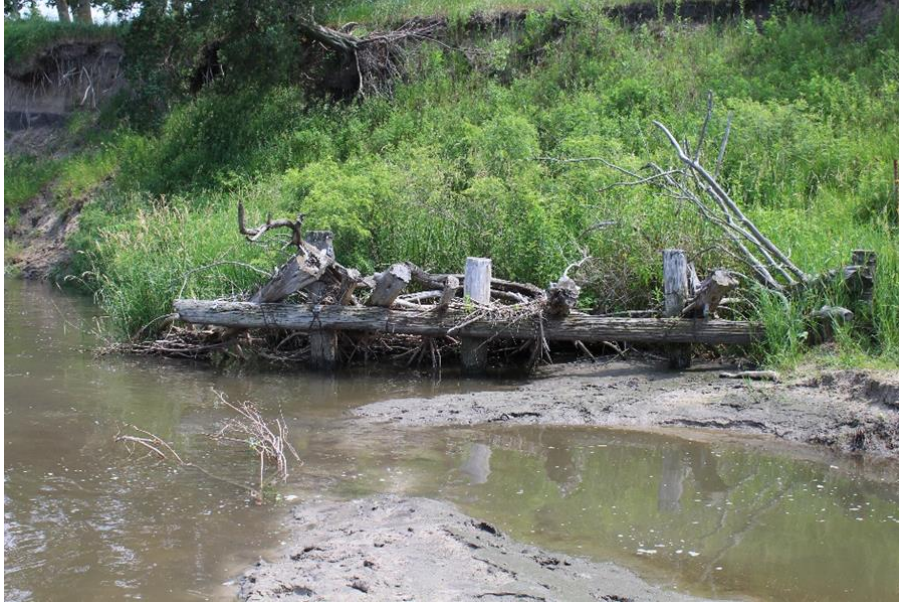
Figure S1. An example of a wooden jetty used on Cedar River as part of the 2005 Cedar River Stabilization Project.

Three reaches of Cedar River were stabilized with wooden jetties (Fig. S1) in 2005 in an attempt to prevent further degradation and encroachment into landowner's property. Each of the jetties was installed using the same materials, methods, and contractor, but due to differences in each reach, jetty length, angle, spacing, and number installed varied from site to site (**Table 1**). Unlike the first two study reaches, reach 3 had a large section of exposed bank between jetties 4 and 5, which was not used in our calculation of jetty spacing. The average spacing of the first four jetties had an average spacing of 30.6 m and jetties 5–9 had an average spacing of 38.5 m. These values are more comparable to the spacing measurements calculated for reach 1 and 2. According to the contractor, the methodology for installing the jetties was not a set spacing distance. Jetty placement was determined by visual inspection with the upstream jetty being placed at the location of first bank failure and the downstream end being positioned where maximum flow velocity coincided with the cut bank. The following jetties were then installed where the deflected flow next contacted the riverbank downstream of the previous jetty.

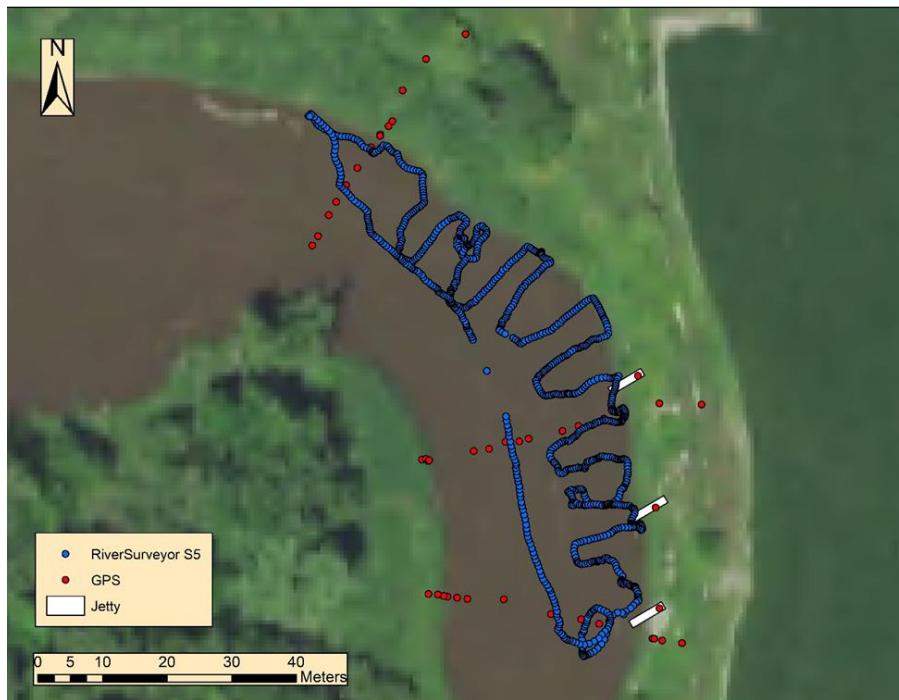
Figure S2. Two different surveying methods were used in this study: GPS cross sections (Red) and RiverSurveyor S5 (Blue). White arrows depict flow direction.

Two survey instruments were used to conduct sediment accumulation surveys in 2018 and deposition surveys 2019. Using a survey-grade GPS with real time kinematics (RTK), we conducted multiple cross-sectional surveys including the upstream, downstream, and middle section of each stabilized reach (Fig. S2). We then measured water depth around the jetties using the RiverSurveyor S5 and surveyed in a grid pattern along the critical bank, extending into the middle of the river. This pattern permitted rapid, high coverage surveys. RiverSurveyor S5 allows measurements to be taken in areas that were too deep or out of reach of the GPS and it has the additional benefit of a high rate of sampling ( $\sim 0.75$  data points per second). The horizontal resolution of the data collected using both the GPS and RiverSurveyor S5 ranged from 1.5 to 3.0 m for the three reaches for 2018 and 2019. No data was collected for reach 2 in 2019 due to equipment malfunction. Lower resolution (3.0 m) was seen where the water was too shallow for the River Surveyor (20 cm). For those areas, GPS was used to complete the remaining profile.
