POST-FIRE EROSION FOLLOWING THE CZU LIGHTNING COMPLEX FIRE:
QUANTIFYING HILLSLOPE EROSION AND PROVIDING GUIDANCE TOWARDS
IMPROVING POST-FIRE RESPONSE

A Project presented to
the Faculty of California Polytechnic State University,
San Luis Obispo

In Partial Fulfillment
of the Requirements for the Degree
Master of Science in Environmental Sciences and Management

by
Matthew Crockett
September 2022

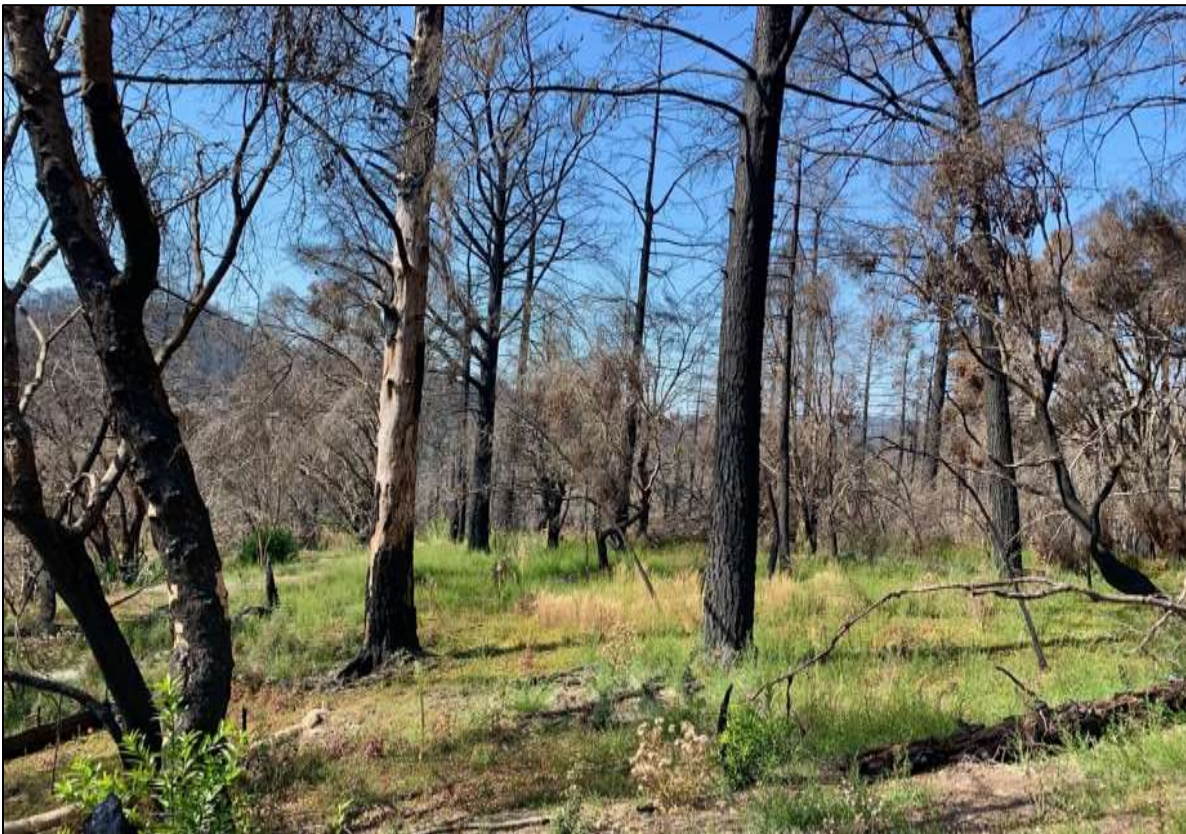
Figure 4. Photograph of study area taken October 2nd 2021

The Little creek watershed includes a variety of vegetative communities including coastal redwood forest, mixed conifer forests, chaparral, coastal oak woodlands, and grasslands. The study site within the watershed features mixed coastal forest with dominant species including Monterey pine, Douglas fir, Coastal redwood, Tan oak, and Coast live oak (Figure 4).

Understory species include California blackberry, Poison oak, and Ceanothus. Revegetation of understory species is dominated by California blackberry and Ceanothus.

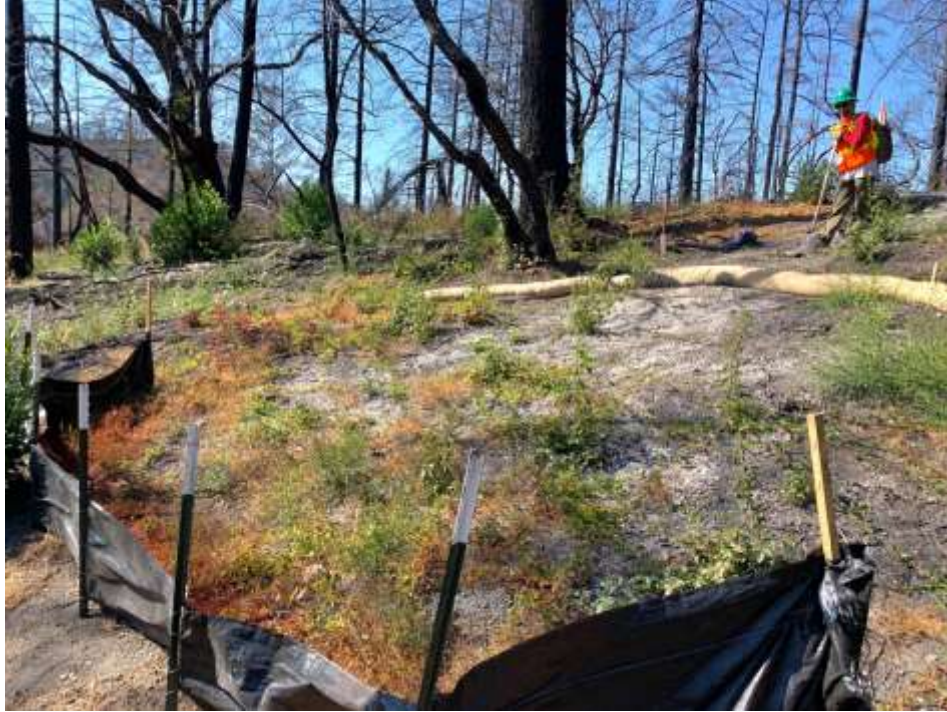
Figure 8. Upslope view of fully constructed silt fence plot.

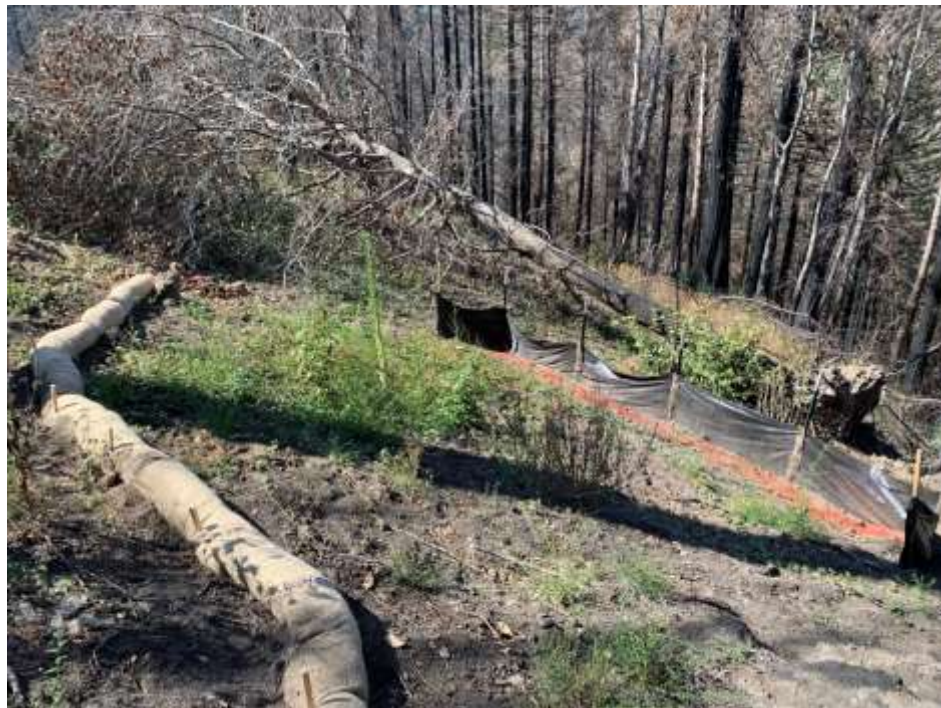
Figure 9. Downslope view of fully constructed silt fence plot and highlighting the red chalk.

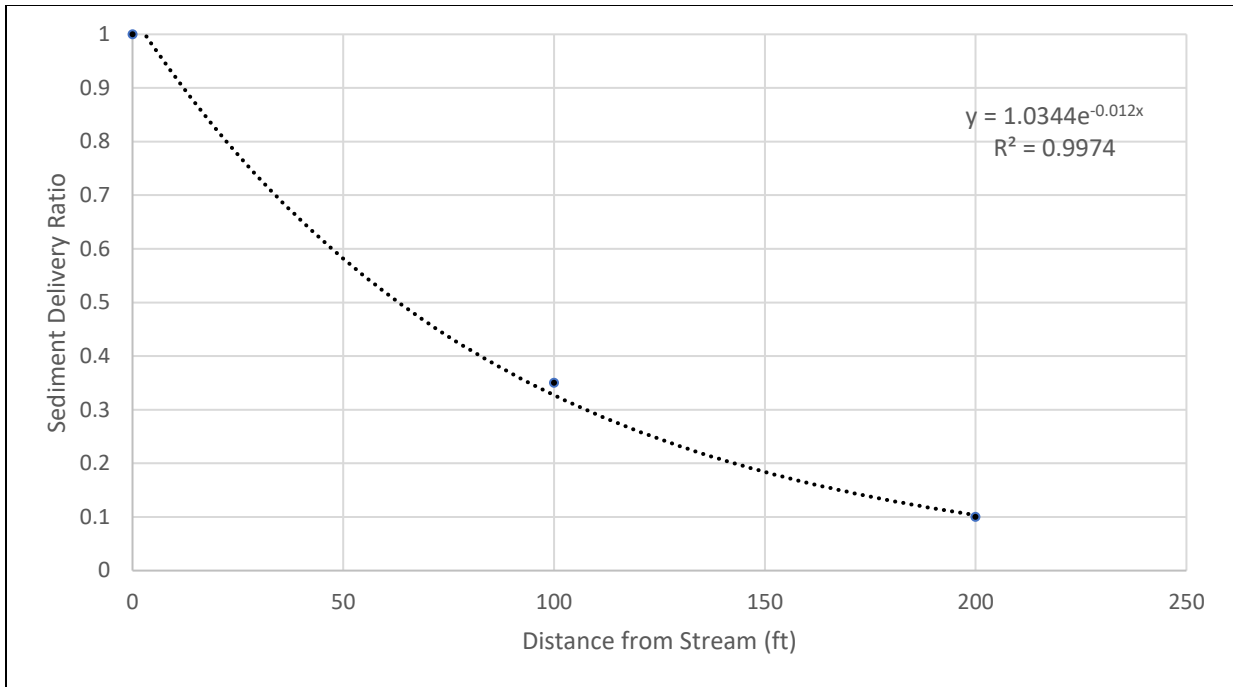
Figure 12. Relationship between sediment delivery and distance from a stream derived from Megahan et al., (1986).

The delivery ratios listed in Table (4) can be used to predict the sediment delivery ratio of a road segment at a chosen distance from a stream (Figure 12).

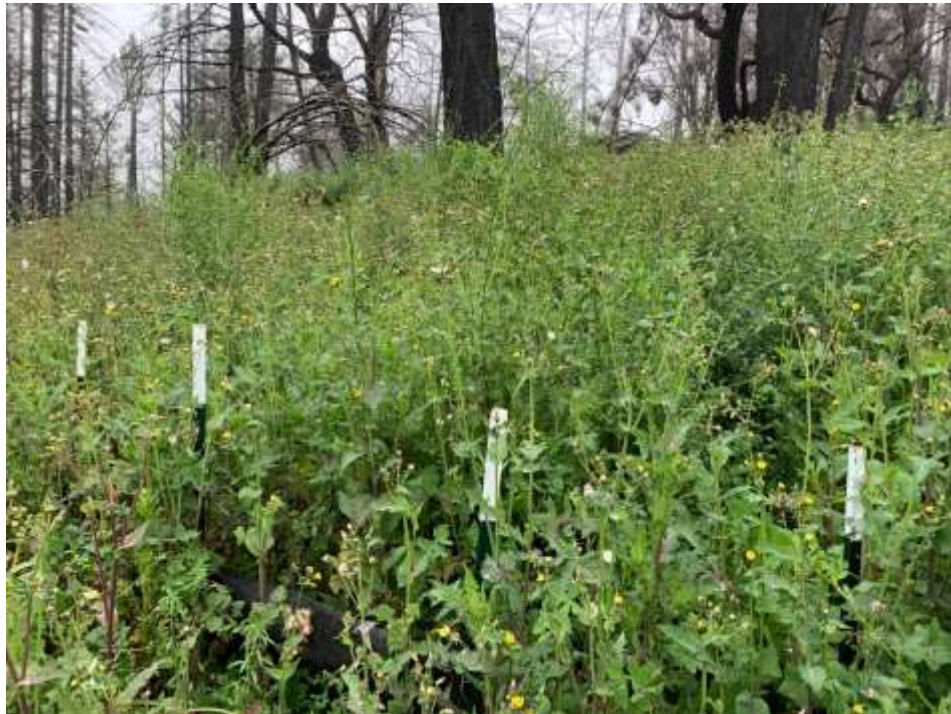
Figure 14. Plot M2 completely overtaken by understory vegetation.

Percent soil cover varied from 59 - 82.5% and changed considerably throughout the study period (Table 5). An average increase in soil cover of about 40% was observed from October 2nd until March 15th, the entire extent of the study period. Understory vegetation growth increased rapidly following substantial rain in late December. Plots M3 and M7 expressed complete soil cover on March 15th (Figure 14).

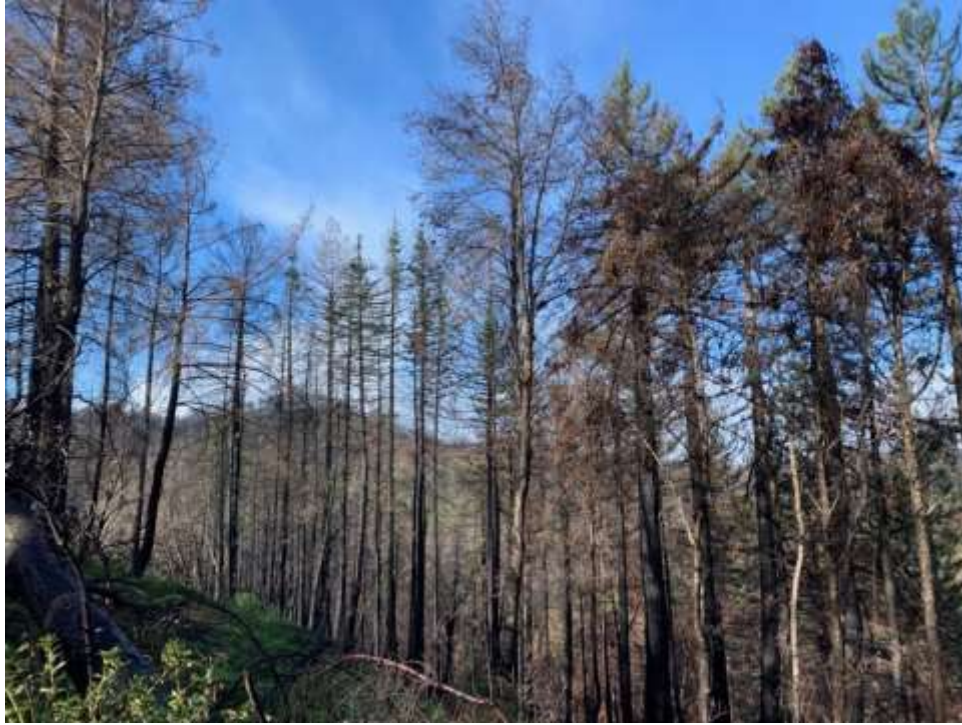
Figure 15. Canopy coverage near plot L10 from scorched Coastal redwood and Tan oak.

Canopy coverage above the erosion plots was predominantly comprised of bare branches from scorched trees or dead leaves which had remained attached to branches (Figure 15). These values were highly variable and ranged from 2.6 - 77.5 % depending on the plot. Canopy coverage averaged 54% across the ten study plots (Table 5). No changes in the type and degree of canopy cover occurred over the study period.

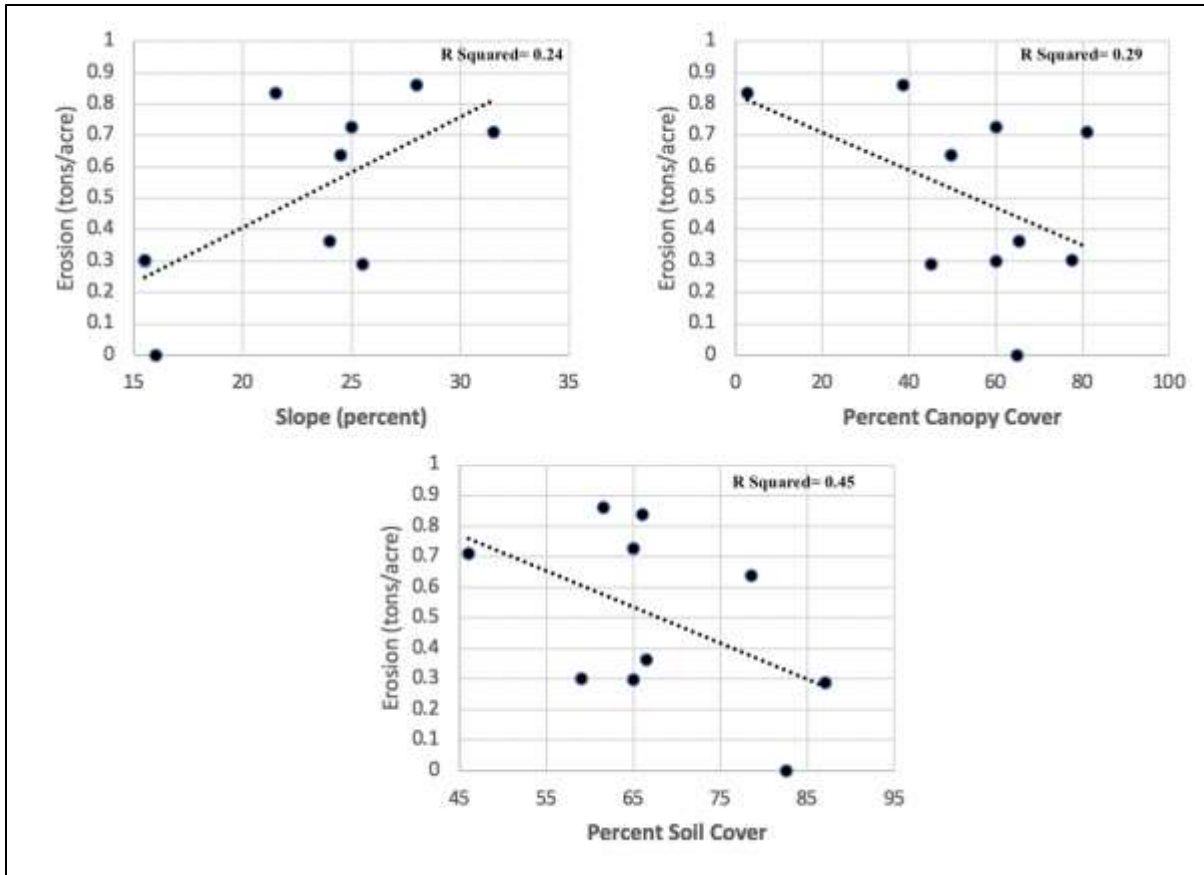
Figure 17. a) Relationship between hillslope erosion and slope steepness. b) Relationship between hillslope erosion and percent canopy cover. c) Relationship between hillslope erosion and percent soil cover.

Explanatory Variable	P-value	R-squared
Slope (%)	0.03 *	0.45
Percent Soil Cover	0.14	0.24
Percent Canopy Cover	0.17	0.29

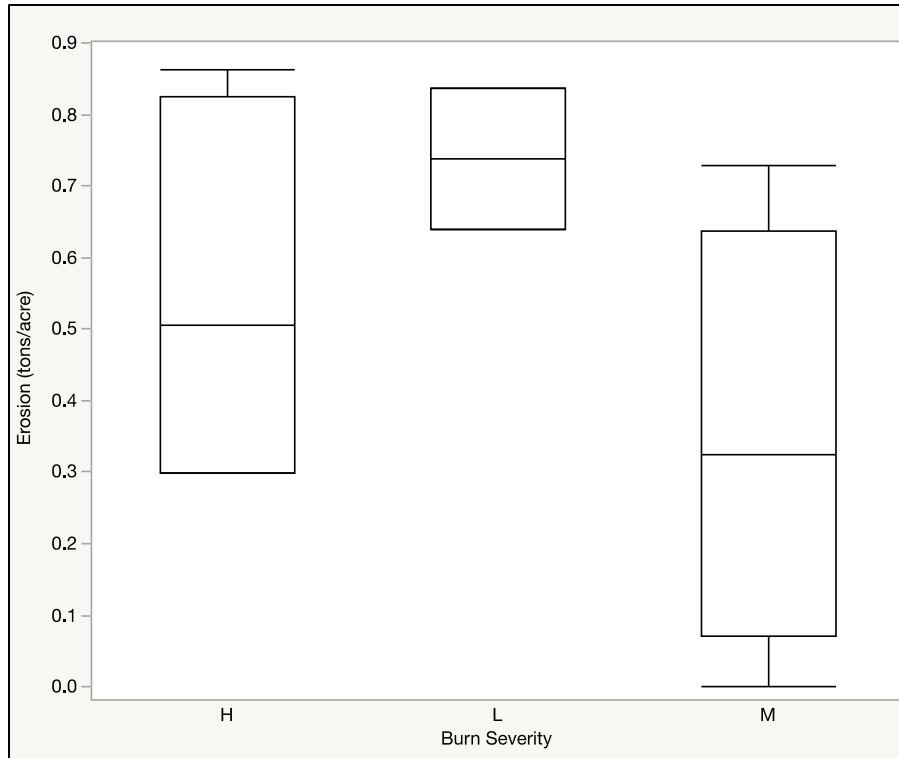
Note: High and moderate burn severity were both represented in four plots, while low burn severity was represented in two.

Figure 18. Mean hillslope erosion rate for each degree of burn severity showing high and low values.

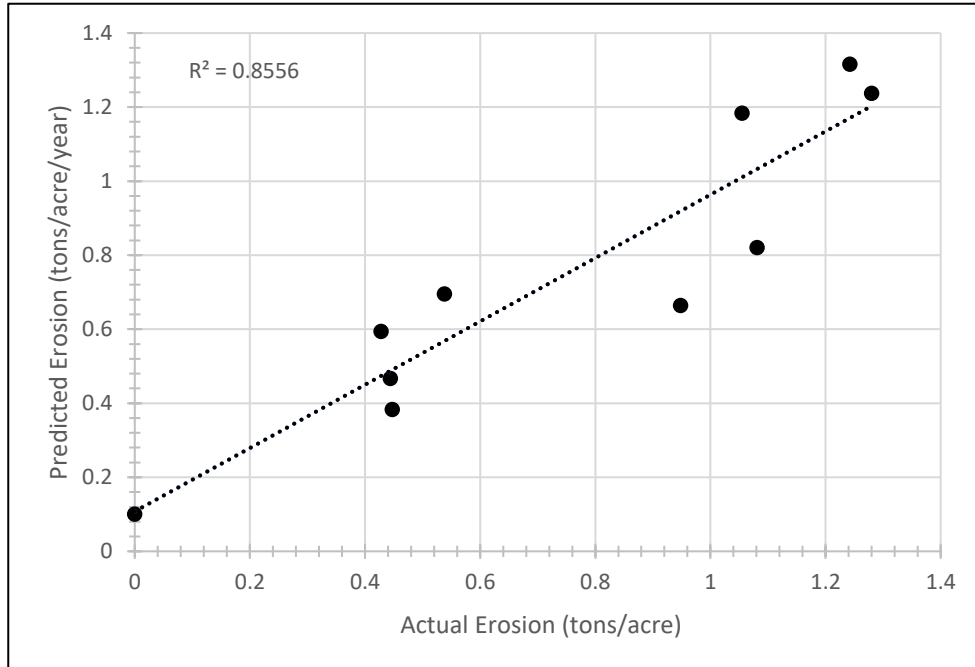
Figure 19. Actual vs. predicted values for erosion based on the best produced model.

$$\text{Square Root of Predicted erosion (tons/acre/year)} = 1.78 + .04 (\text{Slope}) * - 0.02 (\text{Percent Soil Cover}) * - 0.01 (\text{Percent Canopy Cover}) \quad (5)$$

These variables and the intercept of the model are all statistically significant at $p < 0.05$ (Table 9). This model was chosen because it expressed the lowest Akaike Information Criterion (AIC) value and maintained a high R-squared value in comparison to other models. The model explains a large proportion of the observed variability in erosion as seen through an R-squared value of 0.86 (Table 10) (Figure 19). Root mean square error (RMSE), a measure how concentrated actual values are to the predicted regression line, is low at 0.13 tons/acre/year (Table 10).
