# Internal Sulphate Attack in Masonry Mortars with Thaumasite Formation

**Abstract:** The present paper focuses on the study of mortar samples where expansions with thaumasite formation occur as a consequence of sulphate attack. The samples correspond to a masonry mortar used in a rural construction located in the Spanish province of Toledo made of cement with limestone filler addition CEM II/AL. Composition and microstructure of the mortars have been analysed by means of scanning electron microscopy (SEM) using secondary and backscattered electrons (BSE) and X-ray diffraction (XRD). The results show that aggregates are contaminated with gypsum, which is the source of the sulphates for the internal attack. It seems that thaumasite is formed through an ettringite transformation where aluminium atoms are replaced with silicon atoms by means of a solid solution. The study highlights that thaumasite can be formed in warm weather through an internal sulphate attack due to gypsum contamination of aggregates.

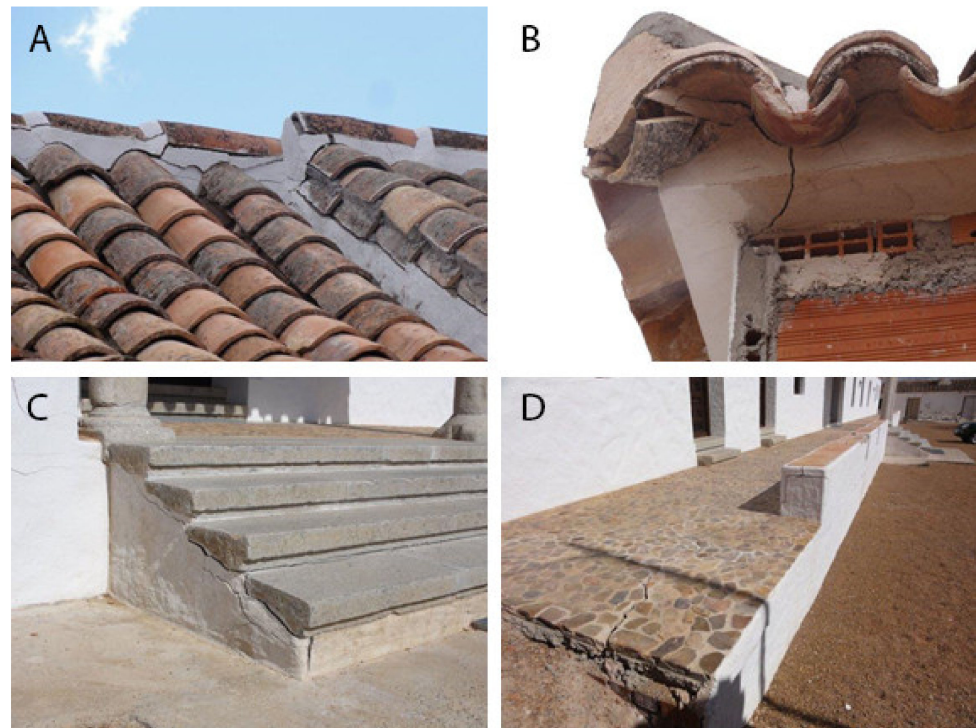
The property under study is called Quinto de Garcillán and is located in Toledo (Spain). It is an estate that houses private and public industries and is a typical example of rural architecture. The samples analysed in this study are of a masonry mortar used to place tiles and for pavements. The photographs in Figure 1. show the state of the mortar, with clearly visible expansions and cracks in many parts of the dwelling such as roofs (Figure 1A,B)) or pavements (Figure 1C,D)).

**Figure 1.** Photos showing the expansive nature of the mortar. (A) and (B) roof tiles, (C) and (D) paving tiles.

Samples of degraded mortar have been taken from the areas shown in Figure 1, as well as mortar from other apparently healthy areas to check the cause of the observed pathology.

This paper describes a case report of internal sulphate attack in a masonry mortar with thaumasite formation. The mortar has been used as a bonding mortar for external paving and roof tiles, and in the most affected areas, there is extensive cracking and weakness in the bond with consequent detachment.

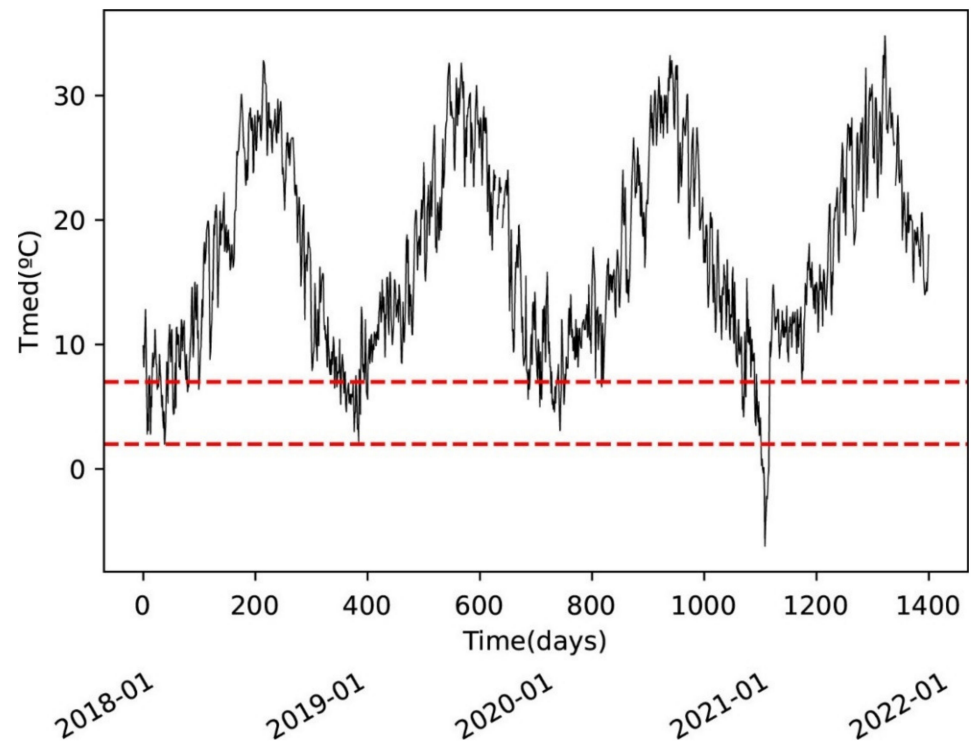
Figure 2 shows the daily average temperatures of the location of the building. This area has temperatures ranging from 2 °C to 30 °C. The graph shows the lower range of temperatures, where thaumasite is told to be formed according to the vast majority of papers published.

**Figure 2.** Daily average temperatures in the site.

As can be seen in Figure 2, very few days per year have temperatures of 5 °C, so it can be concluded that the area has warm temperatures in the context of thaumasite formation.

The fact that the temperatures in the area where the building is located tend to be above 5 °C demonstrates that thaumasite can be formed in warm weather. Thaumasite formation results from an ettringite transformation where aluminium atoms are replaced with silicon atoms through a solid solution.

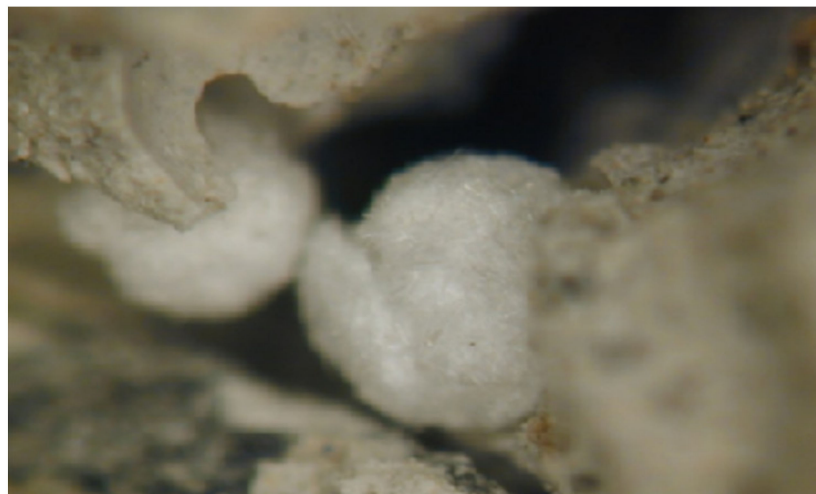
Detailed observation of the samples by stereomicroscope allows the identification of reaction products with a whitish and acicular appearance. These products appear abundantly in different areas of the surface observed in the samples (Figure 3). From the appearance indicated, these products could correspond to secondary ettringite and/or thaumasite crystals, both reaction products of a sulphate attack on the hydrated cement compounds.

**Figure 3.** Acicular and white appearance of compounds observed by optical microscopy.

Samples have been taken from different affected areas. Optical microscopy analyses show the formation of a large number of acicular-type products corresponding to the products of sulphate attack. The results of scanning electron microscopy and X-ray diffraction allow us to identify that the mortar was made using cement with addition of limestone filler and a gravel aggregate contaminated with gypsum. These analyses confirm the first impressions after in situ visual inspection and optical microscopy of a degradation by sulphate attack, after which a large amount of secondary ettringite and thaumasite appears.

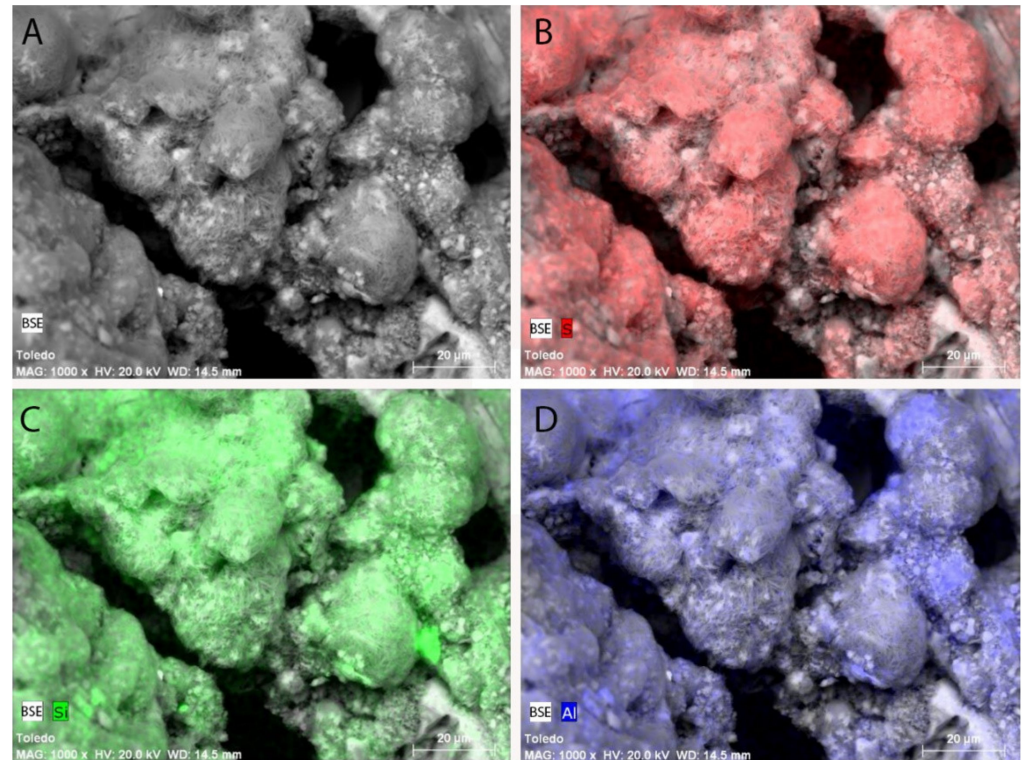
Figure 4 provides the SEM-BSE image at 1000X of the altered mortar. It shows the mapping or element distribution in the surface by colouring sulphur, silicon and aluminium location.

**Figure 4.** (A) Back-scattering electron image and mapping of the elements (B) sulphur, (C) silicon, and (D) aluminium.

The Al and Si mappings performed by BSE-SEM and represented in Figure 4, show that these elements occupy the same places. In principle, this would support one of the three hypotheses about formation given in the introductory section (mechanism b): Thaumasite is formed through an ettringite transformation or conversion where aluminium atoms are replaced with silicon atoms using an ettringite–thaumasite solid solution.

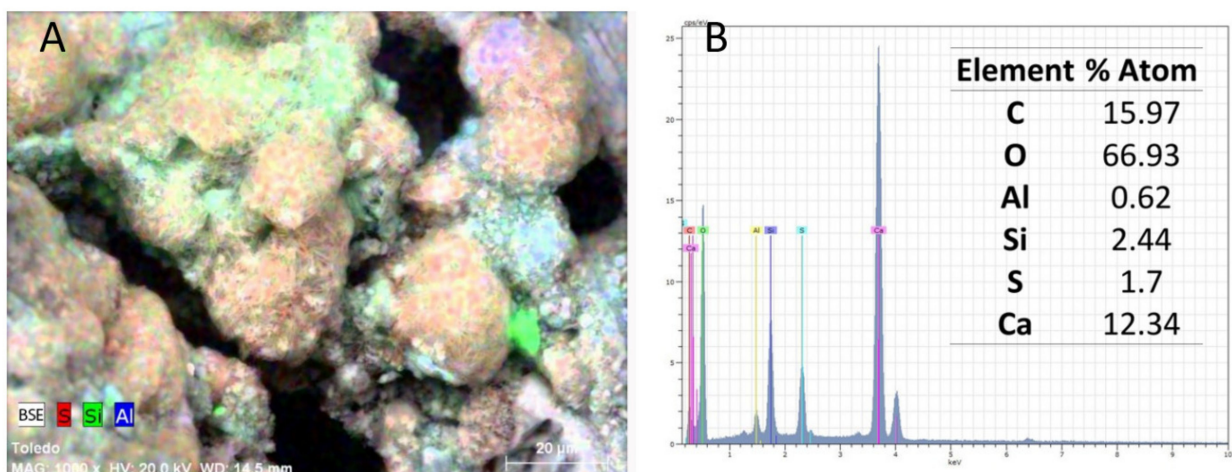
Figure 5 describes the combined distribution of sulphur, silicon, and aluminium overlaid in a backscattered electron image and elemental composition obtained by EDX.

**Figure 5.** Combined mapping for elements S, Si, and Al; (B) EDX results for the area shown in (A).

The results of cell parameter refinement for the XRD spectrum in Figure 7 show parameter “a” values below 1.111 nm—which would correspond to thaumasite–ettringite solid solution compounds according to [39]. Furthermore, the EDX analyses collected in Figure 5 reveal a Si/Al proportion that equals 3.94—corresponding to the values of this parameter [40].

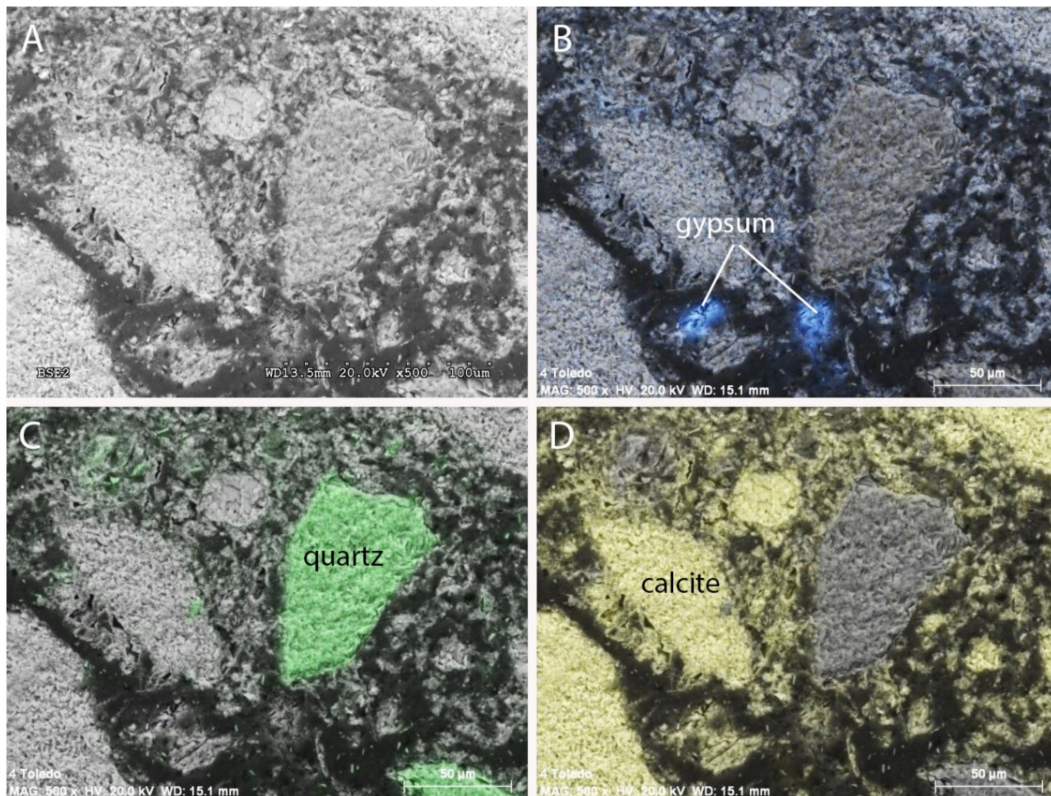
Finally, aggregate composition could be studied after using a brush and cleaning the altered surface in order to obtain a healthy portion of the mortar. BSE-SEM was used for the analysis. Figure 6 shows a BSE image with the Ca, S, and Si mappings superimposed on it.

**Figure 6.** (A) Back-scattering electron image and mapping of the elements (B) sulphur, (C) silicon, and (D) calcium in the non-degraded mortar sample.

The morphology of the aggregates, with well-defined angles and straight sides, represented in the picture provided in Figure 6 fits in with the gravel type. The mappings in Figure 6 as well as the DRX spectrum in Figure 7 prove the variable mineralogy of such aggregates. Gypsum is present among those minerals.

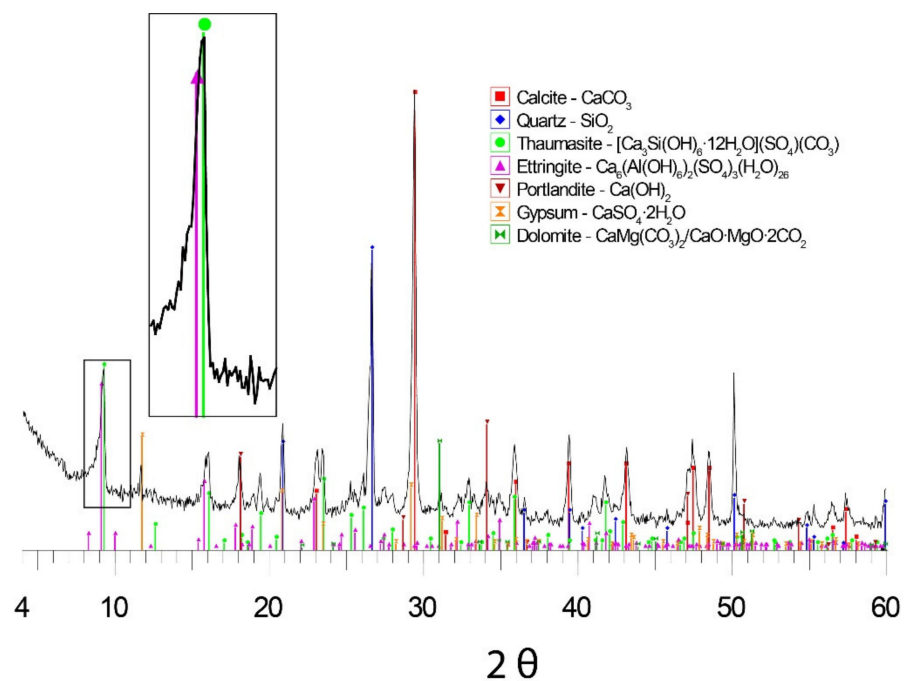
Figure 7 is one of the representative XRD results of a degraded mortar.

**Figure 7.** XRD spectrum of the cleaned mortar sample.

Figure 7 provides the XRD spectrum of a mortar obtained by quartering different mortar portions in the work site. Quartz, calcite, gypsum, ettringite, thaumasite, and portlandite were identified. The amount of ettringite and thaumasite detected in the sample is quite significant and corroborates that the cause of degradation of the mortar used is sulphate attack. It deserves to be highlighted in this respect that the presence of portlandite indicates that the mortar is not fully carbonated and would therefore come from a not-too-old set in use.

As reflected in the spectrum, ettringite and thaumasite coexist in the analysed sample. This fact could indicate that thaumasite is formed independently of ettringite (mechanism a) or due to ettringite crystals as the initial nucleation point (mechanism c). However, more extensive studies in the XRD pattern have been conducted to obtain further insights.

The XRD pattern in Figure 7 served to refine the thaumasite parameters using the data in the Powder Diffraction File with the software described in the Experimental section. Table 1 offers a summary of the results.

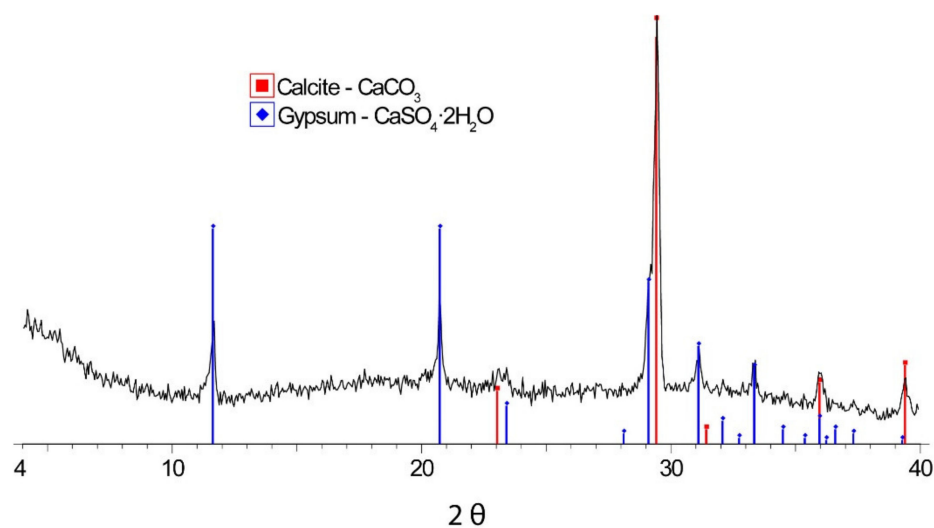
Figure 8. XRD of aggregates.

Figure 8 corresponds to the XRD analysis of the aggregates used to make the bonding mortars.

The amount of gypsum in the analysed samples is significant and is the only possible source of the sulphates that caused the damage. It can then be considered that the source of sulphates is internal to the composition of the mortars, and therefore an internal sulphate attack with thaumasite formation has occurred.
