# SEISMIC VULNERABILITY ASSESSMENT OF HISTORICAL URBAN CENTRES: THE CASE STUDY OF CAMPI ALTO DI NORCIA, ITALY

Federico Romis<sup>1</sup>, Silvia Caprili<sup>1</sup>, Walter Salvatore<sup>1</sup>, Tiago M. Ferreira<sup>2</sup>, Paulo B. Lourenço<sup>2</sup>

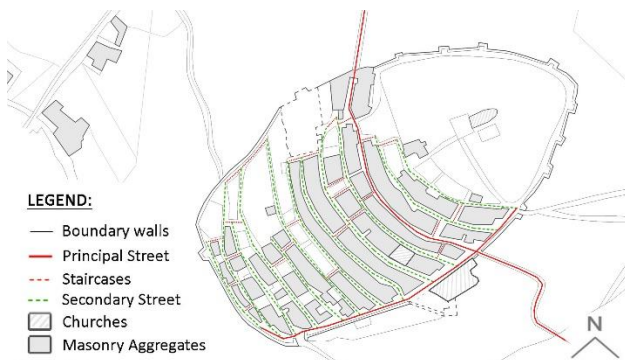
Figure 1. General organization of Structural Aggregates in Campi Alto di Norcia according to the Gregorian cadastre.

The building heritage of Campi Alto di Norcia (Figure 1) covers an area of approximately 35,000 m<sup>2</sup> with a perimeter of 750 m. 32 different structural aggregates can be identified within the area, globally resulting in 75 different structural units. Three Churches (Madonna della Piazza, Sant'Andrea and Santa Maria delle Grazie), completely damaged by the 2016 earthquake, are also present.

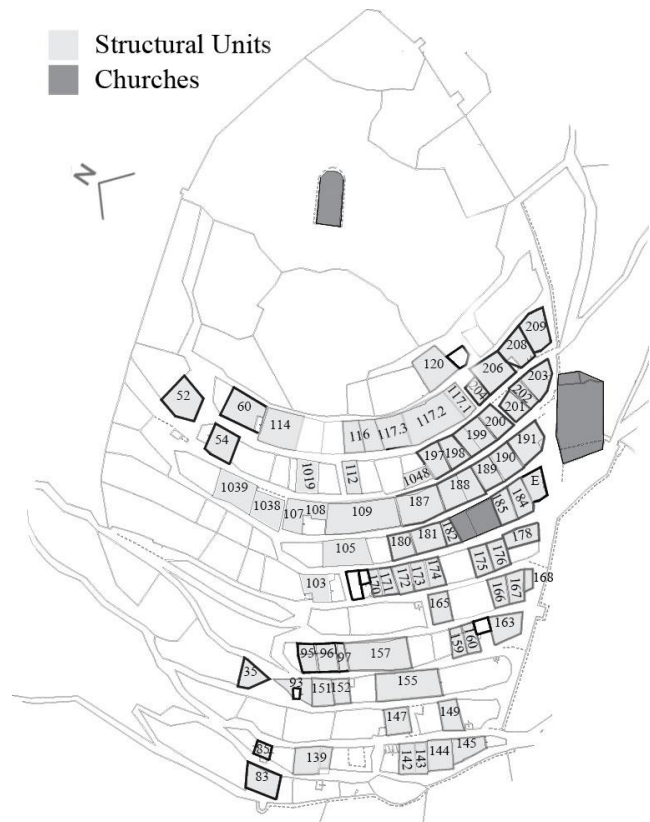
Figure 2. Identification of the Structural Units (SUs) in the case study according to the Gregorian cadastre.

organization of SUs within the historical city centre of the case study, according to deep in-situ surveys performed before and after the 2016 seismic event. About the 16% of buildings inside Campi Alto di Norcia old city centre are characterized by one single floor, owning originally the function of storage areas and representing the remaining portion of ancient medieval houses. The 7% of buildings is organized on two levels, while the 67% - representing most of the masonry heritage - develops on three storeys. A limited number of four storey buildings is also present (Figure 2).

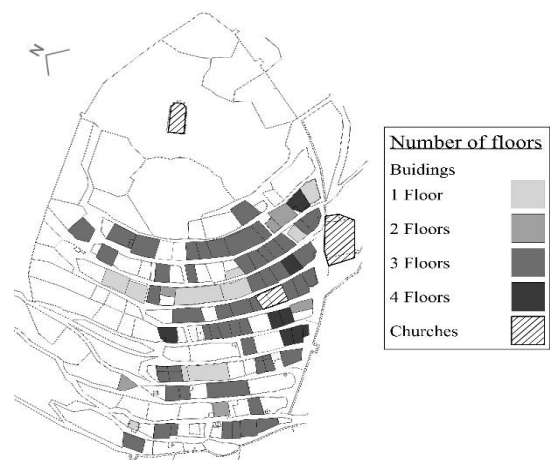
Figure 3. Distribution of the number of floors for each SU in Campi Alto di Norcia.

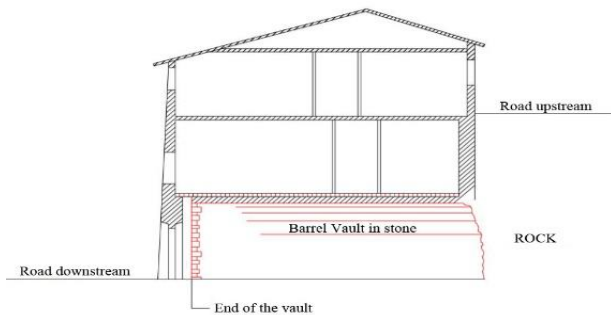
Figure 4. Schematic representation of the typical Structural Unit presents in Campi Alto di Norcia.

The ‘traditional’ structural unit is organized on three different floors: the ground floor (partially underground following the

cleavage of the hill) and characterized by the presence of a barrel stone vaulted surface carved into the rock and two additional floors normally presenting the traditional wooden structure of the storeys, sometimes replaced by reinforced concrete elements if retrofit interventions took place over the years (Figure 4). The average interstorey height (considering ground, first and second floors) of the SU is about 3 meters.

The same organization in elevation can be recognized also in SUs made up of two and four levels, i.e. a barrel vault at first floor and timber/concrete slabs at the other ones.

Concerning bearing vertical elements, masonry walls highlight differences in thickness and materials, with average thickness around 120 cm at the ground floor reducing to 80 cm and 50 cm going to the upper levels. In particular, looking at material properties, four different masonry typologies are determined in the different SUs, all characterized by irregular distribution of components. The mechanical properties of the materials are evaluated, through the execution of flat jack tests on different walls, carried out in the past, allowing to determine the stress-state on bearing vertical elements and the elastic moduli of the considered masonry typologies (Cardani, 2003), (C.M. n.7, 2019).

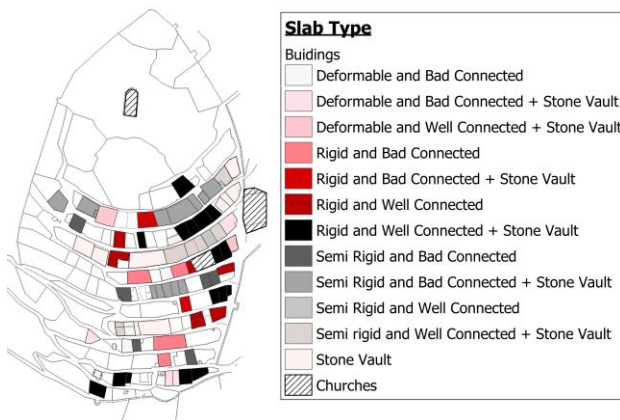
Figure 5. Distribution of the Floor typology for each SU in Campi Alto di Norcia.

The execution of in-situ surveys allows to identify the different horizontal floor typologies present in SUs, mainly divided in rigid, semirigid or deformable storeys in relation to the presence, respectively, of concrete slabs (i.e. associated, usually, to the application of recent retrofit techniques), of double crossed or single wooden plank. The presence of a system of steel chains or ties to connect masonry walls and to create continuity between walls and horizontal floors is also evaluated; Figure 5 shows the graphical representation of different floor typologies and the presence of connection systems within the different SUs in Campi Alto di Norcia.

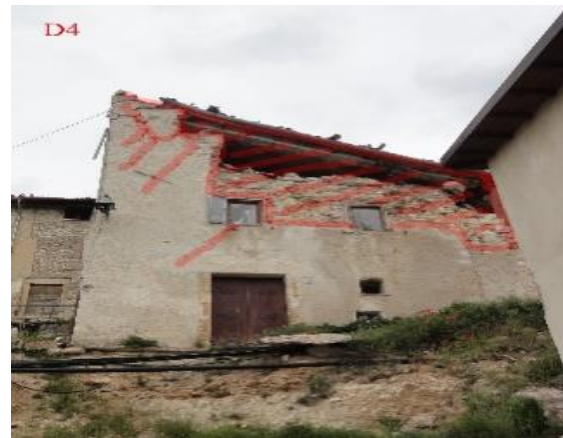
Figure 6. Structural Unite #165. Damage class D4 is assigned (EMS98).

The European Macroseismic Intensity Scale EMS98 (Grünthal, 1998) is adopted for the damage estimation of Campi Alto di Norcia after the 2016 earthquake (Figure 6), providing graphical illustrations and descriptions of six different increasing level of damages (D0, D1, D2, D3, D4 and D5 – corresponding, respectively, to the lack of damages, negligible to slight damages, moderate, substantial to heavy, very heavy and full destruction, Figure 6) for different structural typologies. Stating that for the attribution of the damage level the sensibility of the surveyor plays a major role (Baggio et al., 2007) the procedure is repeated by three different independent observers achieving finally a reasonable average estimation. Table 1 and Figure 8 show the results of EMS98 classification applied to the considered case-study aggregate, in terms of percentage of buildings and volume of the whole construction heritage. Most SUs show a Damage Level D2-D3 and D4-D5, but most of the volume turns out to be in the range D2-D3, since many SUs, used as storage areas and cellars with a low volume, nowadays are fully collapsed.

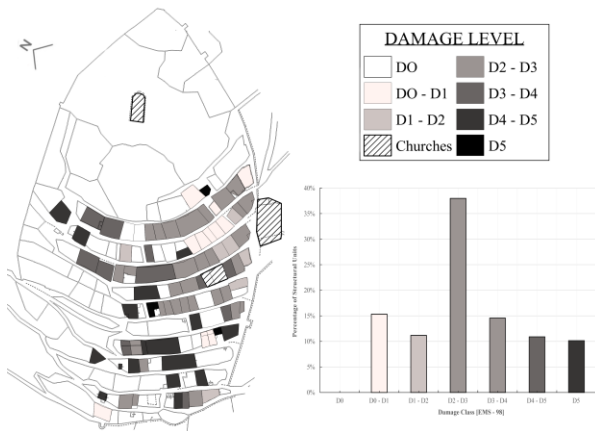
Figure 7. Damages distribution in Campi Alto di Norcia according to the EMS98 in a GIS environment.

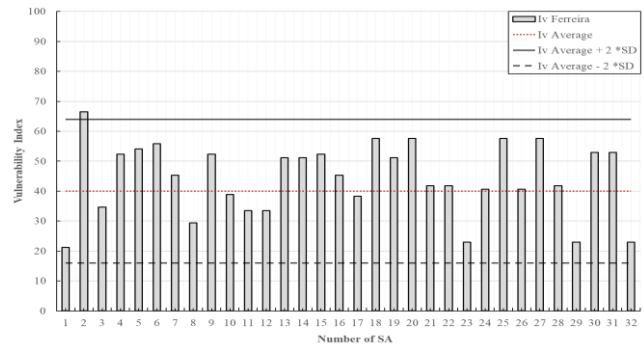
Figure 8. Results of the application of Ferreira method.

The assessment of the historical city centre of Campi Alto di Norcia, performed using the Ferreira method, finally highlights  $I_v$  values evaluated according to [1] between 20 and 30 for the 16% of the SAs analysed, between 30 and 40 for the 16% of the SAs, between 40 and 50 for 25% of the SAs and between 50 and 60 for 44% of the SAs. As a general remark, aggregates have a medium predisposition to suffer damage following an earthquake, showing an average a vulnerability of 40 and a Standard Deviation (SD) of 12 (Figure 8).

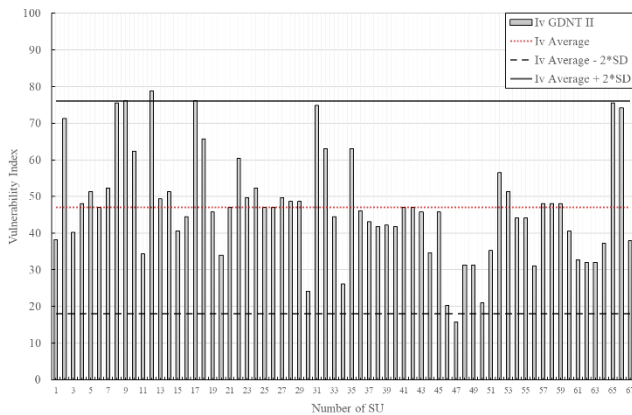
Figure 9. Results of the application of GDNT method.

The GDNT method adopts 11 different parameters to evaluate the seismic vulnerability of isolated buildings, accounting for the geometry and resistance of structural and no-structural elements, floors and roof typologies, walls' thickness and decay's level (Table 3). The application of the GNDT method to Campi Alto di Norcia evidences an average  $I_v$  index equal to 47 and a Standard Deviation (SD) of 14. More in details, achieved values of the  $I_v$  – evaluated according to [1] – are between 20 and 30 for the 6% of the SUs analysed and between 30 and 40 for 19% of the SUs. The 43% of the buildings show a vulnerability index distributed between 40-50, 9% are between 50-60, 7% are between 60-70 and 12% are between 70-80. Remaining SUs evidence a seismic vulnerability below 20 (Figure 9).

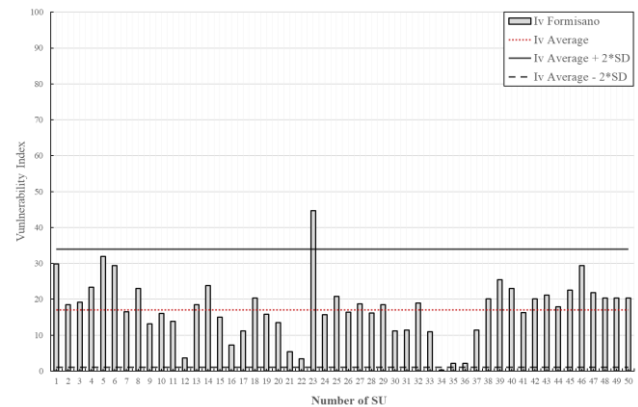
Figure 10. Results of the application of Formisano method.

Since the Formisano method is developed for SA, the isolated buildings are ignored in the analyses, therefore only the 50 SUs in aggregate are taken into account. Achieved values of the  $I_v$  – evaluated according to [1] – are between 0 and 10 for the 13% of the SUs analysed, between 10 and 20 for 44% of the SUs and between 20 and 30 for the 35% of SUs (Figure 10). The 2% of the buildings shows a vulnerability index equally distributed between 30-40 and between 40-50. This method shows a low seismic vulnerability of the masonry aggregates in the historical centre of Campi Alto di Norcia, where the average  $I_v$  index is 17, with a Standard Deviation (SD) of 9.

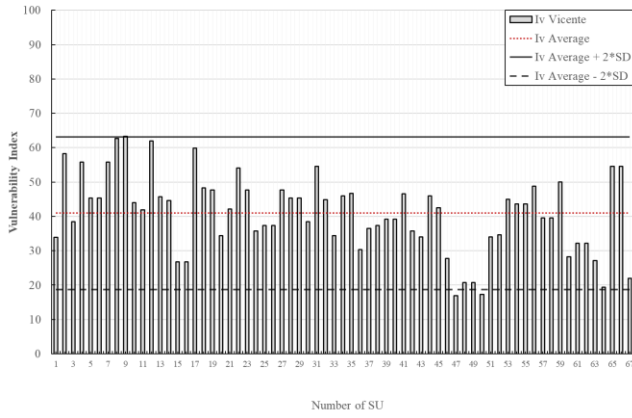
Figure 11. Application of Vicente method, representation of results.

The average seismic vulnerability index is 41, with a Standard Deviation (SD) of 11. More in details, the application of the method shows a medium seismic vulnerability of the masonry aggregates in the historic centre of Campi Alto di Norcia, with  $I_v$  index in the range 10 – 20 for the 4% of the buildings, and 20 – 30 for the 12% of the buildings, between 30 and 40 for the 30% and between 40 and 50 for 35% of the SUs analysed. Remaining SUs present higher vulnerability indexes (Figure 11).

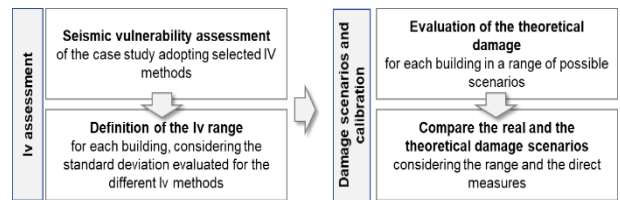
Figure 12. Procedure used in accuracy evaluation of vulnerability assessment methods.

The procedure applied to the case study of Campi Alto di Norcia, considering the vulnerability range for each building, is summarized in Figure 12.

The procedure is applied for each  $I_v$  method, comparing finally the results obtained, checking which method shows the minimum relative error for the case study.

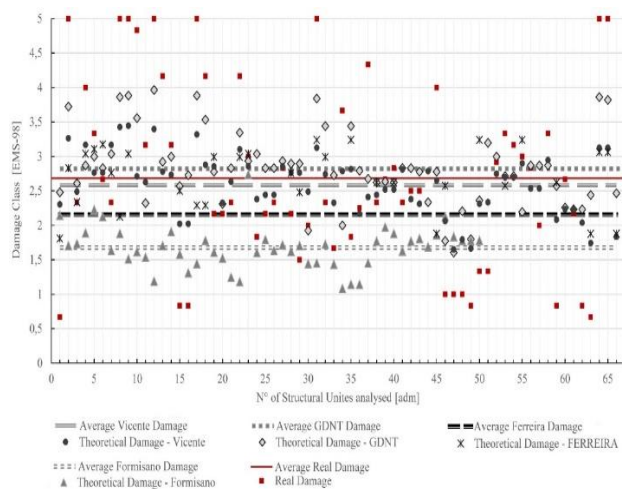
Figure 13. Comparison between the Real Damage detected in the case study and the Theoretical Damage evaluated through different vulnerability methodologies for each SU.

Figure 13 shows the comparison between the theoretical and real damage distribution in Campi Alto di Norcia: the comparison is carried out locally, evaluating for each SU the distance between the real and expected damage, and at urban scale evaluating the differences between the various damage averages. As visible, while real damage shows very scattered values, the estimated damage evidence a distribution concentrated around average values. This aspect highlights a limitation of the formulation [2] in estimating high or low damage classes for different vulnerability values.

The Formisano method, defining a low seismic vulnerability for the SAs of the case study, underestimates the possible damage in comparison with the one detected after the 2016 earthquake. The Ferreira method, similarly, results in average a lower damage class in respect to the real one. The median value of the real damage is found between the GDNT and the Vicente method, showing that the latter one better explains the aggregate effect for the considered case study, reducing not too much the seismic vulnerability. Considering the average vulnerability values obtained for the different approaches and changing the macroseismic intensity, it is possible to develop various damage scenarios following formulation [2]. The vulnerability curves (Figure 14) show the tendency of these methods to overestimate or underestimate the real possible damage even for different macroseismic intensities

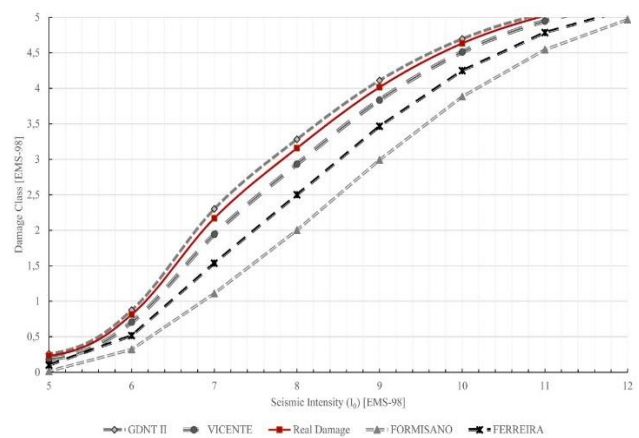
Figure 14. Vulnerability curves for different seismic intensities using the I<sub>v</sub> methods selected.
