Comparative structural analysis of polyurethane and silicone catheters of totally implantable venous access devices by micro-computed tomography

SAGE Open Medicine

Objectives: To investigate microstructural alterations of explanted long-term central venous catheters of totally implantable venous access devices, using micro-computed tomography.

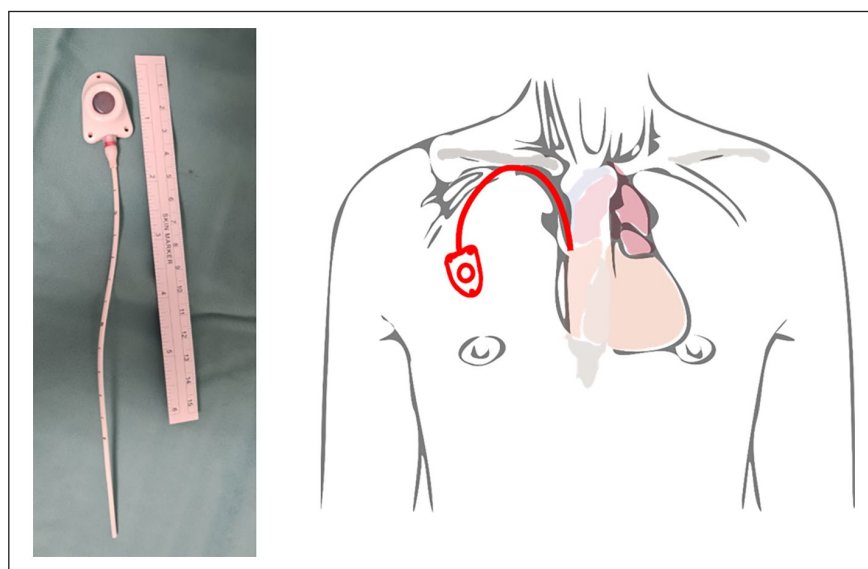
**Figure 1.** A real TIVAD (left) and a sketch showing its final positioning (right).

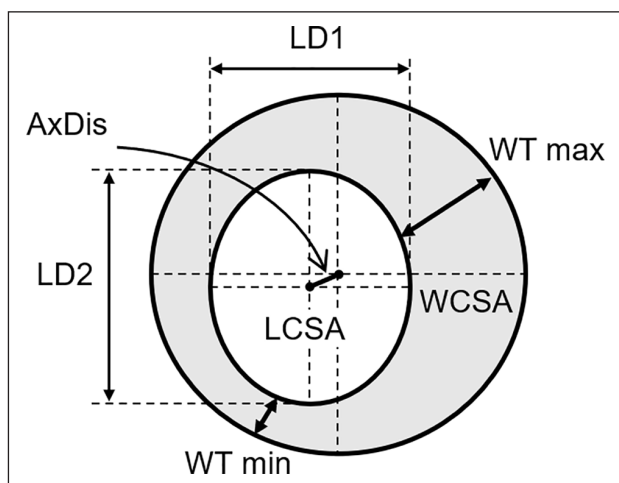
Figure 2. Conceptual scheme of the CVC cross section, with meaning of the geometrical parameters under investigation in this study. The drawing has been done with exaggerated WT variations and displacement between axes, in order to facilitate the visual understanding of the parameters.

Catheter segments on each bundle were independently analyzed using ImageJ ver. 1.53d (NIH, Bethesda, MD, USA).²³ Morphological analysis included the main parameters having a direct effect on mechanical resistance, such as catheter wall thickness (WT), wall cross-section area (WCSA) lumen minimum and maximum diameter (LD1 and LD2, respectively), lumen cross-section area (LCSA), displacement between axes of inner and outer surfaces (AxDis), as shown in Figure 2. Catheter section geometry was assessed

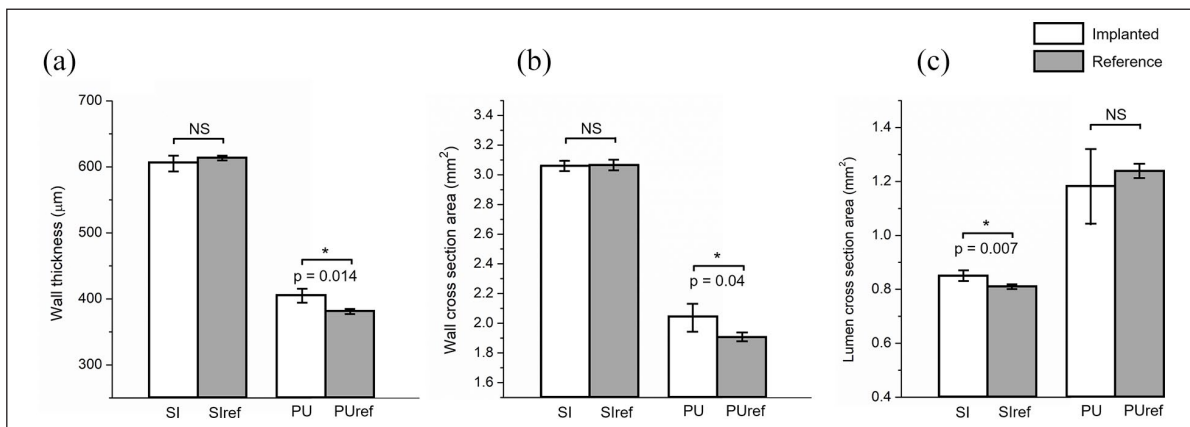
Figure 3. Main morphological parameters showing changes between the implanted group and the reference group: (a) WT, (b) WCSA, and (c) LCSA.

From a macroscopic point of view, the observation of the analyzed segments of CVC did not reveal evident abnormalities, ruptures or failures. The micro-CT quantitative morphometry has shown, as expected, the different section geometry between silicone and polyurethane catheters due to the different nominal caliber (6.5Fr for SI and SIref groups and 6Fr for PU and PUref groups, respectively). Analysis results are reported in Table 2. The graphs in Figure 3 highlight the main morphological changes observed between implanted and non-implanted catheters, for the two materials. While comparing implanted CVC morphology with corresponding control (reference) groups, we have observed that SI group showed increased luminal cross-section area with respect to SIref ($LCSA = 0.851 \pm 0.020 \text{ mm}^2$ in SI vs $0.811 \pm 0.007 \text{ mm}^2$ in SIref, $p = 0.007$). This change is related to the increased luminal diameter of the SI CVCs with respect to their controls ($LD1 = 1032 \pm 11 \mu\text{m}$ in SI vs $1014 \pm 6 \mu\text{m}$ in SIref, $p = 0.02$). This small ($< 20 \mu\text{m}$) diameter increase could suggest a drug-related erosion of the catheter material, even though we cannot exclude differences due to different batches of the catheters. We have also noticed an increased WT and WCSA in the polyurethane group as compared with the reference CVCs of the same materials ($WT = 403 \pm 12 \mu\text{m}$ in PU vs $382 \pm 4 \mu\text{m}$ in PUref, $p = 0.014$; $WCSA: 2.04 \pm 0.09 \text{ mm}^2$ in PU vs $1.91 \pm 0.03 \text{ mm}^2$ in PUref, $p = 0.04$), whereas no significant changes of the luminal diameters and area have been observed for this material. The increased thickness in implanted PU CVCs can not be only explained by the presence of biofilms, which in general have much lower thicknesses.

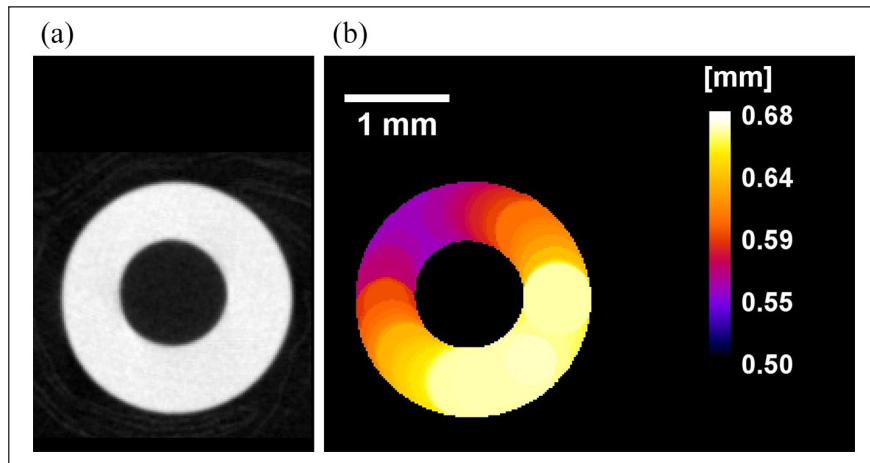
Figure 4. Strong heterogeneity of wall thickness shown by the S1 sample: (a) micro-CT slice of the catheter and (b) quantitative parametric thickness map showing the local thickness at each point of the wall.

(AxDis), was found to be particularly high for one silicone catheter (SI1) as shown in Figure 4. For this sample, $AxDis = 74 \pm 1 \mu\text{m}$, whereas average values were $26 \pm 28 \mu\text{m}$ for the SI group, $35 \pm 5 \mu\text{m}$ for the SIref group, $10 \pm 5 \mu\text{m}$ for the PU group and $8.3 \pm 3.8 \mu\text{m}$ for the PUref group. This resulted in a high difference between minimum and maximum WT for the SI1 sample ($\Delta WT = 127 \mu\text{m}$). Overall, the PU group performed better than the SI group in terms of cross-section geometry uniformity.

in the transverse direction. From a mechanical perspective, we cannot exclude that this type of defect may play a role in the failure process, especially during the explant procedure. Regarding the singular case of the S11 sample, showing a consistent displacement of the lumen axis with respect to the outer surface (see Figure 4), it is also worth verifying in

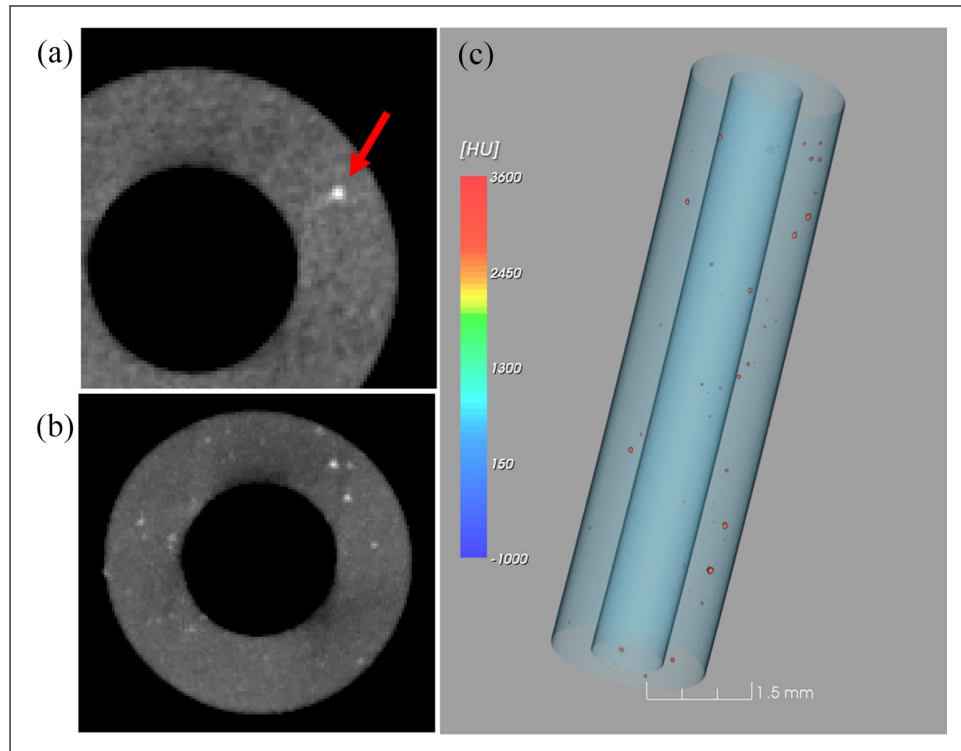
Figure 5. Severe-scored CVC for presence of hyperdense particles (S2 sample). (a) Micro-CT slice of the catheter (voxel size = slice thickness = 18.4 μm), passing through a hyperdense spot. (b) Maximum intensity projection (MIP) of the same sample in (a), integrated over 1 mm along the catheter axis, showing how frequently particles appear in the sample. (c) 3D volume rendering of the same sample, showing the hyperdense particles as red dots.

The local defect analysis showed different patterns between the two types of materials. All CVCs in this study presented hyperdense particles inside the wall. The observed (apparent) diameter of such particles ranged from 20 to $100 \mu\text{m}$ and have been found at random depths within the catheter wall. Six out of nine silicone catheters were affected by > 1 particle/cm, and two of them were scored as “severe” for this type of defect. On the other hand, only few smaller particles have been found in the polyurethane group. Figure 5 shows how these dense spots are distributed in one severe case.

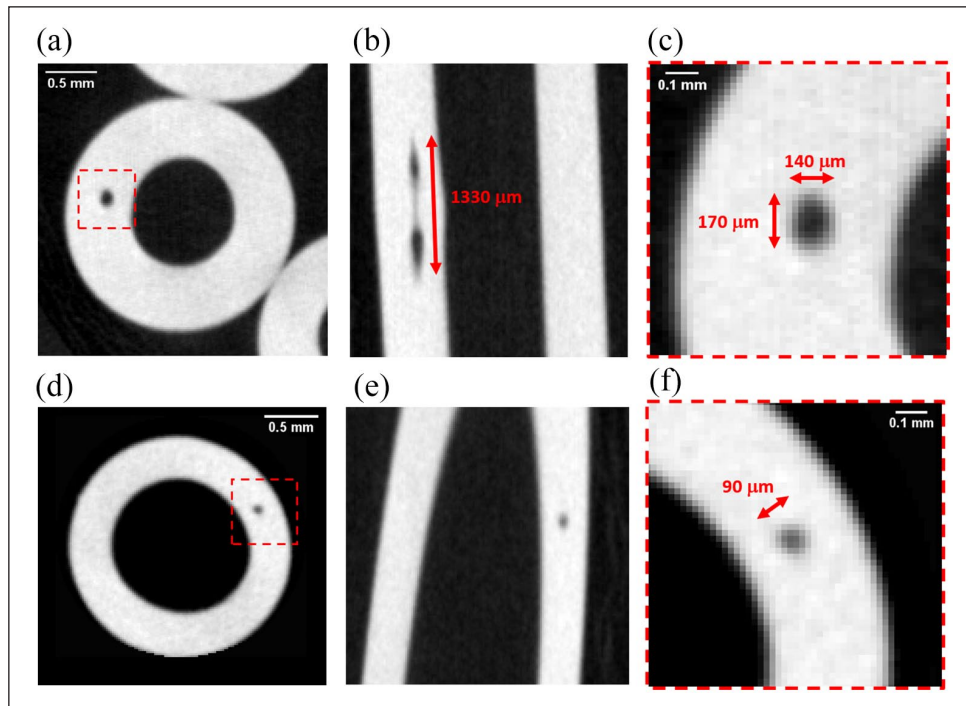
Figure 6. Biggest cavities inside the CVC wall among the samples under analysis, as found in the Slrefl sample (a, b, c) and PUl sample (d, e, f). (a) and (d) show the transverse section of the catheters at the point of maximum diameter of the cavities; (b) and (e) show a longitudinal cross section through the same cavities; (c) and (f) are zoomed views of the highlighted rectangles shown in (a) and (d).

In five samples (one for SI, three for SIref and one in PU), the presence of air cavities or gaps inside the wall was detected (see Figure 6). These gaps appeared less frequently than dense particles in the observed samples. The biggest one was found in the SIref1 CVC, having a maximum diameter of $170 \mu\text{m}$ and a length of $1330 \mu\text{m}$, as shown in Figure 6(a)–(c). All the air gaps had a random distance between surfaces and diameter $> 50 \mu\text{m}$.

have shown no dependence on type and duration of implant, but in some cases reached a size which is one-fourth of the thickness of the entire CVC wall. There is of course no conclusion, from this study's results, about which type of catheter material is better or worse from the point of view of the patient's safety. This is in line with current experimental evidence from several investigators so far.^{12,14,29–31} It is indeed true that polyurethane CVCs showed more geometrical uniformity and much less granularity inside walls, even though the second biggest air bubble was found exactly on this type of material in sample PU1 (ca. 90 μm in diameter, as shown in Figure 6(d)–(f)). The biggest air cavity was instead found in the unused silicone sample, SIref1 (see Figures 6(a)–(c))

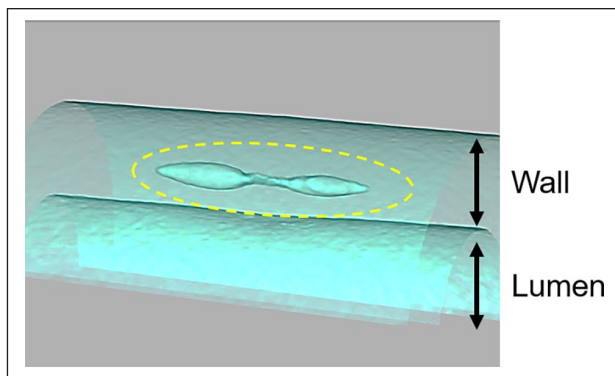
Figure 7. Three-dimensional volume rendering of a section of Slrefl sample, including the biggest observed air cavity (dashed line) among the analyzed samples. Transverse and longitudinal sections of this cavity were shown in Figure 6(a) and (b), along with dimensional annotations.

and 7) with a complex shape that can only be fully evaluated in 3D (Figure 7). That cavity had a maximum diameter of ca. 150 micron in the transverse cross section and was elongated in the direction of the catheter axis for a total length of about 1.3 mm. In both cases (SIref1 and PU1 samples), the observed cavity diameters were roughly one-fourth of the catheter WT
