FIREFIGHTER PORTABLE RADIO
CARRYING METHODS: POCKET OR
STRAP?

Nicholas Brondum
Masters of Science, 2022

Thesis submitted to the Faculty of the Graduate School of the
University of Maryland, College Park, in partial fulfillment
of the requirements for the degree of
Masters of Science
2022

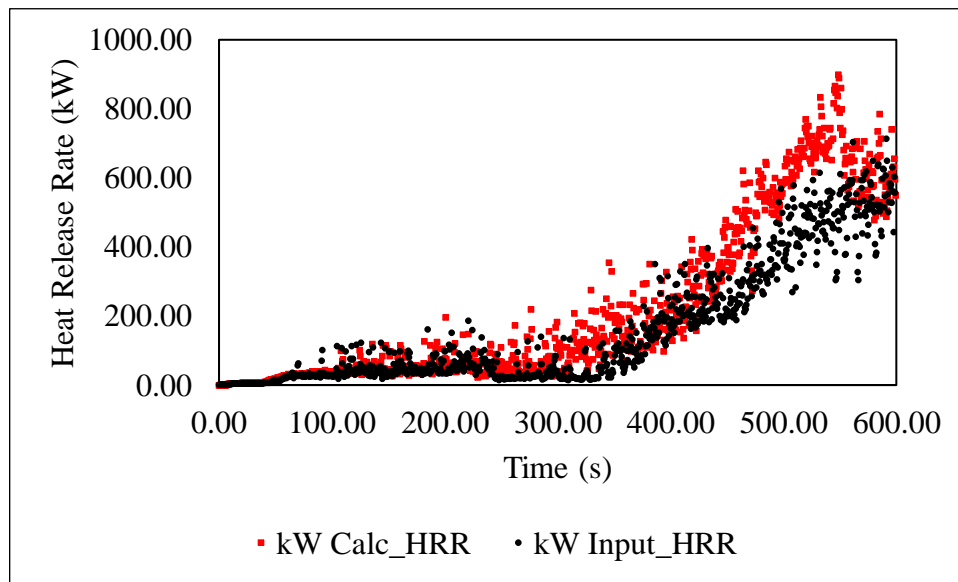
Figure 0.31: Living Room Simulation Heat Release Rate Curve

The final analysis conducted before reaching the heat flux for each individual firefighter is the heat release rate of the couch. While the couch presented at the beginning of this section was for the example case without any ventilation, the heat release rate curve presented below as Figure 3.31 is for the room that was modeled for this analysis. This graph also shows the heat release rate from the example simulation. The curves report similar curves, but the heat release rate data decreases at the end of the curve presented below. This is likely due to the decreased ventilation available in the compartment as it moves closer to flashover.

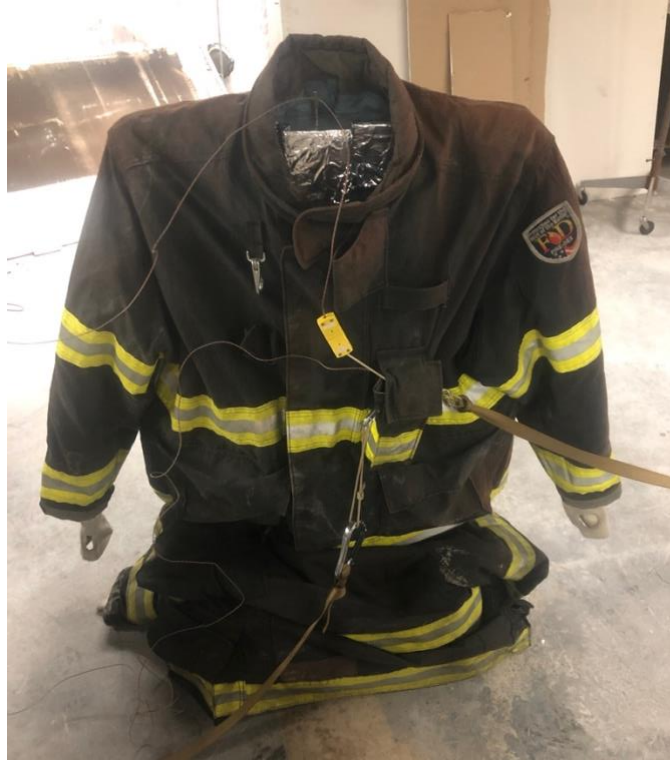
Figure 0.7: Radio Pocket R1 Setup Image

Many of these radios had quite similar failure times, excluding the first radio. This radio was tested without a shoulder microphone, using a bungee cord assembly to relieve pressure from the radio's PTT button. Images of the setup of this radio can be seen as Figure 4.7.

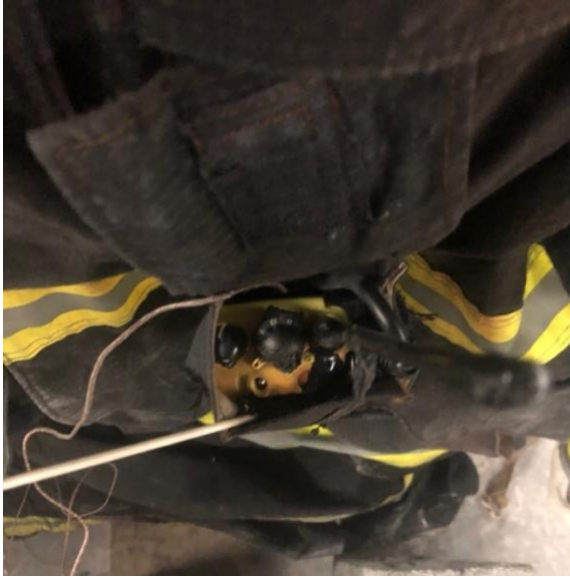
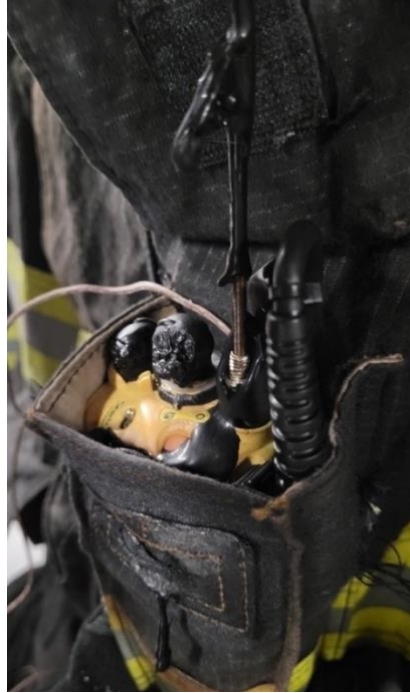
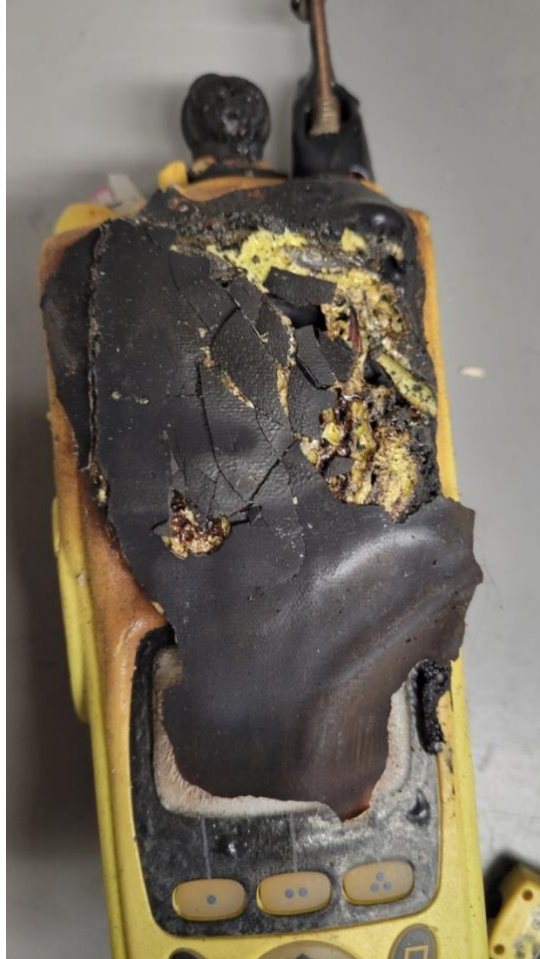
Figure 0.13: Radio B Damage Before Removal

Figure 0.14: Radio B Antenna and Knob Melting

Figure 0.17: Radio B Damage Close Up After Removal

The second test also served as a bit of an outlier as it was the longest test of any carrying arrangement that resulted in a failure. This radio was a more modernized radio than the others and used its own battery. The same style antenna was used for all radios. This radio experienced significant signal degradation about halfway through the test, but it was able to continue the test. The radio was unable to transmit after the test was completed. The radio and antenna both showed extensive damage. The radio had to be removed from the radio pocket with a knife as the rubber sheathing on the antenna melted during the test and coated much of the speaker of the battery. The rubberized channel selector and power knobs also showed significant damage, with the channel selector knob being left inoperable. A pair of pliers was used to power up the radio, but the radio remained unable to transmit after the test. Furthermore, the radio produced a chirp when powered up before the test, but this was absent after the test. Coupled with the extreme screen damage, it was not possible to determine if the radio could be powered on. Figures 4.13 through 4.17 show this damage.

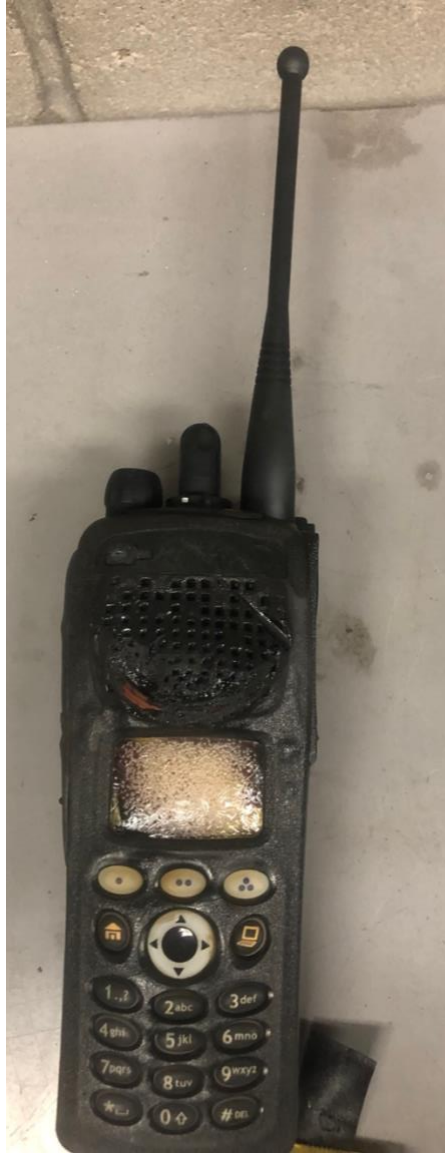
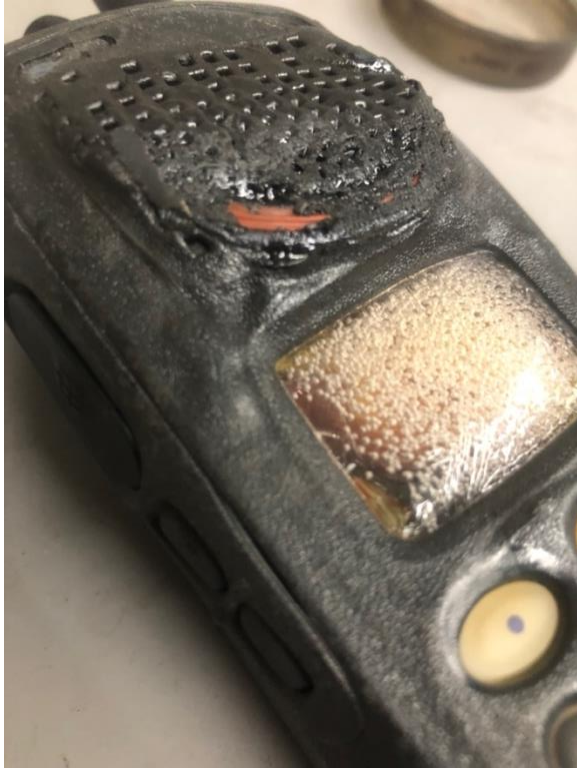
Figure 0.19: Radio C Damage After Pocket Test R3

Figure 0.20: Radio C Melting After Pocket Test R3

The third radio to be tested provided results which were consistent with the rest of the pocket radio tests. Note, this radio also did show some significant static about ten minutes into its exposure, but it was still able to transmit and receive. However, it did suffer the significant signal loss just over twenty minutes into the test, as depicted in Table 4.5. The radio also suffered significant visual damage. The screen was significantly crazed and unreadable. The top of the case also suffered melting and shape deformation, allowing some of the radio's internal components to be visible. Figures 4.19 through 4.21 show this damage. However, the radio and its battery continued to function with a new antenna. Both devices were used in subsequent testing.

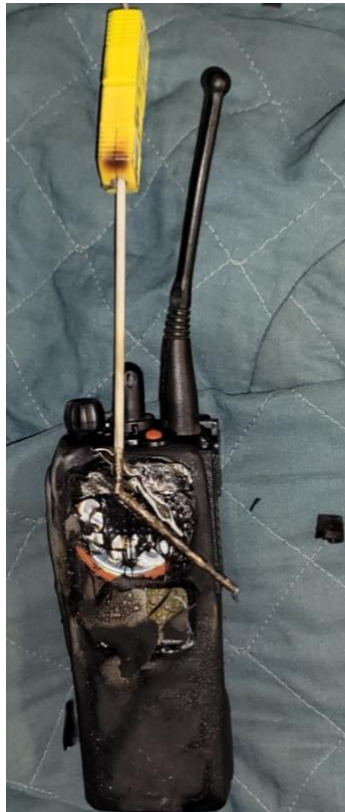
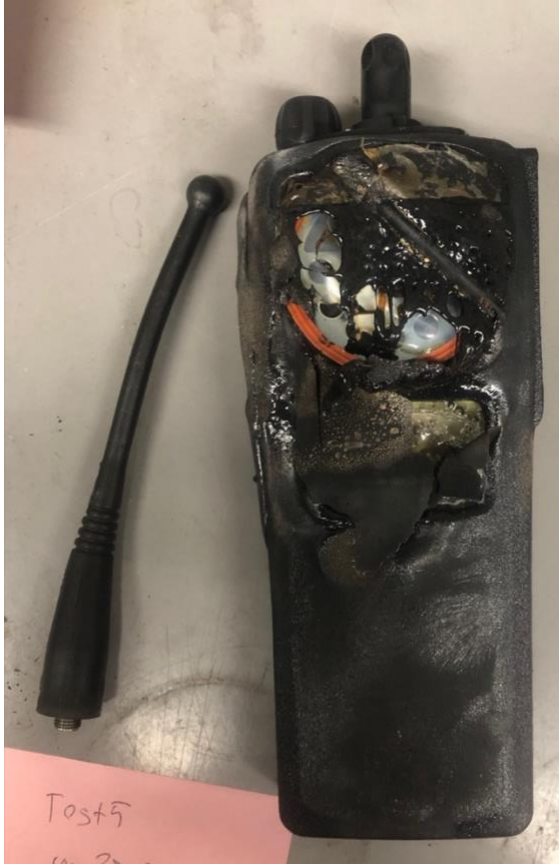
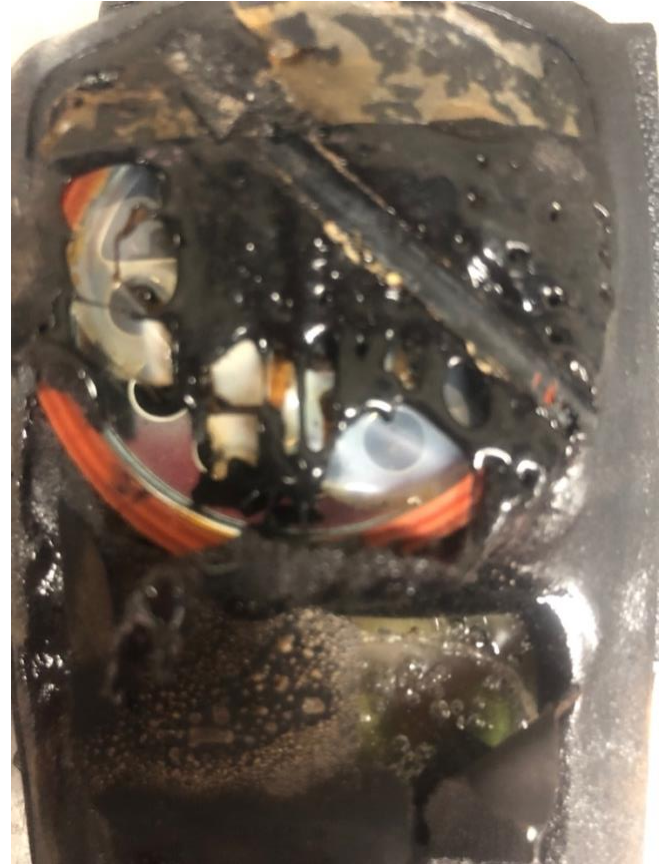
Figure 0.26: Radio C.1 and Thermocouple Damage After Removal After Pocket Test #5

Figure 0.27: Radio C.1 and Antenna
Damage After Removal After Pocket Test

Figure 0.28: Radio C.1 Damage Close Up
After Pocket Test #5

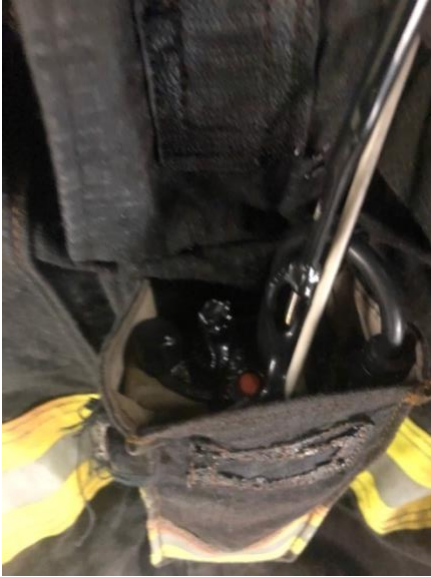
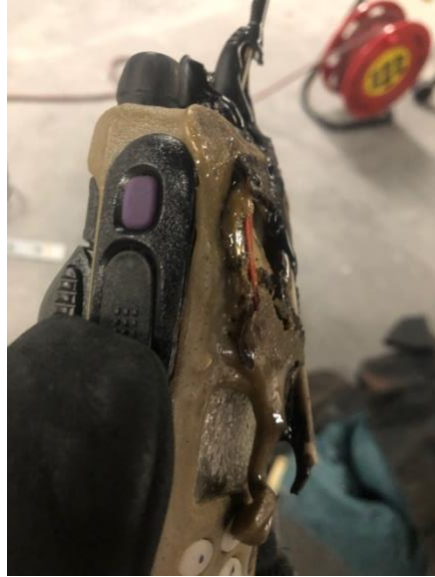
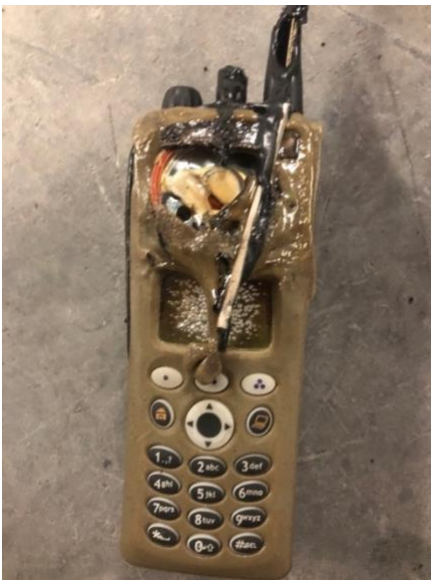
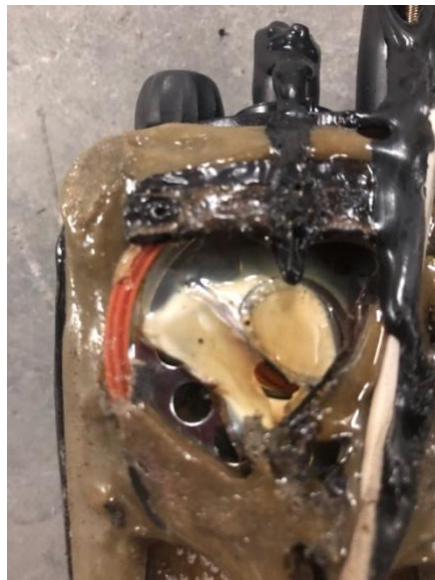
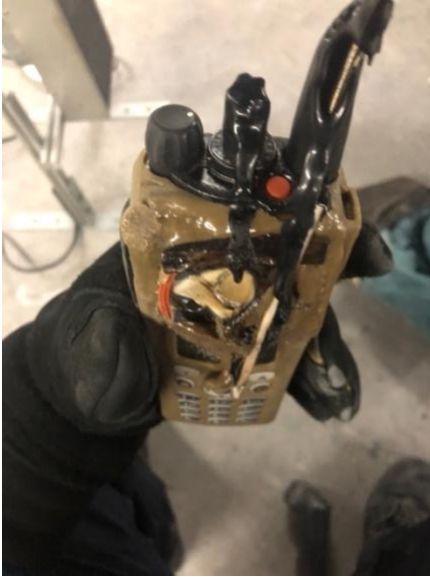
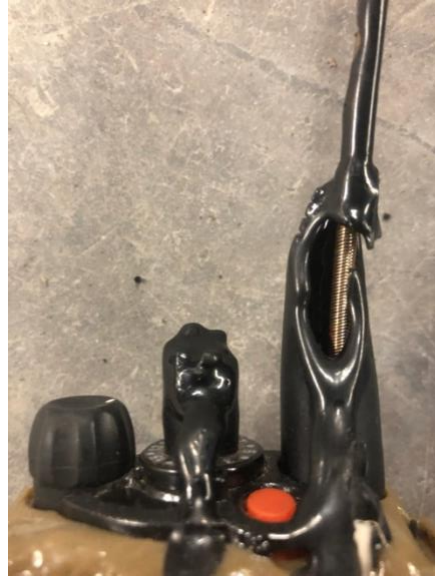
Figure 0.30: Radio A.1 Damage Prior to Removal After Pocket Test #6

Figure 0.31: Radio A.1 Damage Post Removal After Pocket Test #6

Figure 0.32: Radio A.1 Damage Post Removal After Pocket Test #6

Figure 0.33: Radio A.1 Damage Close Up After Pocket Test #6

Figure 0.34: Radio A.1 Top Damage After
Pocket Test #6

Figure 0.35: Radio A.1 Knob and Antenna
Melting After Pocket Test #6

The final pocket test conducted was the sixth test. The radio used for this analysis was the first radio used in the pocket testing. However, this radio lasted significantly longer during this final pocket test yet experienced significant thermal damage. The antenna's rubber sheathing melted significantly onto the face of the radio, again requiring the radio to be cut from the turnout coat pocket. The face temperature thermocouple also melted to the face of the radio, possibly explaining the erratic face temperature behavior. The radio casing itself also melted near the top of the radio, leaving plastic melted to the screen. Internal components of the radio were also visible at the conclusion of this test. At a cursory glance, this radio experienced more visual thermal damage than any other radio tested. Figures 4.30 through 4.35 attest to this extreme damage.

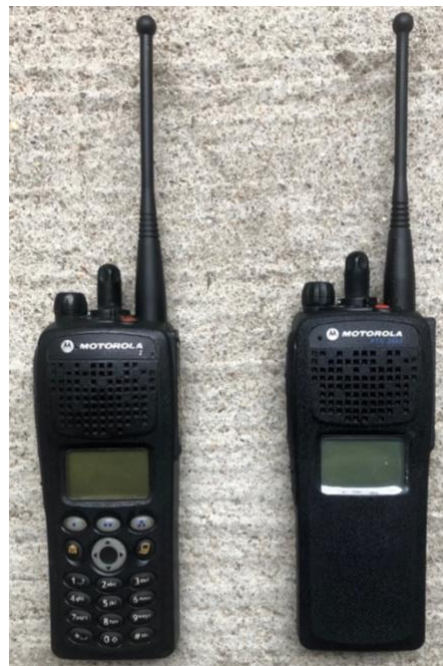
Figure 0.40: Radio Model A (L) and C (R).

While many of these trends were discussed above, Figures 4.38 and 4.39 show all of the temperature data for the radios worn in the turnout coat pocket. While the failure times may be quite different, there are a few possible explanations that can be made. The first is the radios themselves. All Radios with an A prefix had a keypad, meaning that numerical entries could be made on the radio. While firefighters rarely use these functions, many radios remain equipped with these buttons. However, while the functionality is increased in these radios, the apertures allow for more heated air to enter the radio and to increase the internal temperature. Because the radios have the same size vents located at the rear of the radio facing the battery, this heat is dissipated at the same rate in both A and C model radios. Therefore, Radio A models were more susceptible to thermal soak damage. Figures of these two different models can be seen below in Figure 4.40.

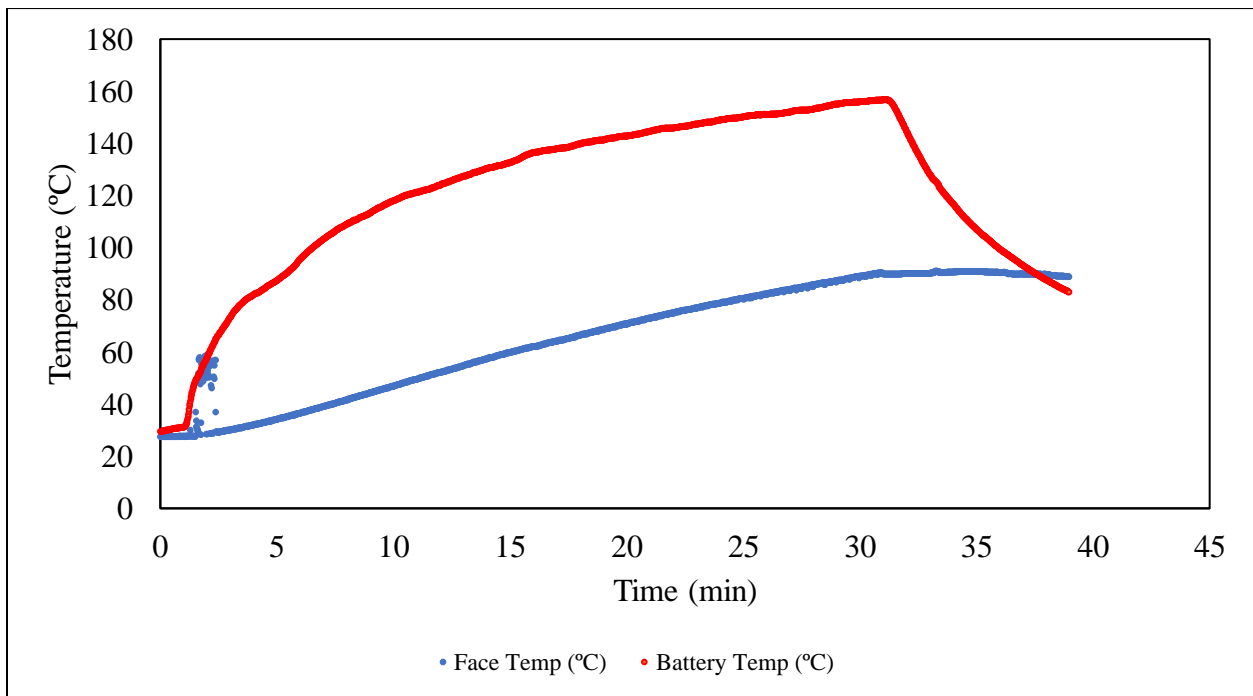
Figure 0.50: 12 kW/m^2 Radio Strap Test #1 Temperature

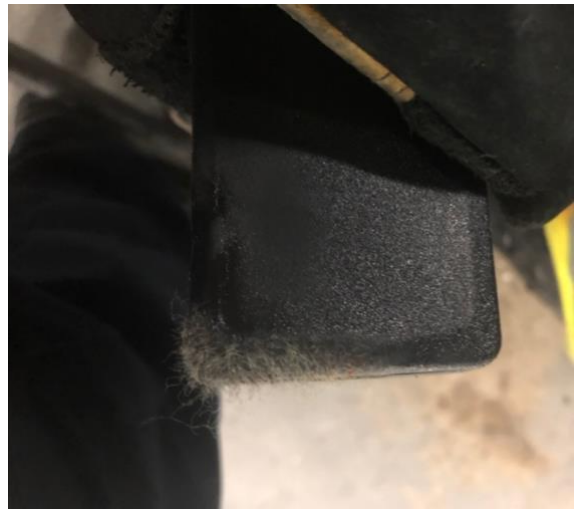
Figure 0.52: Radio E.4 Thermal Damage
After 12 Strap Test #2 Close Up

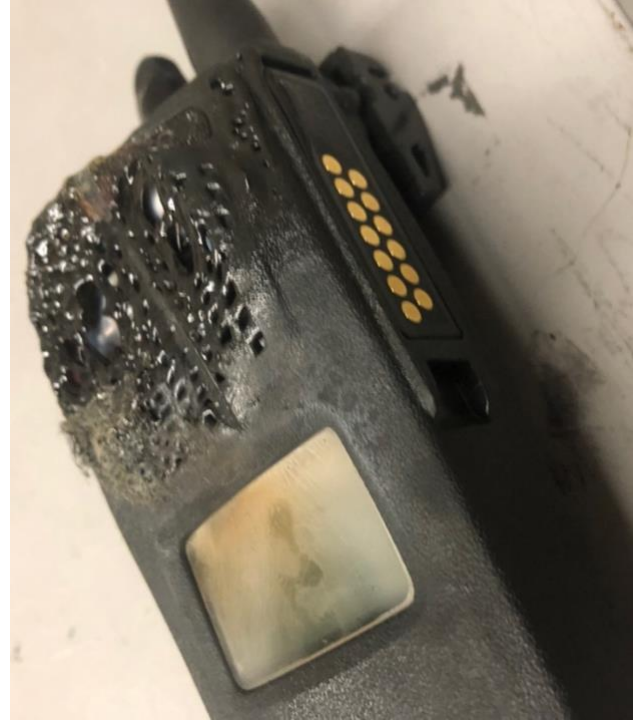
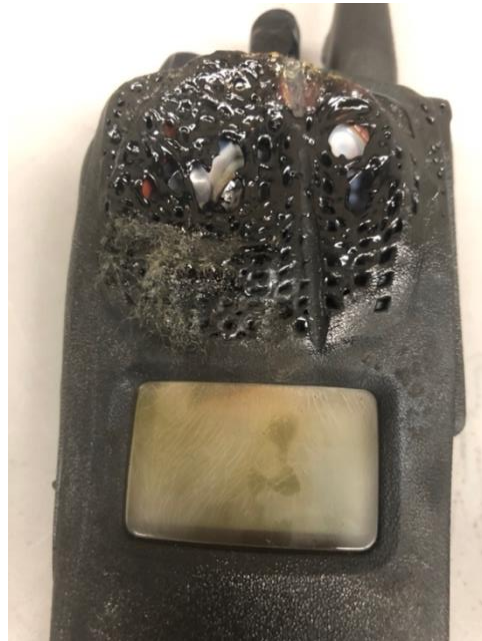
Figure 0.63: Radio E.6 Melting After 12 Strap Outside Test #1

Figure 0.64: Radio E.6 Melting Close Up After 12 Strap Outside Test #1

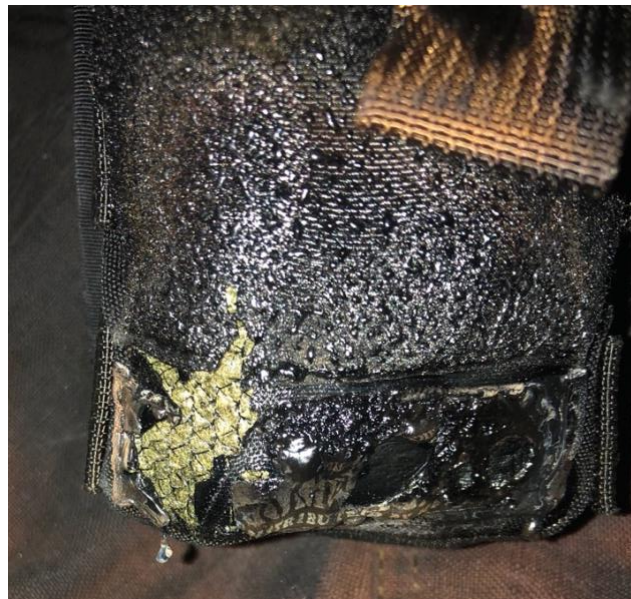
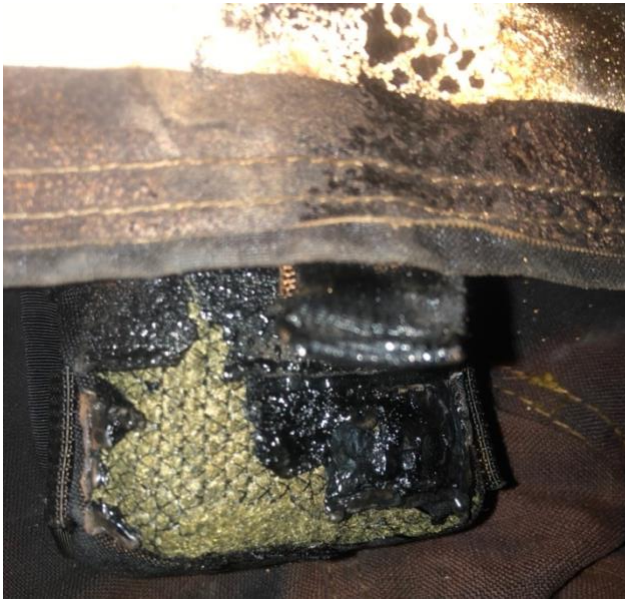
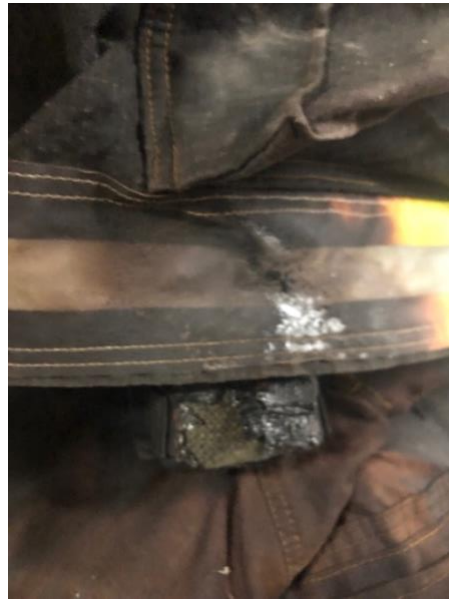
Figure 0.66: Radio Strap Degradation Between Tests

Figure 0.67: Nylon Radio Strap Label Melted After Testing

Figure 0.69: Radio Strap and Reflective Trim Damage

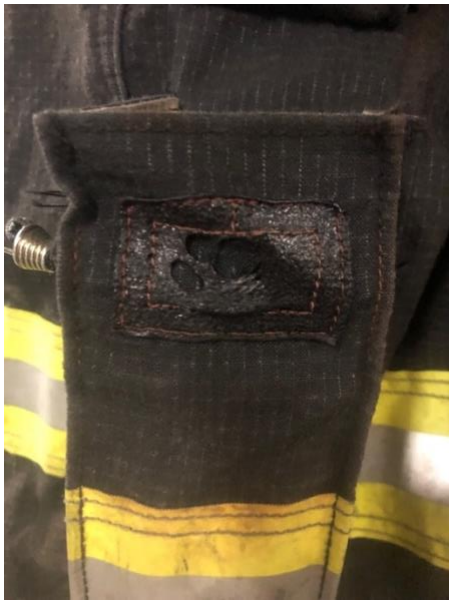
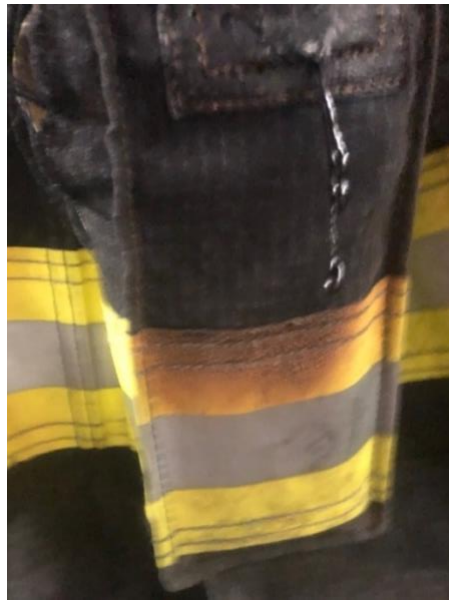
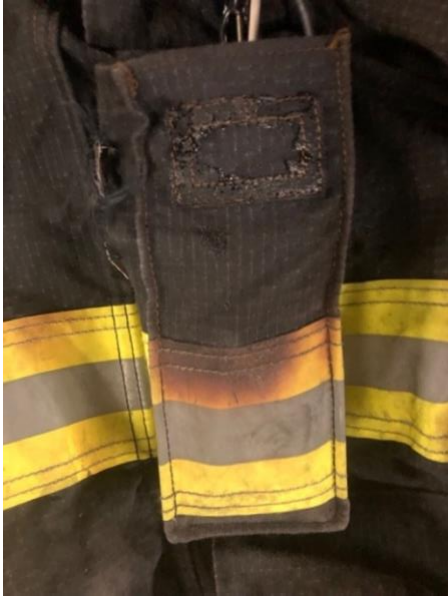
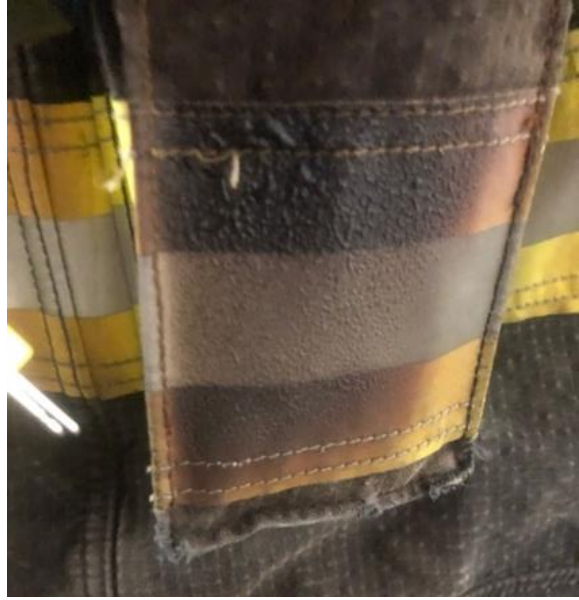
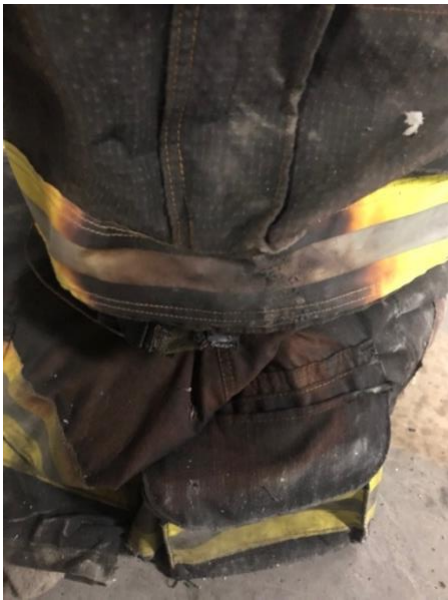
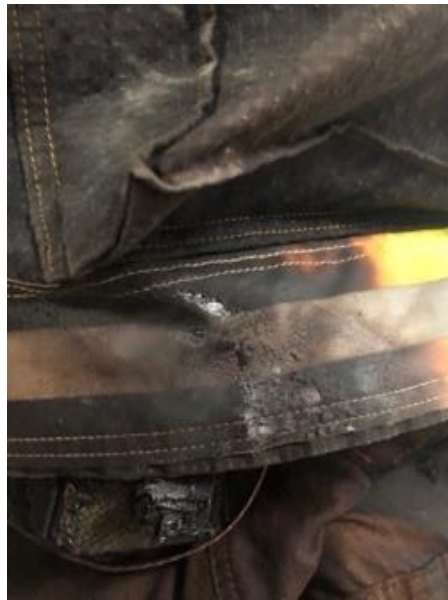
Figure 0.68: Turnout Coat Radio Pocket Closure Degradation after Pocket Test #1

Figure 0.70: Radio Pocket Closure Dripping After Pocket Test #2

Figure 0.71: Radio Pocket Closure Completely Degraded

Figure 0.72: Radio Pocket Trim Degradation

Figure 0.73: Trim Degradation and Turnout Gear Discoloration

Figure 0.74: Trim Damage After Strap Tests
