## Inspection of Flexible Fillers in Post-Tensioned Bridges

A Thesis Submitted to the College of Engineering, Department of Civil Engineering  
In Partial Fulfillment of the Requirements for the Degree of  
Master of Science in Civil Engineering

August 2022  
Embry-Riddle Aeronautical University  
Daytona Beach, Florida

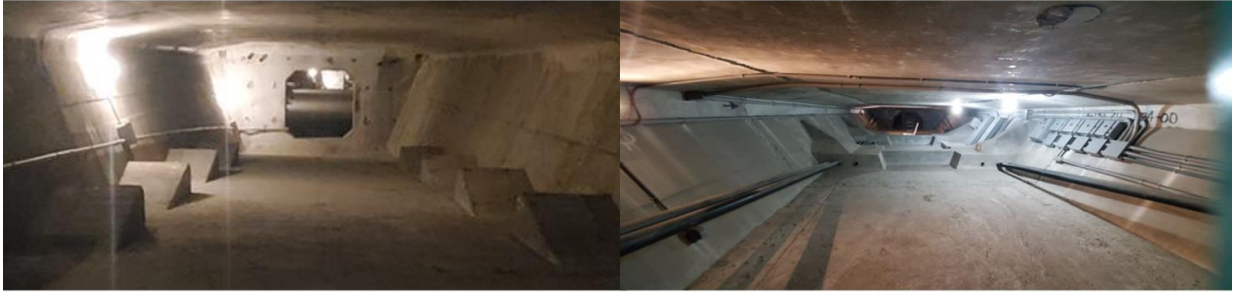
**Figure 3: Seabreeze Bridge (Left), Broadway Bridge (Right)**

There are two different kinds of post-tensioning ducts utilized in bridges: internal and external ducts. Internal ducts are embedded within the structure, which makes them difficult to access and inspect. This topic is explained more in the Radiography Section. External ducts are not embedded in the concrete, allowing for easier less intrusive inspections. External ducts are preferred by inspectors, allowing for a clear visual when performing field inspections. The differences can be seen below in Figure 3, which were taken from the Seabreeze and Broadway bridges, located in Daytona Beach, Florida. Both the eastbound and the westbound Seabreeze bridges are constructed with internal ducts, whereas the Broadway bridge utilizes external ducts. Both types of ducts run along the length of the bridge girders in these two examples. The Broadway bridge's external ducts allow for easy access, whereas the ducts utilized in the Seabreeze bridges are instead embedded in concrete.

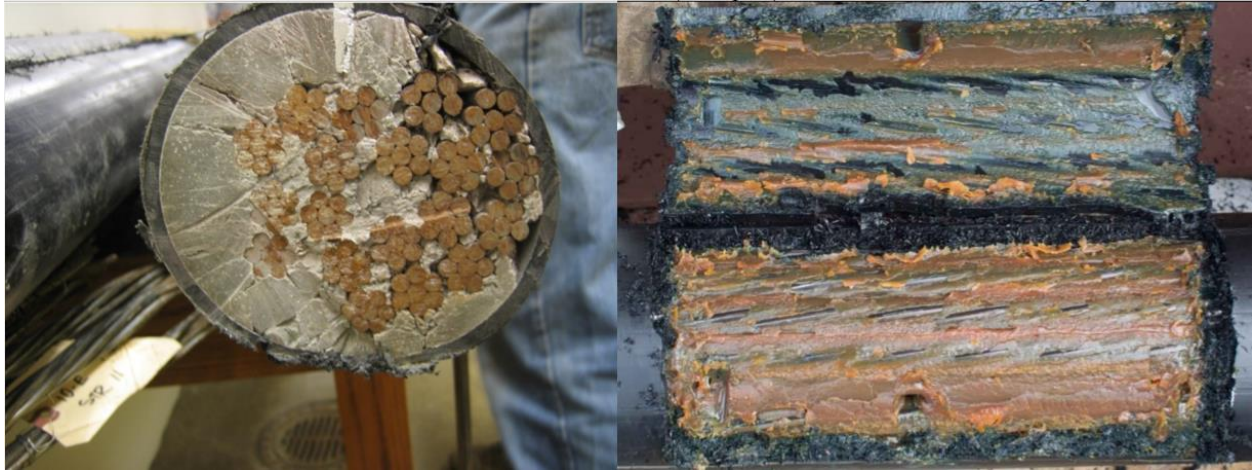
**Figure 4: Duct filled with CG (Left) (FHWA, 2014), Duct filled with FF (Right) (Hamilton et al. 2017)**

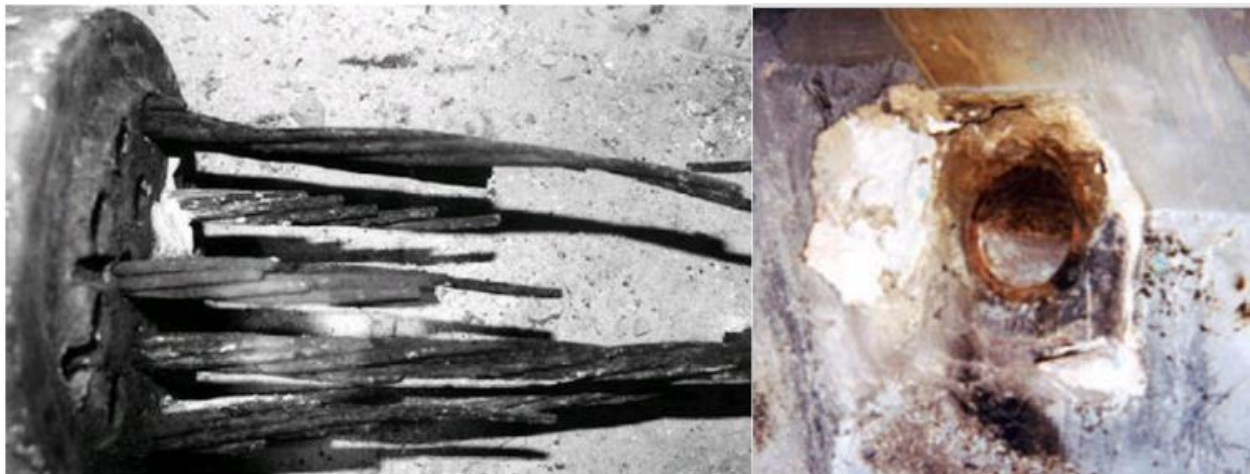
**Figure 5: Corrosion of strands in the anchorage (Left), Anchorage of the Failed Tendon with Water Staining from the Leaking Expansion Joint (Right) (FDOT, 2002)**

The 1999 biennial inspection of the Niles Channel Bridge led to the discovery of failed longitudinal PT tendons. In this case, the boot connecting the duct to the steel pipe at the expansion joint was opened which led to active corrosion of the PT strands in the tendon (FDOT, 2002). This tendon was then quickly replaced to avoid further damage to the bridge. Once removed, inspectors noticed voids and pitting of the strands within the failed tendon. This failure was attributed to bleed water segregation initially, but after further investigation they learned that ocean salt spray was leaking into the expansion joints onto the anchorages and then into the duct, thus further corroding the strands/anchorages. After this incident, FDOT worked to better understand PT bridges and performed multiple different NDE methods such as MFL & Impact Echo to identify any other voids/defects that could be present within the bridge. After this incident, FDOT worked to control the grout quality and grouting techniques to further prevent possible voids in future ducts.

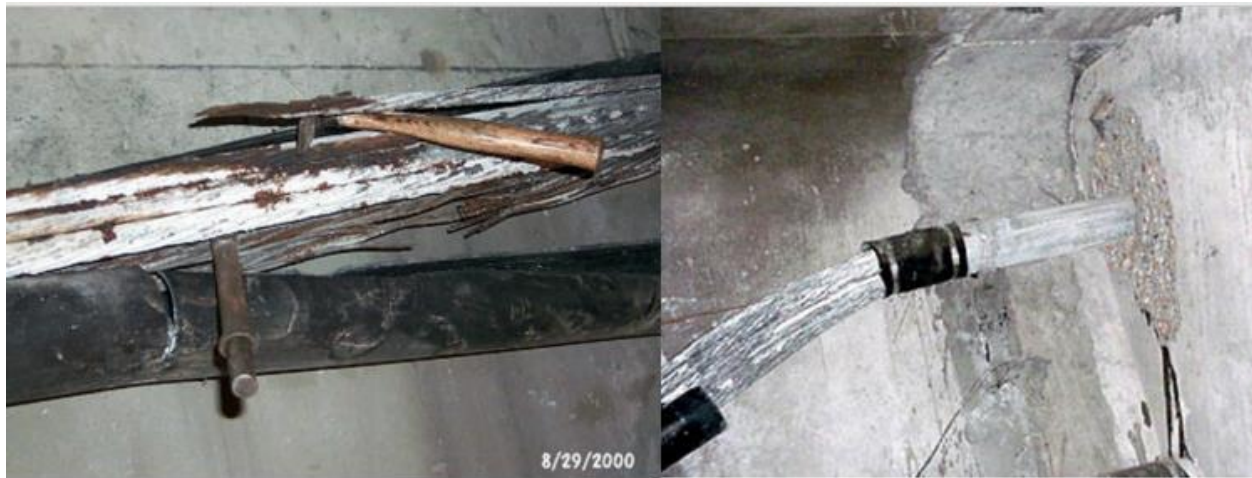
**Figure 6: Tendon failures on the Mid-Bay Bridge (FDOT, 2002)**

of isolated corrosion which was caused by a breach in the duct, allowing for excess moisture to enter (FDOT 2002). The second tendon failed due to corrosion that occurred in the anchor head, similar to the Niles Channel Bridge failure. The Mid-Bay bridge failure led to emergency inspections consisting of visual assessments, sounding of the ducts, borescope investigations, MFL, and vibration testing (FDOT,2002). After more in-depth inspections, 11 corroded tendons were discovered and quickly replaced. This incident led to additional precautions from FDOT including the use of prebagged grout and extensive inspections during construction.

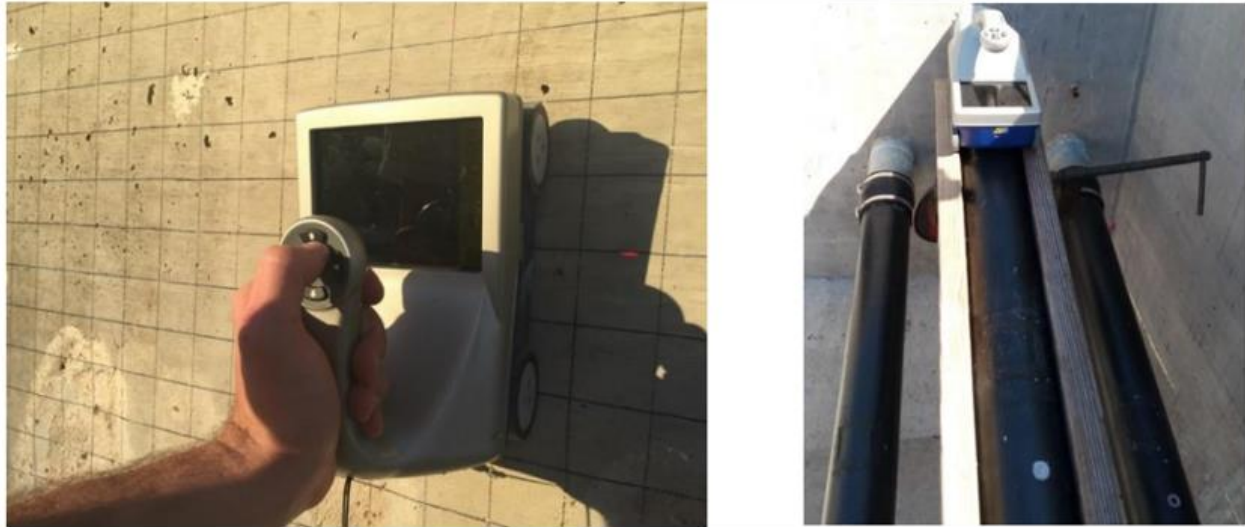
**Figure 7: StructureScan Mini HR GPR unit (Left), GPR unit inspecting the external tendons (Right) (Hurlebaus, Hueste, Karthik, and Terzioglu, 2016)**

In this study, GPR was able to accurately show the profile of the metal ducts due to the strong reflections they produce, however the scans were not able to detect any strand or grout defects within the ducts as expected. The HDPE duct profiles were also identified when using GPR but produced weaker reflections when compared to the metal ducts. GPR produced more promising results while scanning the external tendons and was capable of detecting voids along with some water infiltration in the ducts. When used upon the deviator region, the metal ducts were detected, yet none of the defects in the ducts were identified.

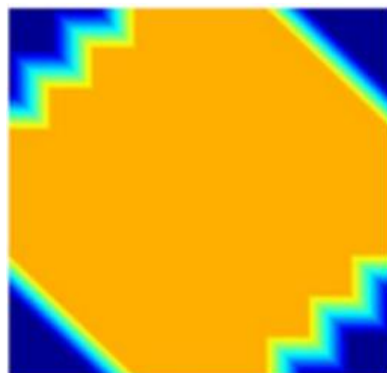
No faults

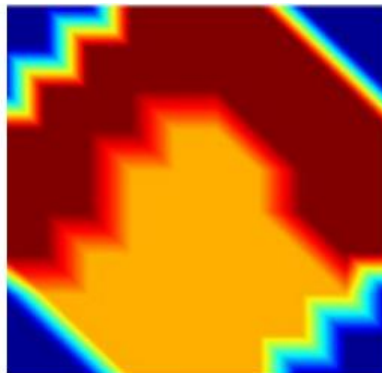
Red indicates moisture  
(water/bleeding grout)

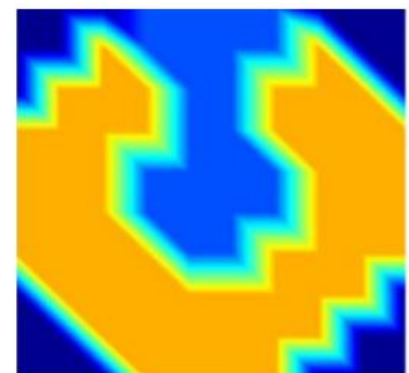
Blue indicates  
air void

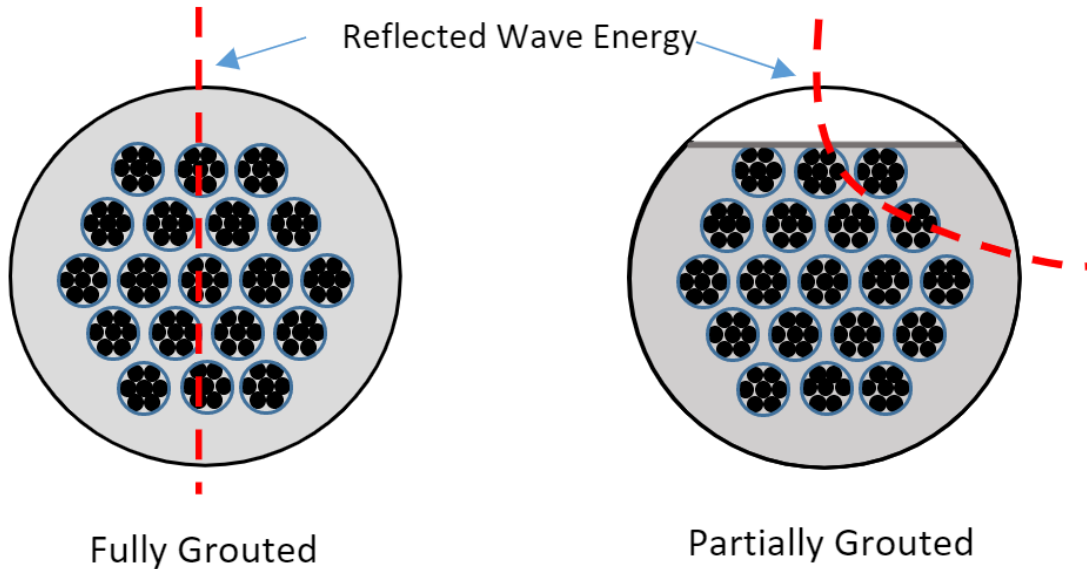
**Figure 9: Reflected wave energy propagating through a duct**

the impact joint (Hurlebaus, Hueste, Karthik, and Terzioglu, 2016). This method can detect voids in metal and HDPE internal ducts. The impact device can measure the wave energy which is depicted below. A fully grouted duct will emit a current passing straight through the duct, while a voided duct will behave differently and veer off.

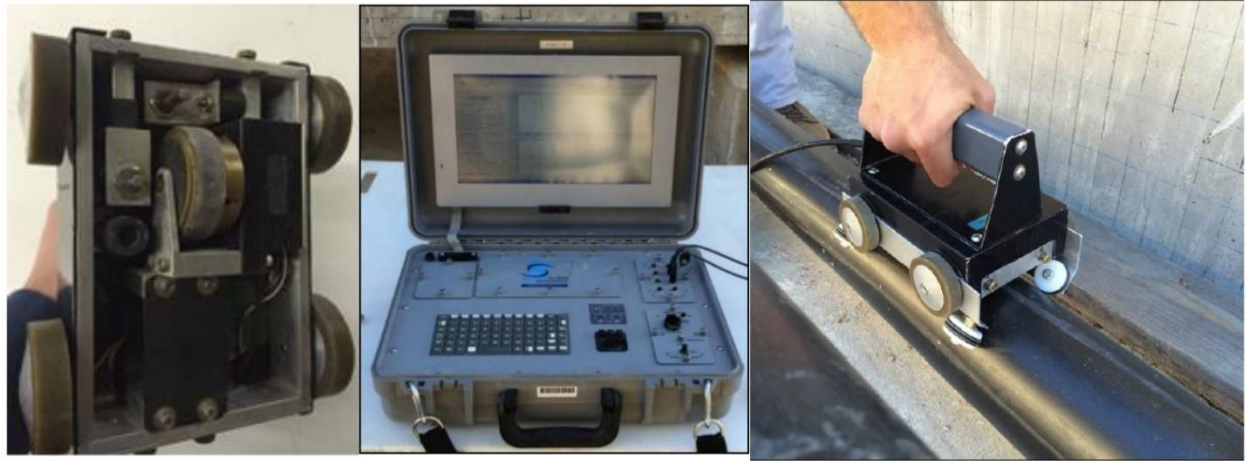
**Figure 8: (Left) Shows the IE scanner test head, (Middle) Shows the PC data acquisition platform, (Right) Shows the IE device in use on an external duct (Hurlebaus, Hueste, Karthik, and Terzioglu, 2016)**

In the study, “Condition Assessment of Bridge Post-Tensioning and Stay Cable Systems Using NDE Methods,” the IE method was utilized on an internal and external PT girder system using an Impact Echo Scanner test head and a PC data acquisition platform as seen below. Once GPR was performed to determine the location of the ducts, an impact echo test was performed at 6” intervals as determined by the inspector.

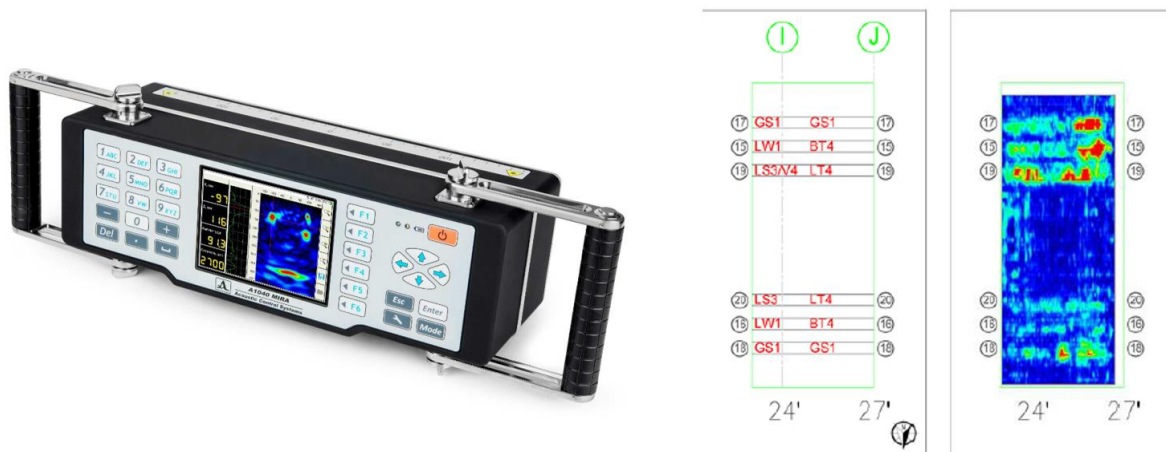
**Figure 91: (Left) A1040 MIRA device, (Right) results from the deviator blocks (left is defect key and right is the UST scan) (Hurlebaus, Hueste, Karthik, and Terzioglu, 2016)**

Ultrasonic Tomography (UST) consists of reflecting ultrasonic waves at a material and measuring the change in acoustic impedance to identify grout defects in internal ducts. In the study “Condition Assessment of Bridge Post-Tensioning and Stay Cable Systems using NDE Methods” UST was tested upon a 75’ long PT bridge girder along the anchorages and deviators. The device used for this test was the A1040 MIRA as seen in Figure 12 which has many applications such as the identification of voids, rebar, cracks, and substance filled cavities.

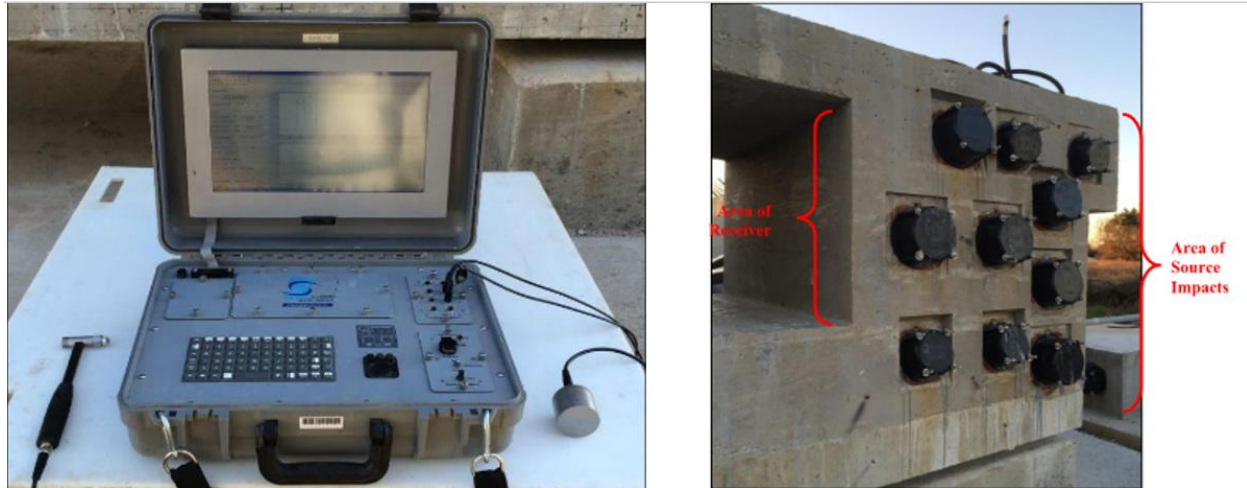
**Figure 102: SPV testing system along with impulse hammer, data acquisition system PC and ultrasonic transducer (Left), Photograph showing location of source impact and receiver for SPV testing (Right) (Hurlebaus, Hueste, Karthik, and Terzioglu, 2016)**

pylon anchorages to assess internal grouting conditions. This testing required a source and a receiver which can be seen below.

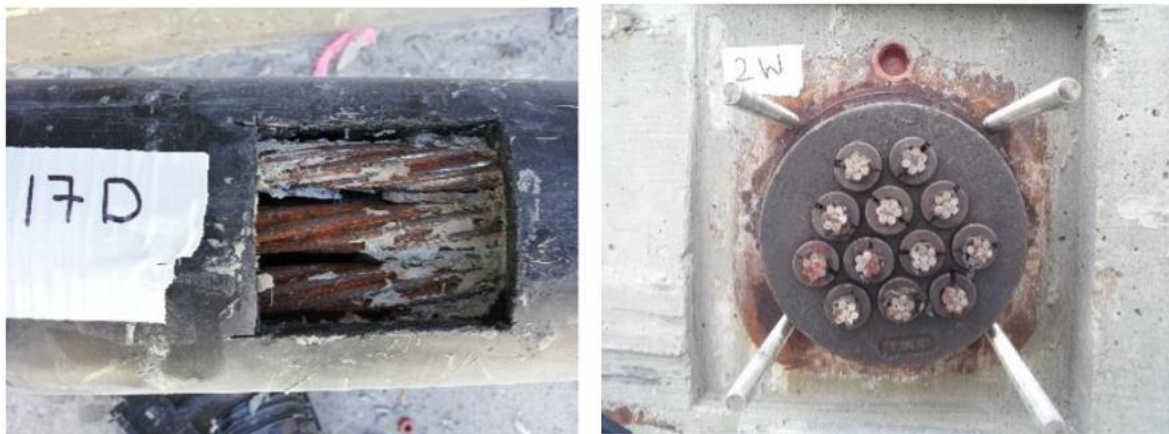
**Figure 113: Visual testing of an external tendon (Left) and end cap (Right) in PT Girder Specimen (Hurlebaus, Hueste, Karthik, and Terzioglu, 2016)**

Visual testing is effective in detecting grout defects, corrosion, or any kind of deterioration that could negatively affect the structure. Visual testing is effective for internal and external tendons, however internal tendons pose more difficulties of accessibility to the tendon resulting in VT being less common in these scenarios. In terms of external ducts, visual testing is one of the more common methods utilized to detect abnormalities. Visual testing consists of opening the duct or end cap in areas that are a cause for concern and looking inside to determine the state of the strands. Images of this can be seen below from the study “Condition Assessment of Bridge Post-Tensioning and Stay Cable Systems Using NDE Methods”.

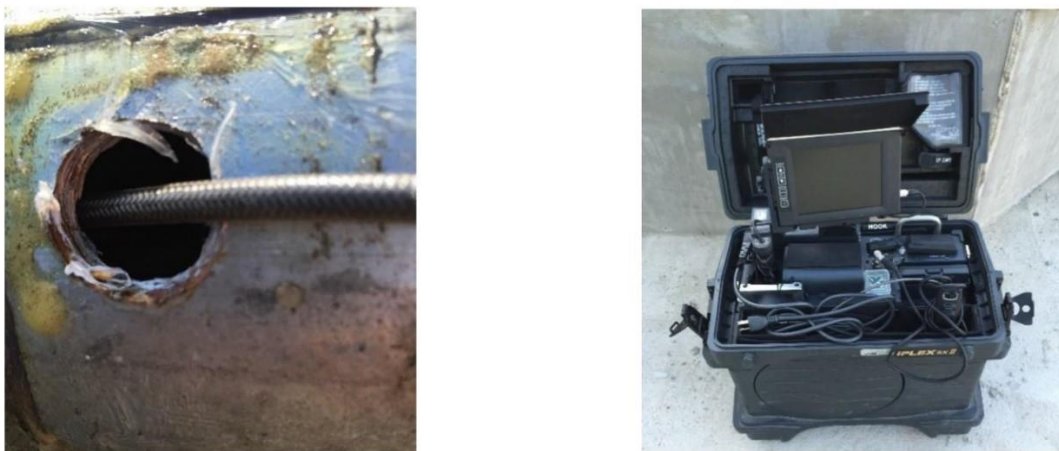
**Figure 124: Depicts the borescope access port and the equipment used (Hurlebaus, Hueste, Karthik, and Terzioglu, 2016)**

Another tool that is utilized by bridge inspectors is the Borescope. This method is more invasive than some of the other NDE techniques, so it is sometimes referred to as a semi-destructive method, as it requires creating an access port for the borescope to enter through. This method is effective for determining voids and corrosion in both internal and external systems. This method is deployed once sounding or visual testing is completed and detects degradation of the grout or strands. This method allows the inspector to observe the corrosion or voids within the duct by running the borescope inside the system. In the study, “Condition Assessment of Bridge Post-Tensioning and Stay Cable Systems Using NDE Methods” the inspectors drilled access holes and used an Olympus IPLEX SX ii system as seen below.

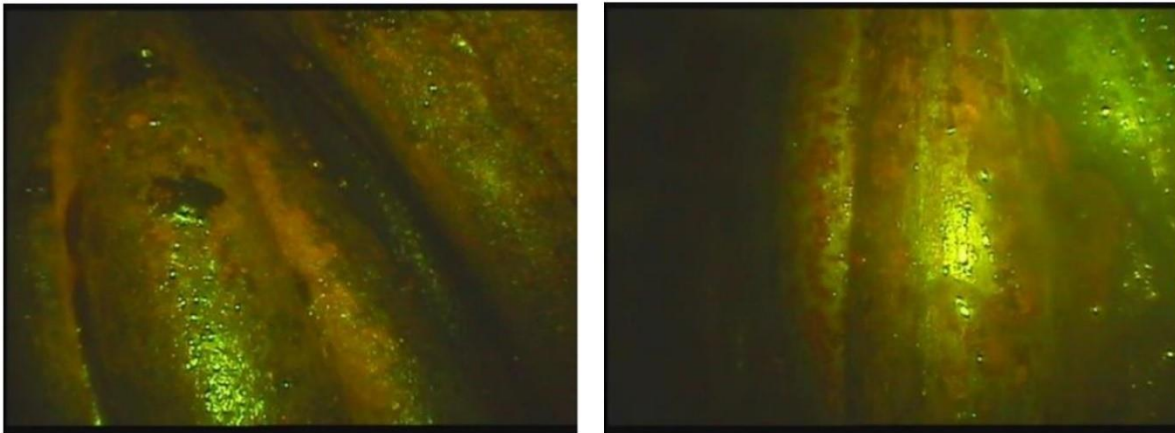
**Figure 15: Images provided by the borescope inspection inside the external tendons depicting corrosion of the strands (Hurlebaus, Hueste, Karthik, and Terzioglu, 2016)**

In this study, four external ducts were investigated along with the anchorages. The borescope was able to show voids, water infiltration defects, and corrosion of the strands which can be seen in the images below. This method is a more accurate representation of what is occurring within the ducts, which allows the inspectors to see the state of the tendons and decide on how, where, and if repairs are necessary to keep the structural integrity of the bridge.

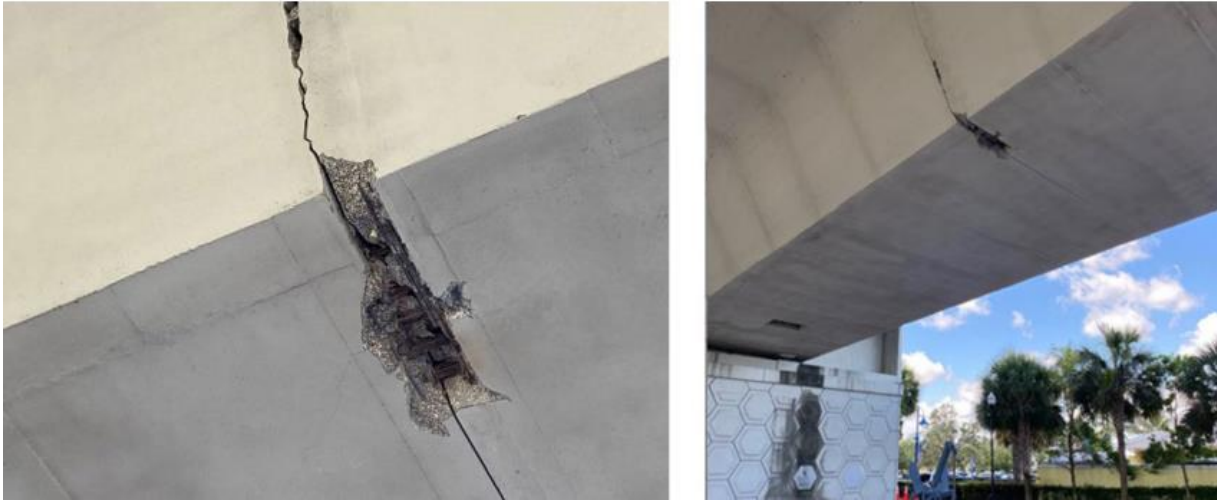
**Figure 13: Localized corrosion damage for internal tendon in Stuart, FL (Roustan and Erblat, 2020 & Detman and Rodriguez, 2020)**

An example of a bonded system failure is the Roosevelt Bridge in Stuart, FL. In 2020, this bridge experienced corrosion damage due to a poorly constructed closure pour (as previously stated in Chapter 1) and, as a result, showed some severe visual indicators such as those in figure 16 below.

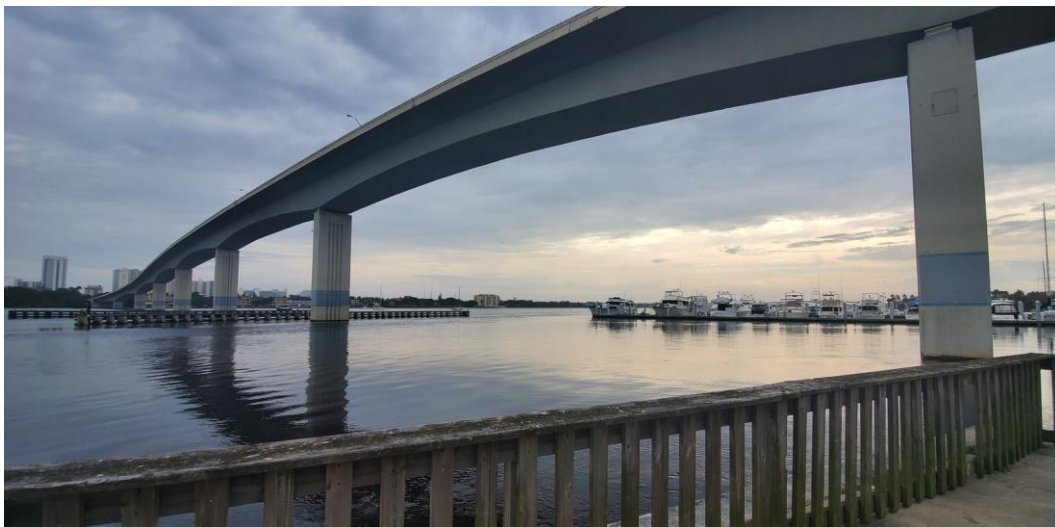
**Figure 14: Seabreeze Bridge**

Seabreeze Bridge is a PT segmental box girder bridge in Daytona Beach. During an inspection on the eastbound section of this bridge, insight was gained on the normal operating procedures of FDOT inspectors.

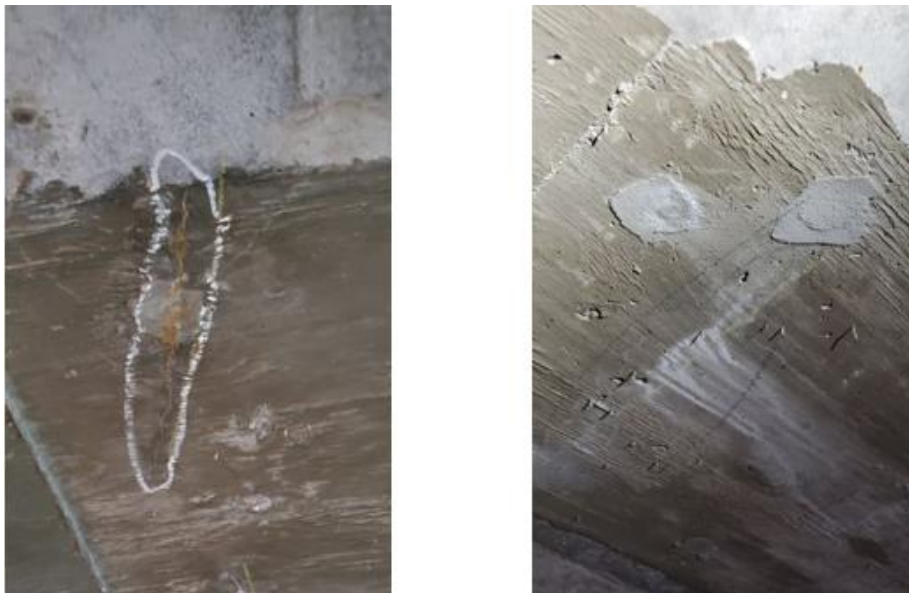
**Figure 15: Example of cracking (Left) and efflorescence (Right) from the eastbound Seabreeze Bridge Inspection**

Examples of visual indicators found during the Seabreeze Bridge inspection are shown in Figure 18 below. There was some cracking that appeared, along with efflorescence. Efflorescence is a white salt residue that occurs as moisture migrates up to the surface of the concrete. This white substance is the calcium salts from within the concrete that traveled up with the excess moisture. Now efflorescence isn't necessarily always an indication of major defects within the bridge, it does indicate moisture intrusion, which can usually lead to corrosion of any reinforcement within the bridge.

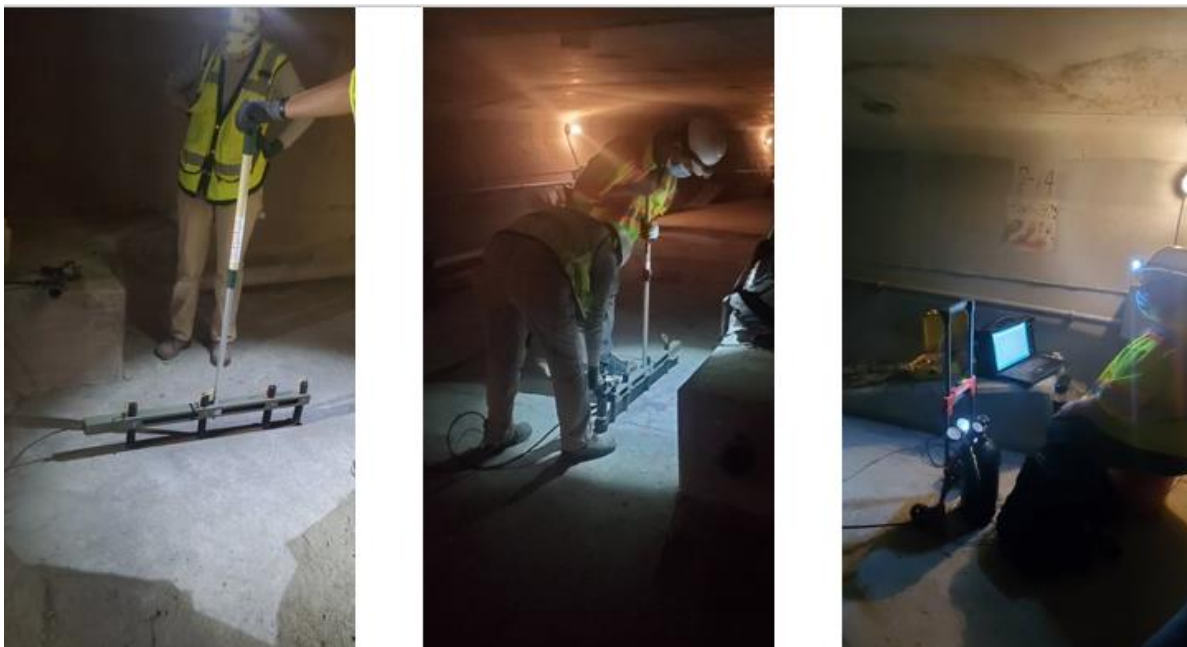
**Figure 16: Impact Echo NDE performed on Seabreeze Bridge**

method, the inspectors identified areas of the bridge that required more in-depth testing, which led to the IE testing that was performed. This IE testing was used to evaluate the closure pours and can be seen in Figure 19. The device used for this testing was a tool developed by Vector Corrosion Services who performed this inspection. The impactor was used to propel a stainless-steel BB into the concrete surface, while ultrasound transducers were positioned adjacent to the point of impact. The data acquisition system can also be seen in the figure. This IE testing required highly skilled operators that were extensively trained to use this equipment. The set-up for this equipment was minimal and lightweight, however it required constant power and a pressurized nitrogen source for the impactor.

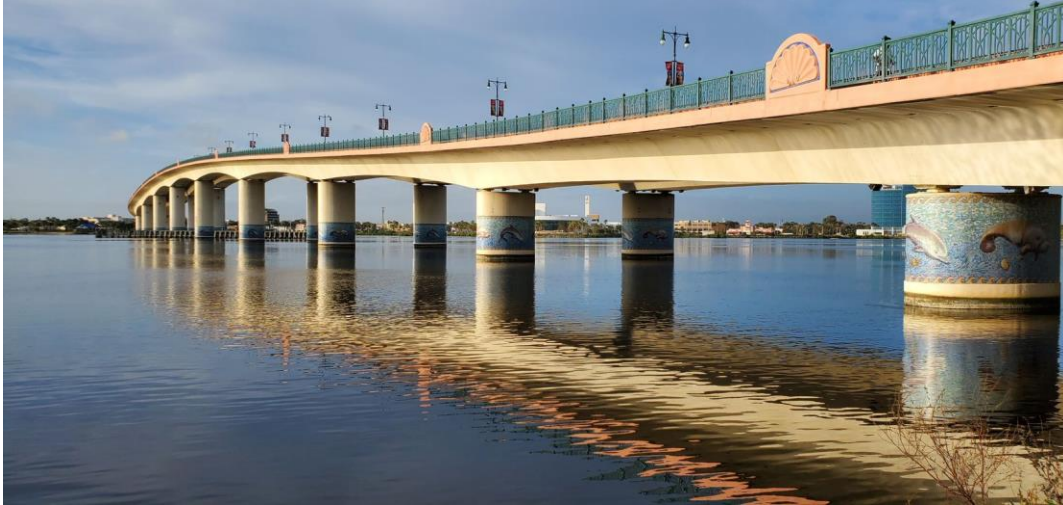
**Figure 17: Broadway Bridge**

Broadway Bridge is another PT segmental box girder bridge in Daytona Beach, FL. The main difference between the Broadway Bridge and Seabreeze Bridge is that Broadway has external tendons. These external tendons allowed for easier access and a more in-depth visual inspection allowing a clear visual of the ducts and any possible defects.

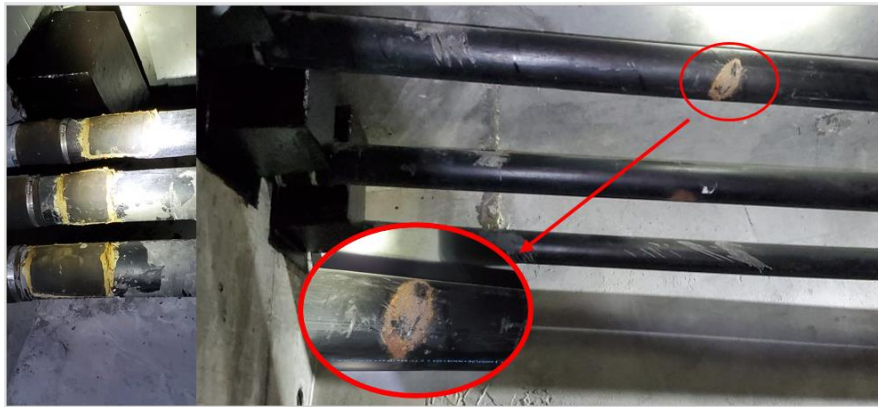
**Figure 18: External ducts that were repaired from previous intrusive NDE inspection (Left) Rust stains on external tendon (Right)**

Images from this inspection can be seen in Figure 21 below. A clear rust stain could be seen on one of the tendons, which was a cause of slight concern from the inspectors and led to a more in-depth inspection.

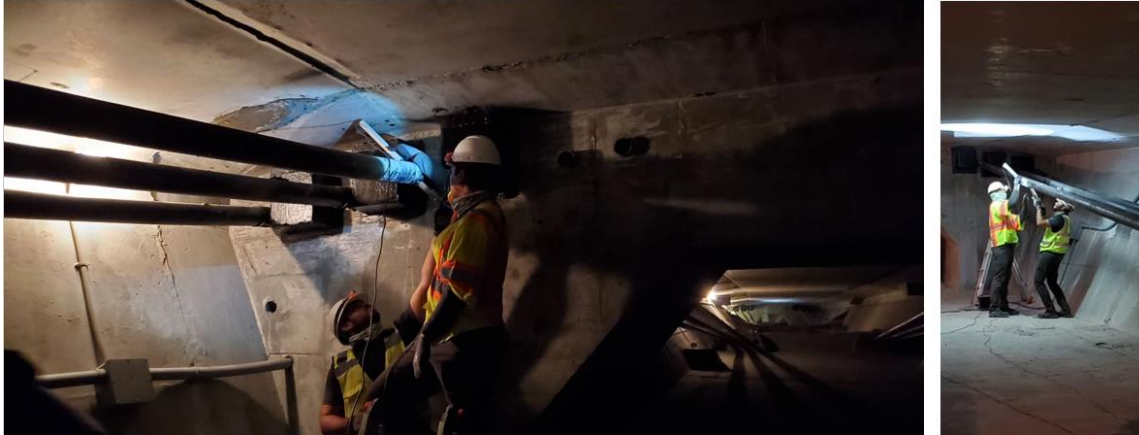
**Figure 19: Ultrasonic Pulse Velocity (UPV) Testing**

length of the tendon as shown in Figure 22 below. This NDE testing requires trained operators to identify any possible defects or abnormalities.

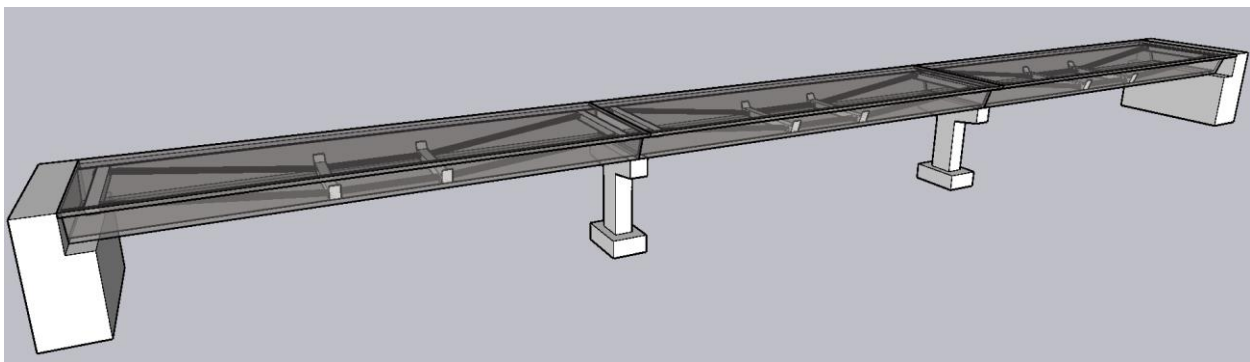
**Figure 21: Three-Span Segmental Bridge**

The first Structure type this guide will focus on is a three-span segmental bridge. This structure can be seen in Figure 24 below.

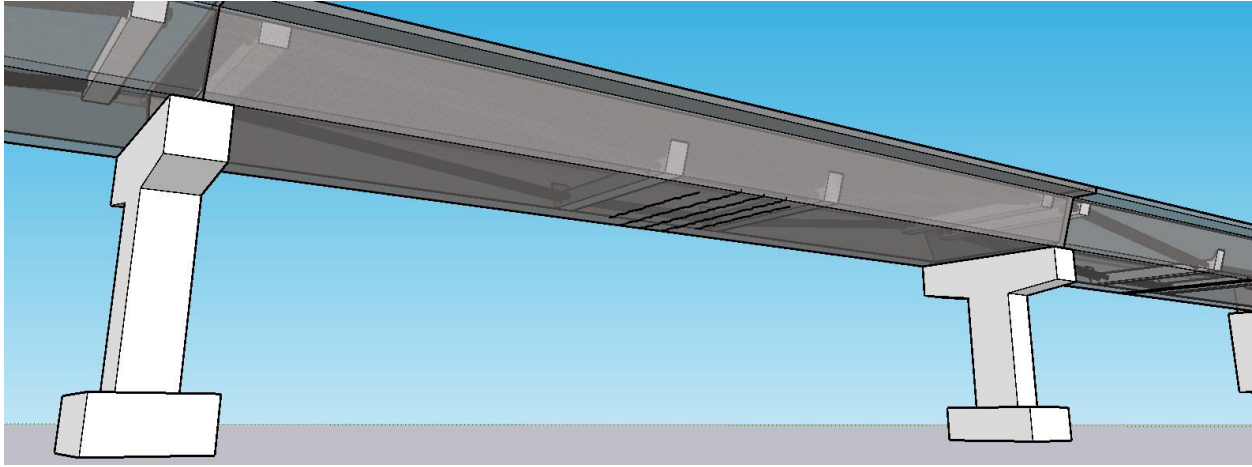
**Figure 22: Cracks due to tension in the middle of the span**

high tensile stresses in the bottom of the beam. This will lead to cracking that should be apparent to the inspector.

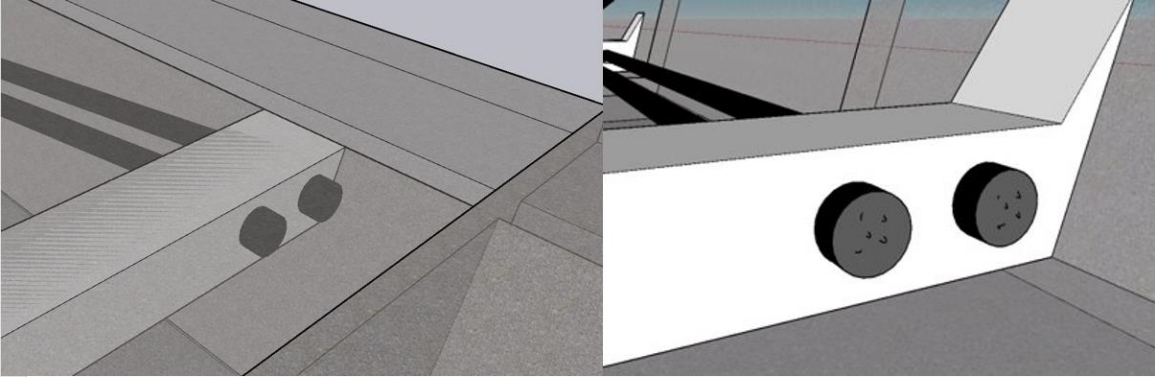
**Figure 23: Anchorage Region, protruding strands/defects (Right)**

perform a more in-depth visual inspection, the inspector could remove the cap but this is not preferred due to possible time constraints of the inspection process. Most structures utilizing FF would use a Type 5 anchorage protection system which allows for a clear visual of the cap.

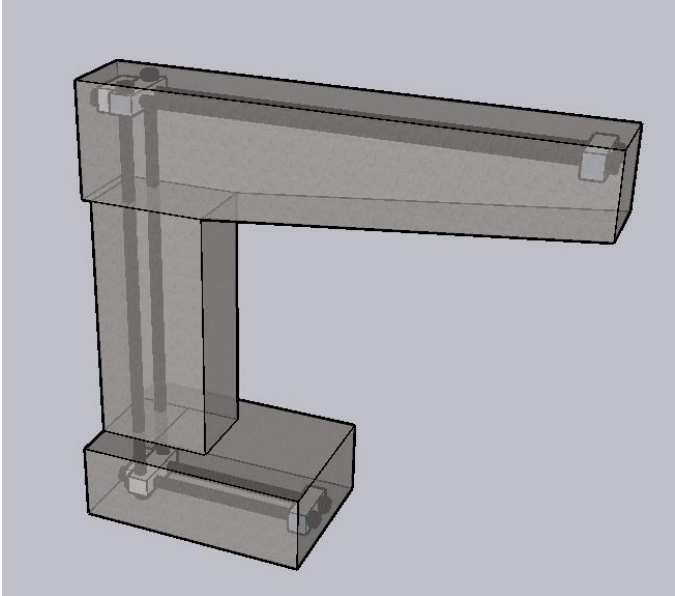
**Figure 24: Post-Tensioned C-Pier**

The next structure type that is included in this guide is the C-Pier. This pier type is useful in bridge locations that span over other roadways where the use of a traditional pier is not possible. This pier type has internal post tensioning ducts to allow for the distribution of the load required to support the bridge.

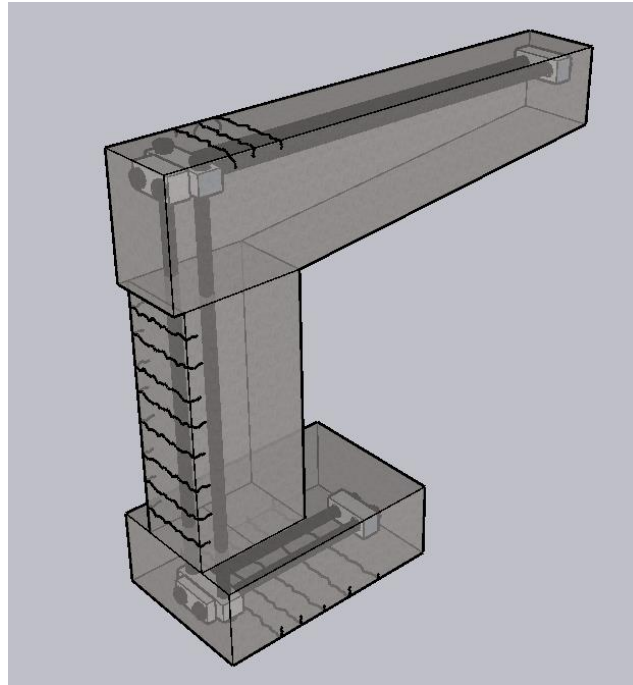
**Figure 25: Post-Tensioned C-Pier with cracks**

Similar to the three-span segmental bridge, if loss of prestressing force occurs, cracking would appear along the length of the structure as shown in Figure 28 below. These cracks would appear in the regions experiencing high tensile stresses.

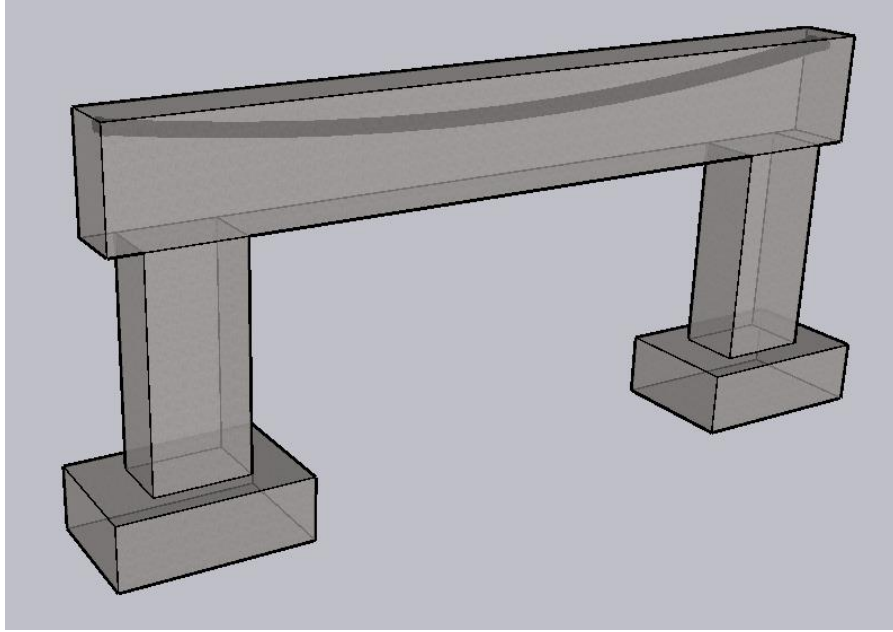
**Figure 26: Post-Tensioned Straddle Bent pier**

The final structure type that will be included in this guide is the straddle bent pier. Similar to the C-pier, the straddle bent pier as shown in Figure 29 is also utilized in confined bridge construction where the placement of a traditional pier is not possible. This pier type can span over roadways to support the bridge without disrupting the road below.

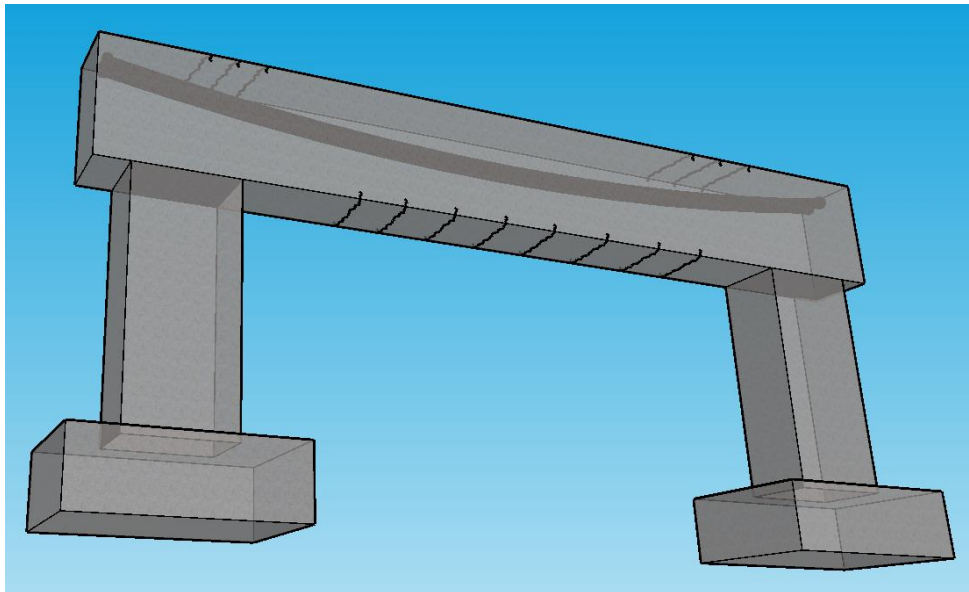
**Figure 27: Post-Tensioned Straddle Bent pier with cracks**

Inspection for this structure should be carried out similarly to the segmental bridge and the C-pier. The high moment regions should be carefully inspected for cracking along with the anchorage regions. Locations of where cracking could occur can be seen in Figure 30 below.

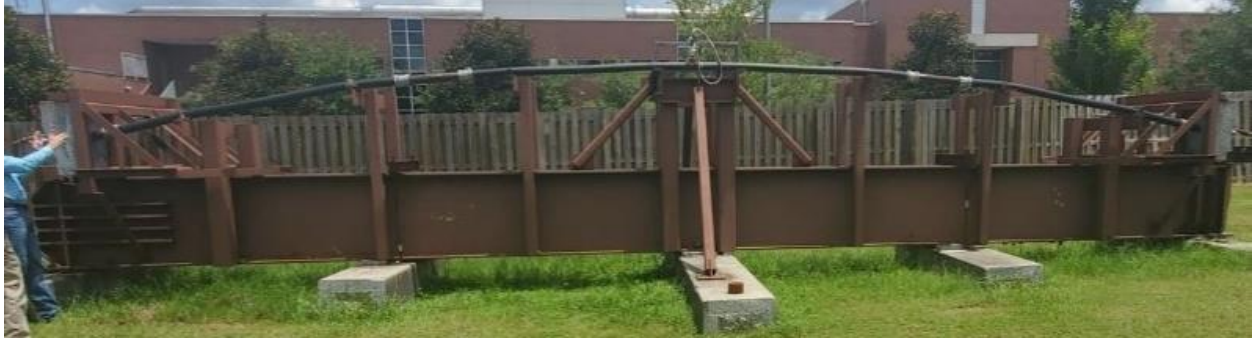
**Figure 31: Filled External Tendon Mock-up**

The second specimen that was tested on is an external tendon mockup filled with FF. This was created at the FDOT structures laboratory and is used for training on how to fill these ducts in the field. This specimen mimics a real duct and acts as a filled external duct for testing purposes. By testing on a filled duct, it is possible to determine if radiography will be effective in imaging through the FF to see the strands within.

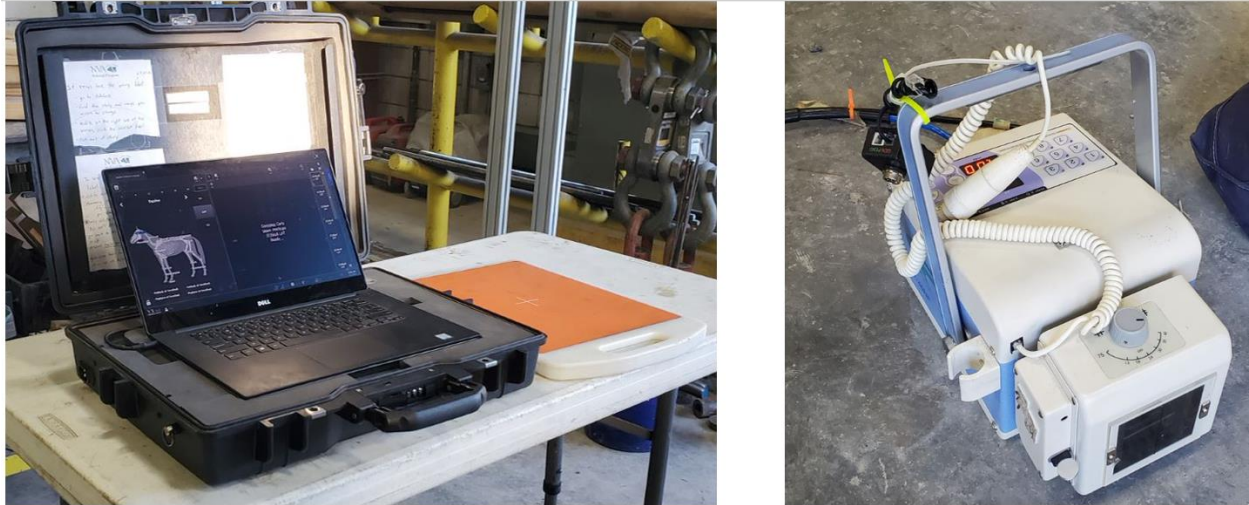
**Figure 33: POSKOM PXM-20BT**

To determine the best radiographic setup, two different X-Ray machines were utilized. The first setup included the POSKOM PXM-20BT which is a low power (60-80 kV, 1.3-1.6mAs) portable X-Ray machine used by equine hospitals to assess their patients. This device is lightweight (~20lbs), user-friendly, and requires minimal setup. As this machine only needs a 120-volt electrical outlet, it is easy to use on any site; there are even models that run on battery making them even more portable for hard-to-access sites. This machine is low power, thus minimal PPE is necessary due to this equipment being used on equines and must be safe for veterinarians and their patients. Due to the simplicity of this device along with its portability, it seemed like a feasible option that could be employed on regular bridge inspections. The major drawback with this machine is its limited power and thus its inability to image through concrete.

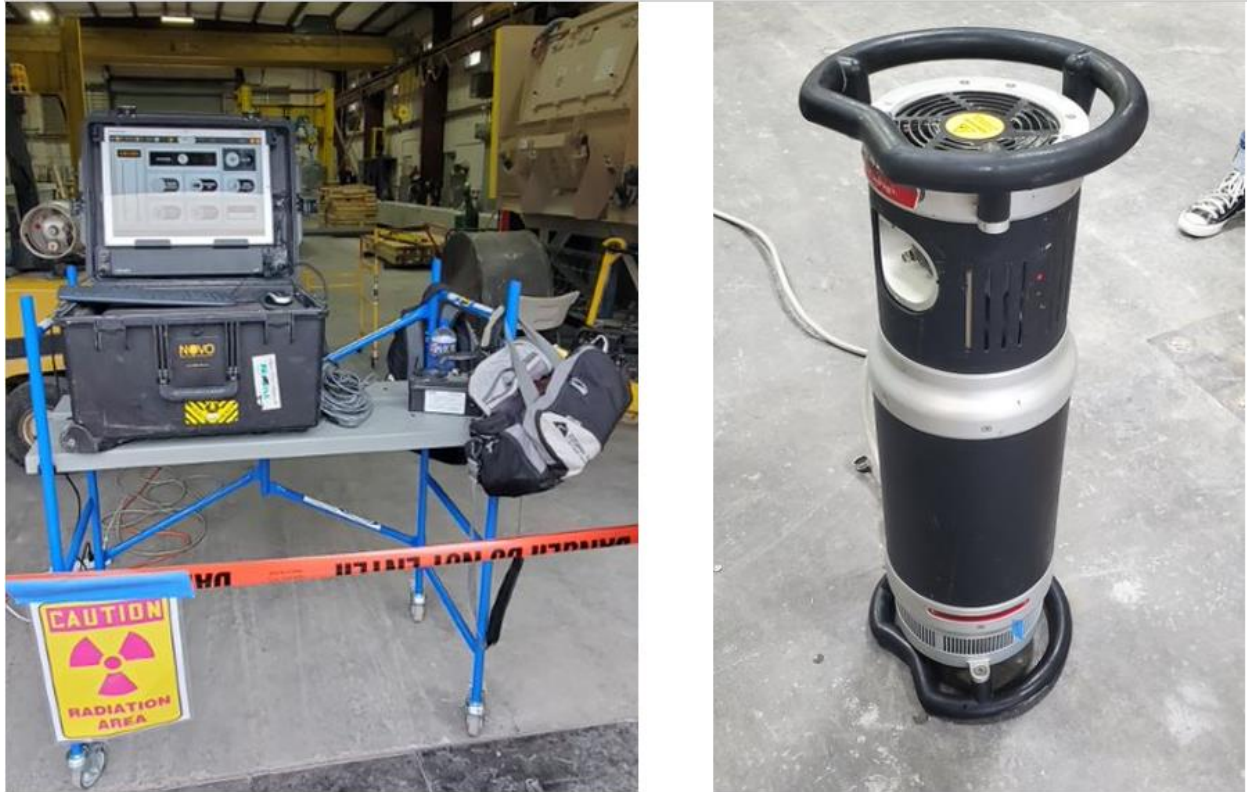
**Figure 34: YXLON**

The other setup is the YXLON X-Ray machine, which is a higher power (250kV, 2.4mAs) industrial machine that can image through up to 12” of concrete. YXLON would be ideal for assessing internal tendons but requires more setup and safety precautions. As this is an industrial machine, it is more powerful compared to the POSKOM PXM-20BT and requires more equipment and power to run. YXLON is also much larger than the POSKOM PXM-20BT and is less portable, which requires more planning to effectively inspect the bridge. While this machine can image through up to 12” concrete, a 30’ radius is required from the machine to the operator to allow for a safe distance from the strong radiation source. In some cases, it would be necessary to close the bridge to perform the inspections, which is not ideal or feasible.

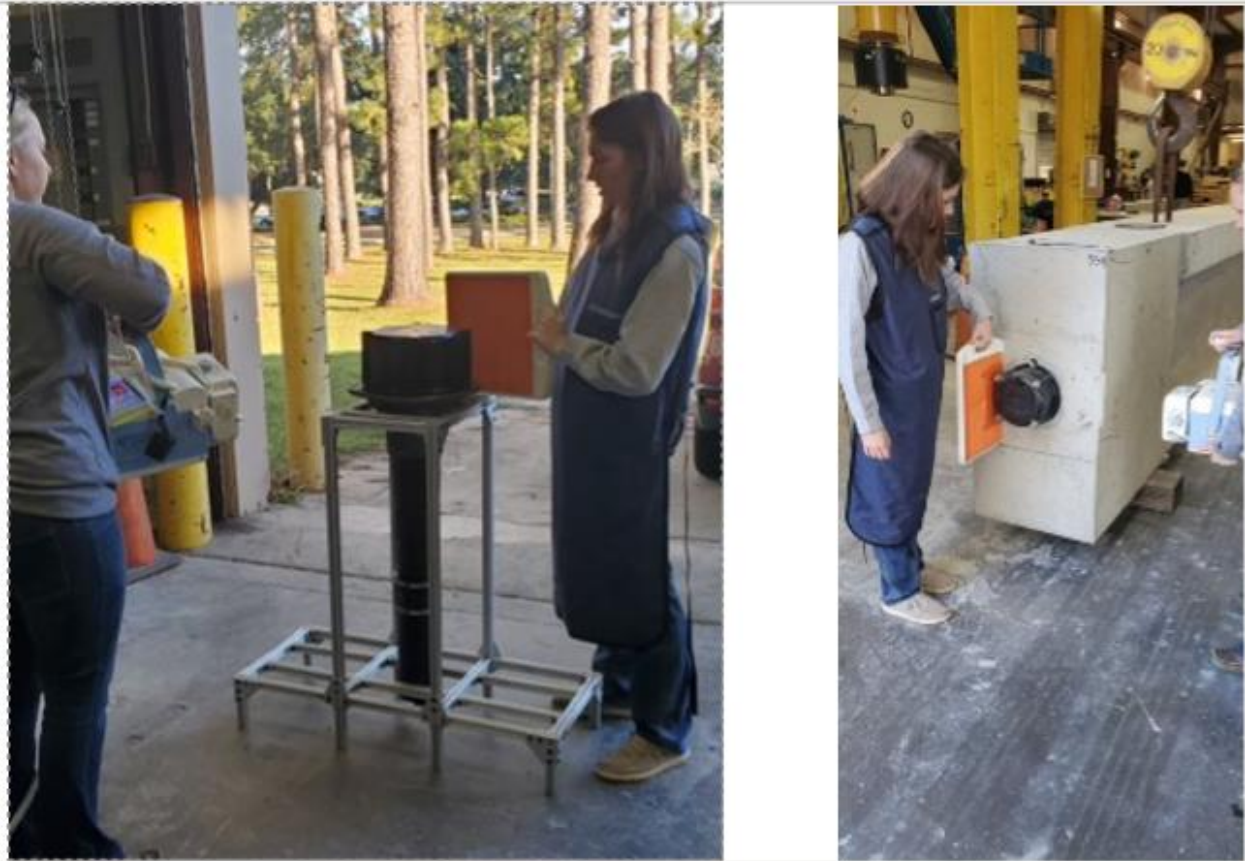
**Figure 35: POSKOM PXM-20BT Setup**

As previously mentioned, this is a low-power portable device. This device can be seen in action in Figure 38 below.
