## Inspection of Flexible Fillers in Post-Tensioned Bridges

A Thesis Submitted to the College of Engineering, Department of Civil Engineering  
In Partial Fulfillment of the Requirements for the Degree of  
Master of Science in Civil Engineering

August 2022  
Embry-Riddle Aeronautical University  
Daytona Beach, Florida

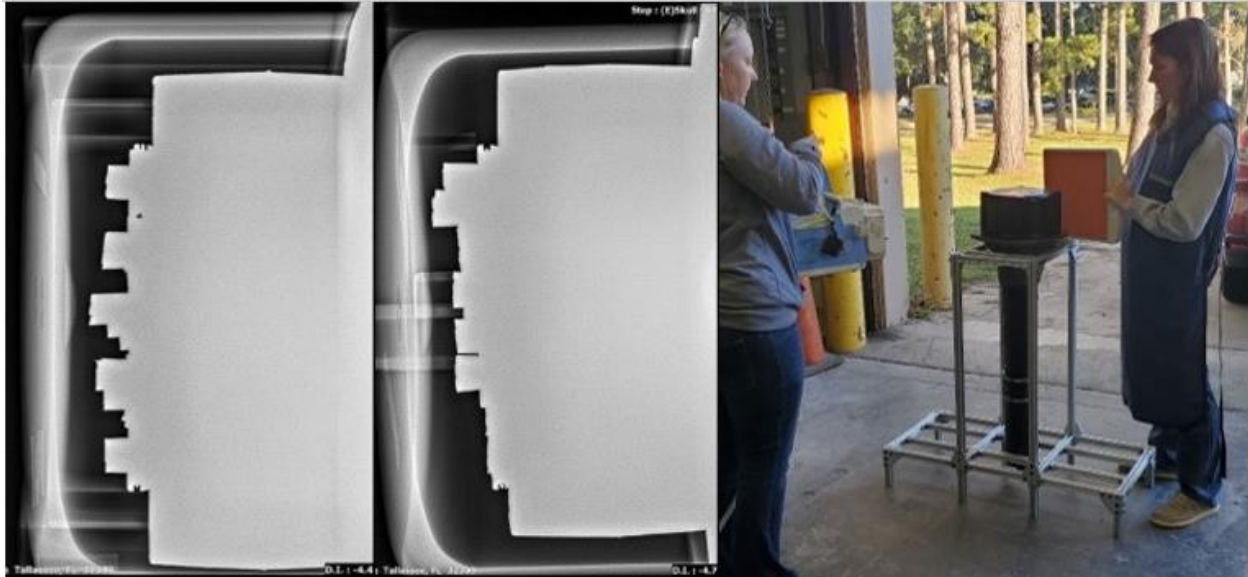
**Figure 36: Specimen 1 Anchorage Cap Results: Images collected from POSKOM PXM-20BT from different angles**

This machine produced promising results when imaging through the anchorage cap region. The following images would allow the inspector to determine strand and grip locations along with any other defaults within the cap, such as voids or corrosion. This inspection method could be carried out as a quick additional test to the current inspections to ensure that the cap region is free of faults. The anchorage mockup (Specimen 1) had strands of varying heights to simulate damage, which is clearly shown in the following images and proves that this method would be effective in the field.

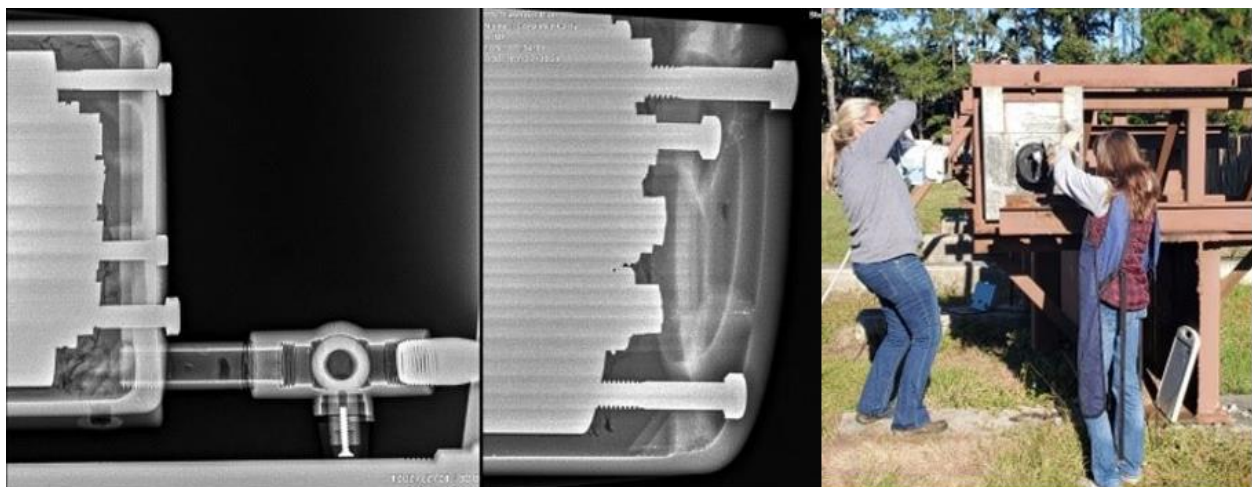
**Figure 37: External Duct Mockup: Filled Anchorage Cap Results**

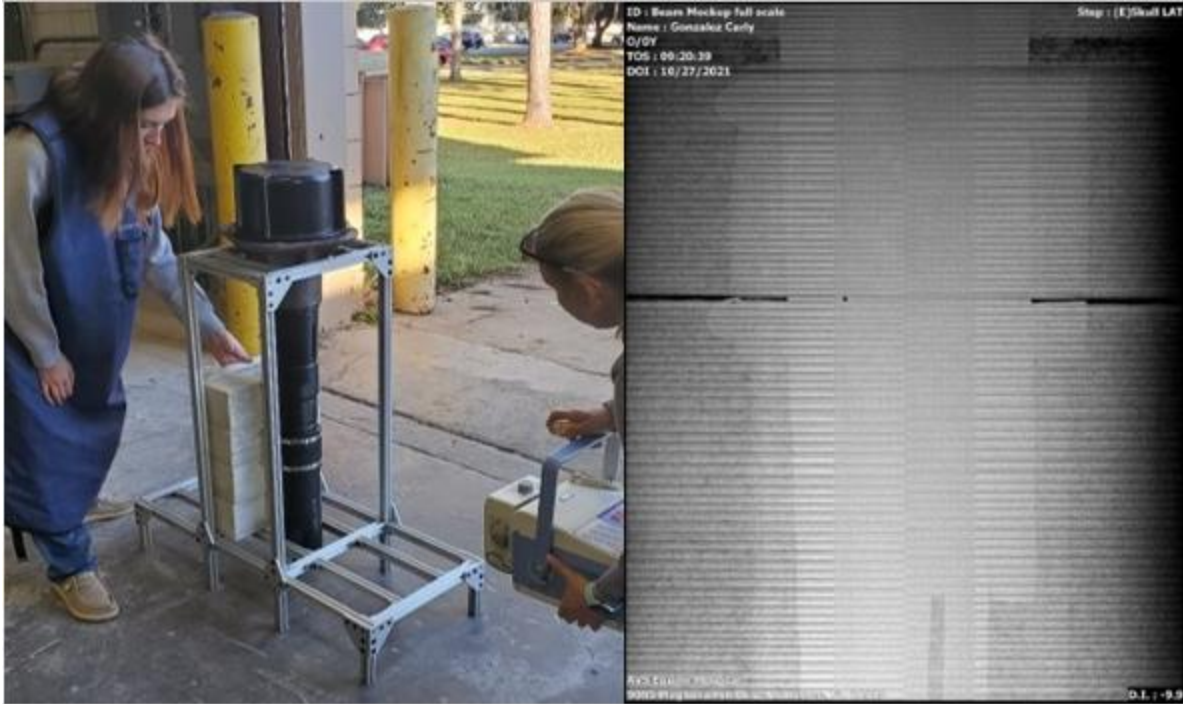
**Figure 39: Anchorage Mockup: Duct Results**

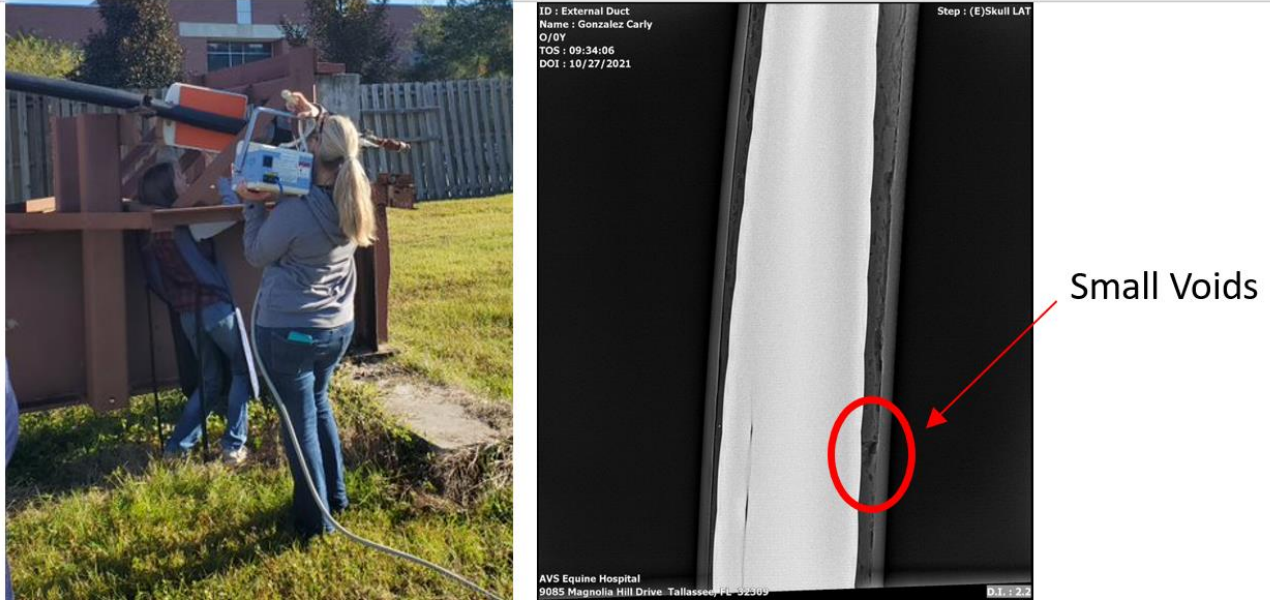
**Figure 40: Specimen 2: Filled Duct Results**

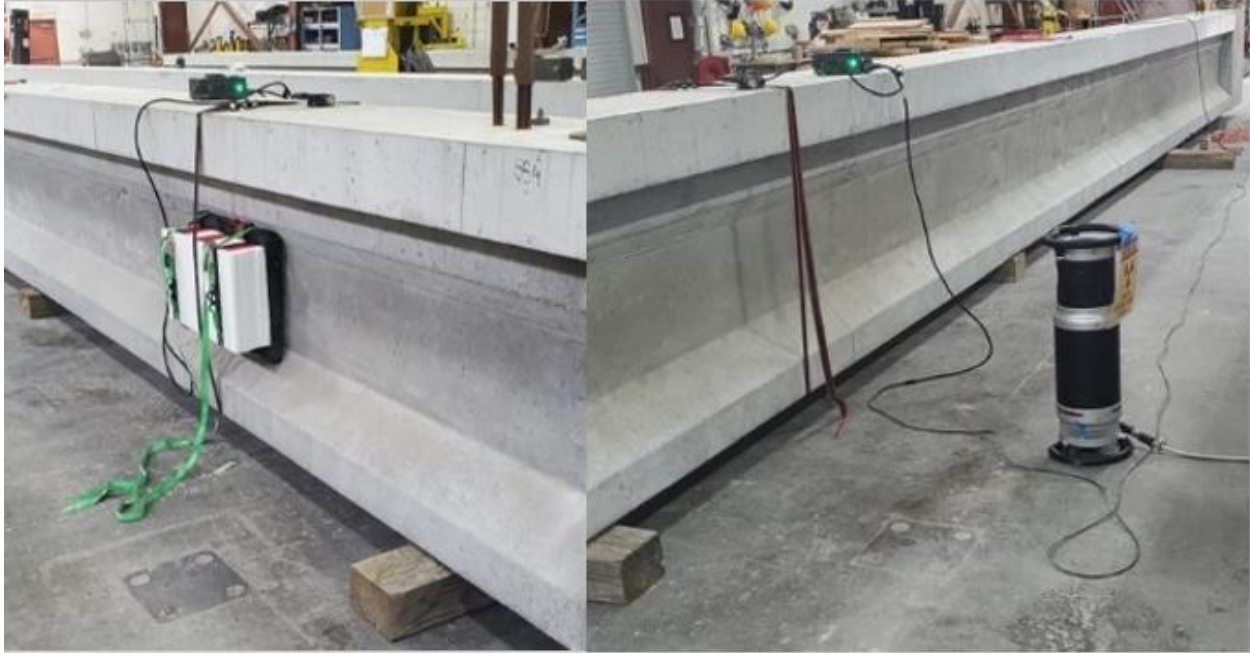
**Figure 42: YXLON X-Ray Machine on Internal Duct Specimen**

The images below show the setup of the YXLON machine on the internal duct specimen. The imaging plate is on the left, while the radiation source is on the right.

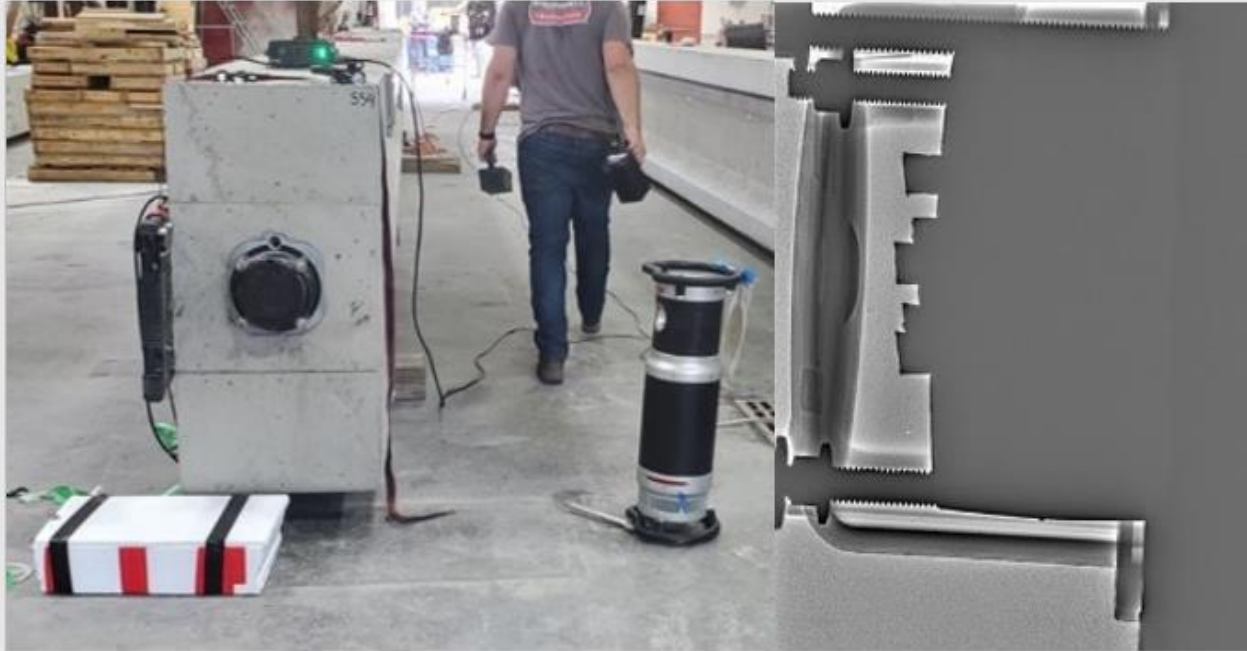
**Figure 43: YXLON Machine on Internal Specimen Anchorage Cap**

Due to the high power of the YXLON X-Ray machine, the images through the cap were slightly over exposed resulting in the “grayed” image of the cap seen below. Reducing exposure time could have prevented these overexposed images which should be explored in future testing. Fortunately, even with being over exposed, it is still possible to see the outline of the strand and grip locations. For inspection purposes this would be adequate in inspecting the cap and informing the inspector of any faults occurring within the cap.

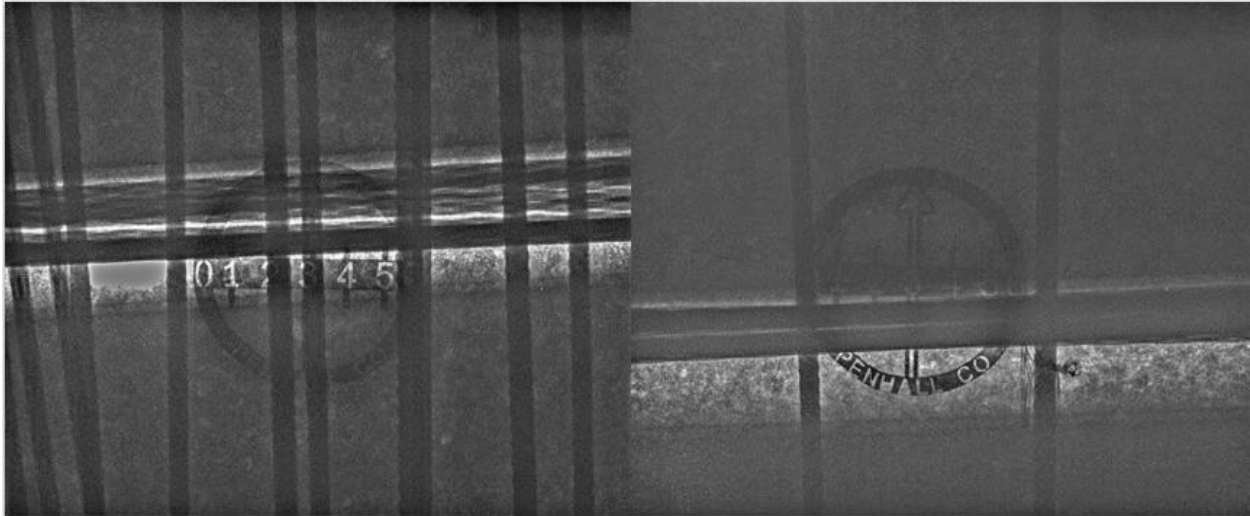
**Figure 45: Internal Duct Specimen: Duct with strands 1ft away from end block (Left) and 5ft away from end block (Right)**

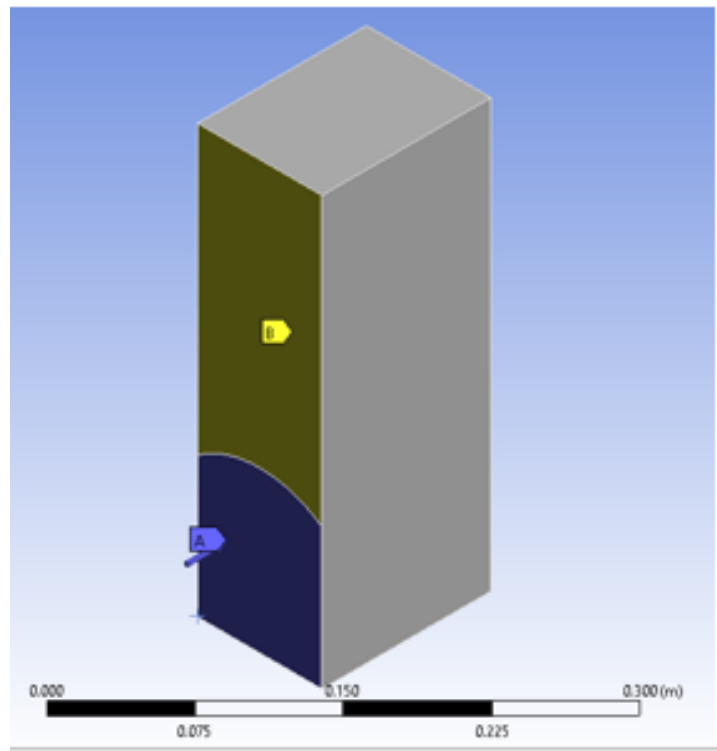
**Figure 49: Model Geometry & Boundary Conditions**

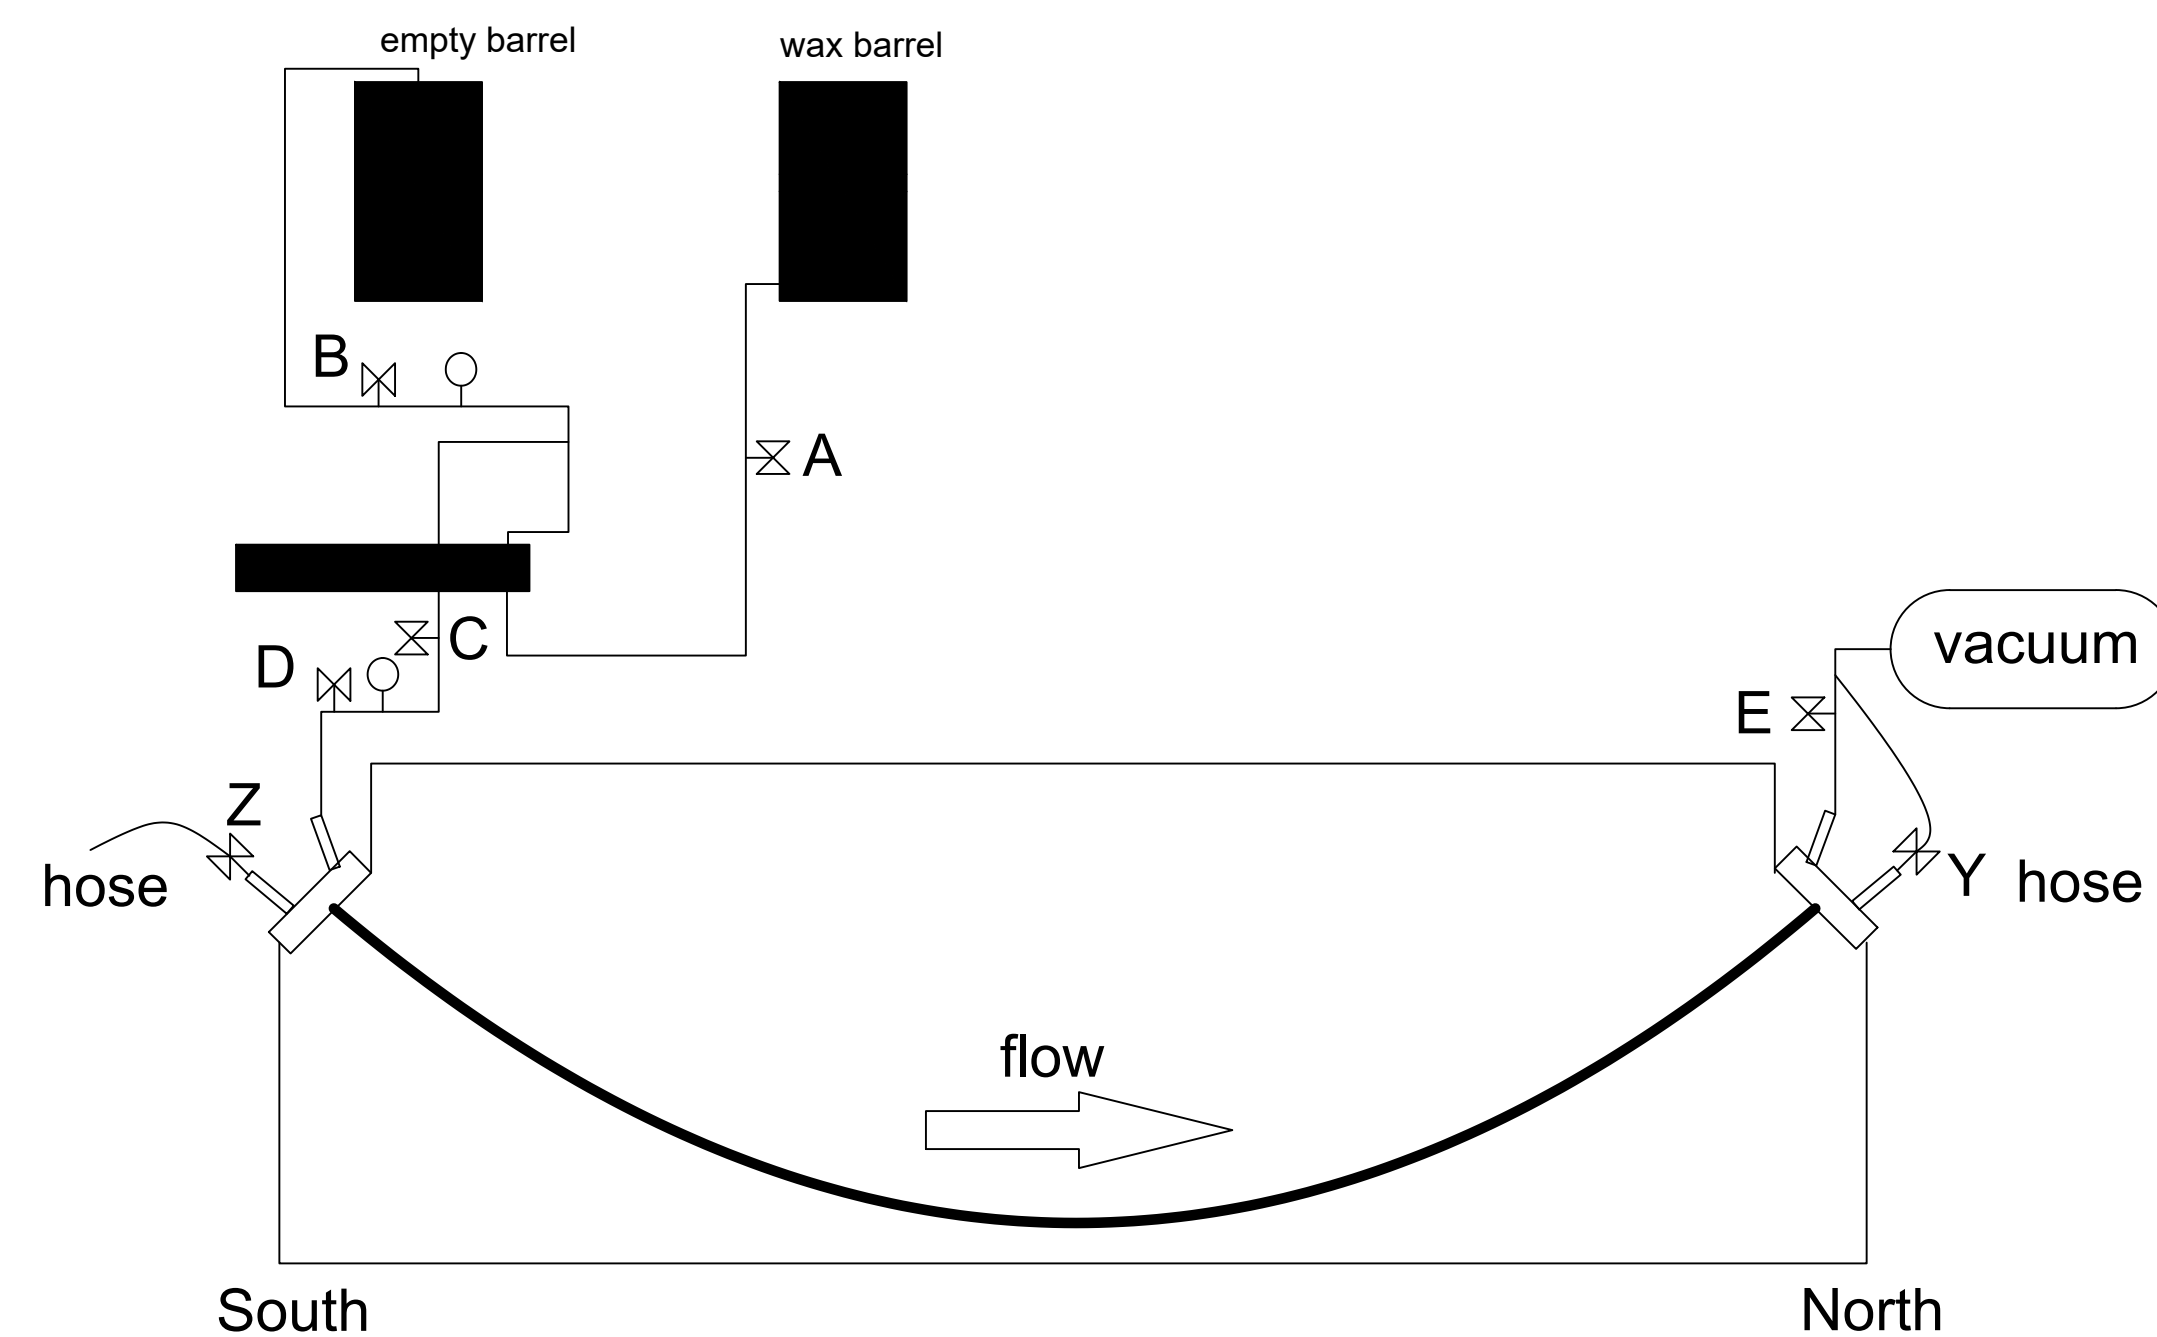
Figure 1—Schematic of set up for vacuum injection

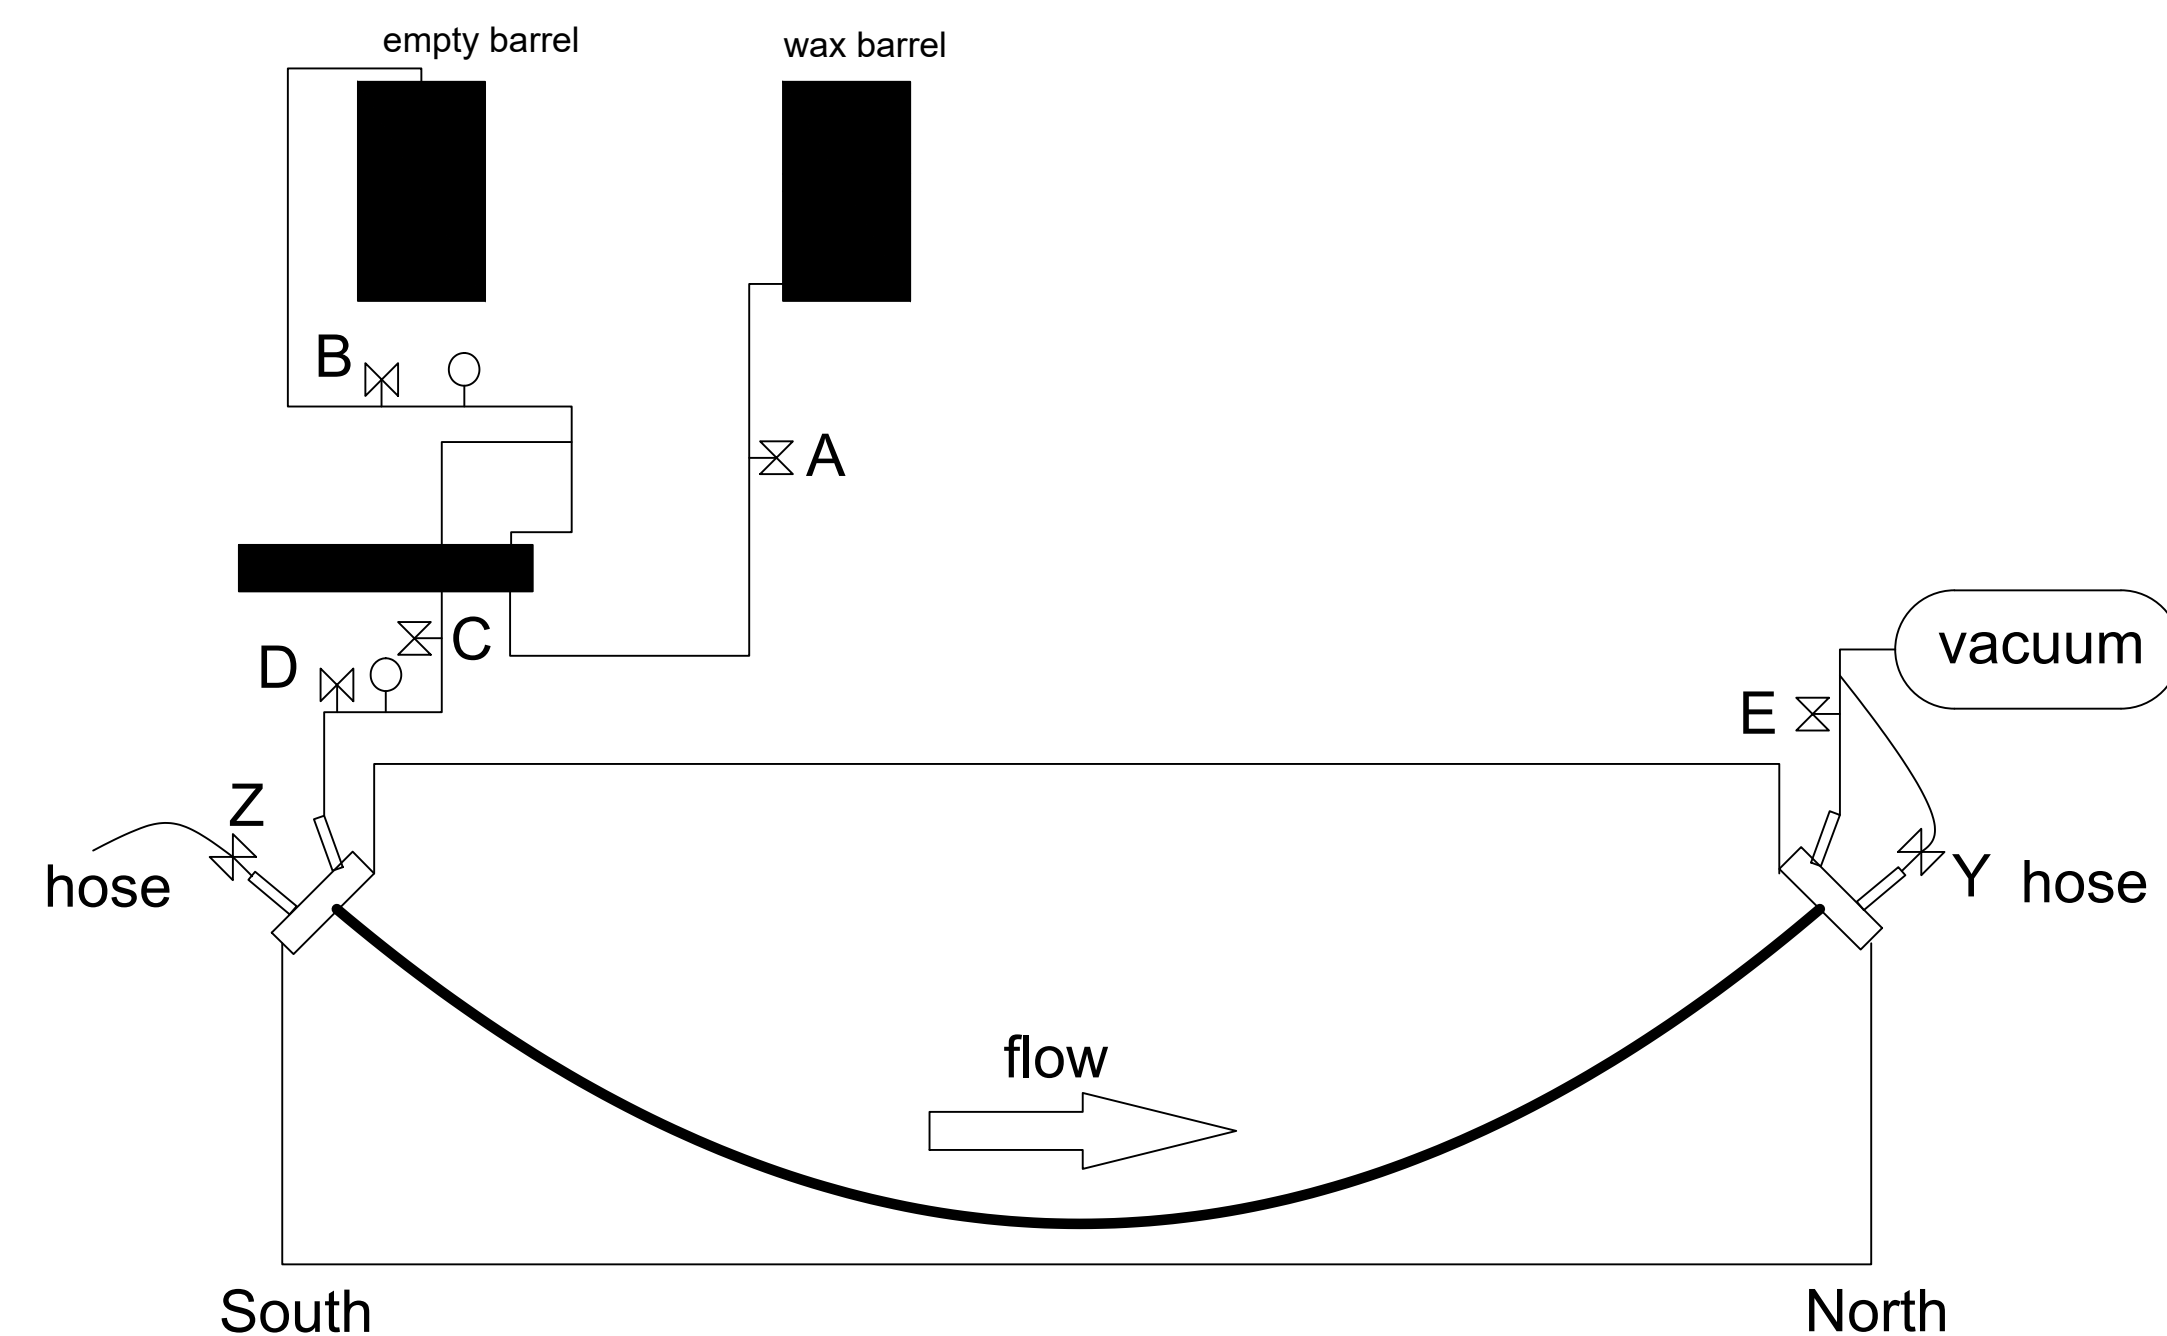
Figure 1—Schematic of set up for vacuum injection
