Guidebook for Omaha's Urban Geology and the Anthropocene Nebraska Well Drillers 2022 Field Trip

Field trip August 31st, 2022

Harmon Maher, Ashlee Dere, Melina Luethje
Dept. of Geography and Geology
University of Nebraska at Omaha

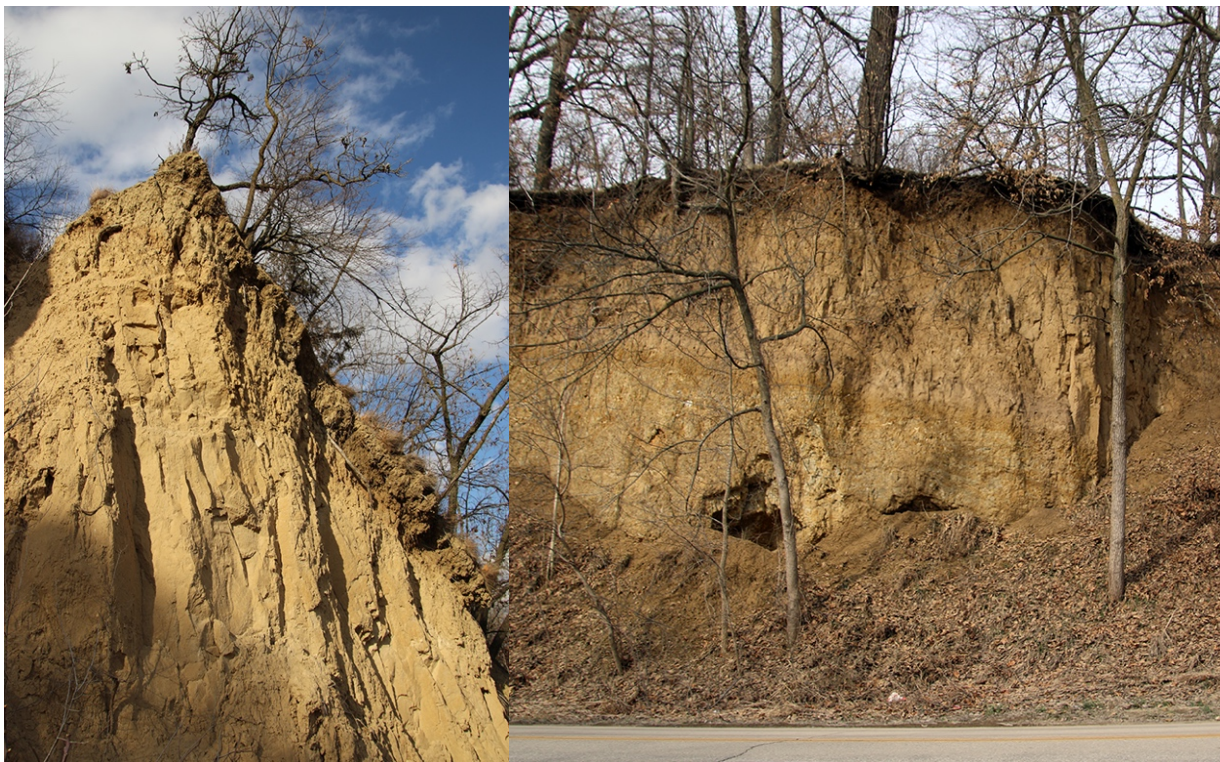
Figure 2: Left - view of loess exposures at Devil's Slide in Hummel Park with the columnar fracturing on display. The deposits are fairly massive, likely due grassland related bioturbation, but laminated or bedded loess does occur. Right - outcrop of till and overlying loess along the road south of Hummel Park. The orange layer midway in the cliff is an iron oxide rich paleosol developed on top of a distinctly weathered till with overlying loess. When freshly exposed the till can be medium grey in color.

One of the more important geologic units in the Omaha area is loess. These wind-blown 'dust' deposits form a good bit of Omaha's near surface geology (Schroba et al, 2001; Figures 2 and 3), and have unique engineering and geomorphic properties (e.g., Brice 1964). A weak carbonate cement bonds the silt sized grains just enough that characteristic steep-sided gullies and bluffs form. Bluff exposures are sometime columnar due to subvertical fractures. One good exposure is along the front road for Hummel Park, and is known as Devil's Slide (Figure 2, 41.369° -95.555°). Hikes through Hummel Park, Neale Woods, or Fontenelle Forest provide a good introduction to a distinct steep loess geomorphology.

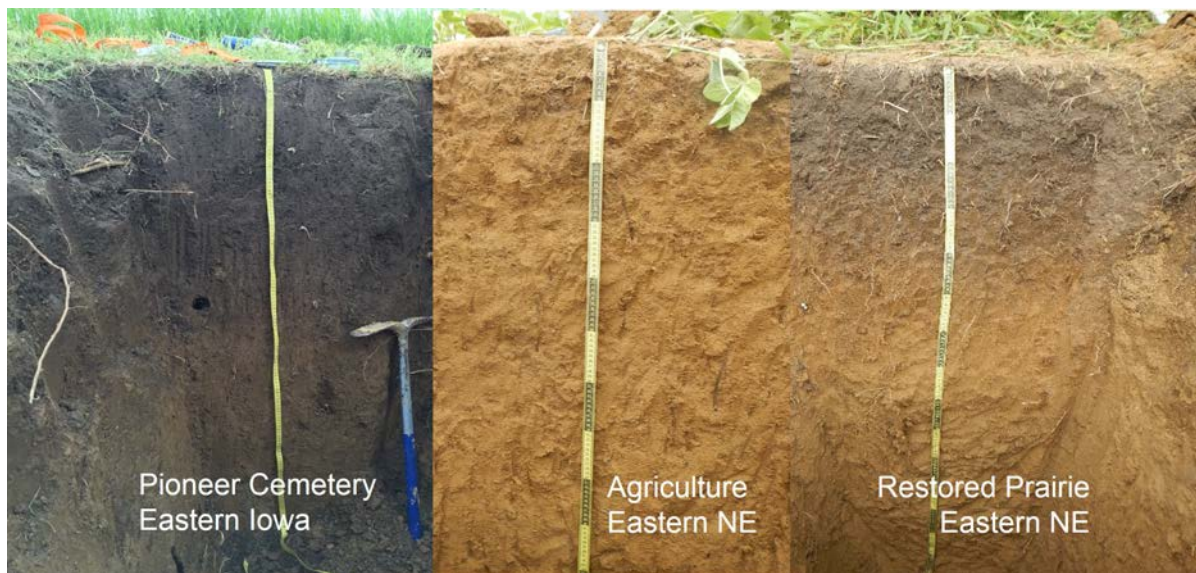
Figure 9: Images of soil pit profiles from unfarmed prairie soil in Eastern Iowa (left), the agricultural soil at Glacier Creek (middle) and the restored prairie at Glacier Creek (right). All three soils are developed in loess with broadly similar climatic conditions, although the Iowa soil receives higher rainfall (89 cm mean annual precipitation versus 78 cm mean annual precipitation in eastern Nebraska). The humus content is one obvious difference, and what is of interest is the significant humus accumulation after only ~50 years of being restored as a prairie. Image courtesy Dr. Ashlee Dere.

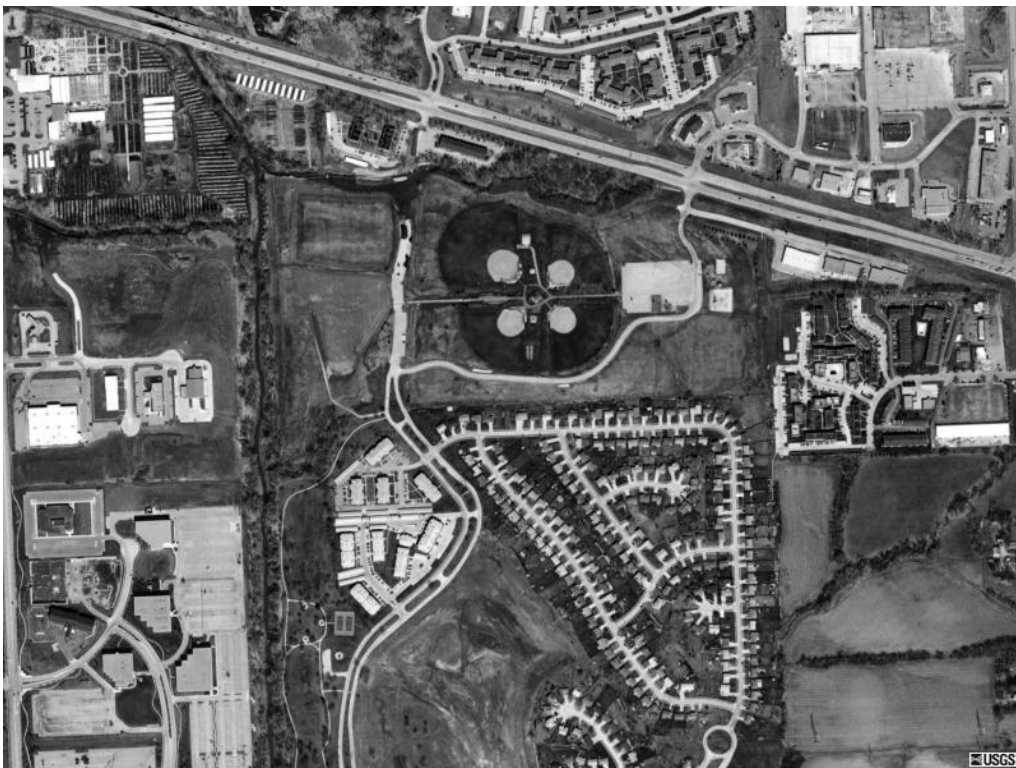
Figure 13: USGS air photo image (\approx 2001) of Heflinger Park back when it was used as public softball fields and after the development to the south had been built. North is to the top. The southeast corner of Heron Haven can be seen north of the double lane West Maple road in the upper left corner of the image. The wooded Papillion creek riparian corridor runs north to south to the left.

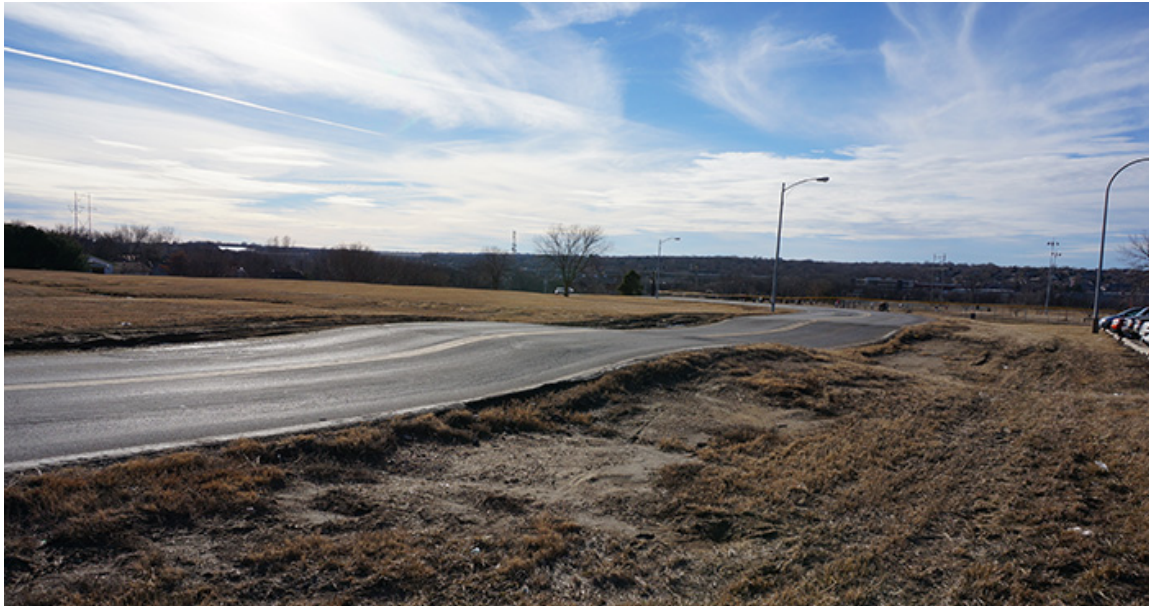
Figure 15: View of road in Heflinger Park looking southwest of where it crosses two of the trenches with waste fill that underwent significant compaction during biodegradation. The road has since been regraded and repaved, but additional subsidence continues.

Five methane venting pipes are surrounded by fences to S of the road with the neighborhood development just further south. Some of the surface venting pipes are tilted significantly due to differential settling, and may not be operating as initially engineered (Figure 17). It is unclear how much methane is still being produced. Some of the wastes were from South Omaha packing houses, paunch manure, promoting both methane production and significant differential settling through biodegradation. Drainage to capture runoff/leakage exists along the S border. In places on the steeper southern slope there are minor patches of shallow erosion. In these, garbage fill (rusty tin cans, bones, plastic, one tire) has either worked its way to the surface or has been exposed. Close mowing may have helped sheet wash to

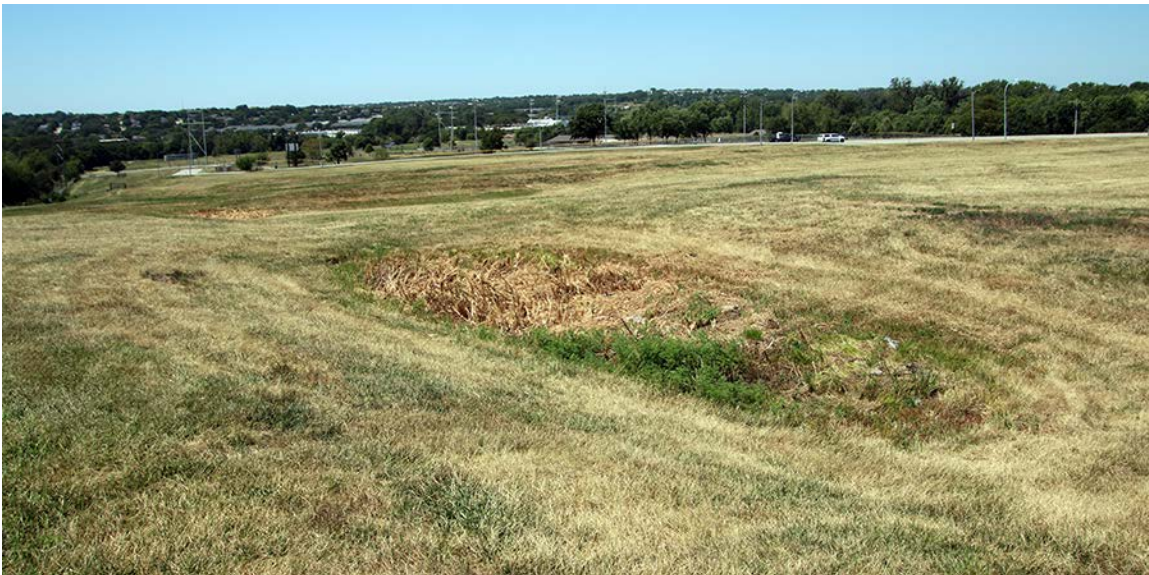
Figure 16: View looking westward from the top of the landfill site down slope towards the Big Papillion Creek. An enclosed depression with dried out reedy plants is evident in the foreground. A second one is just evident to left and down the slope. Image taken in August 2022.

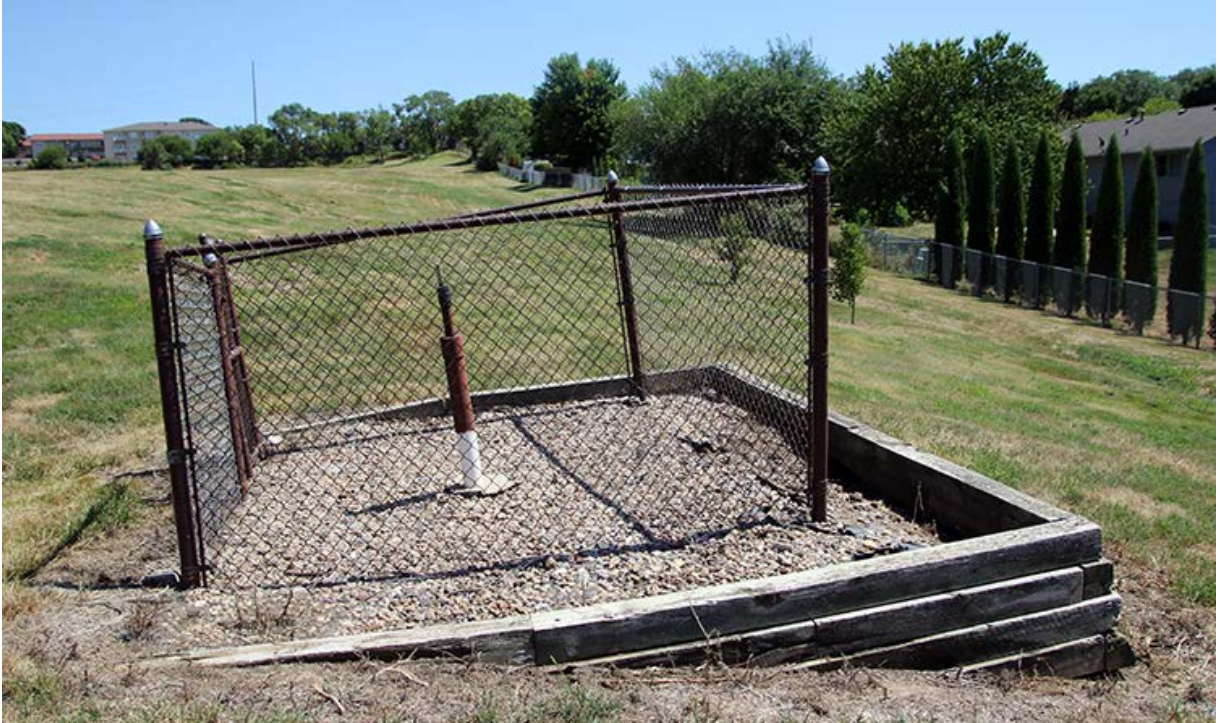
Figure 17: View looking east at uppermost methane venting site. A sign on the gate says “no smoking”. In the upper right image section a small drainage ditch, along with a house belonging to the development to the south, also is evident. Image taken in August 2022.

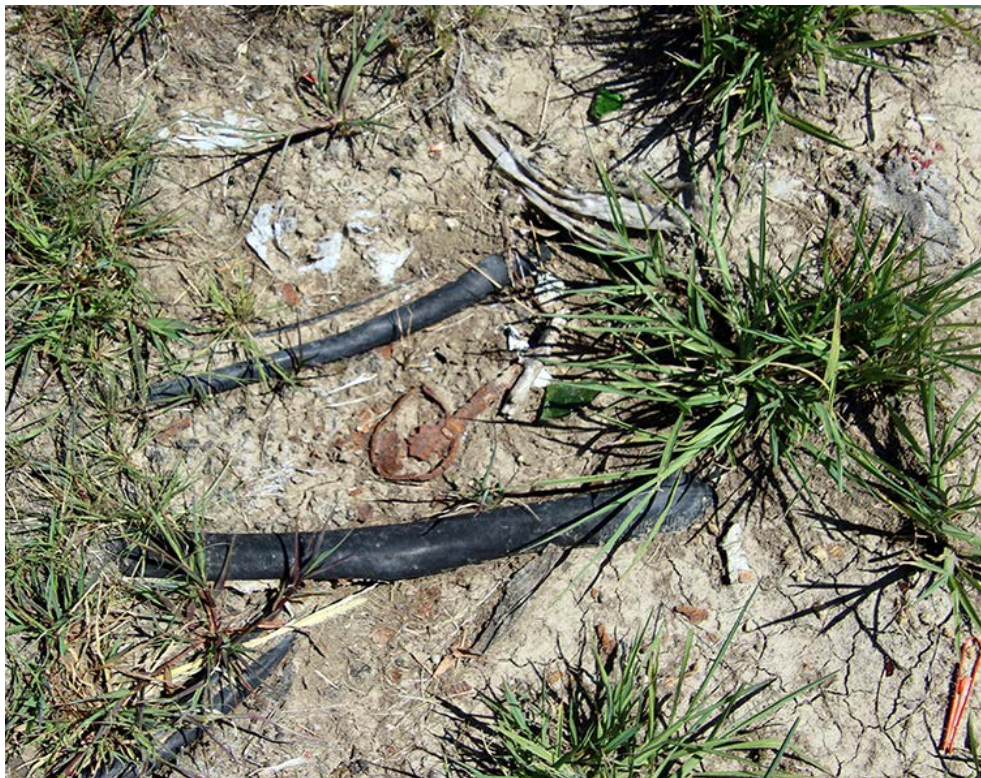
Figure 18: View from south slope of landfill showing garbage exposed that was and likely part of the fill. Sheet wash may have removed overlying soil, or the garbage has worked its way up to the surface. Illegal dumping after the land fill was closed can not be ruled out.

remove cover material. Rip-rap was placed along the steep-walled and entrenched small creek that flows along the northern border. In its lower section sheet piling and sediment dams were installed. One has to work through the brush and small trees to find these structures. Garbage fill may be exposed here in a few places (figure 18). Monitoring wells used to exist toward the south, but could not be found on the well registry or on site.

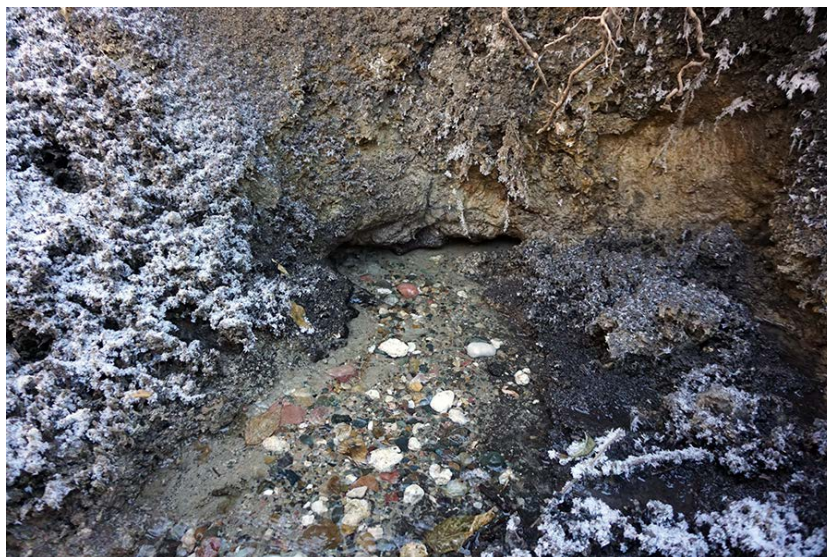
Figure 22: Spring source upstream from Heron Haven. Note the clay rich material above the spring, and the gravel clasts in the outflow. The pink clasts are Sioux quartzite and the light-colored clasts are Paleozoic limestones. Some of the dark clasts are Precambrian metavolcanics. These are a clear indication that glacial till and/or outwash is involved. A visual estimate is that the

discharge for this particular spring was several gallons per minute. At least 4 similar separate springs were observed and more likely exist. The white covering is frost.

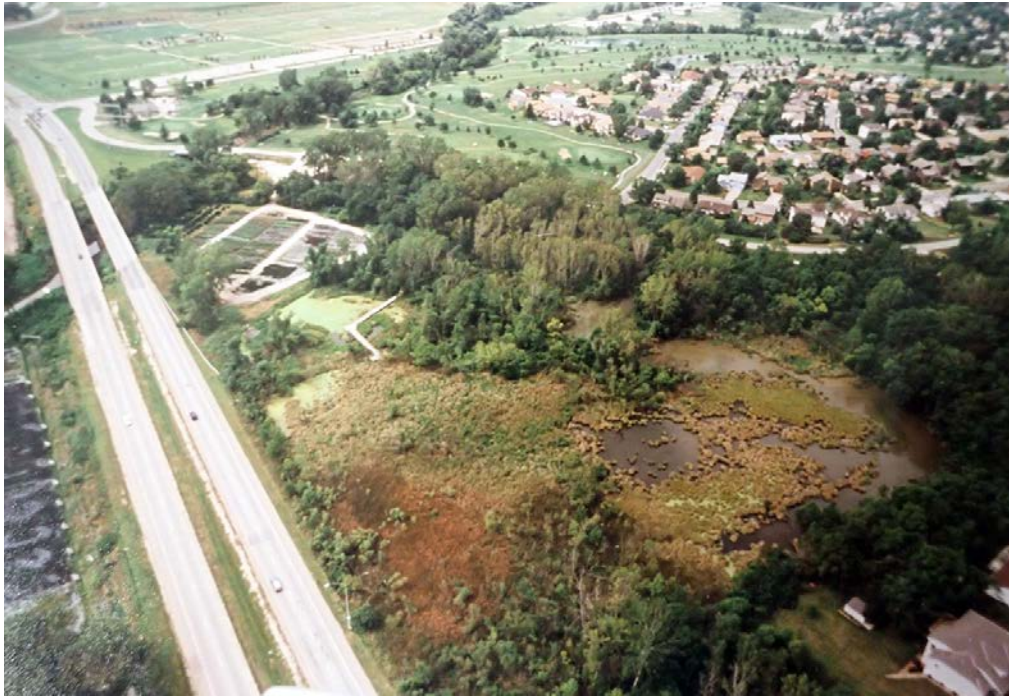
Figure 23: Oblique air photo view of Heron Haven before dredging showing the amount of siltation that had occurred. Photograph courtesy of Friends of Heron Haven.

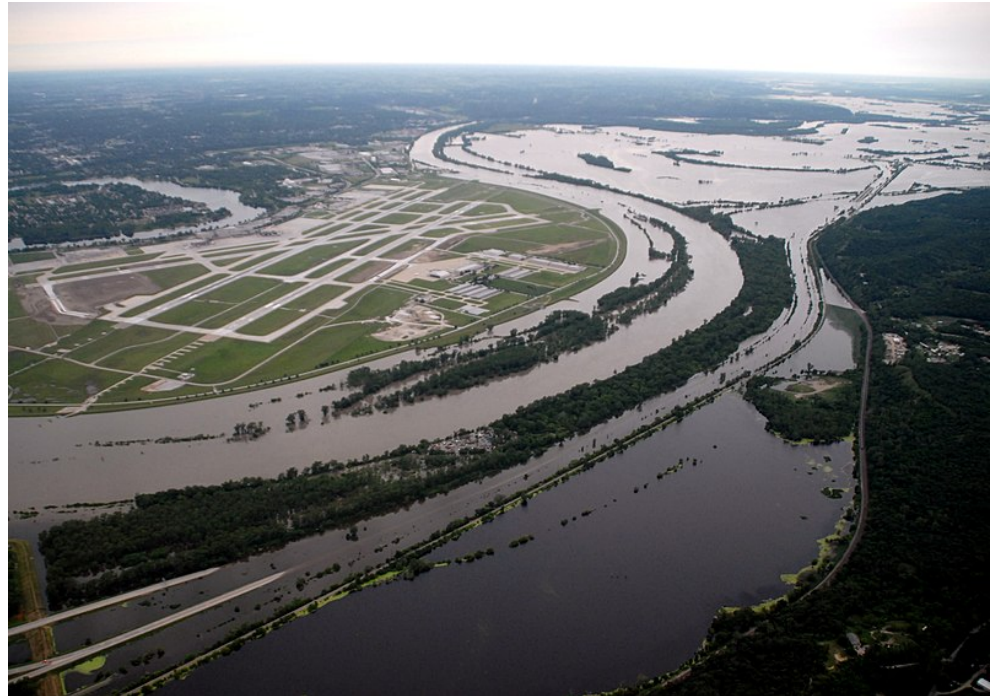
Figure 27: View of Eppley airport looking northwest during the June 16th 2011 flood. Carter Lake can be also be seen on the far side of the airport.

Many people living in the Omaha area have likely seen Carter Lake on the way to the Eppley airport, or perhaps from the jet window. The airport is protected from Missouri River flooding by a substantial levee (Figure 27), and we can use this opportunity to review the efforts required to save the airport during the **historic 2011 flood**. A key aspect of that flood was its duration. In the Omaha area the river was in flood stage for some 3 months (Figure 28). This was sufficient time for the substantial head provided by the water behind the levee to drive groundwater flow under the levee, and raise the already shallow groundwater table under the airport area, forming sand boils and standing water in areas (Figure 29). The river was ≈ 20 feet above the level of the airport runways. As sand boils formed they were covered with gravel pads to stabilize the sediment in that area, but clearly much more had to be done given that water table could be expected to continue to rise. Basically, the airport was in danger of flooding from underneath, and the sand boils and associated sediment mobilization could threaten the stability of the levees leading to a more catastrophic event. The economic worth of the airport was estimated at \$745 million a year, and so a major, multi-party response costing about \$24 million was launched (Hendee 2011).

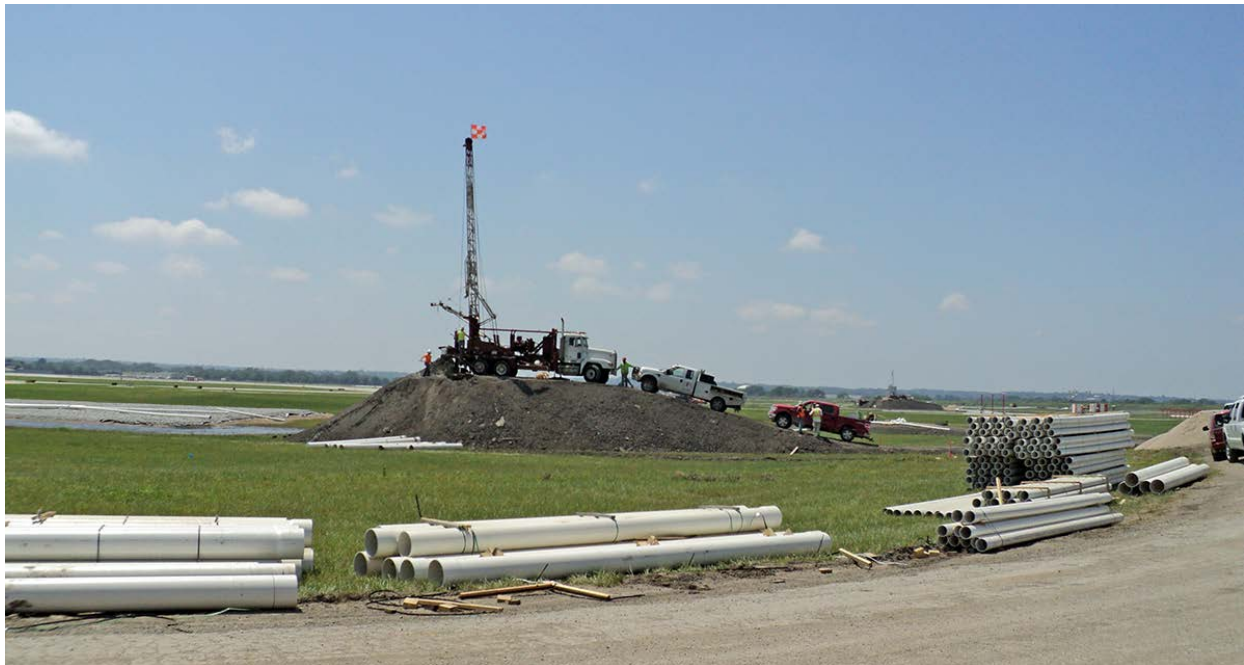
Figure 29: One of the drilling sites during the 2011 flood Eppley airfield dewatering response. The levee and river are to the viewer's back. Note how the drill rig had to be on an elevated pad. To the left of the drill pad is one of the seep sites with a gravel pad installed on top to stabilize the sediment and prevent liquefaction and attendant loss of strength. Photograph courtesy of Griffin Dewatering.

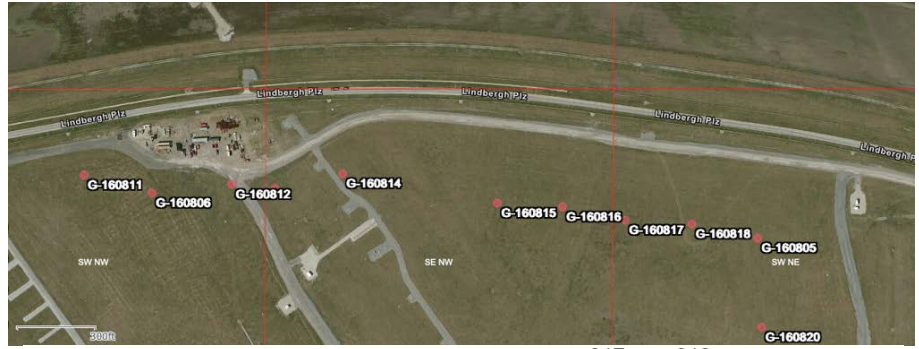
Top: Portion of well registry website map showing the position of the well logs depicted below.

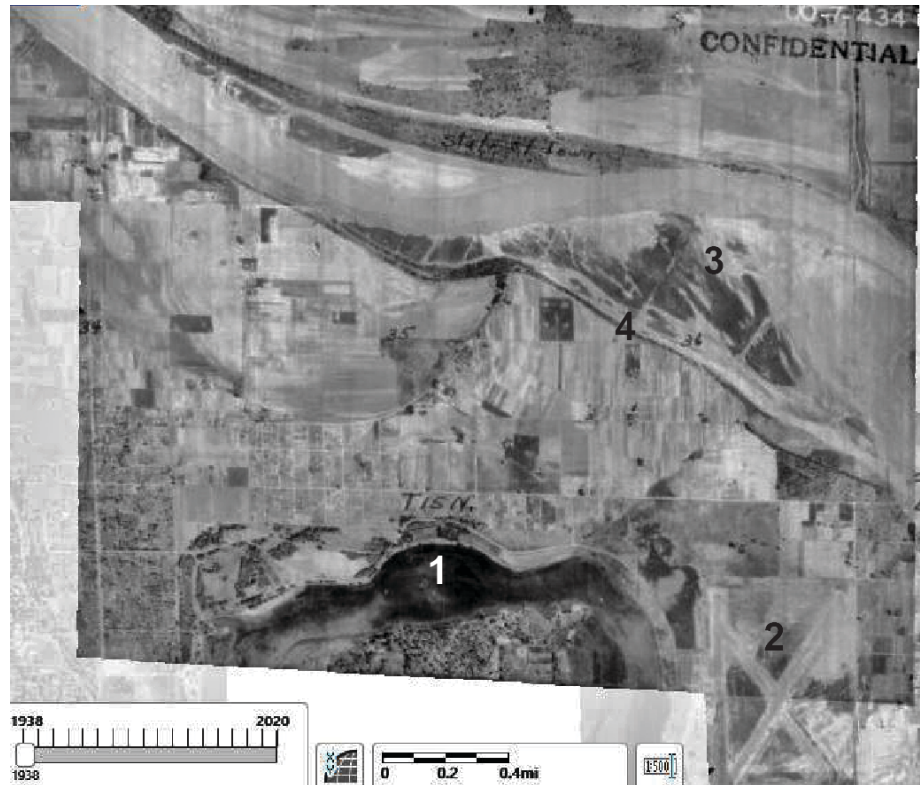
Figure 33: Roughly the same area as above, but in 1991. The airport has expanded significantly behind a new levee (marked with 1s). The river has been constrained to a ≈constant width channel by Army Corp structures. A close look shows small indentations that likely represent small scour pits down-flow of the wing dikes. Much of the point bar area of exposed sand bars is now on the protected side of the levee, but remnants are evident in the air photo. These sand bars would influence the shallow groundwater flow under the airport. Note the residential development in the area.

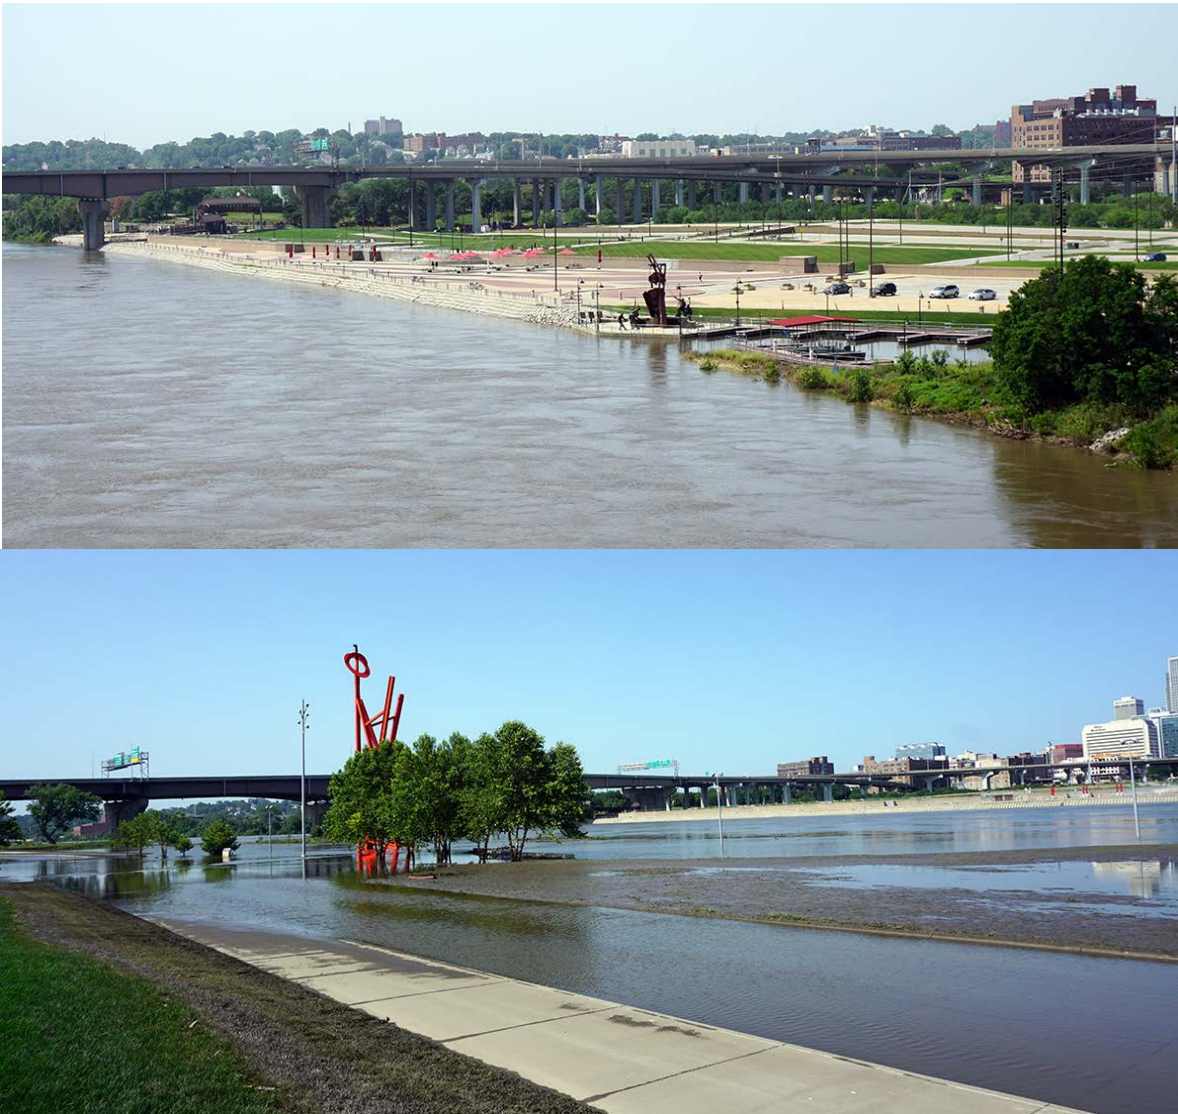
Figure 34: July 4th 2018 images of Heartland Park from the Bob Kerry bridge (above) and minor flooding and siltation on the Council Bluff side (below) in Tom Hanafan's River's Edge Park. Note the marina just upstream from the metal sculpture that is part of the Heartland Park.

Background: Two themes associated with this particular stop are: a) Missouri River flooding (Figure 34) and related control structures and engineering, and b) the environmental legacy of earlier industrialization. The bridge provides a good perspective to see many of the types of structures involved in flood control.

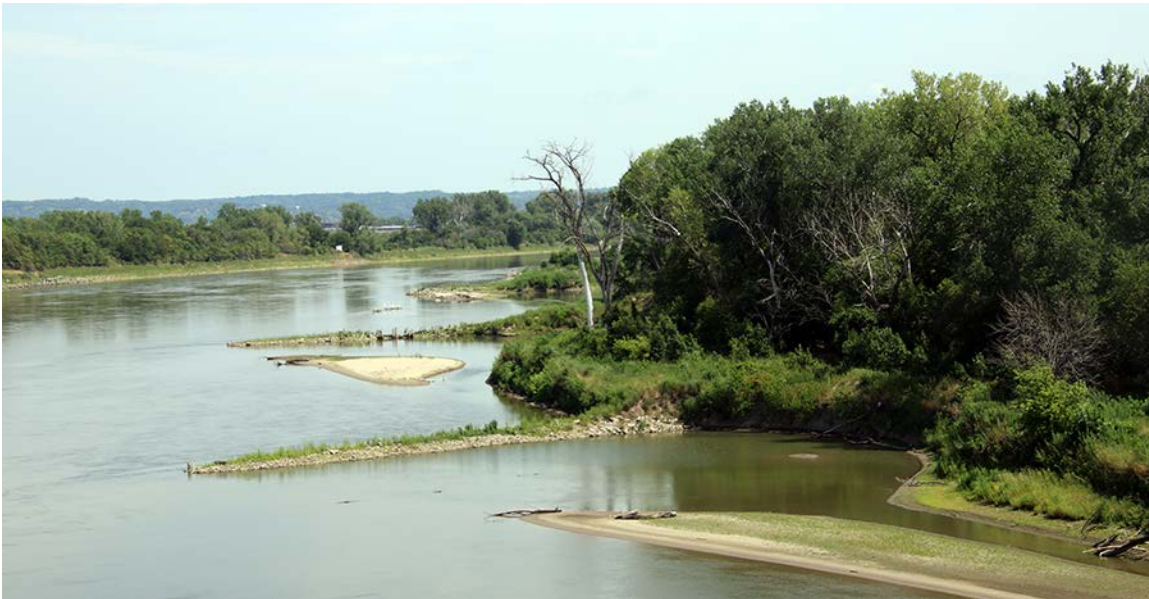
Figure 35: View looking upstream at Iowa side of the river showing the prominent wing dikes with eddy scour pools immediately downstream and sand bars further downstream. This image was taken during August of 2022 when flows were relatively low and the wing dikes and associated features well exposed.

Levees on the Omaha side of the river extend for 13.26 miles, have an average height of 14' and were constructed in 1950. This includes those that protect the airport. They are of variable design from earthen to reinforced concrete cantilevered walls and steel sheet pile. More details can be found at the USACE levee database (<https://levees.sec.usace.army.mil/#/levees/system/4705000082/summary>). Levees on the Council Bluffs side of the bridge (the inner bend of the river), are set back from the normal channel margin some 300 m. In the intervening area are wetlands and wooded areas providing some riparian

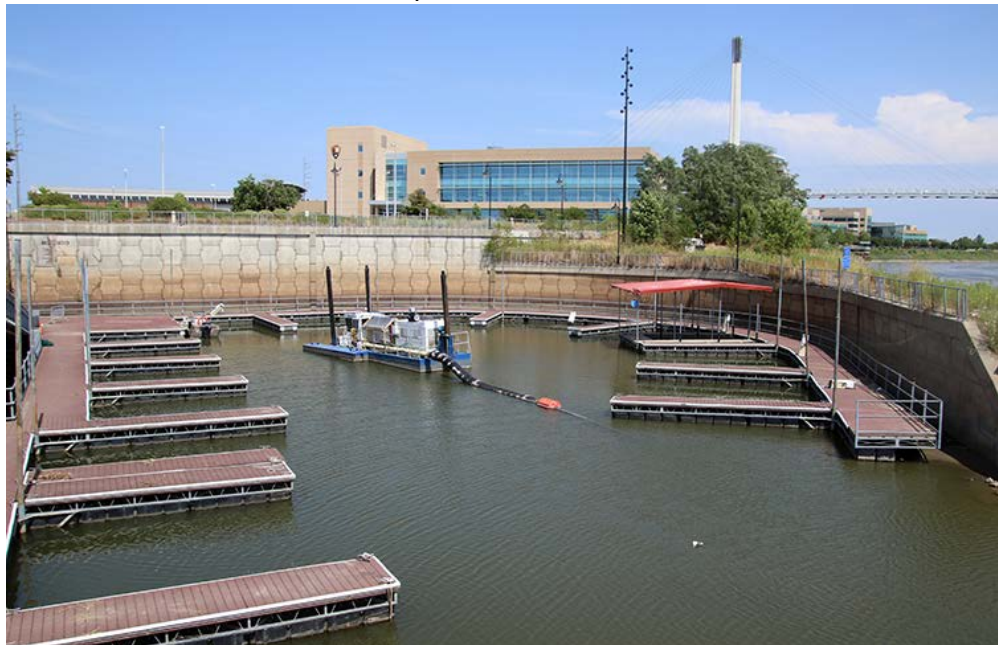
Figure 35: Image of the marina being dredged in August 2022. Sediment is still visibly exposed under the docks on the right side. Part of the Bob Kerry Bridge is visible in upper right corner.

Much thought involving Missouri river management and engineering is related to sediment. Not surprisingly, the river has always been particularly sediment rich, and the section that flows by Omaha these days is still quite 'muddy', sediment rich, despite the main stem dams upstream. The >150 mile long stretch upstream to Gavins Point Dam and the Lewis and Clark Reservoir crosses loess and till rich stretches, and has substantial drainage coming in (e.g. the Big Sioux River at Sioux City), so that the sediment resupply is significant. Heiman (2016) estimates the annual average sediment load at Omaha at 6.61 million tons per year and details how much the various tributaries contribute. The marina at the riverfront is an excellent example of the significance of this sediment load. In August of 2022 the maraine was being dredged (Figure 35) by a company based in in Kansas City (Dredge America) at a reported cost of \$447,375 (Crisler, D. 2022). FEMA will cover 95% of the costs. Most of the infilling was during the 2019 floods. The dredged sediment was reintroduced into the river. This marina, with room for perhaps 30 boats, is an example of the long term maintenance costs associated with engineered river structures. The basin is basically a backwater body where the sediment laden current slows down, and some of the sediment load is deposited. The tension is between having 'quiet' waters, good for mooring boats, and waters swift enough to prevent sediment from accumulating. Like oxbow lakes, marinas or ephemeral basins, and must be maintained.

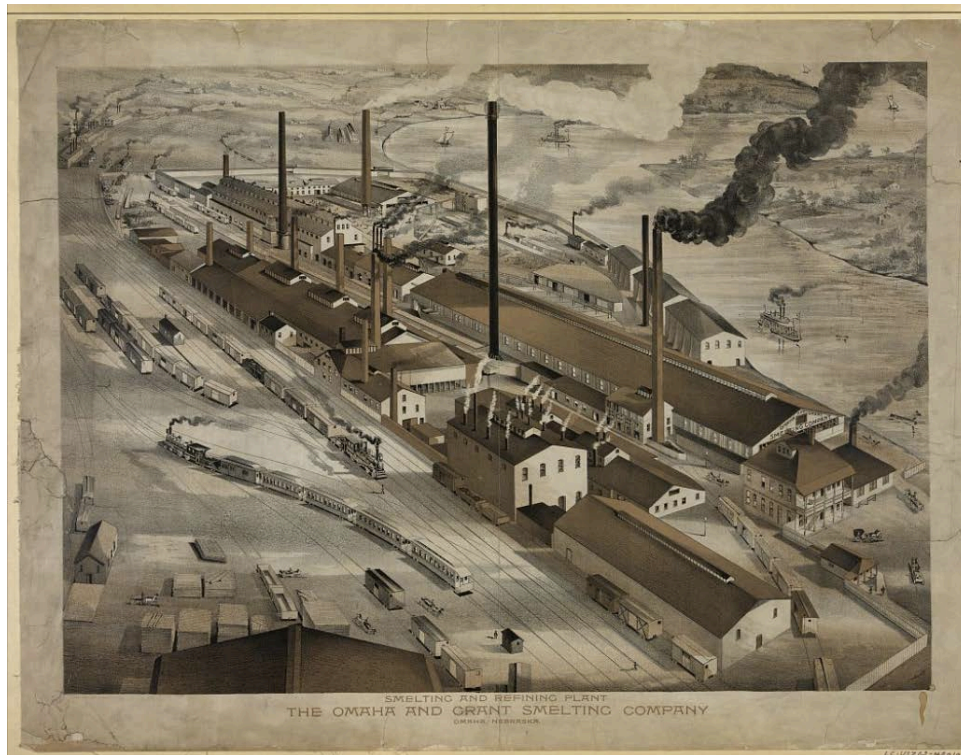
Figure 36: Image from Library of Congress, likely prior to 1899 when this site became part of the newly formed ASARCO. The dark plume of smoke is notable, although the wind direction here is depicted as towards Council Bluffs.

and Refining Company, Inc., (ASARCO) and other industrial operations (Figure 36). Because of available water for cooling and processing, and river transportation, rivers passing through urban centers were or are often sites of industrialization. As in Omaha's case, many cities are reclaiming such once industrialized areas for public use.

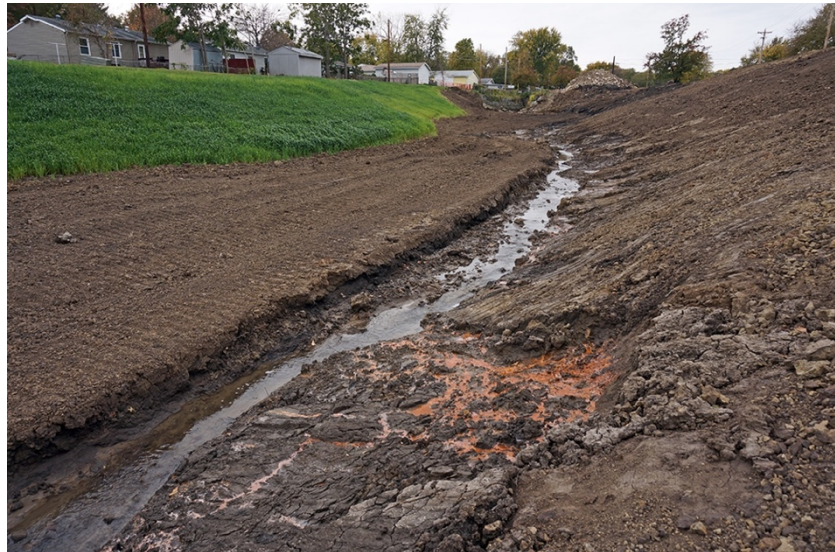
Figure 38: Image taken during construction associated with the restoration project (Oct. 2015). The intentional channel meanders are evident. Some of the bank material was clay and organic

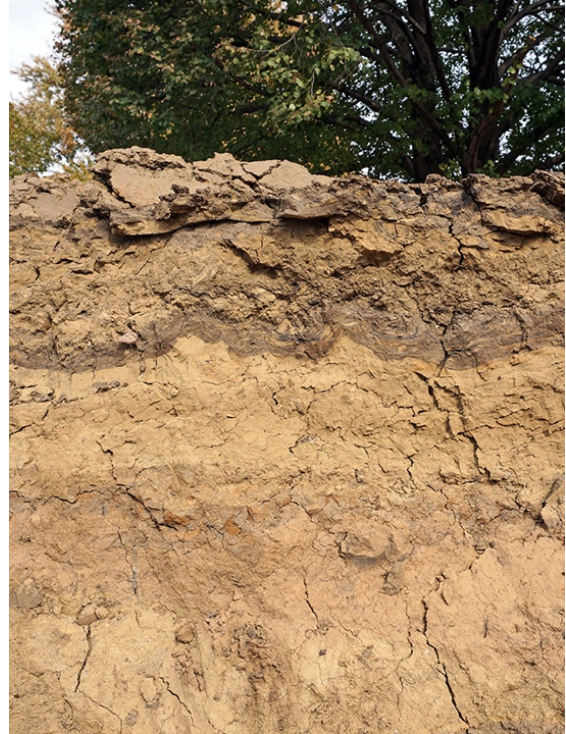
Figure 39: Excavation face from Oct. 2015 showing Anthropocene related deposition (4-5 cycles of different fill types), with the soft-sediment deformation in the upper darker layer likely related to construction machinery moving over wet soil. Exotic clasts in the fill indicate human emplacement.

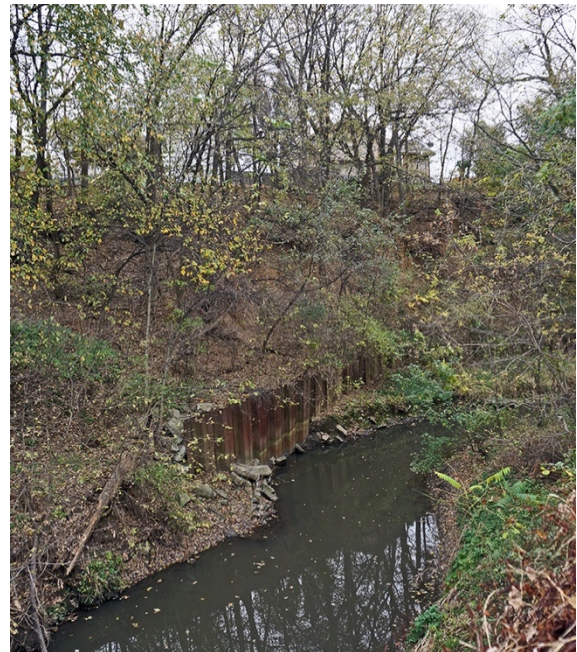
Figure 40: Image taken Oct. 2015 of erosion control structures along Thompson Creek south of 72nd street. Brown loess silts are exposed in the steep bank behind the vegetation. Note the house on the cliff top.

Downstream of the 72nd street bridge substantial erosion and incision has occurred, locally 7-15 feet (La Vista City Government, retrieved 8/2/2022), locally exposing the loess. Exposed tree roots and drainage pipe indicates the relative recency of the erosion, and control structures including sheet pilings and large rip-rap have been emplaced (Figures 40 through 42). That the stream morphology is so different above and below 72nd street (even before the watershed restoration) suggests that the street has significantly modified the fluvial processes,

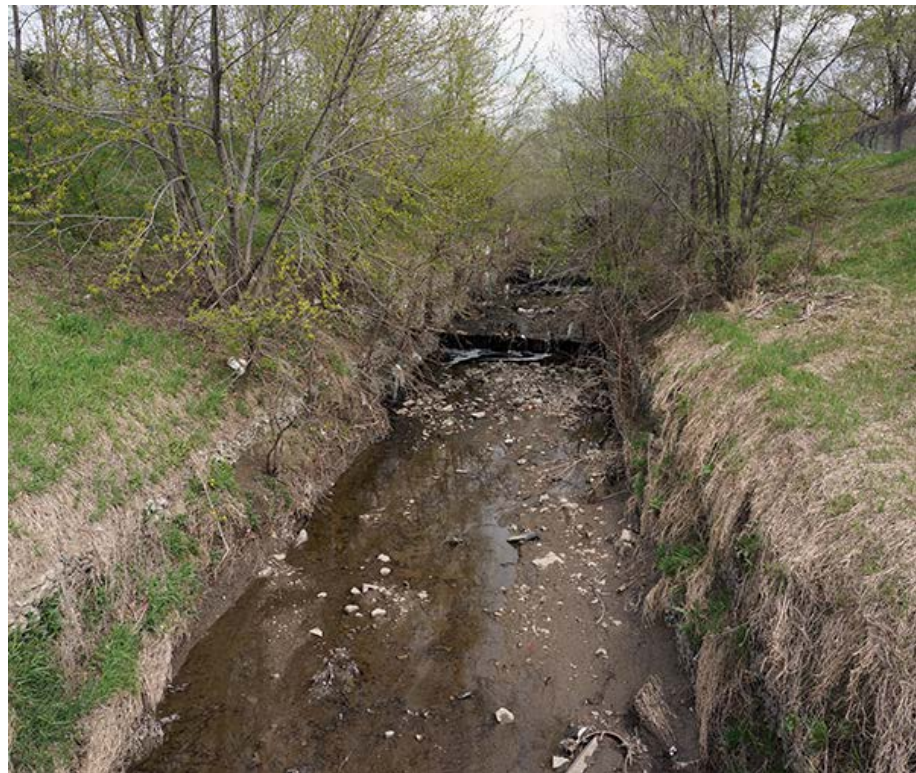
Figure 47: Looking upstream along the small tributary from the east at this site. Through the grass one can see rocks enclosed in wire (gabions) designed to stabilize the creek. In addition two sediment dams can be seen. These are full of sediment and can no longer store sediment. Coarse rip-rap and other debris can be seen in the channel bed.

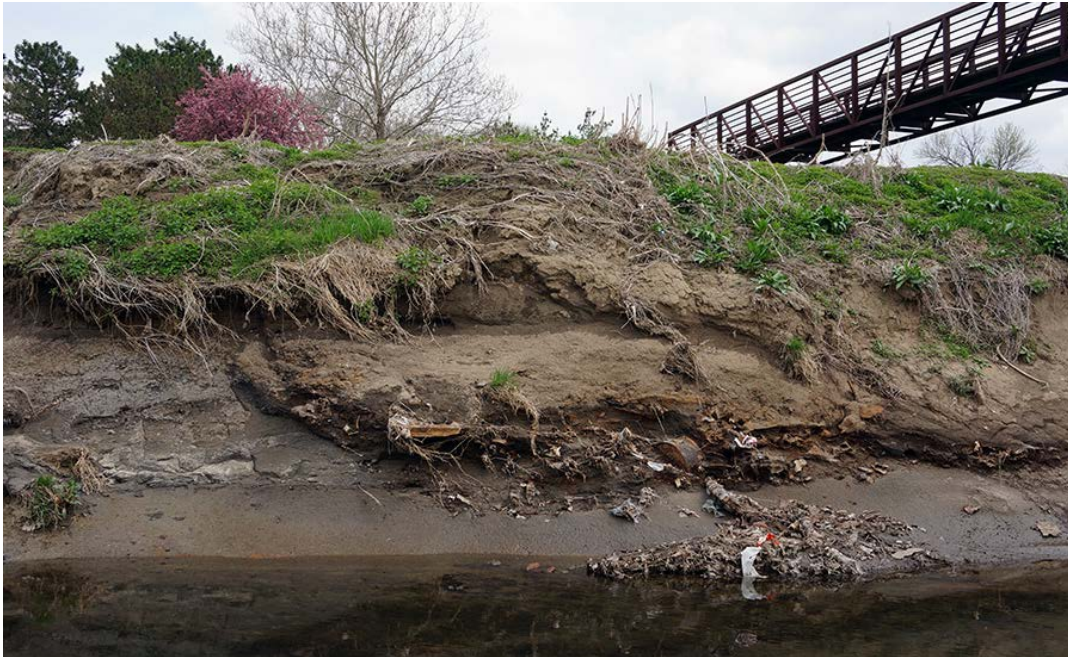
Figure 48: View of east bank of Little Papillion Creek underneath where the Keystone Trail bridge crosses it. Note the substantial amount of garbage including an old metal drum that is being disinterred. Due to the density of debris, this is interpreted to be an older small-scale dump site. Also note the darker and fine-grained color of the lower alluvium being cut into.
