Hydrogeomorphic Response of Steep Streams following Severe Wildfire in the Western Cascades, Oregon

Thesis

Master of Science
in Geosciences

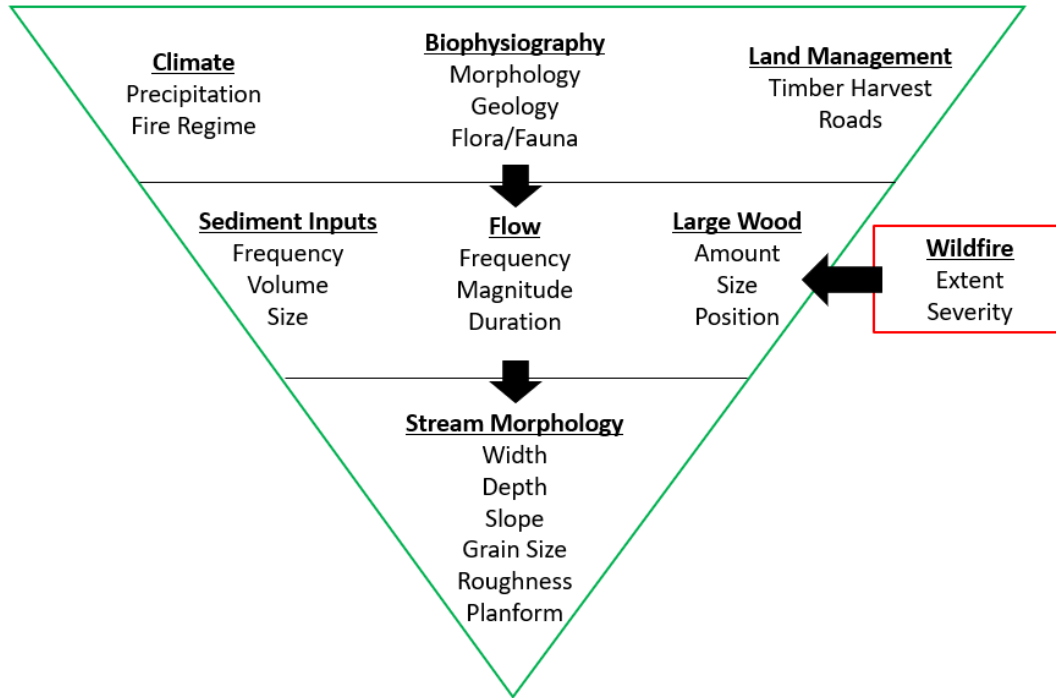
Figure 2. Conceptual figure illustrating the role of wildfire as a disturbance in mountain watersheds. Green triangle illustrates the tiered controls on steep stream morphology in a mountain watershed characteristic of the study area that existed prior to the 2020 wildfires. Wildfire (red rectangle) alters sediment, flow, and large wood regimes, thereby influencing stream morphology.

Severe fire may alter the morphologic resilience of steep streams by changing fluxes of water, sediment, and wood in channels (Fig. 2). Increased overland flow and runoff in the years after fire is frequently attributed to (i) reduced surface storage capacity for rain due to the destruction of vegetation and litter, and (ii) increased soil water repellency (i.e., hydrophobicity) that reduces infiltration, but the latter is dependent on the amount and type of litter consumed and on the temperature reached (Shakesby and Doerr, 2006; Moody et al., 2013). Peak discharges can increase by up to two orders of magnitude in the immediate years following severe fire (Shakesby and Doerr, 2006), and subsequent failure of large wood jams can cause further increases (Neary et al., 2003). Floods of these magnitudes may be sufficient to destabilize bed structures and scour steep channels to bedrock (e.g., Germanoski and Miller, 1995; Chin et al., 2019).

Here, I examine potential controls on the observed hydrogeomorphic responses, considering the tiered controls on stream response to wildfire shown in Figure 2. The high burn severity of the 2020 fires, steep topography, and high mean annual precipitation of study sites (Table 1) suggested that these streams would be highly susceptible to geomorphic change from post-fire flooding and debris flows. This was not the case during the study period, suggesting that thresholds were not exceeded, either to trigger debris flows or to mobilize large clasts and initiate widespread channel change.

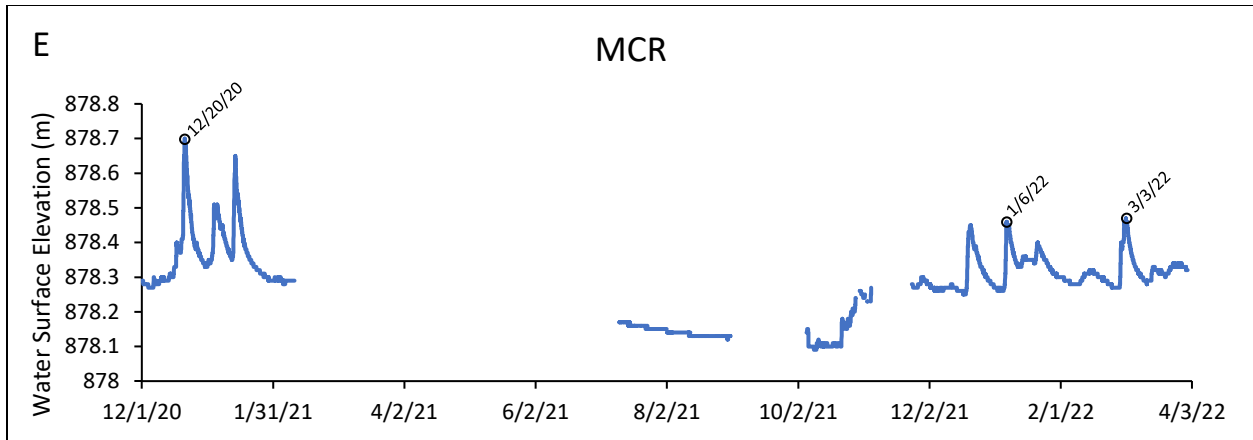
Figure 5. Time series of stage (measured from pressure transducer sensor; A-D) and water surface elevation (E) in study sites. Data gaps indicate measurement error or when the transducer was not submerged. For MCR, peak flow dates at nearby gages in the HJ Andrews Experimental Forest (Table A8) suggest that the available record captures peak flows for WYs 2021 and 2022. Black circles mark distinct flow peaks within 10 mm of the highest recorded stage for each WY. Vertical dashed line indicates a change in the transducer location. Y-axis scales differ.

The bulk of streamflow during the study period occurred between the months of October and April. Storms caused rapid increases in stage that produced flashy hydrographs in burned sites (Fig. 5). Flow in MCR was less flashy (Fig. 5), perhaps due to less overland flow during storm events and a greater amount of precipitation falling as snow. Identification of peak flows during WYs 2021 and 2022 showed that there were sometimes up to three distinct peaks in the stage hydrograph within 1 cm of the highest recorded stage (Fig. 5); I thus considered each of these in order to better characterize discharge and associated flow competence. There was variability in the timing of peak flows among Archie Creek Fire sites in WY 2021. Flows in CON and MCR peaked on 20 December 2020. In WY 2022 flows in all sites peaked from 5 to 7 January 2022 (Table 3; Fig. 5). Despite some variability, timing of peak flows in study streams was mostly consistent with those in unregulated gaged streams within 25 km of my sites (Tables 3, A7, and A8).

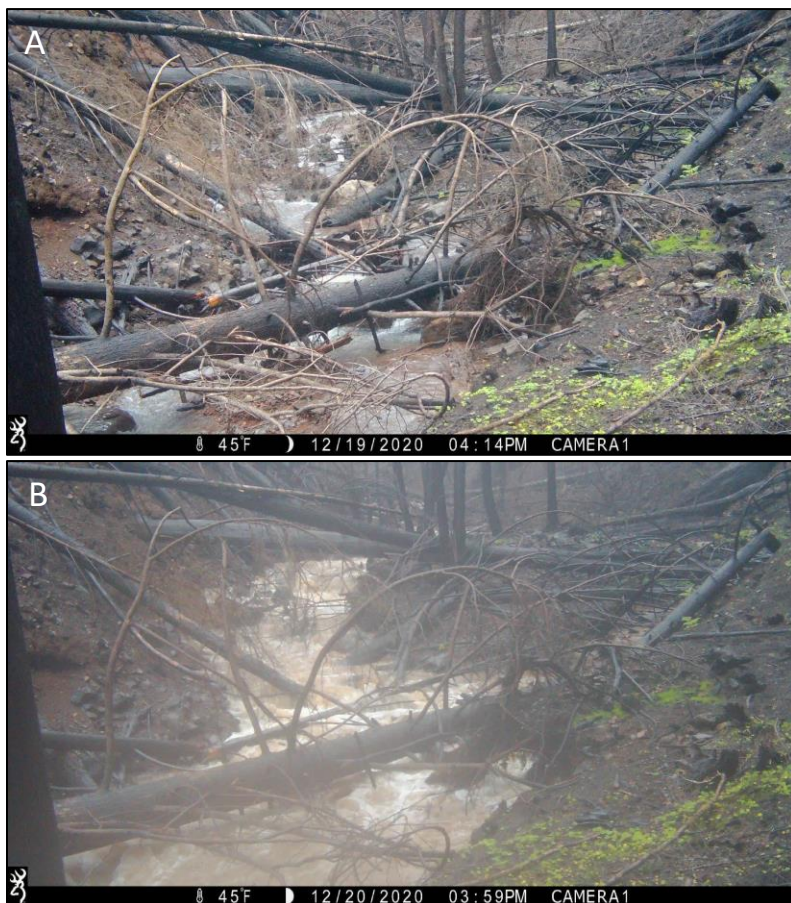
Figure 7. Trail camera time-lapse photos looking just upstream of BOG showing flow (A) the day before and (B) the day of the peak flow on 20 December 2020. Note elevated turbidity in bottom photo.

Trail camera time-lapse photos showed increased turbidity during high flows in burned sites (Figs. 7, A11, and A12), likely from fine sediment inputs from burned hillslopes. Comparing

timing of turbid flows to precipitation data suggests erosive overland flow occurred during storms exceeding a 24-hour, $\sim 1.6 \text{ mm hr}^{-1}$ intensity. I also noted overbank fine sediment deposition in BOG and CON in the initial 1.5 months after the fires (Fig. A13). Increased turbidity was not observed in MCR during the peak flows. UAV surveys and field observations revealed little evidence of rilling and gullying on burned slopes, suggesting that erosive overland flow occurred mainly as sheetwash. However, I identified one rill just upstream of BOG during initial surveys that deposited a small fan of fine to cobble-sized sediment on the floodplain (Fig. A14), although it is unknown if the rill developed post-fire. I documented three slumps along channel margins that supplied sediment to study sites. The first occurred in BOG during the initial 1.5 months after the fires (Fig. 8). Two other slumps occurred at the downstream end of CON during the second winter rainy season after the fires (Fig. A10). Bank erosion did not appear to be a large source of sediment to study reaches. There were isolated cutbanks in BOG (Fig. A15), CON, and MCR, but little evidence of erosion during the study period. There were recently fallen trees along the channel margin in BOG (Fig. 8) and WRT. SWP was the most visibly unstable of my study streams. In some places the stream was deeply incised with steep and undercut banks of exposed soil (Fig. 9). I documented recent bank

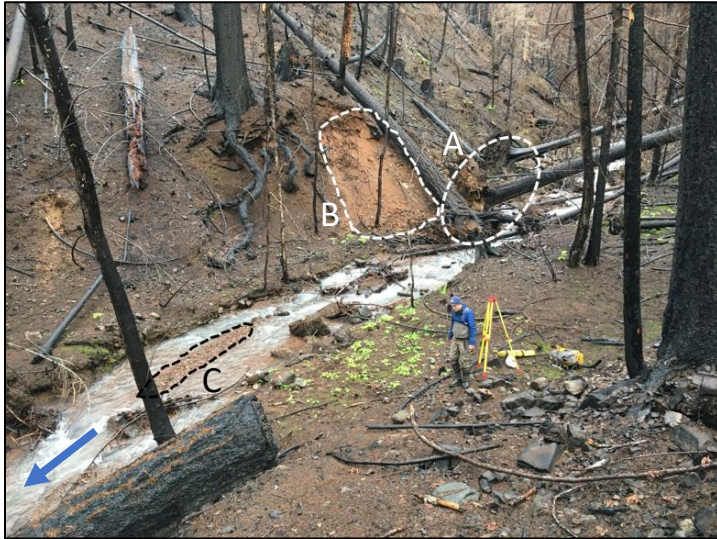
Figure 8. BOG in Dec-20 indicating (A) treefall along the bank, (B) slumping, and (C) a mid-channel gravel bar. Blue arrow indicates flow direction.

1.5 months after the fires, there was notable gravel aggradation in BOG that appeared to be post-fire deposition (Figs. 8, 10, and A15). The gravel mostly persisted during the first winter after the fires, and further aggraded in some areas (Fig. 10), but was largely eroded during the second winter rainy season (Figs. 10 and A18). This is supported by repeat pebble counts which showed little change in the D_{50} during the first winter and a 50% increase during the second winter (Table 4; Fig. 13), reflecting bed-material coarsening. Only the change in grain size distribution between Dec-20 and Mar-22 was statistically significant (Fig. 13).

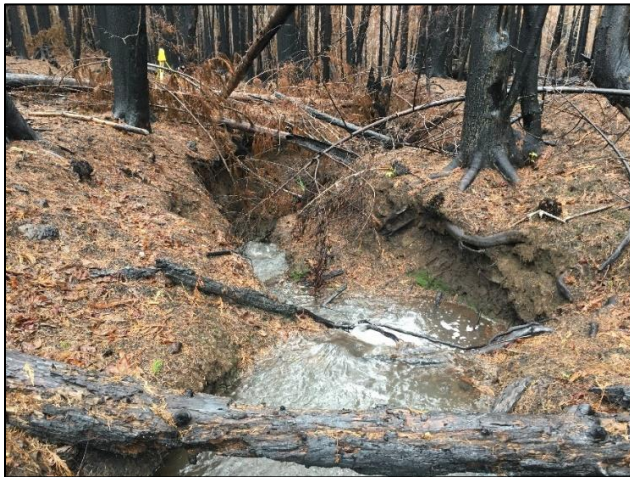
Figure 9. View downstream from within the tributary to SWP showing channel incision and bank erosion in Dec-20.

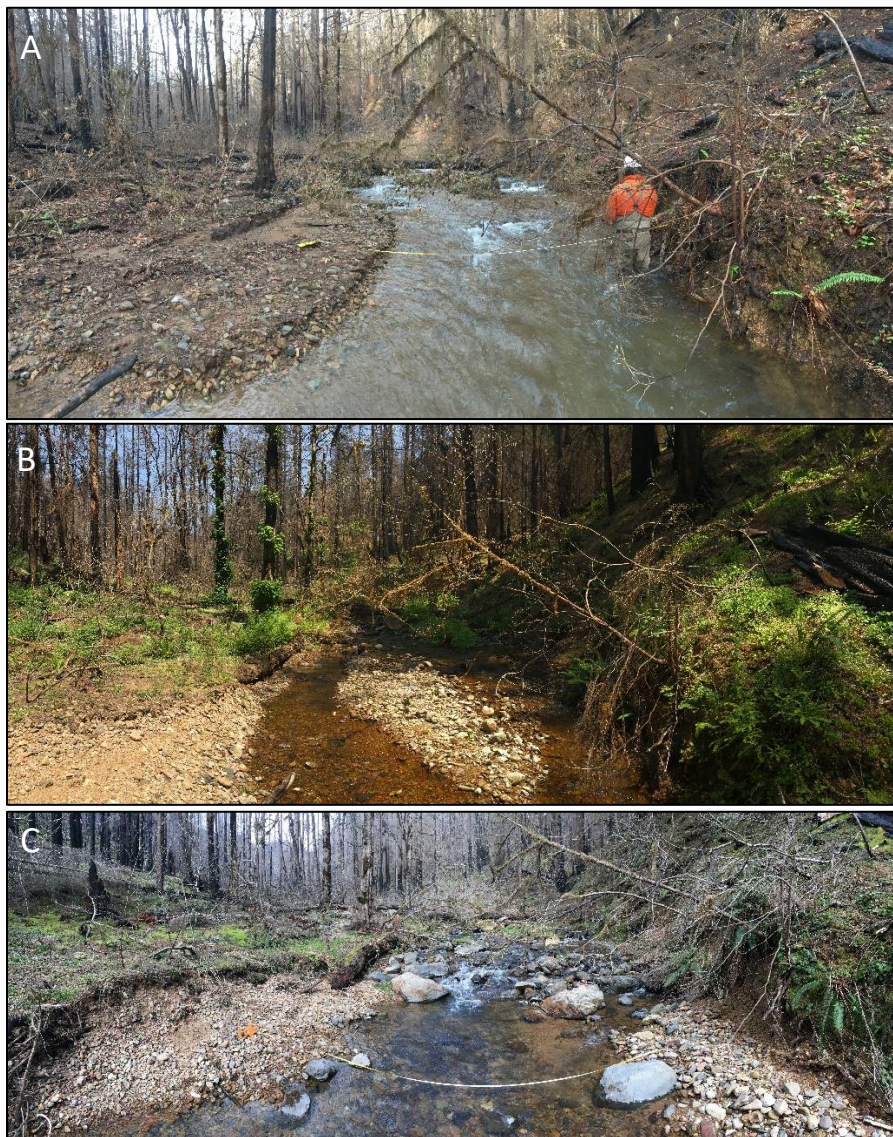
Fig. 11. Repeat photos looking upstream in CON showing mid-channel bar formation between (A) Dec-20 and (B) Jun-21 and erosion by (C) Mar-22. Note bank erosion and widening of the bankfull channel at left in (C).

There was a marginal channel bar of fine to cobble-sized sediment at the downstream end of CON 1.5 months after the fires that appeared to be post-fire deposition. During the first winter rainy season after the fires, the marginal bar began to erode, and a new mid-channel bar formed (Fig. 11). There was also substantial gravel deposition above large wood jams at the upstream and downstream ends of the reach during the initial rainy season (Fig. A19). While

the jam-forced gravel deposition persisted through the second rainy season (Fig. A19), flows eroded the newly formed mid-channel bar and cut into the bank, widening the bankfull channel (Fig. 11). This erosion was accompanied by an increase in average bankfull depth of 33% (+0.19 m), although this was not statistically significant (Table 4). Bed material coarsened significantly during the initial winter, and then remained consistent (Table 4; Fig. 13).

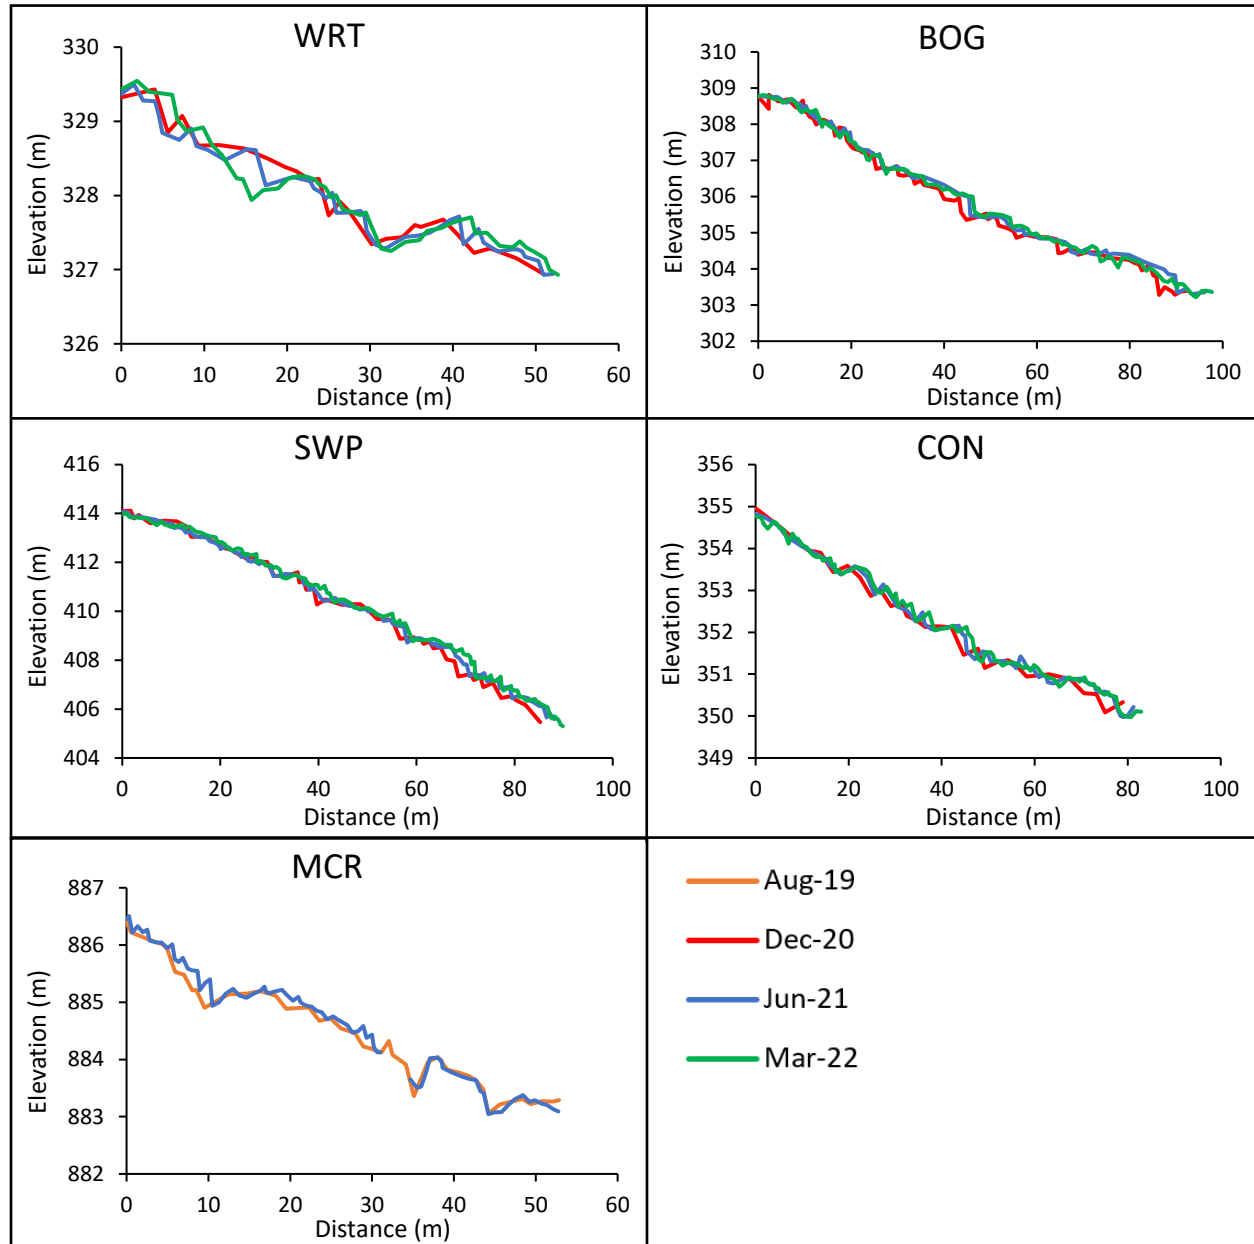
Figure 12. Thalweg longitudinal profiles of study reaches. Changes were mostly minor, but note degradation in the upper portion of WRT over the course of the study. Because the thalweg location sometimes shifted between surveys, plots may not accurately depict areas of incision and deposition. Axes scaled to data.

Bed-material mobilization in burned sites induced changes in bed grain size and local changes in channel geometry, although gross channel changes in width, depth, slope, and bed roughness height were limited (Table 4; Figs. 12 and 13). Peak flows in burned sites in WYs 2021 and 2022 were competent to transport the D_{50} at nearly all cross-sections. In MCR, flows were not competent to transport the D_{50} . Boulders were not mobilized during the study period (Table A10). Here, I provide my site-specific interpretation of morphologic change, based on field

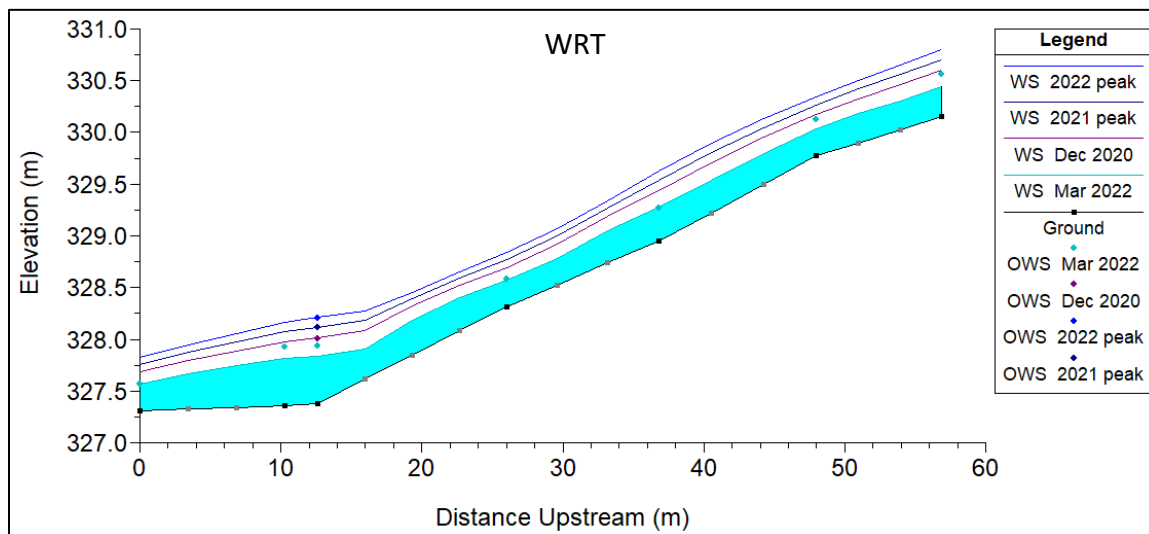
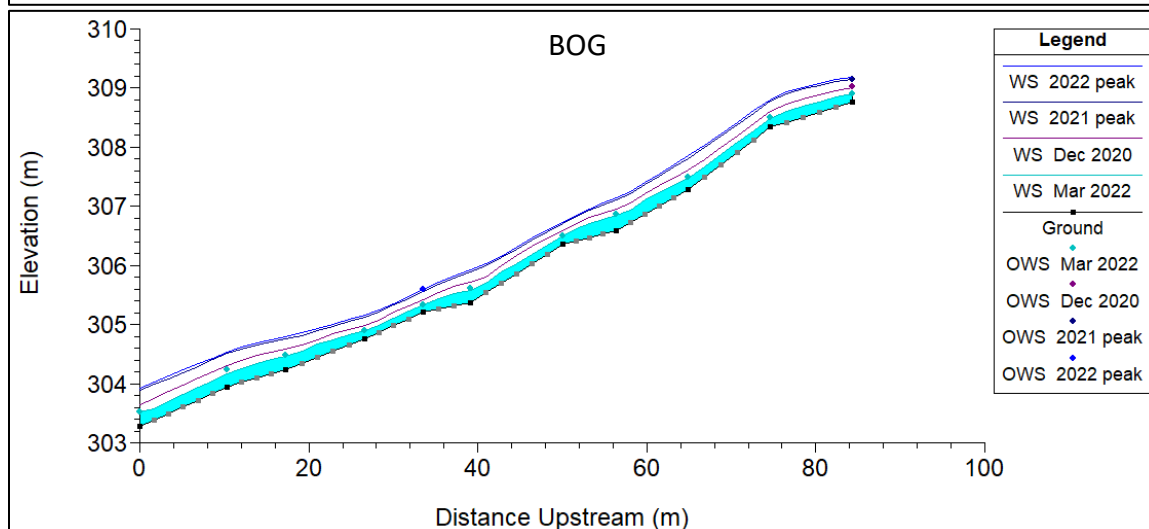
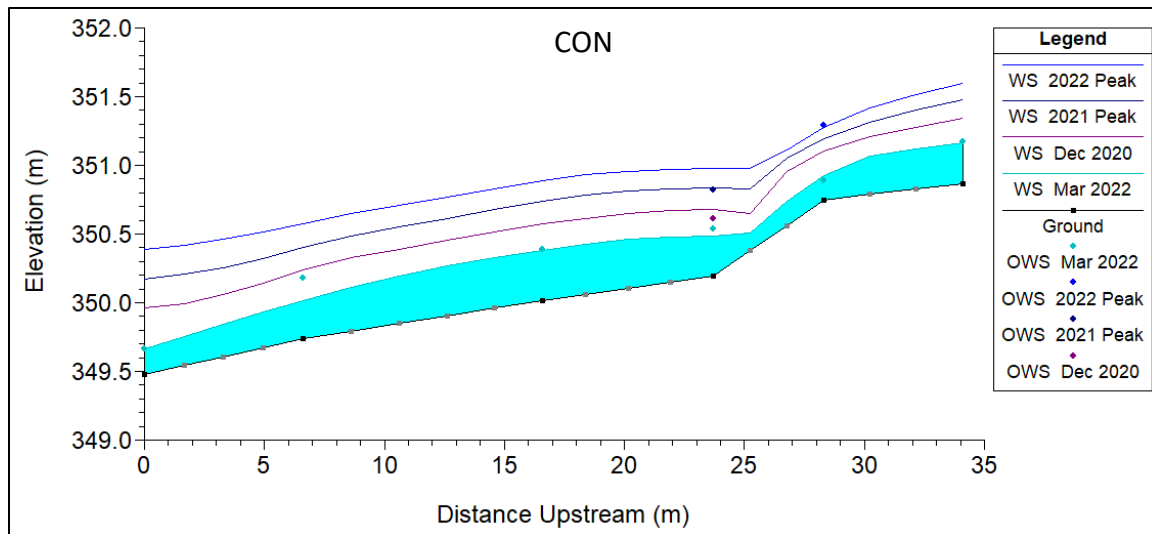
Figure A6. Water surface (WS) profiles from HEC-RAS modeling. When available, observed water surface (OWS) is indicated. Interpolated cross-sections displayed as gray dots. Axes scaled to data.

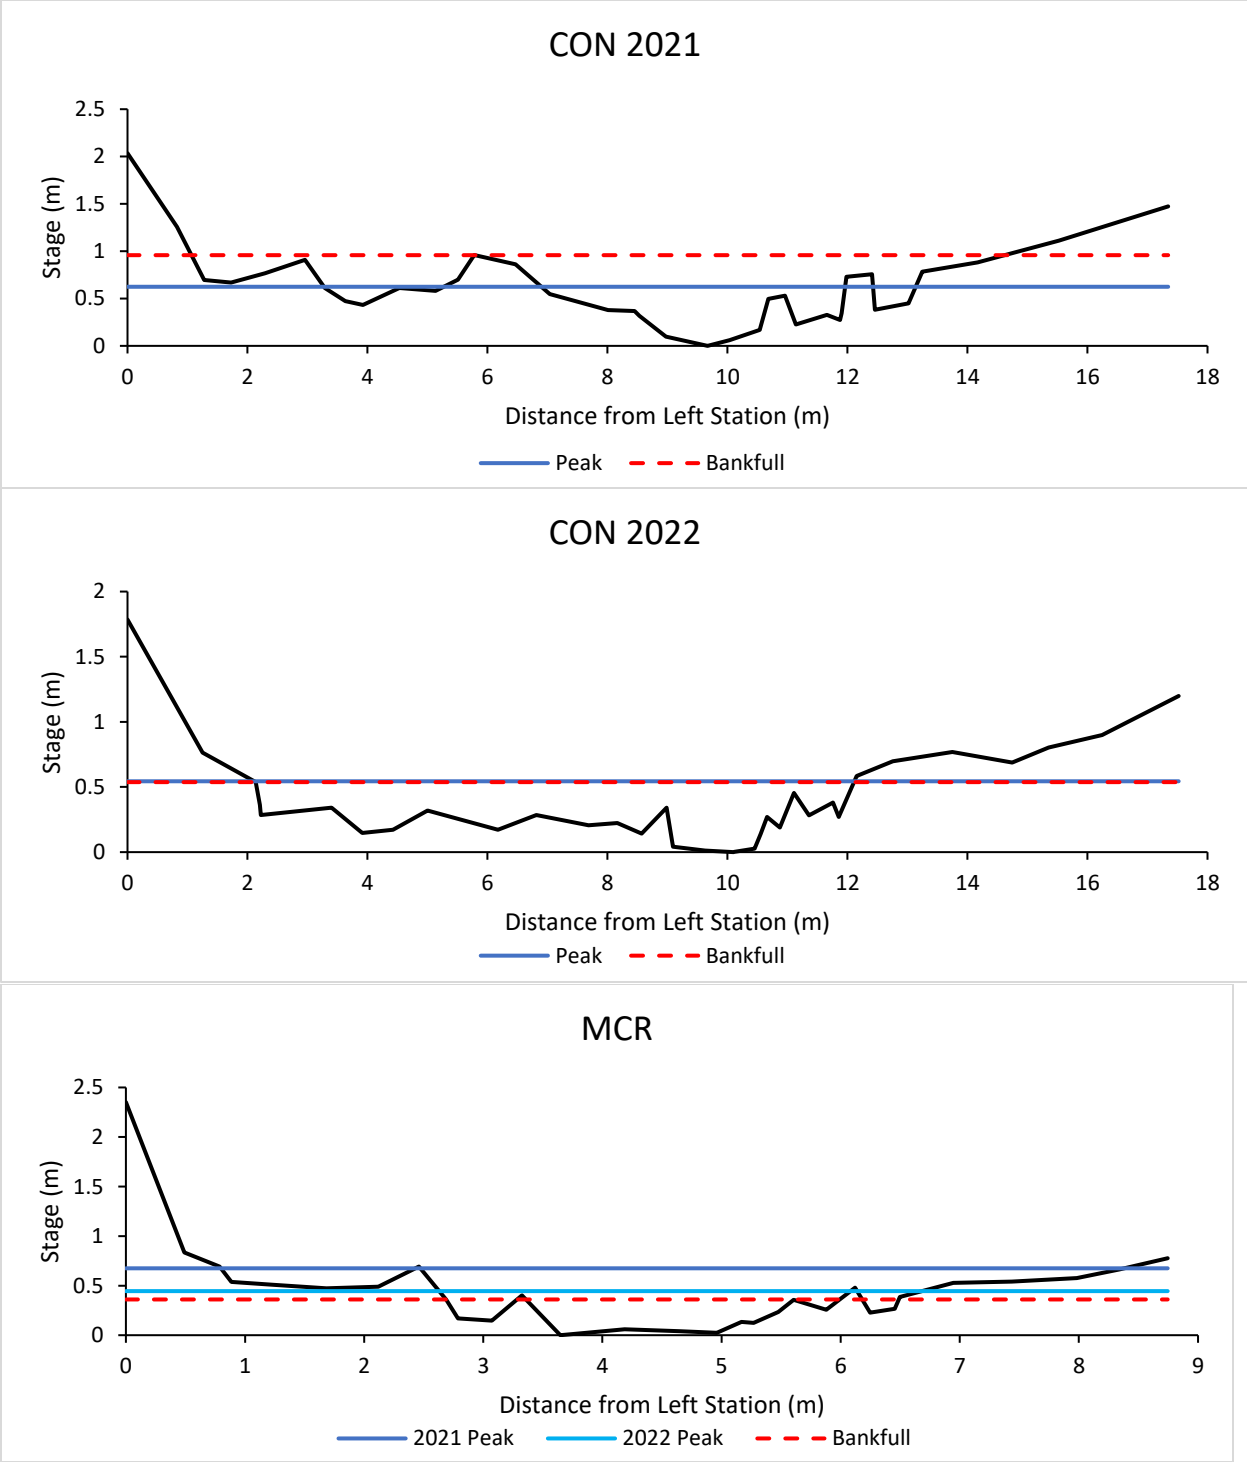
Figure A7. Peak flow stage at the pressure transducer cross-section in WYs 2021 and 2022. At all sites but WRT and MCR, the transducer was moved to a different location in Jun-21. Cross-section geometry for MCR is from August 2019.

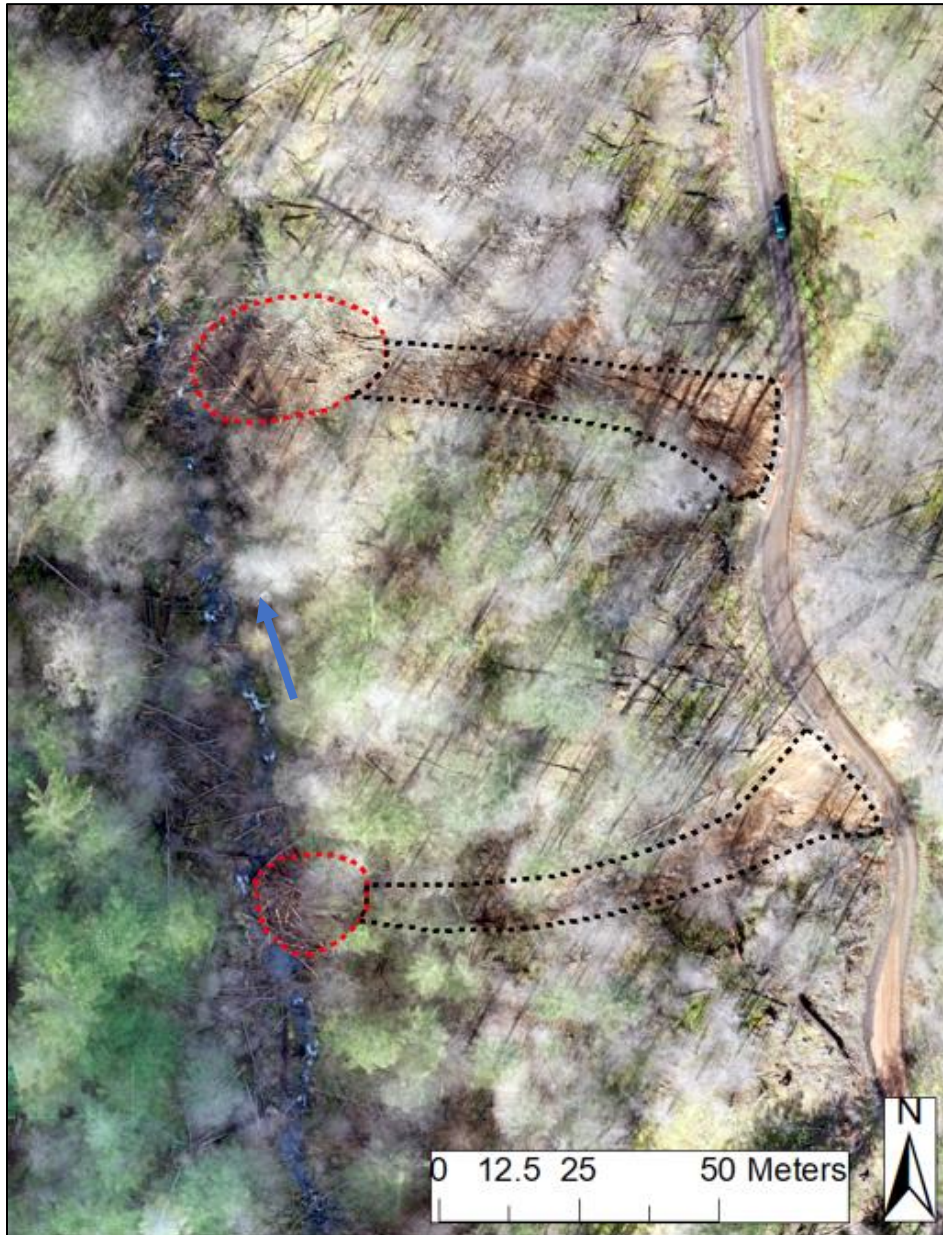
Figure A8. Mar-22 orthophoto in WRT showing slide paths (black dashed polygons) and debris fans (red dashed ovals) from two landslides that occurred upstream of my study reach in January 2022. Blue arrow indicates flow direction.

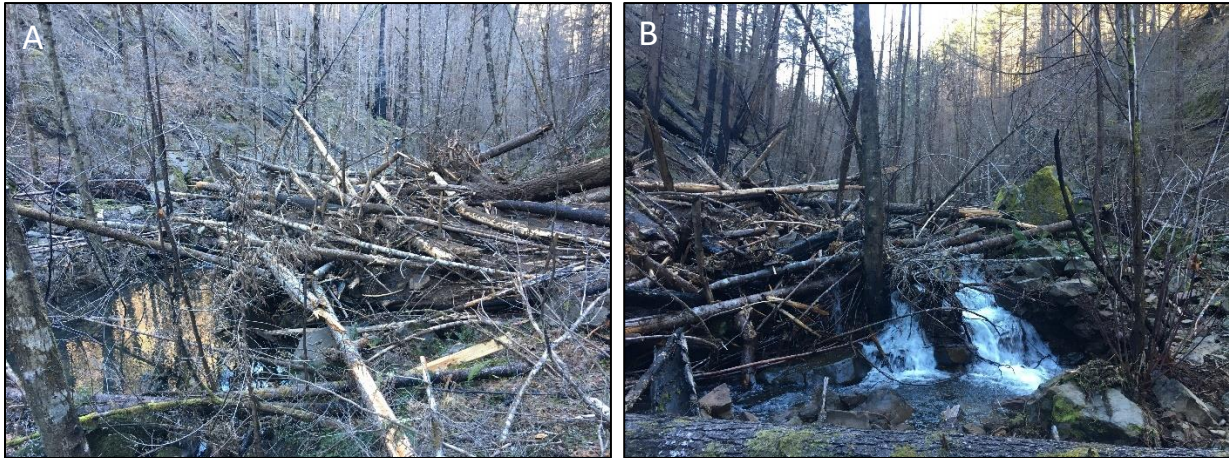
Fig. A9. The upstream landslide debris fan in WRT. The fan constricted the channel, forcing (A) a pool on the upstream side and (B) a drop on the downstream side.

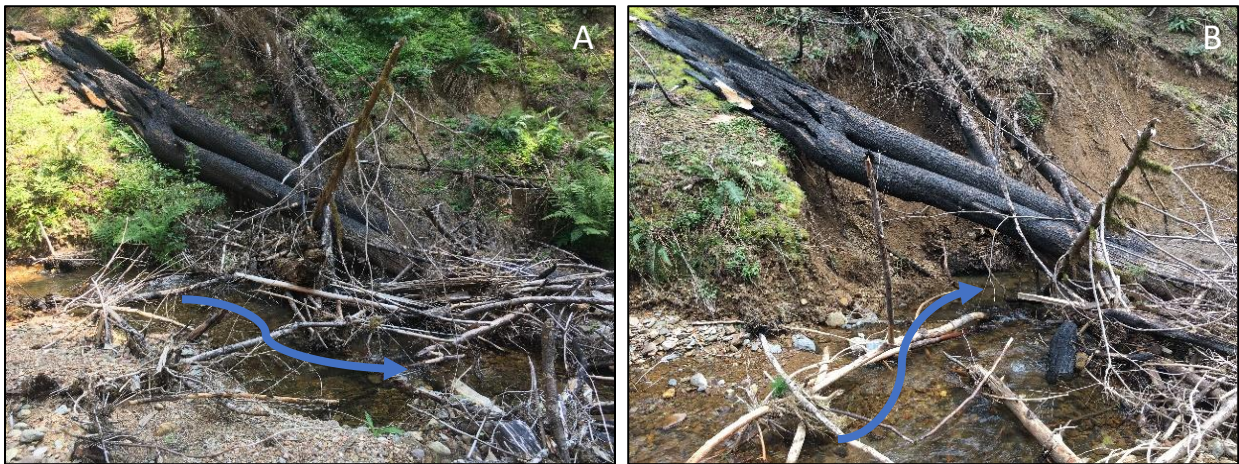
Figure A10. Repeat photos in CON in (A) Jun-21 and (B) Mar-22 showing two slumps along the channel margin in (B). Blue arrow indicates flow direction.

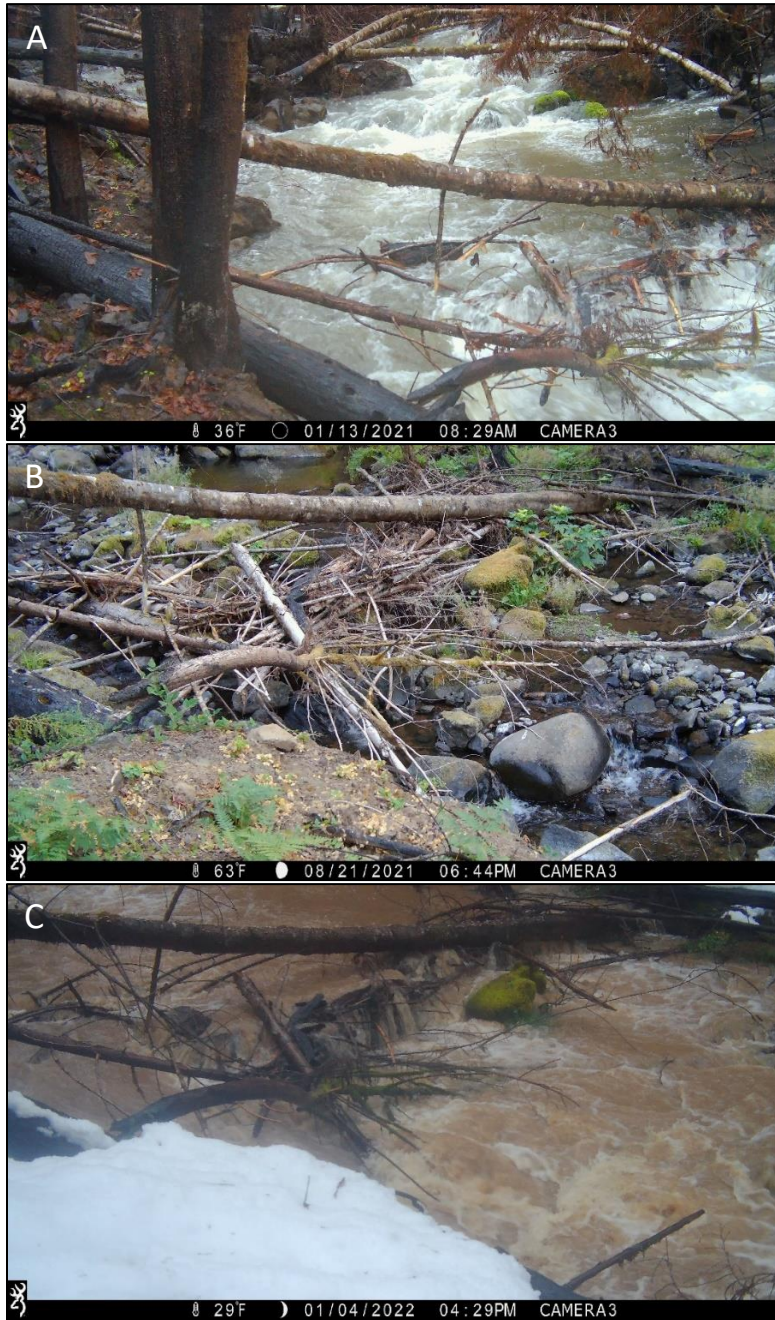
Figure A11. Trail camera time-lapse photos looking upstream in WRT during (A) the 2021 peak flow on 13 January, (B) summer 2021 low flows, and (C) following the two landslides upstream of my study reach in January 2022.

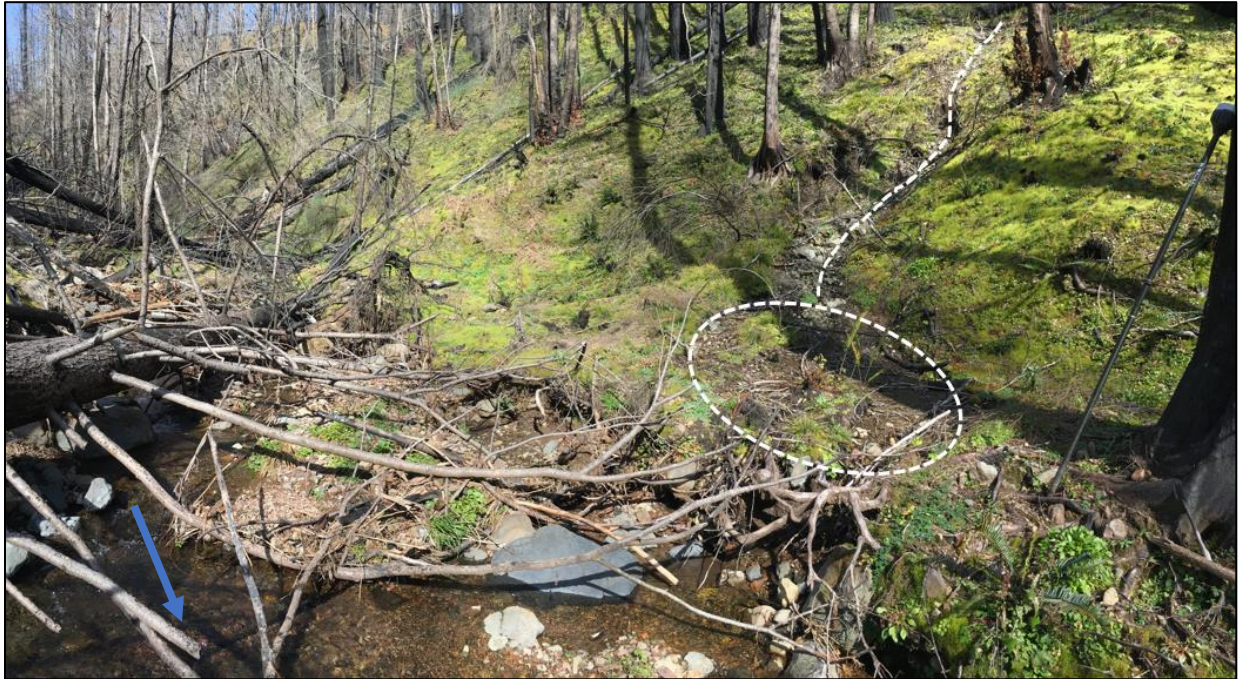
Figure A14. View just above the upstream end of my study reach in BOG in Mar-22 showing a rill (dashed line) and associated sediment fan of fine to cobble-sized clasts (dashed oval). The rill was present in Dec-20 but it is unknown if it formed after the fires. 2 m survey pole on right side for scale. Blue arrow indicates flow direction.

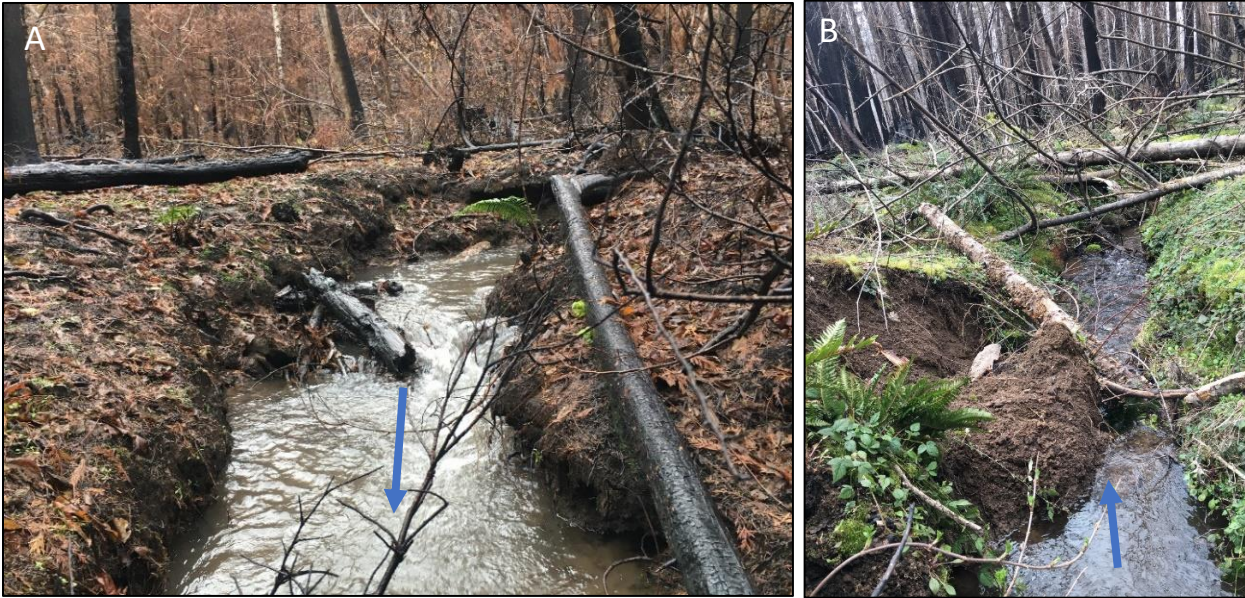
Figure A16. Examples of recent bank collapse in SWP from (A) Dec-20 and (B) Mar-22. Blue arrows indicate flow direction.

collapse over the course of the study period (Fig. A16). There was also a large rootwad in the middle of the channel that degraded during the study, supplying sediment to the stream (Fig. A17).

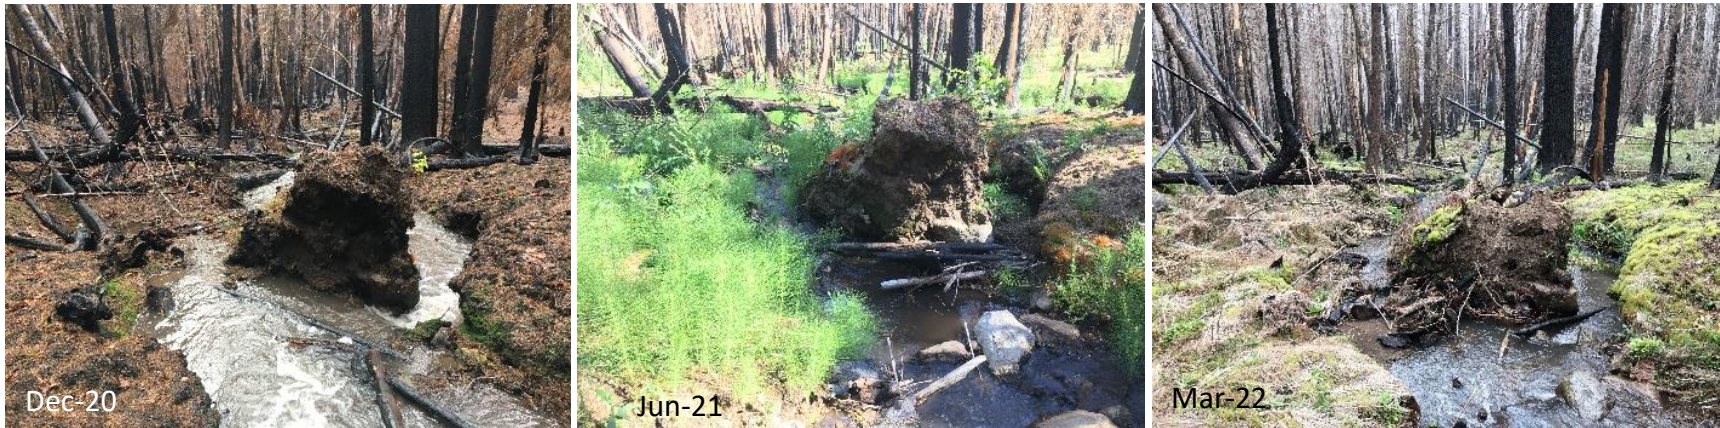
Figure A17. Repeat photos looking downstream in SWP showing degradation of a large root wad and wood jam formation.

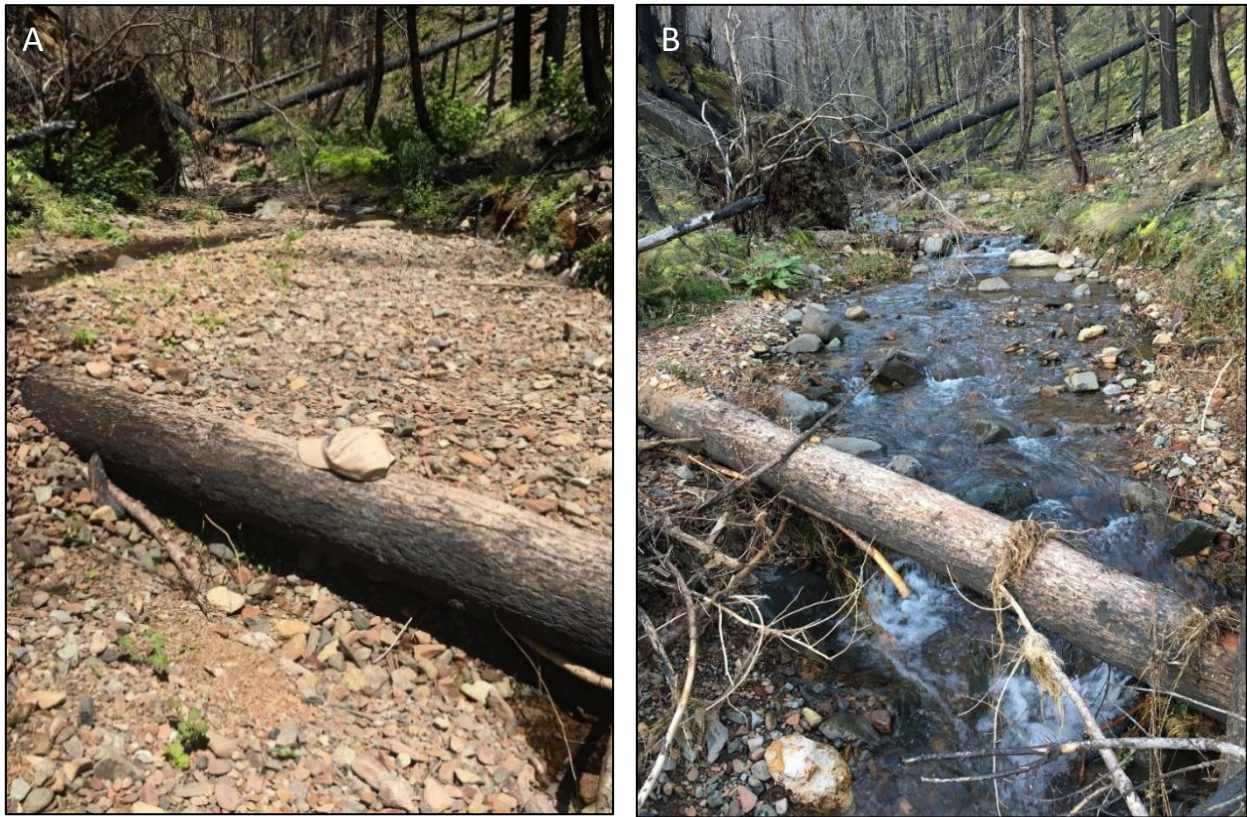
Figure A18. Repeat photos looking upstream in BOG showing wood-forced gravel aggradation in (A) Jun-21 and subsequent erosion by (B) Mar-22 . There was >0.6 m of channel incision on the upstream end of the log in the photo. Hat on log in left photo for scale.

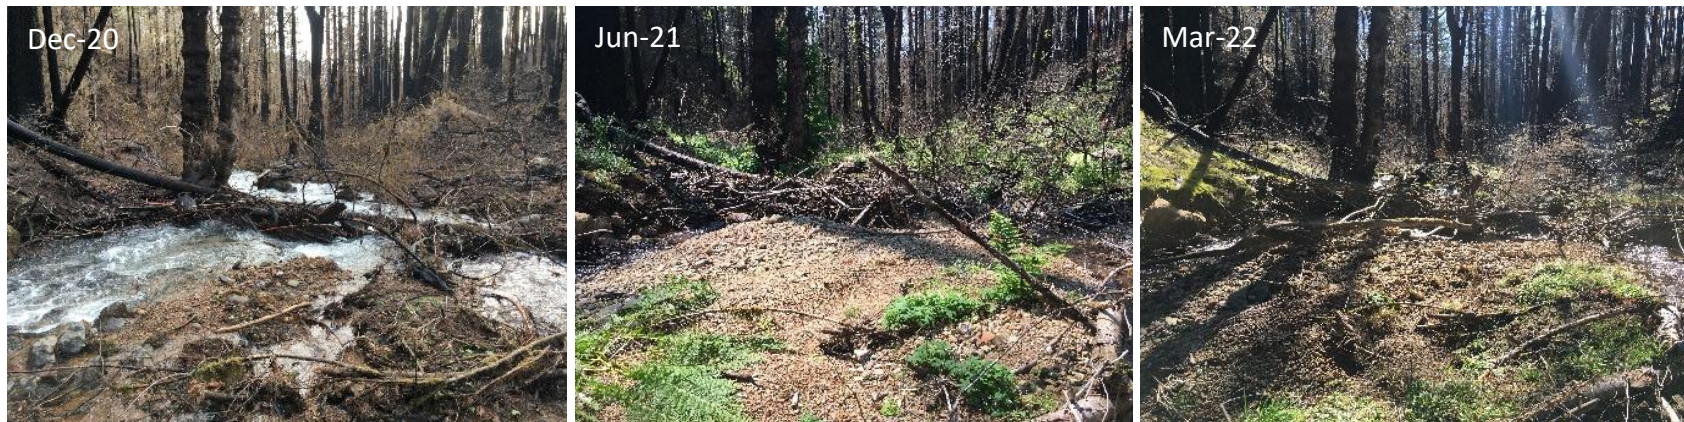
Figure A19. Repeat photos looking downstream in CON showing fine to cobble-sized sediment aggradation upstream of a channel-spanning large wood jam.

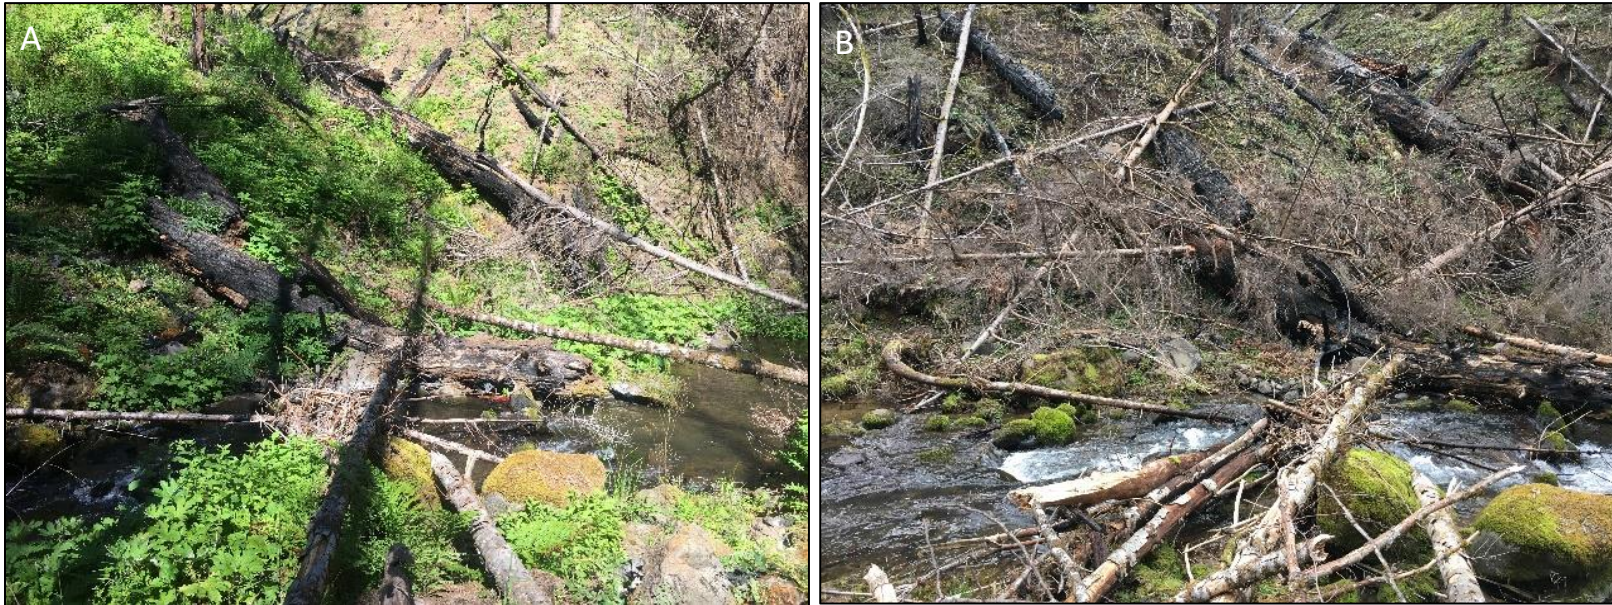
Figure A20. Repeat photos in WRT showing post-fire treefall between (A) Jun-21 and (B) Mar-22.
