Catetinho: The first presidential house in Brasília, Brazil

ABSTRACT: Among the monuments of Brazilian modernist architecture, Catetinho, built in 1956 near the construction site of Brasília, is one of a kind. The only work by Oscar Niemeyer built out of wood, it was intended to be a temporary office for the President of the Republic during the construction of the new capital city. This work discusses the current state of conservation of the Catetinho, how its design and construction techniques impact conventional wisdom on the preservation of both modernist and wooden buildings, and recommended strategies to protect material integrity and the intelligibility of its original design. The research points out that, while the hastily detailed structural system is itself a risk factor to the Catetinho's durability, conservation efforts can be helped by a clear vision as to which, among the existing materials and techniques, are essential to the building's identity.

Keywords: 1950s, Catetinho (Brasília), Wood, Maintenance, Restorations

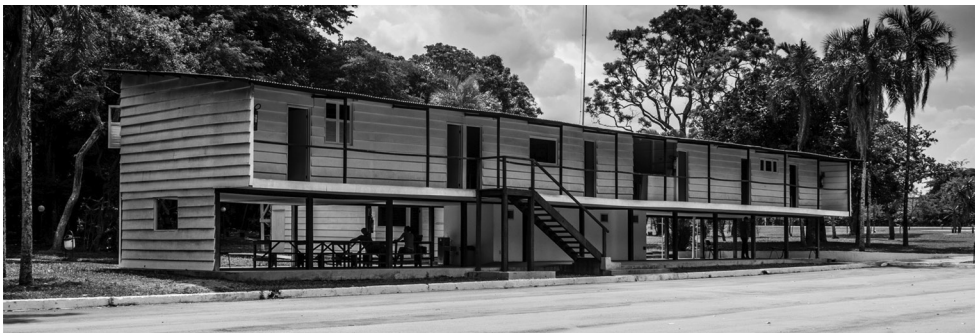
Figure 1. Catetinho, exterior view. P.P. Palazzo, 2016.

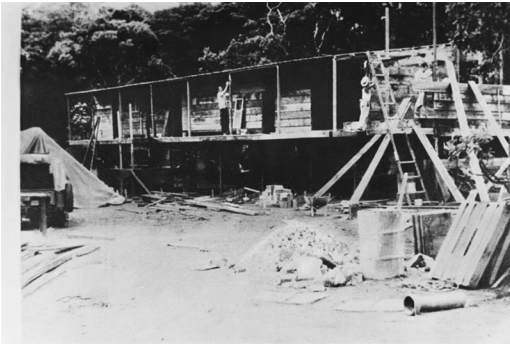
Figure 2. The Catetinho under construction on the last week of October, 1956. Federal District Public Archives (ARPDF), Novacap collection D4.4.b2 514.

picked up from Magalhães Penna’s construction company along the way. The original posts, beams, floor planks, and siding were made of dimension wood, locally known as *ipê* (*Handroanthus* or *Tabebuia*, genera of flowering plants in the family *Bignoniaceae*, see Mabberley 2008). This tree genus is native to central Brazil and was once widely used as building material, before being declared an endangered group in the 1980s. A slab of unreinforced concrete was poured at grade to stabilise the posts and create a level ground floor plate, over which a small brick room provided minimal bracing for the whole building. Beams were created with makeshift assemblies of wood planks screwed eccentrically to the posts (Fig. 3). The roof was a simple rafter and purlin grid supporting corrugated metal plates. The main floor counted only five suites and a large office, so that a service building with kitchen and janitor’s quarters had to be added a couple of months after inauguration.

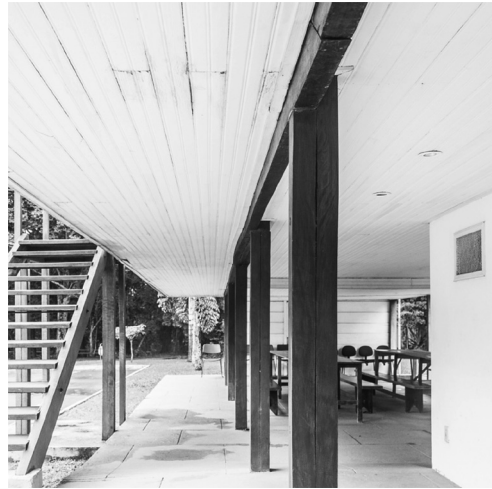
Figure 3. Pilotis of the Catetinho. P.P. Palazzo, 2016.

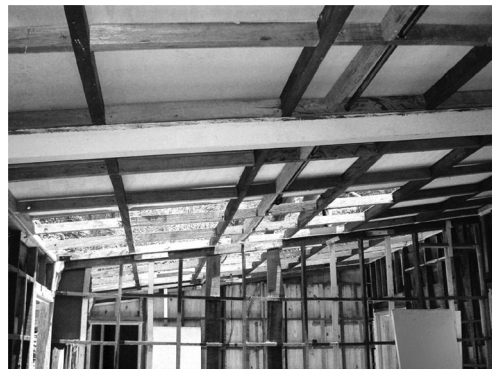
Figure 4. Replacement of the interior sheathing in progress, showing roof structure, first half of February, 2012. Federal District Historic Preservation Office (Supac) digital archive.

- Interior sheathing replaced again in 2012 (Fig. 4);
- Original plumbing siphons replaced with new, production-line parts in 2012, even though there had been no running water in the building for decades and the original parts were in a fair state of conservation;

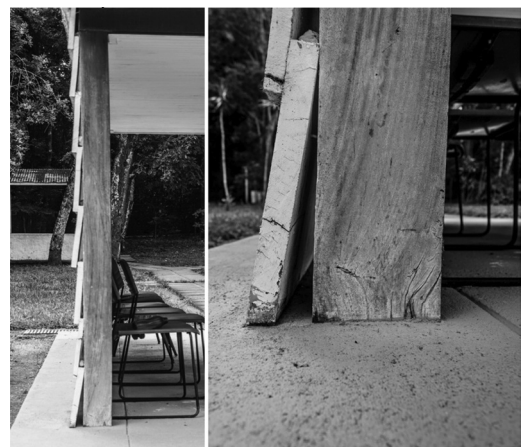
Figure 5. Side view and detail of clapboard bracing at the Catetinho. M.M. Mennucci, 2017.

- Clapboard bracing removed from both ends of the *pilotis*, in 1957, and southeast bracing recreated in 1995;
- Original rolling mat blinds removed from the corridor balcony before 1978, and from the windows at some point between 1978 and 1995;

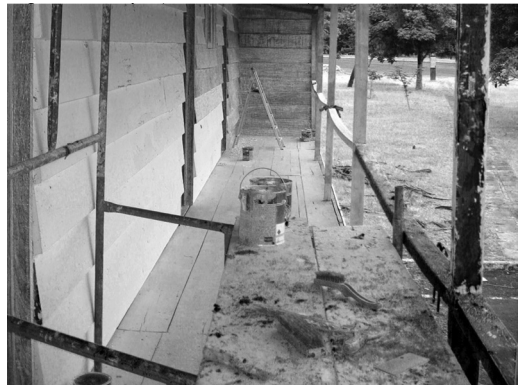
- Repainting and priming on several occasions, including changes in paint colours, with neither recorded justification, nor a precise record of the existing or new products and techniques employed (Fig. 6).

Figure 6. Scraping and repainting in the Catetinho veranda, first half of February, 2012. Supac digital archive.

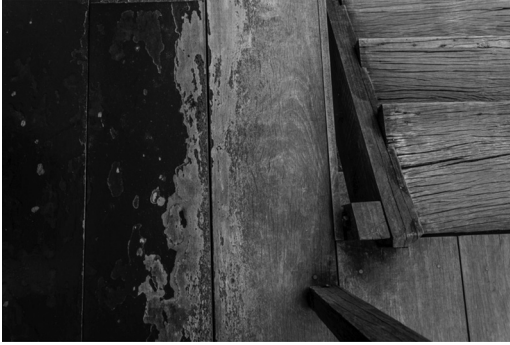
The ceiling over the ground floor, suffering from water run-off (Fig. 8), and the floor paint in the areas most exposed to sunlight and rain, that is, the stairs and the edge of the veranda (Fig. 7), have

Figure 7. Veranda floor and stairs showing deteriorated paint coat in exposed areas. M.M. Mennucci, 2017.

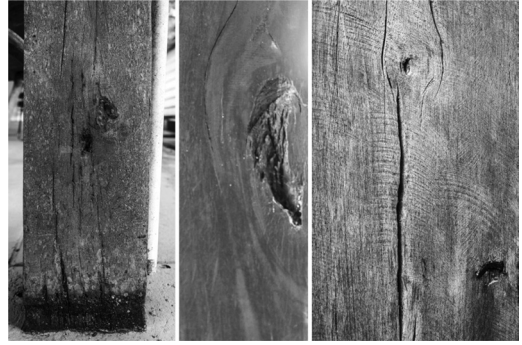
Figure 9. Posts showing damage by rot, loss of supporting section creating a habitat for insects and arachnids, and cracking due to buckling. M.M. Mennucci, 2017.

Structural damage to the posts reflects the difference in species and assemblies used, as well as biological factors, and bodes ill for the durability of the building. The unprotected insertion of the posts into the concrete slab has caused rot in their lower ends, whereas their middle and upper parts display cracks due to buckling and bolt corrosion (Fig. 9).

Due to the temporary purpose of the Catetinho, its physical conservation is often at odds with the preservation of its architectural character. Indeed, much of the damage that begins to take place shortly after each intervention can be ascribed to the lack of design detailing such as waterproofing, flashing, or even a sturdier structural concept. This contradiction requires particular attention, on the historic preservationist's part, to inconspicuous

interventions such as wood treatment, joint detailing, and choice of paint. This is to avoid future need for intrusive solutions such as bracing, or even the repeated replacement of major parts of the construction.

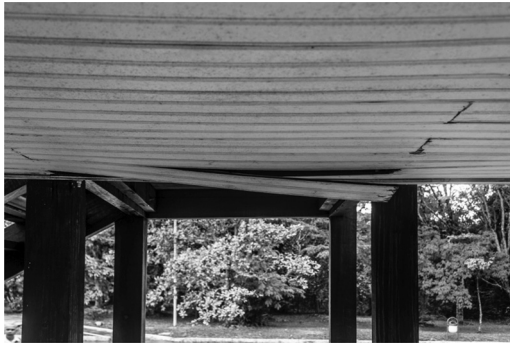
Figure 8. Ceiling on the ground floor of the Catetinho showing deterioration. P.P. Palazzo, 2017.

sustained the strongest damage. Sheathings in the kitchen annex are moderately compromised by fungi and termites. Most of the dimension wood in the building—posts, beams, and boards—need attention to their excessive moisture content during the rainy season, and several parts are infested with arachnids, insects, fungi, and bacteria.
