CONDITION ASSESSMENT OF SUBSURFACE DRAINED AREAS AND INVESTIGATION OF THEIR OPERATIONAL EFFICIENCY BY FIELD INSPECTION AND REMOTE SENSING METHODS

Keywords: soil moisture regulation, tile drainage, condition assessment, GIS

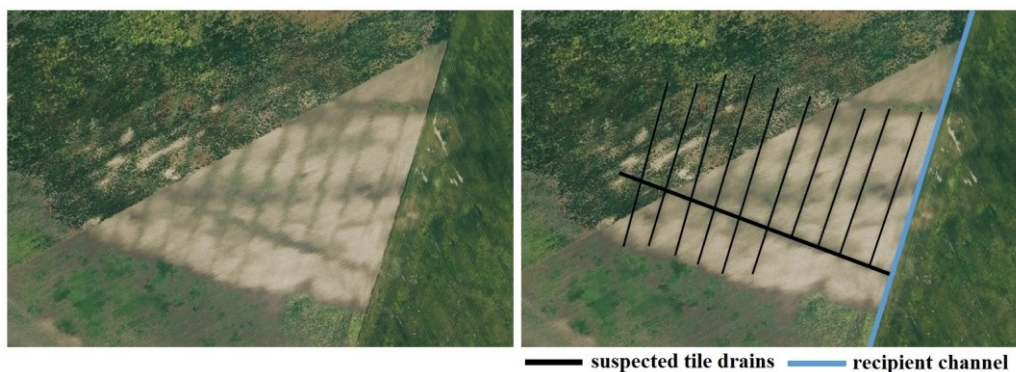
Fig. 4 Appearance of tile drain lines near Kunszentmárton, Hungary. The drawn lines on the bare soil continue on the surface with vegetation too, where the lines still could be observed due to differences in vegetation growth or species composition (source: Institute of Geodesy, Cartography and Remote Sensing of Hungary)

In general, after a precipitation event, the wet and drier parts of the study sites were easily separable in the case of bare soil surface. Contrary to our expectations we could not observe linear traces on UAV images suggesting the presence of drains at Mezőtúr study site. We observed drain lines only on the examined orthophotos (Institute of Geodesy, Cartography and Remote Sensing of Hungary) e.g. around Kunszentmárton, Hungary (Fig. 4).

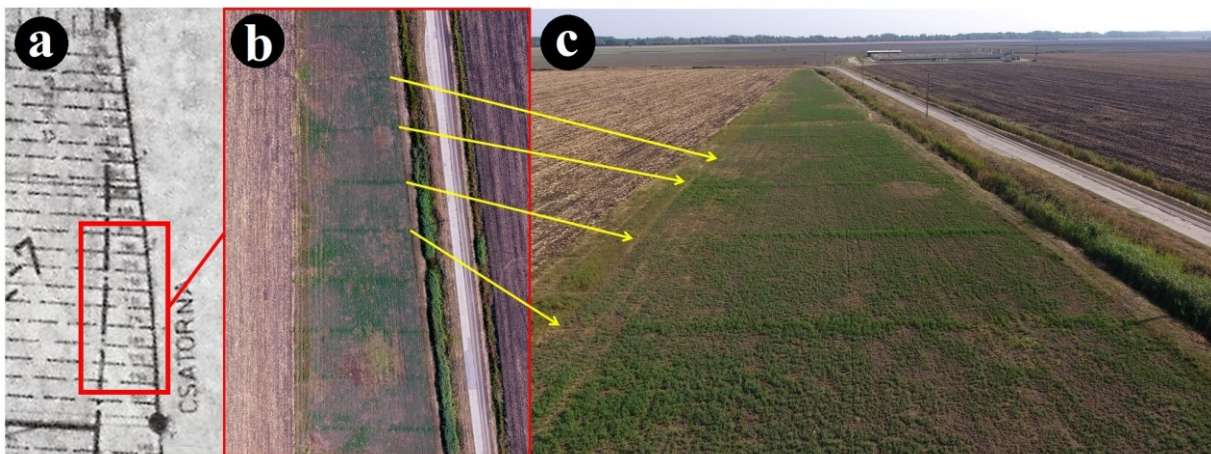
Fig. 6 Phenological differences in alfalfa plants over drains and the intermediate areas: (a) blueprint of the tile drains, (b) vertical aerial photo of the alfalfa field (UAV), (c) oblique aerial photo of the alfalfa field, where denser vegetation indicates the lines of the drain (UAV)

It should be noted that the appearance of inland excess water inundations fundamentally questions the efficiency of the operation of the drains, or the application of the correct agrotechnical treatments. In August 2018, an aerial photograph of a harvested alfalfa field right next to our pilot site was taken. Our experience suggests, that alfalfa had faster growth along the assumed soil drain pipes (Fig. 6). The original blueprint documentation reflects, that the pipes extend from the alfalfa field to the other plot with different land cover and land use, but there is no visible trace of them on that field. The reason for this phenomenon could be explained by the fact that alfalfa roots can penetrate into the deeper soil layers (as “bio-

drains”), and thus they get better water supply along the drains. Similar phenomena can be experienced in stubble areas after crop harvest, where various weeds and volunteer crops indicate the location of drainage pipes. The UAV thermal imaging survey that was executed in March 2021 did not yield the expected results at Mezőtúr study site. The surface temperature showed no differences that suggesting the presence of drains.

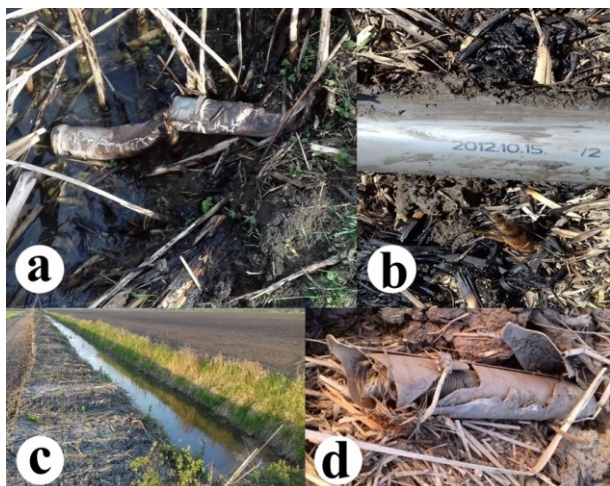
During the first field survey (August, 2018) at the Mezőtúr test site, we found that only five drainpipe outlets were visible in the side slope of the channel. In situ inspection of the drain outlets was repeated three times. Finally, the number of identified drainage pipe outlets or their remains increased to 42 out of the 46 we found in the documentation of the area. In our experience, the documentation and the blueprints can only serve as an approximate reference for finding drain outlets. Contrary to the constant distance of 20 m stated in the plan documentation, various distances of 15–25 m between some pipes were found. In some cases, the PVC drain pipe outlets were melted, as the result of inappropriate maintenance of the channel: the farmer eliminated the excess vegetation by periodic burning (Fig. 7A). Despite of the critical injury of the pipelines, some pipes had outflowing drainage water. Other evidence of improper maintenance was a drain outlet (manufactured in 2012) that was found in the non-drained side slope of the channel, suggesting heavy disturbance (Fig. 7B).

Fig. 7 Typical conditions of the drain pipes at the Mezőtúr study site: (a) melted PVC drain outlet in the channel side slope, (b) a few years old relocated drain pipe outlet, (c) open channel after sludge removal in Csanytelek, (d) ruptured drain pipe in spreaded sludge

some outlets were visible, as the excavator machine cut and teared the last sections of the pipes exposing them (Fig. 7C-D). In the case of the Zsadány study site, after the crop harvest the weeds in the field indicated the linear pattern of the drains. To verify their existence, the buried pipeline was excavated from the side slope of the recipient channel (Fig. 8).

Based on the results of the field inspections at Csanytelek and Zsadány sites, we concluded that the drain systems there are characterized by the same conditions and maintenance problems as at Mezőtúr plot. The Mezőtúr study site is unique, since here the outflow of drain pipes was visible, though their condition was unsatisfactory with a few exceptions. In the other two study sites, the drain outflows had already been destroyed and the pipe ends were buried in the side slope of the recipient channel. During the field survey at the Csanytelek site, no pipe outlets were found, but after the dredging of the drainage canal and removing the sludge,

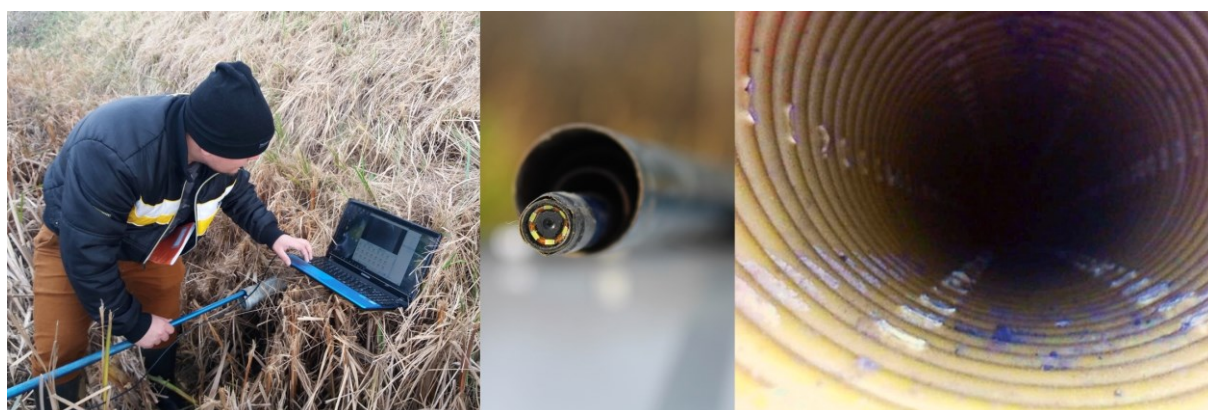
In the Mezőtúr study site, endoscope camera inspections of five drain outlets gave good results. The condition of the inner tube was very good in the examined 4.5 m length (Fig. 9). Precipitates around the pipe perforations were visible, but these did not cause clogging. Most of the inspected drains were found free of dirt, but we also found a tube with sediment in the last 50 cm of the drain, at its outlet. The results suggest that drain pipes are permeable to water, and they can function. Along the recipient channel most of the drain outlets were damaged or buried, and they contained sediment. The causes of perforation clogging and precipitation on the drain pipes were also examined. We opened a soil section and performed a mechanical slope excavation, which proved that the perforations of the 30 years ago installed drain pipe are still permeable to water, i.e. they are free of blockages (Fig. 10).

Fig. 9 The inspection of drain outlets and inner sections by endoscope camera
