MOLINO PALOMBA - DEGRADATION AND POSSIBLE STATIC RECOVERY OF A DISUSED INDUSTRIAL BUILDING

E. Biondi, G. Frunzio

ABSTRACT

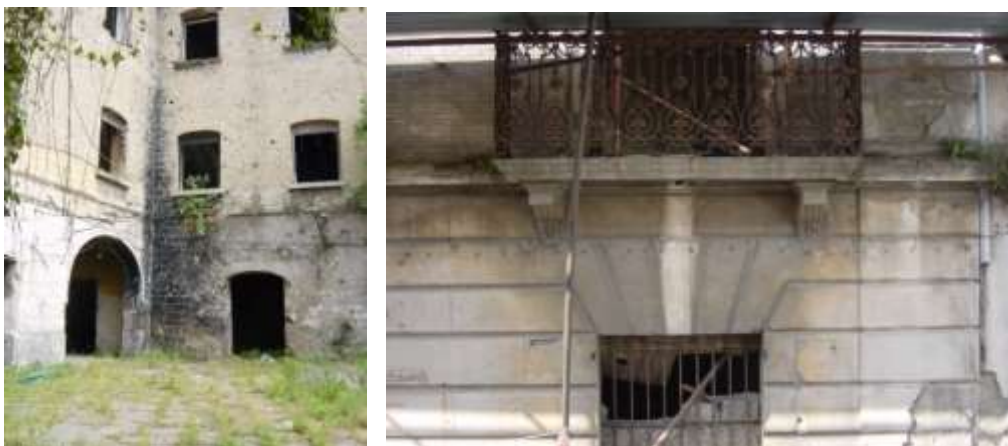
The building covers an area of 2460 square meters and is developed on three levels above ground for a total of 30,000 cubic meters. It's characterized by a central courtyard of 527 square meters: it's bordered by a large courtyard to the north and east, by a covered porch and a surrounding wall to the north and west and by a garden to the south. It was complicated carrying out detailed reliefs due to the deep state of decay which affects the whole area (fig. 4).

Figure 4 (a) and (b). The current deterioration of the building

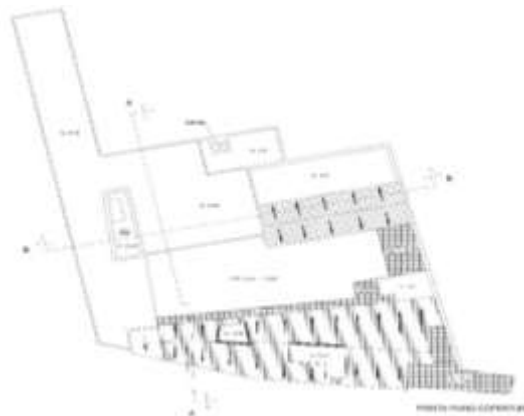
- On the ground level there are both timber than iron floors; there are moreover stone vaults, and in detail ribbed, cross, and barrel vaults, all with a key height of 4 meters;
- On the first floor: the carpentry is homogeneous with wooden floors;
- On the second floor: uneven, between iron floors and tile roofs (fig. 11). The tiled roof is present in greater numbers throughout the building, with a double warp of wooden beams 2.05 meters from the floor. The production body has flat iron floors, waterproofed with bitumen.

Figure 11. Roof plan plan

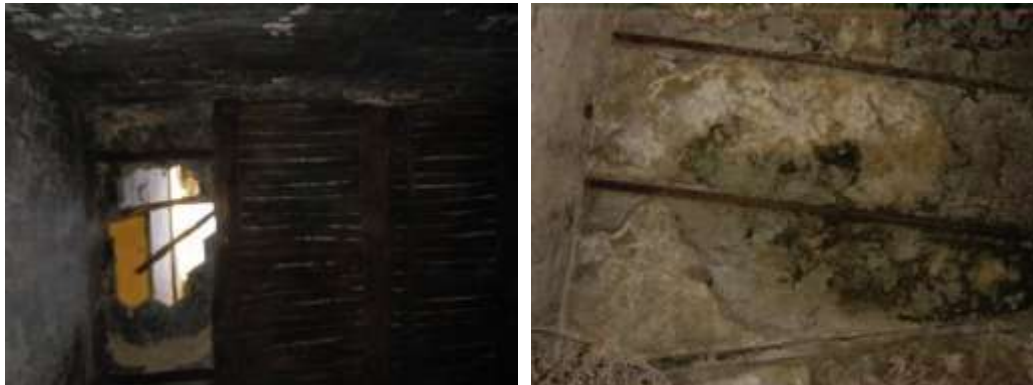
Most of the wooden floors have collapsed (the "survivors" are in the area used as a private residence) (fig. 12 a). The structure has walls 13 meters high and up to 11 meters apart. This describes an advanced state of structural degradation. What remains intact is the iron elements of the slabs, despite being rusty (fig. 12 b). The walls, however, do not show signs of serious subsidence: the cracks were found in small isolated portions of the tuff masonry.

Figure 12 (a). Collapsed wooden floor; (b) Rusty iron

As for the wooden floors, the authors verified that it is possible to hypothesize recovery and stiffening interventions that do not overturn their significant aspects [11] imagining the slab reconstruction (in a modern key) with homogeneous materials.

While it is easy to hypothesize a wood-wood type reinforcement intervention on the timber floors of the Molino, the choice for repairing and reinforce the iron floors is not simple. With LCA method it could be possible to compare the hypotheses to restore slabs with wood (like the other floors) or iron, in addition to traditional structural analysis. This consideration would be useful in the choice of interventions aimed at contrasting first mode collapse phenomena and therefore all the safeguards necessary to guarantee box-like behavior.

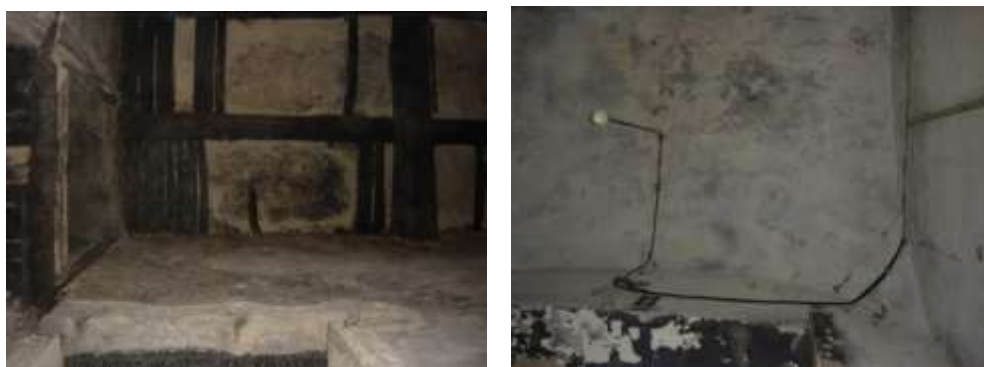
Visible issues concern the plaster, false ceilings (fig. 13), and stairs (fig. 14). For the rest, the general state of deterioration is strongly connected to the presence of weeds and efflorescence that caused cracks in masonry. The building presents moreover degradation phenomena due to the extended exposition to the weather.

Figure 13 (a) and (b). Degraded plaster and false ceiling

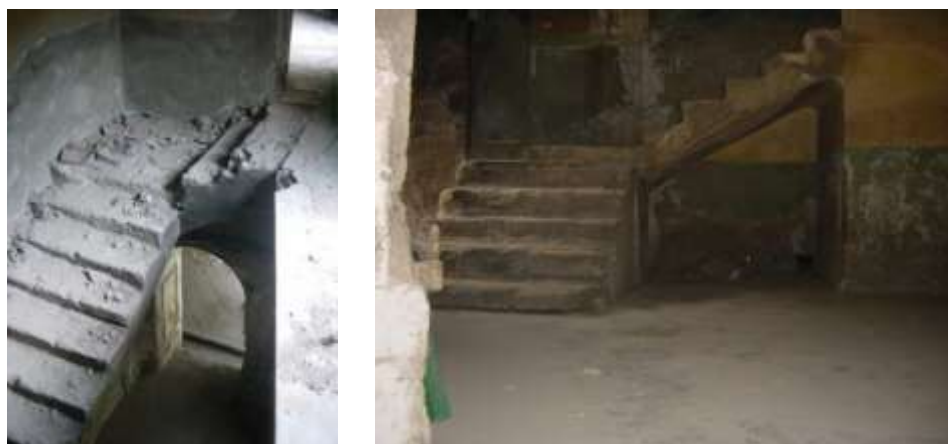
Figure 14 (a) and (b). Collapsed stairs

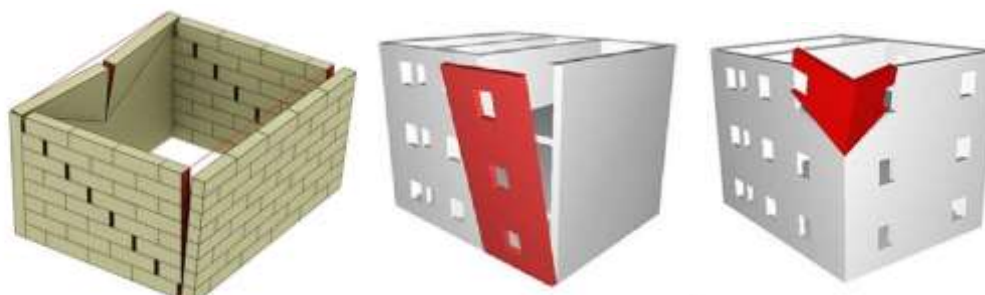
Despite the long neglecting period and several tampering, the building does not present significant elements of static instability. The tuff masonry is compact, even as the different layers of mortar. The greatest degradation is attributable to floors both for timber that iron ones. To realize an effective intervention for the wooden elements an accurate investigation campaign will be required to decide which elements have to be replaced and which repaired and or reusable. The iron floors are deeply degraded and present a high degree of corrosion, there are therefore depressions and irreparable failures. The structural elements cross section is significantly reduced and follows the lower bearing capacity and lower bending resistance. Structural inefficiency of the floors determines a higher freestanding length of masonry walls: in the absence of decks walls have a maximum height of inflection (equal to the sum of those of each single order). The walls do not cooperate under the action of horizontal forces, or in the event of an earthquake. The global masses are not correctly distributed among the vertical structures due to the lack of coupling masonry beams, so the walls behave as if they were shelves. This results in the "artichoke" opening of the walls with consequent definitive collapse of the entire structure, or it would generate an overturning towards the outside (fig. 15).

Figure 15 (a) Non-box-like behavior of the structure without decks in the event of an earthquake; (b) Simple tipping mechanism; (c). Reversal of the cantonal.

- In the first one the crack pattern doesn't show visible and excessive cracks. Only partially on the architrave.
- In the second one, the walls present widespread damage and secondary collapses.
- In the third one, the cracks are significant in the architraves, in the hammers and cantons, and in the overhanging areas of the load-bearing wall.

What would most have caused the instability phenomena listed above would be the shortcomings of the decks and the age of the walls themselves. Other causes are the crushing phenomena and the exceeding of critical shear stresses.
