Diagnostic Reliability in the Assessment of Degradation in Precast Concrete Elements

Citation: Bossio, A.; Faella, G.; Frunzio, G.; Guadagnuolo, M.; Serpieri, R. Diagnostic Reliability in the Assessment of Degradation in Precast Concrete Elements. *Infrastructures* **2021**, *6*, 164. <https://doi.org/10.3390/infrastructures6110164>

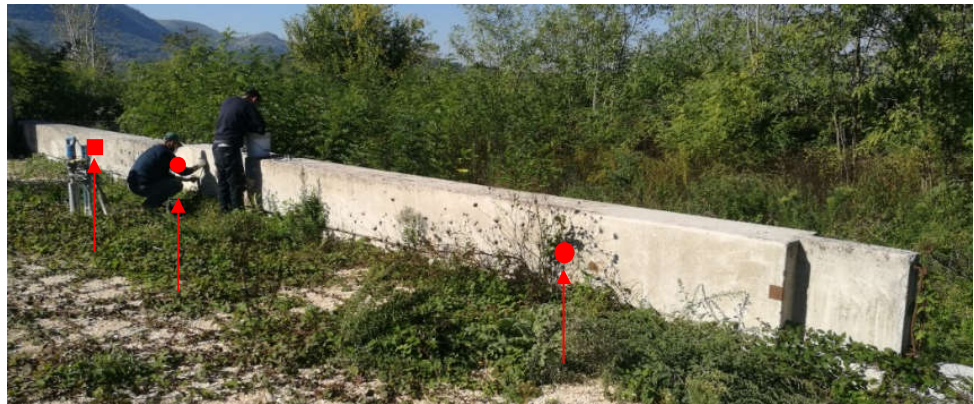
Figure 1. Precast RC squared column “C”; red circles show the location of coring sites; the red square shows the location of the extraction site of the parallelepiped-shaped diamond-cut sample.

Core sampling was performed in compliance with the Italian standards UNI EN 12504-1/2002 [43]. The size of the samples was selected, as recommended, in due consideration of the aggregates' size and structural element geometry. Core samples of diameter 10.4 cm were extracted from column "C" and beam "B2", while a sample of diameter 7.0 cm was extracted from the beam "B1". The cored length was 14 cm or longer. From each structural element, two cores were extracted. Figures 1–3 show the position of the extracted cores by red arrows and dots.

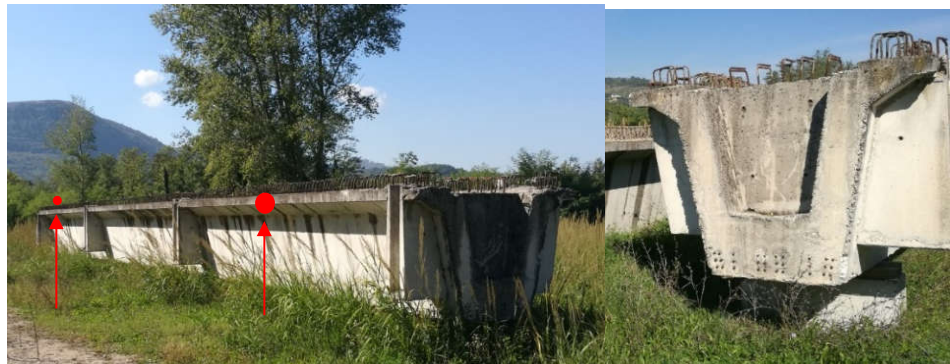
Figure 2. Prestressed RC omega-beam “B1”; red circles show the location of coring sites.

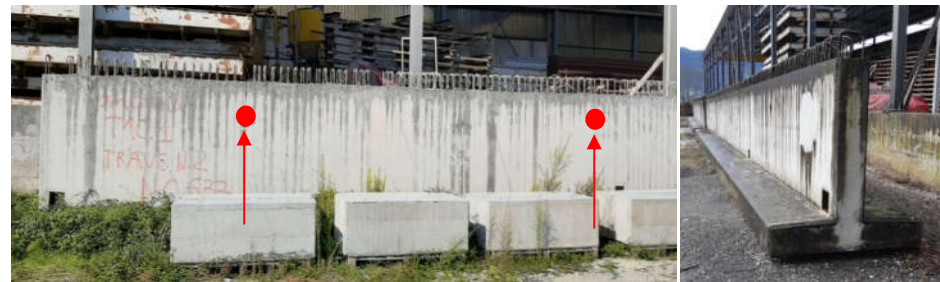
Figure 3. Prestressed RC-T-beam “B2”; red circles show the location of coring sites.

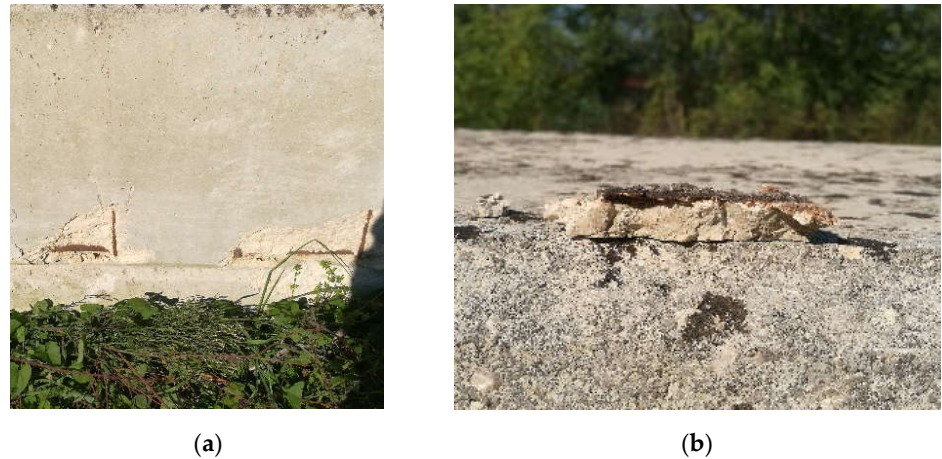
The tested elements were in a good state of conservation, except for expectable brownish signs of oxidation visible over the steel surfaces which were directly exposed to atmospheric agents. Cracks, which revealed concrete spalling and delamination, were visible in very circumscribed regions of the tested elements. The limited extent of spalling was verified in one of these regions by hammer blows that produced forced concrete cover delamination (see Figure 4a). The percentage of surface extension of the degraded regions over the total area of visible exposed surfaces was assumed, with a reasonable safety margin, lower than 2% (see Figures 1 and 4a). The resulting debris (as shown in Figure 4b) revealed a concrete cover about 1 cm thick. After the first visual inspection alone and based upon on-site environmental conditions, the concrete surface of the elements was deemed to be classifiable into either the EC2 exposure class X0 (falling within the denomination “No risk of corrosion or attack—concrete with reinforcement or embedded metal: very dry”) or into any of classes XC1–XC4 (falling within the denomination “Corrosion induced by carbonation”).

Figure 4. Spalling in column C after struck by hammer (a), detached cover due to hammer strike (b).

- A close visual inspection of the structural elements showed what could be expected for prefabricated structures of twenty years of age. Only the steel surfaces directly exposed to the atmosphere showed generalized superficial corrosion. The same corrosion was detected in limited superficial regions with an insufficient thickness of concrete, or where cracks were present. As reported, a conservative upper bound of the percentage of surface extension of these degraded regions over the total area of the visible exposed surfaces can be reasonably set to 2%, while an upper bound of the thickness of the delaminated cover in these regions (see Figure 4b) can be set to 1.5 cm.

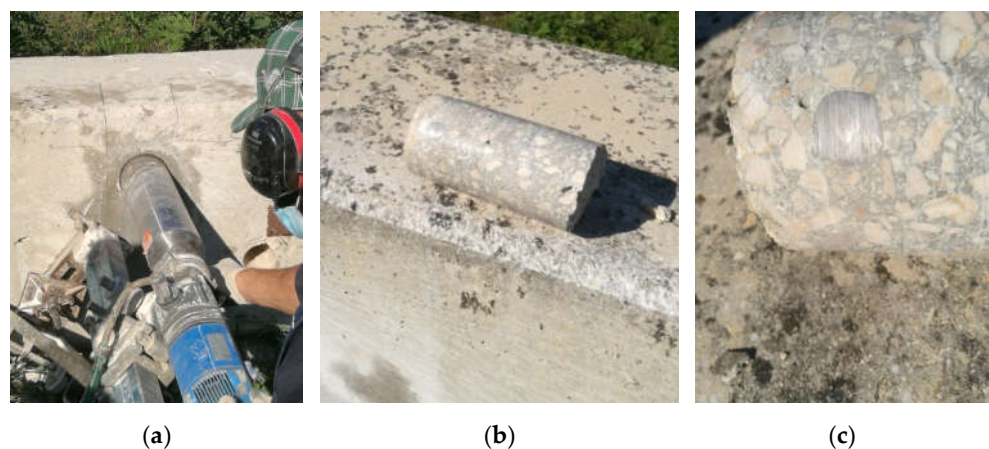
Figure 5a shows the core-drilling device. Each core was labeled after extraction with a univocal code: C1 and C2 for column C, B1_1 and B1_2 for beam B1, and B2_1 and B2_2 for the second beam. Each specimen was photographed next to the relevant extraction site; Figure 5b shows sample C2.

The lateral surfaces of the cored samples showed uniform concrete compaction and a well-sorted grain size distribution. Remarkably, no visually perceivable corrosion was detected across the cut surfaces of the bars in all the extracted samples, as Figure 5c shows for a core sample from column C.

Figure 5. Core drilling C1 (a); sample C2 (b); visual inspection of cores (c).

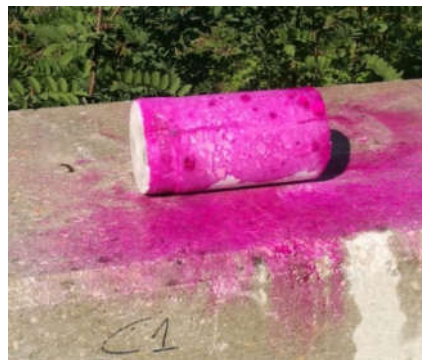
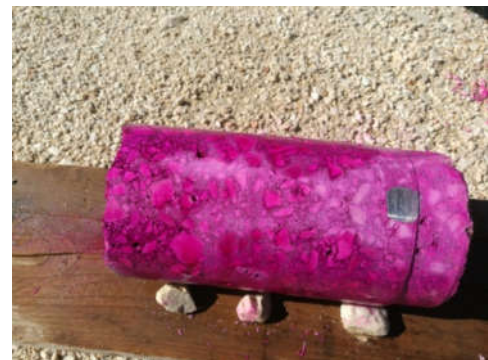
Figures 6–8 contain photographs of the core samples before and after phenolphthalein spraying. In four out of the six sprayed cores, the assays failed to detect a neutralization front. Only two samples (B1_1 and B1_2 extracted from the prestressed omega beam) showed neutralization with carbonation depth (at pH approximately below 9.2) ranging between 10 mm and 20 mm.

Figure 6. Samples C1 (a) and C2 (b) after phenolphthalein spraying.

The integrative tests on sample C3 suggest that the failure to detect a neutralization front in cores C1 and C2 may be explained by an alteration in the external surface of these cores, due to the deposition of concrete powder ensuing from coring. The neutralization assays on the drilling powders by the Carbondtest method provide further evidence of the presence of a carbonation front; however, it has to be emphasized that with this latter, indirect method, the brute depths of the carbonation fronts in the two dust samples (where brute refers to the absence of the application of corrective correlation factors) are in ratios of 283% and 250% with the golden standard measure d_k of the neutralization front which was directly observed on sample C3, therefore, an overestimation by a factor greater than 2.5 should be taken into account. A magnification by an approximate factor of 2 between the real thickness and the powder thickness has been also indicated in [39,40], concerning the instrumentation and measurement parameters therein employed.

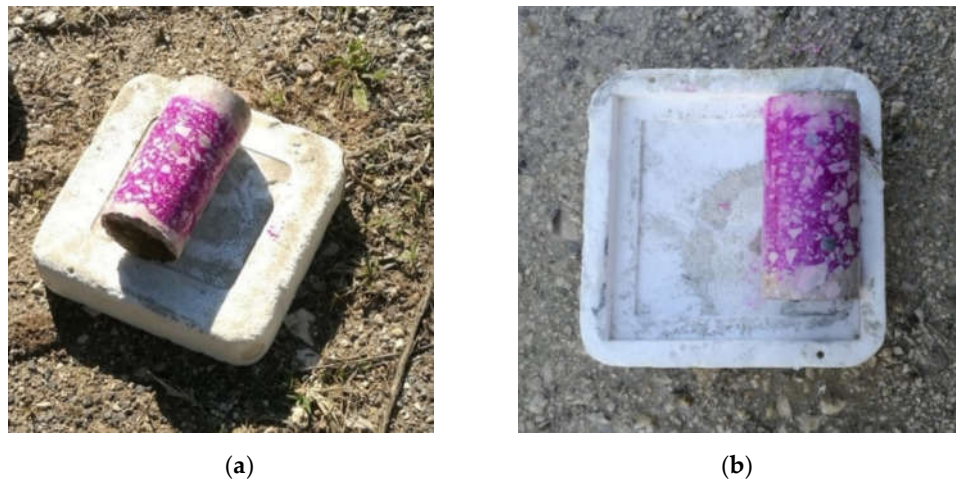
Figure 7. Samples B1_1 (a) and B1_2 (b) after phenolphthalein spraying.

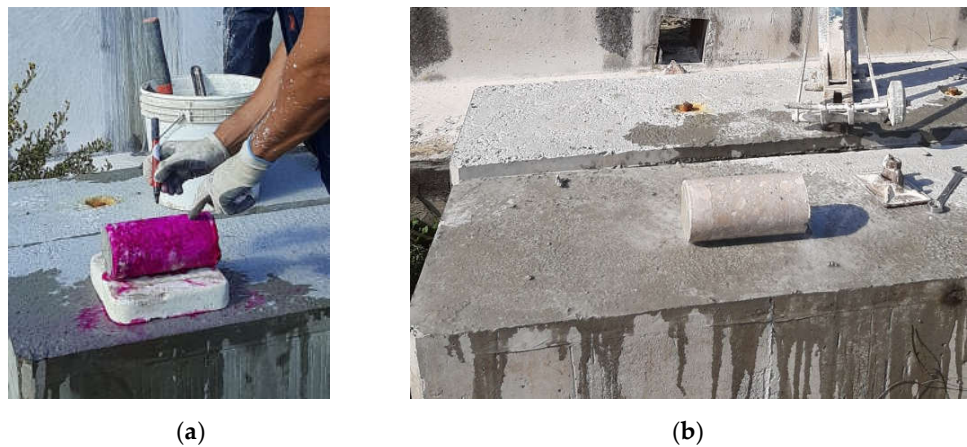
Figure 8. Samples B2_1 after phenolphthalein spraying (a) and sample B2_2 before spraying (b).

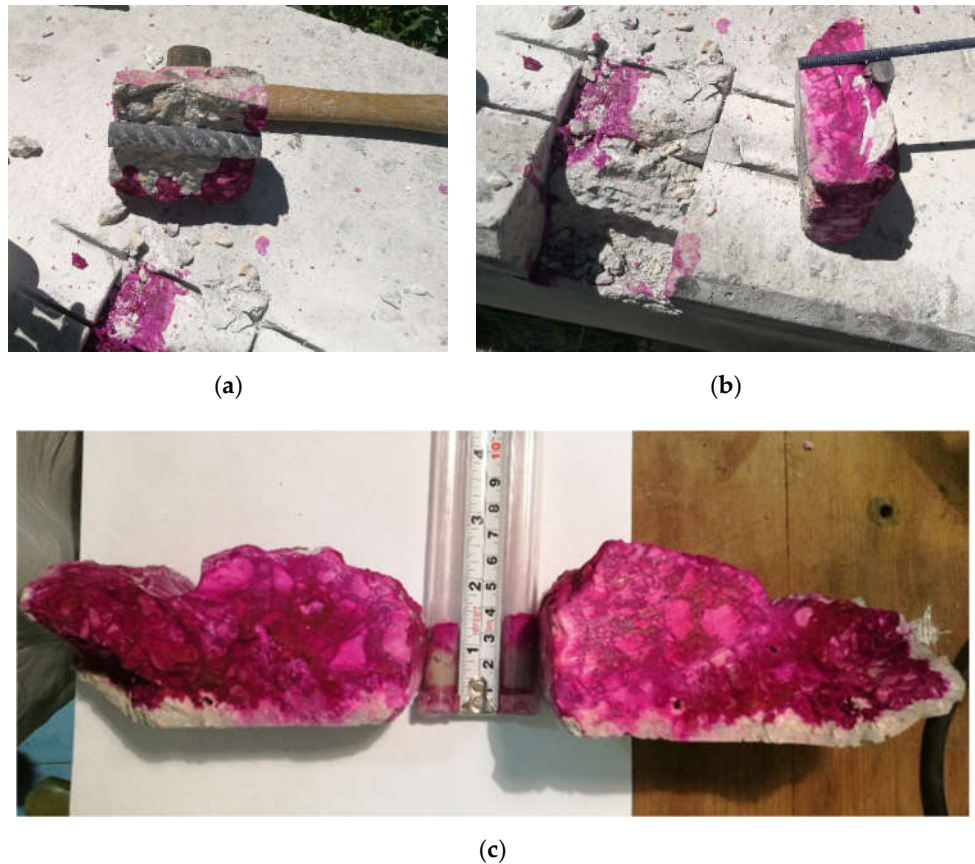
In a second phase, a further test according to the UNI 9944 standard was considered necessary. A sample C3 of approximately parallelepiped shape and with the approximate dimensions of $11 \times 12 \times 5$ cm was extracted from column C at one of its upper lateral edges by making four planar surface cuts, using a rotating diamond disc, as shown in Figure 9a,b. Under the UNI 9944 standard, the sample was then divided into two halves using a chisel and hammer, after having made a superficial incision on the face of the sample that was opposite to the upper face exposed to atmospheric agents. The split surface thus produced was substantially free of dust and, with good approximation, was orthogonal to the surface of the concrete cover, therefore, the phenolphthalein test was carried out. After 1% phenolphthalein spraying on these surfaces, the appearance of a neutralization front was observed, which delimits the pH 9.2 limit between purple shades and the absence of visible shades. It was carefully verified that this front did not belong to the pilot cut surface, and was quite far from it. It was also verified that the surface areas containing this face were all free from any deposits of cement dust that resulted from the diamond cuts. As shown in Figure 9c, the neutralization strip was substantially parallel to the surface of the concrete cover. The average measured depth of this zone was $d_k = 6$ mm, and its maximum value was $d_{k\ max} = 9$ mm. This last test is preferable to the previous ones, since it offered a less disturbed testing surface, although very often the number of cores/specimens that can be extracted from the same structural element is limited.

Finally, two additional neutralization phenolphthalein assays of the concrete powders, flowing out from two sample percussion drillings made on column C, were collected into test tubes, and were performed according to the Carbondest® method, employing the specific commercially available instrumentation [39,40]. The device comprises an annular head with a circular brush, fitted with a funnel that directs the powder coming out during perforation down into a vertical, transparent test tube. The test tube is devised to facilitate the infiltration of the collected powder by phenolphthalein solutions for neutralization assays. Measured drilling depths were: $p_{powd,1} = 40$ mm for the first sampling and $p_{powd,2} = 35$ mm for the second one. The respective depths of the dust layers deposited in the test tubes were $h_{powd,1} = 30$ mm and $h_{powd,2} = 25$ mm. The tests on the CLS powder samples were carried out by adding the same phenolphthalein reagent solution into the two test tubes and then waiting for the time required for the complete imbibition of the dust layers. The measured depths of the carbonation front in the two dust samples were $d_{k\ powd,1} = 17$ mm and $d_{k\ powd,1} = 15$ mm. Figure 9c shows altogether the pH 9.2 neutralization fronts in both the split specimens and the two test tubes. Notice that the vertical support base of the test tubes is placed 7 mm below the bottom of the powder container.

Figure 9. Additional neutralization assays in column C. (a) bottom view of specimen C3; (b) lateral view and extraction site; (c) neutralization fronts after phenolphthalein addition over the two split fragments of specimen C3 and across the drilling powder in test tubes.
