# Applied Research of the Hygrothermal Behaviour of an Internally Insulated Historic Wall without Vapour Barrier: In Situ Measurements and Dynamic Simulations

**Abstract:** The hygrothermal behaviour of an internally insulated historic wall is still hard to predict, mainly because the physical characteristics of the materials composing the historic wall are unknown. In this study, the hygrothermal assessment of an internally thermal insulated masonry wall of an historic palace located in Ferrara, in Italy, is shown. In situ non-destructive monitoring method is combined with a hygrothermal simulation tool, aiming to better analyse and discuss future refurbishment scenarios. In this context, the original U-value of the wall (not refurbished) is decreased from 1.44 W/m<sup>2</sup>K to 0.26 W/m<sup>2</sup>K (10 cm stone wool). Under the site specific conditions of this wall, not reached by the sun or rain, it was verified that even in the absence of vapour barrier, no frost damage is likely to occur and the condensation risk is very limited. Authors proposed further discussion based on simulation. The results showed that the introduction of a second gypsum board to the studied technol

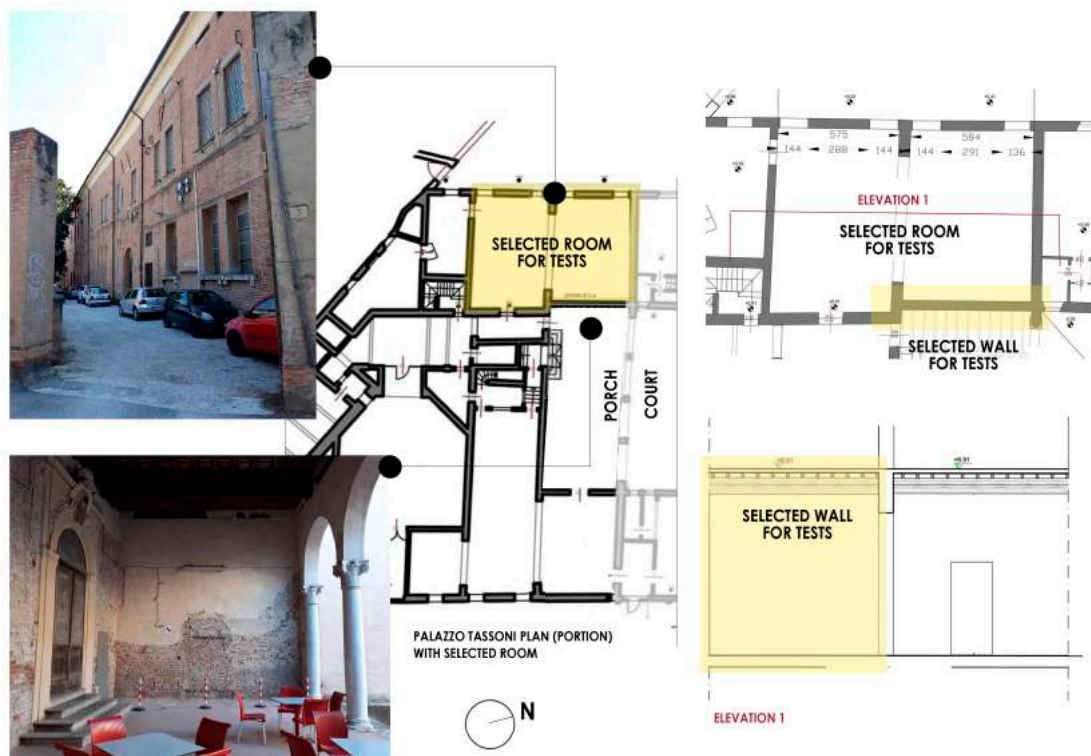
**Figure 1.** Palazzo Tassoni Estense: ground floor plan with the identification of the room where the experiment is carried out. Views of the external walls of the selected room: the one on the top left represents the front view from via Cammello, the one on the bottom left is a view of the wall under the porch (selected to be studied). The yellow shape underlines the selected room and the corresponding wall selected for the tests.

The room selected to perform the study is located on the ground floor of a not-yet refurbished and naturally ventilated part of the palace (Figure 1). Due to the reminiscences of highly probable presence of two chimneys on two of the outer walls of this room (Figure 2), it was decided to undertake the study on the remaining wall, NE oriented, under a porch (Figure 3). “Though this situation does not correspond to a ‘worst-case scenario’” [37] (p. 2), authors recognize the limitation of their study. The results obtained are limited to this experiment condition: “rainwater might not reach directly the wall, but neither does the sun, i.e., both the capacities of wetting/absorbing and drying are limited” [37] (p. 2).

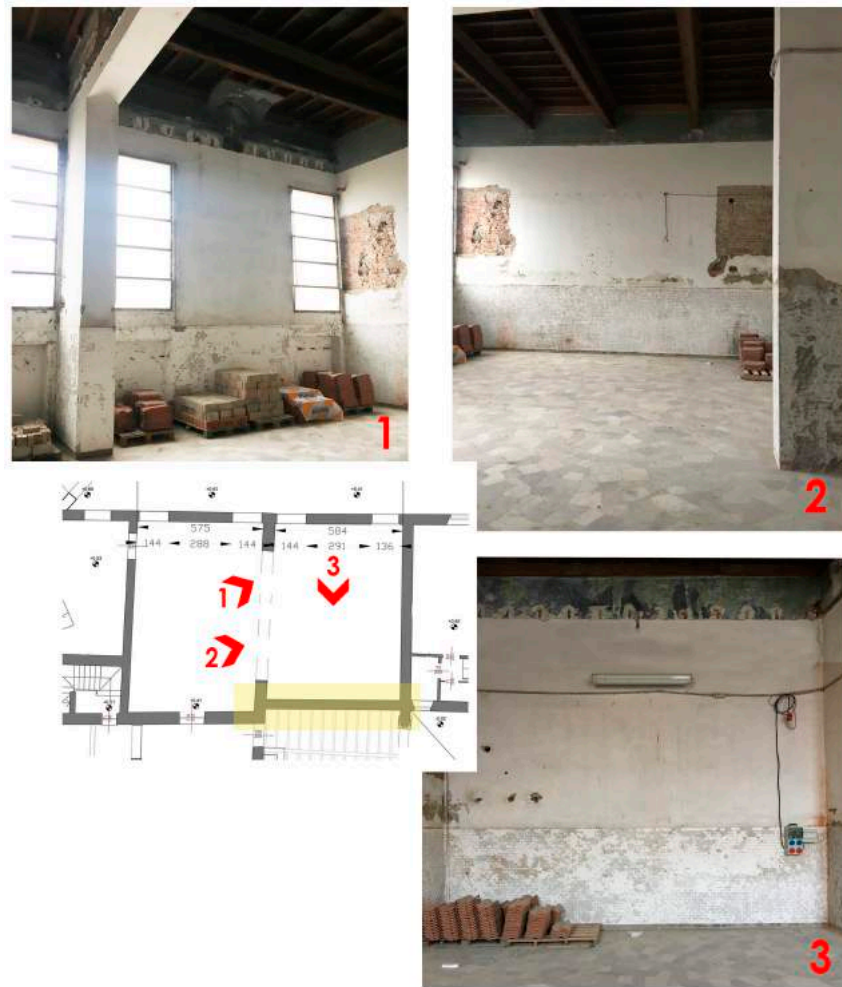
Figure 2. Internal views of the room. The picture 3 represents the wall selected for the tests.

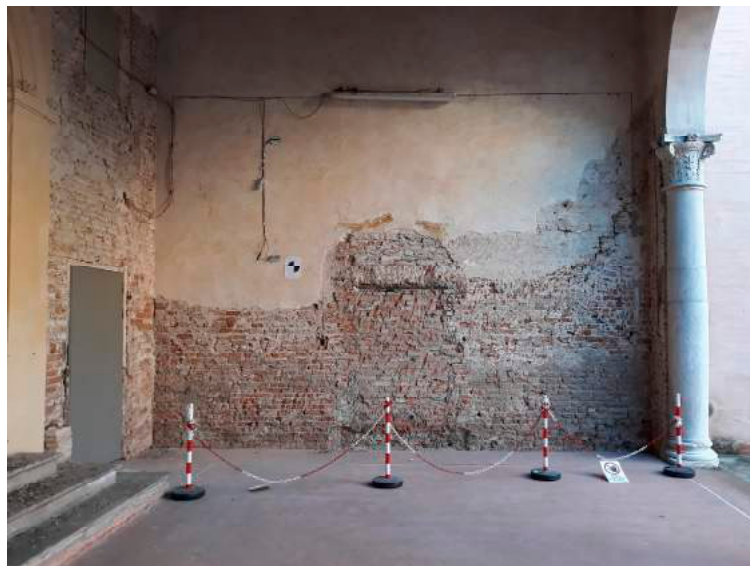
Figure 3. External view of the studied wall (internal courtyard under the porch) [6].

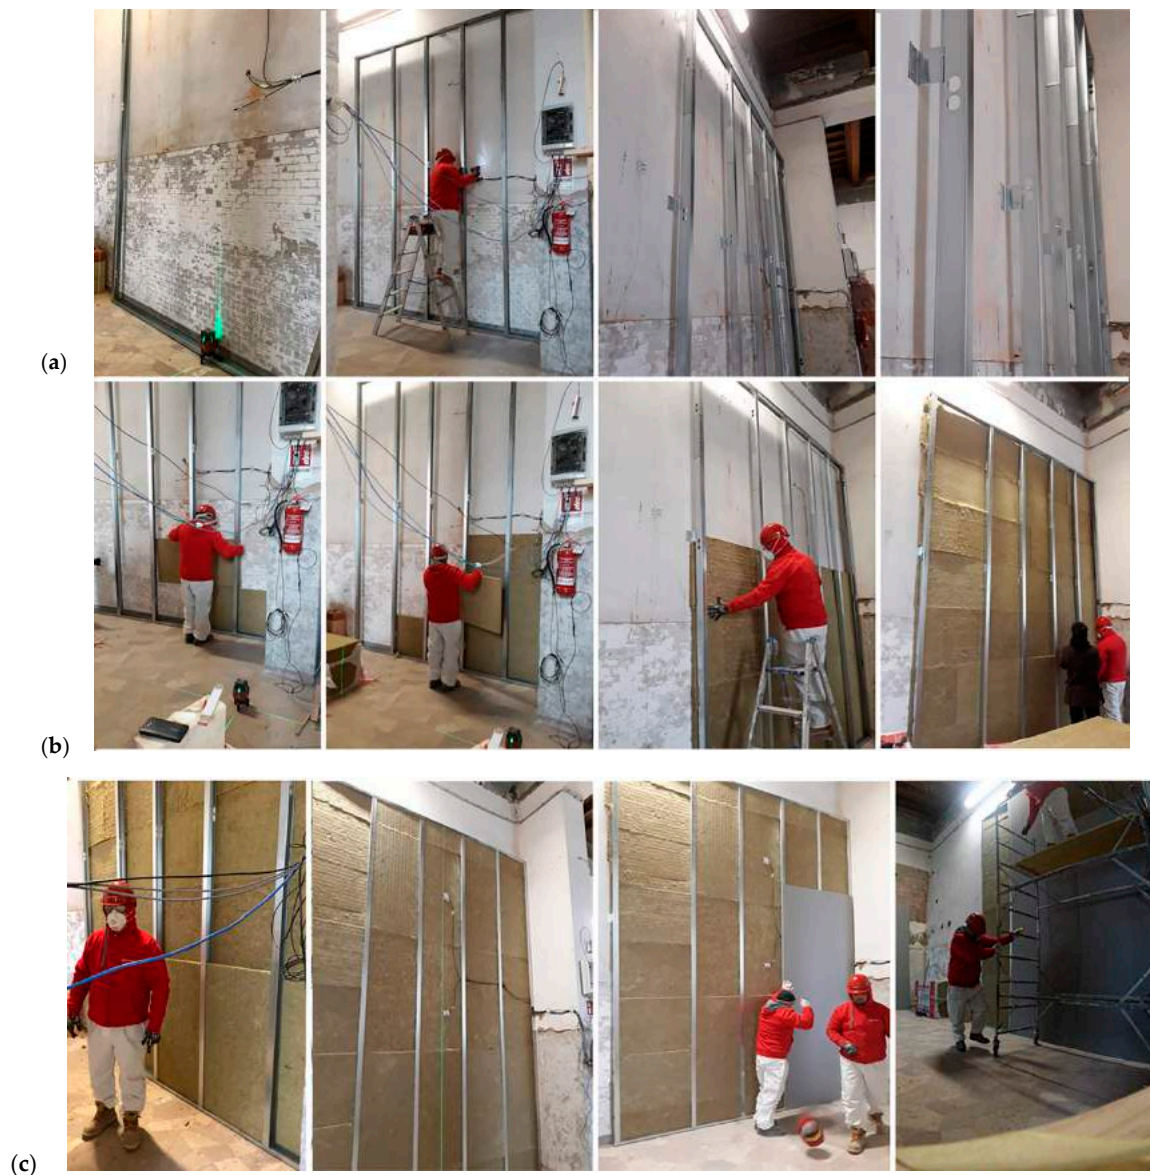
Figure 4 shows the phase's sequence of the installation of the selected insulation system: in (a), the installation of the C metal structure outdistanced from the wall to minimize the number of anchor points on the historic wall; in (b), the insertion of the additional insulation layer between the metal frame and the wall; finally, in (c), the interposition of the second stone wool set of panels between the vertical steel elements, then covered by the gypsum board finishing.

**Figure 4.** Installation of the selected insulation system.

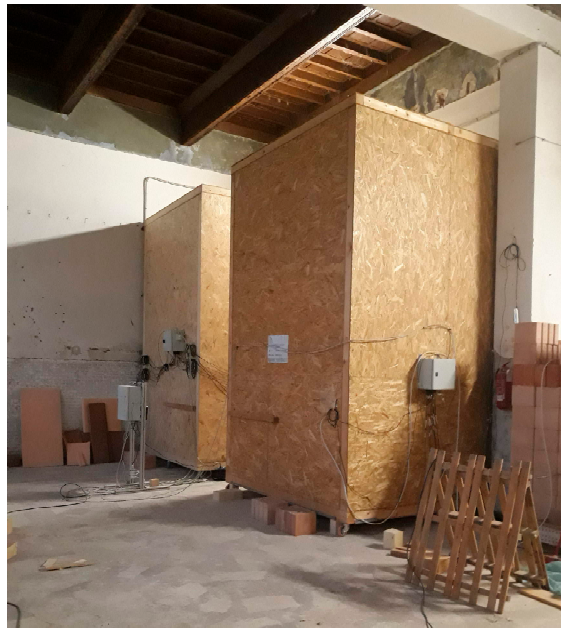
Figure 5. Internal view of the room, with the two boxes tied up to the studied wall.

As pointed out earlier, inside the 700 m<sup>3</sup> room, two smaller volumes (25 m<sup>3</sup>/each) were constructed. In each volume (Figure 5), a standard indoor environment was set-up [indoor air temperature ( $T_a$ )  $\approx$  20 °C and relative humidity (RH)  $\approx$  55%], according to the main international guidelines as EN ISO 7730 [42], EN ISO 13788 [43] or ISO 17772-1 [44]. Besides its special features (0.10 m high density stone wool insulation material, lined with a vapour barrier on the inside), each box was provided of a 2000 W heating convector (with 3 power levels), regulated by control system; two ultrasonic humidifiers (argo HYDRO digit, Argoclima S.p.A., Alfianello, Italy), 30 W each, self-regulated, which permitted controlling the indoor comfort parameters, Figure 6.

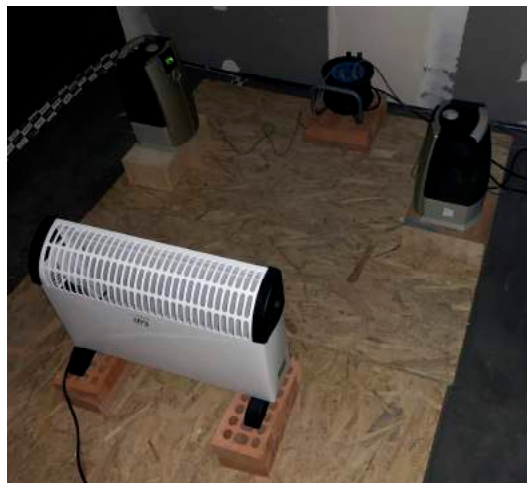
Figure 6. Hygrothermal control devices.

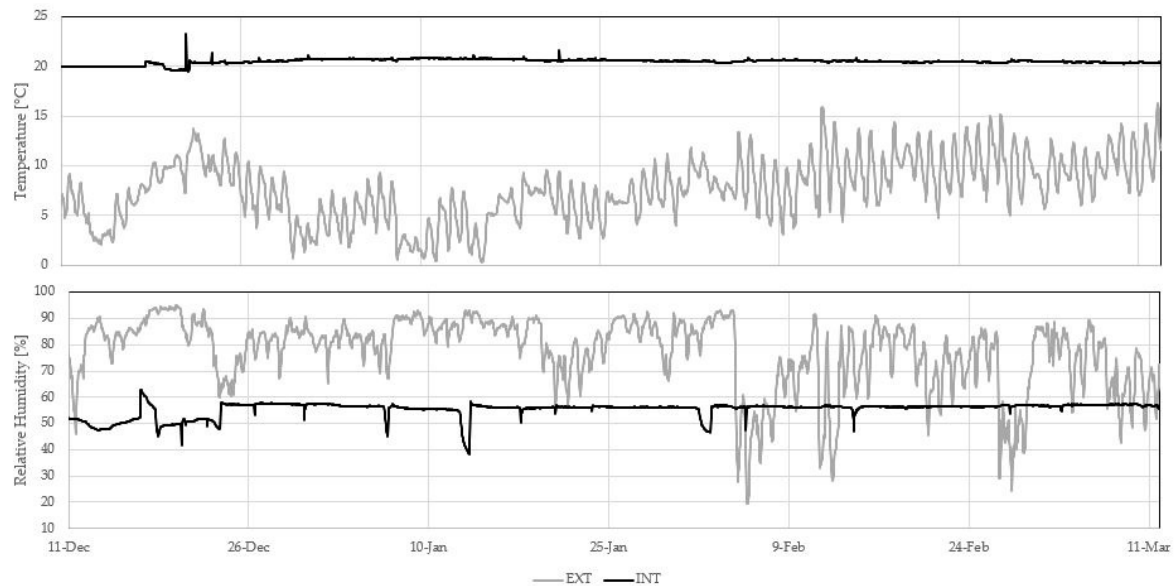
**Figure 8.** Hourly monitored data between 11 December 2019 and 11 March 2020, for external and internal climate: temperature (top panel) and relative humidity (bottom panel).

The used climatic dataset was monitored in the framework of the mentioned research project HeLLo [33] and included hourly data of T and RH of the surrounding air, both for external and internal environment. Rain and solar action were not considered, as the studied wall is located under a porch of the courtyard of the building, so it is not exposed. Figure 8 shows the in situ monitored hourly data of T and RH for the internal and external climate, related to the period between 11 December 2019 and 11 March 2020, used also for the model validation.

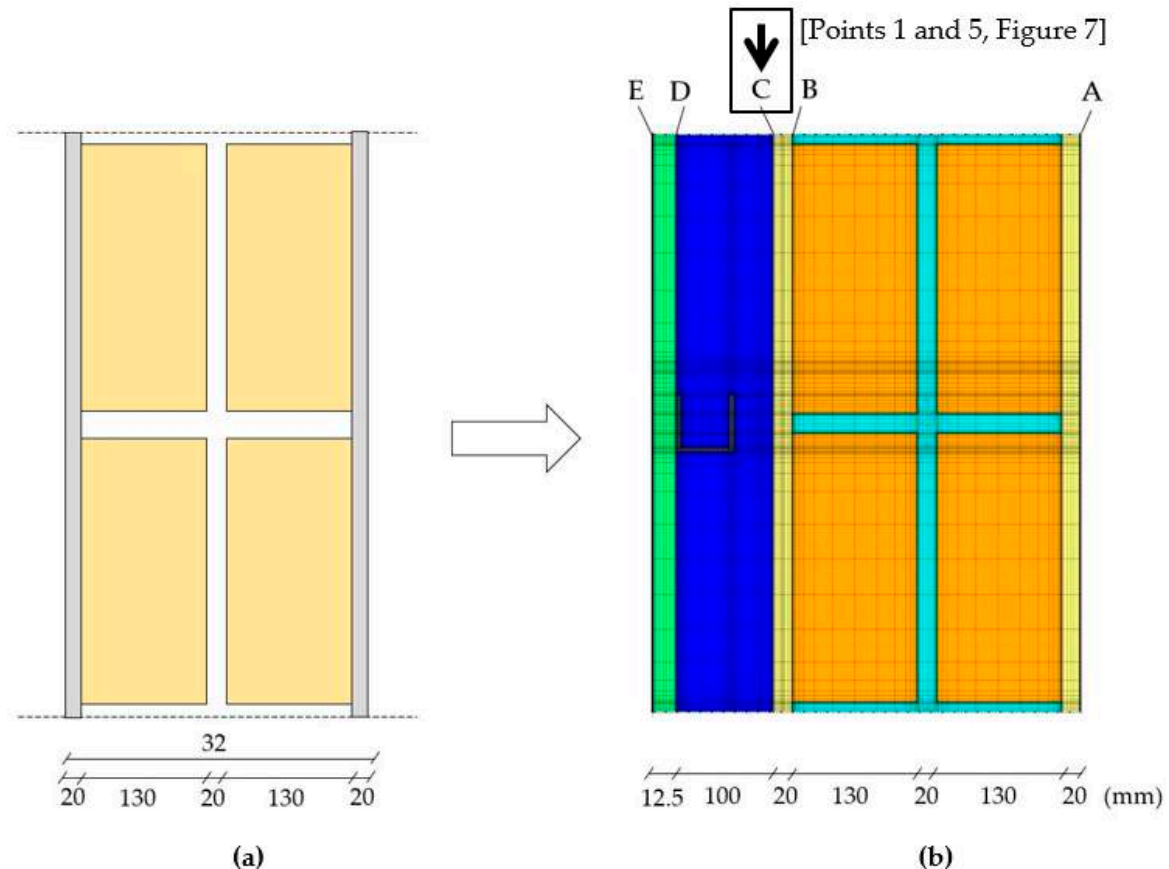
Figure 9. Two-dimensional model deduced for the dynamic simulation.

The hygrothermal model was designed on the basis of the horizontal section of the historic monitored wall (Figure 7). A two-dimensional (2D) hygrothermal model was constructed for the dynamic simulation from the horizontal section of the historic wall, as presented in Figure 9: in (a), the architectural survey is visible; while in (b), the 2D transport model used for dynamic simulations is found (the interfaces between the materials are indicated from A (external) to E (internal side)).

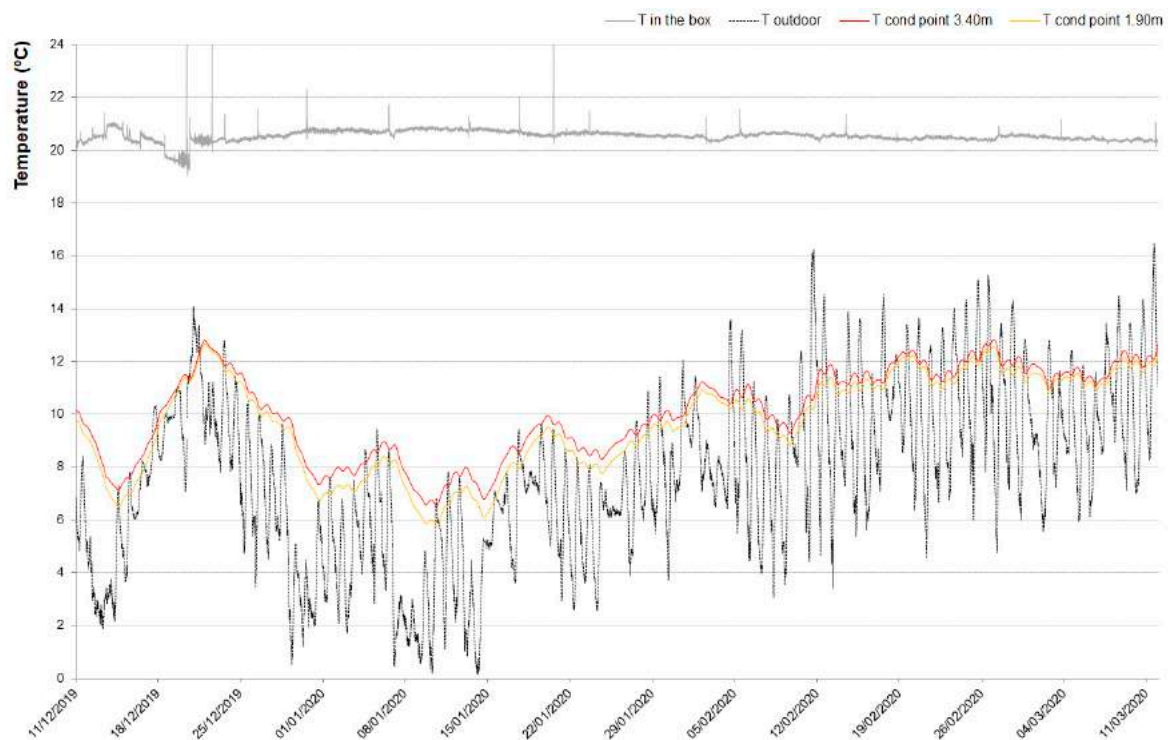
**Figure 11.** Graphical representation of the T values between 11 December 2019 and 11 March 2020.

Figures 11 and 12 show the 10 min averaged values of measured T (°C) and RH (%) at the most probable condensation point (sensors 1 and 5, Figure 7b), i.e., the point between the insulation panels and the historic wall, at both heights 1.90 m and 3.40 m. As the measured parameters inside the room

As can be observed (Figure 11), T (°C), values measured on the inner side of the wall (just before the insulation, sensors 1 and 5, Figure 7b), clearly follow the outdoor trend. At the coolest moments, T was

always above 5 °C, therefore the risk of frost damage did not occur. This data should be cautiously considered—in a colder winter, a different result could be expected. The maximum deviation between the line T 1.90 m and T 3.40 m is  $\Delta T_{\max} = 0.8$  °C and has no significance, since the difference of values is within the accuracy of the T sensors.

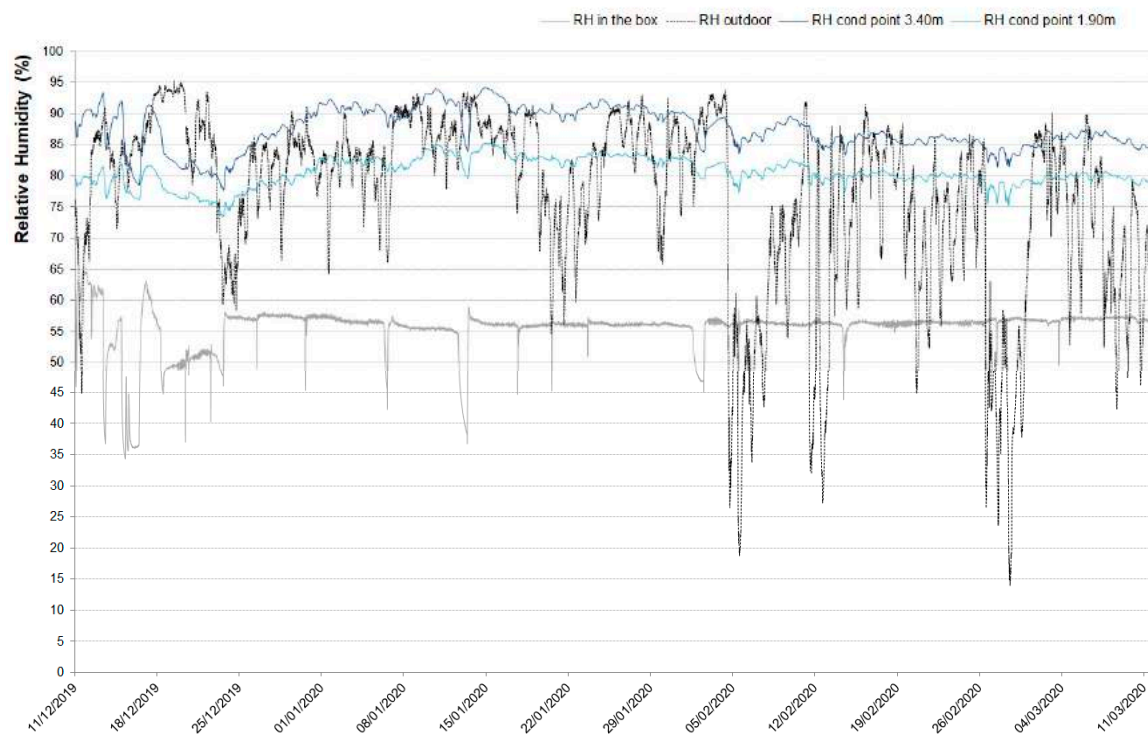
**Figure 12.** Graphical representation of the relative humidity (RH) values between 11 December 2019 and 11 March 2020.

The risk of interstitial condensation, even if limited, was present. According to the measured data authors would be tempted to state it did not happen, as RH maximum was 94.2%, measured at 3.90 m. Nonetheless, considering sensors accuracy, previously declared, it might have occurred. Through the observation of Figure 12, there seems to be a trend of a drying out process, as RH values were getting slightly lower in the beginning of March. Nonetheless, this hypothesis can only be discussed based on the simulation (Section 5.2), as for present monitored data do not allow one to confirm it. The maximum deviation between the line RH 1.90 m and RH 3.40 m is  $\Delta RH_{\max} = 12\%$ . In this case, it is significant, since the difference of values is beyond the accuracy of the RH sensors. This may be caused by several factors depending on the historic wall: e.g., the non-homogeneity of materials, possible presence of cracks or the limited adherence of the insulation materials to the out-of-line wall.

Concerning the internal condition of the box, an observation can be outlined. Some insignificant peaks (in terms of time and amplitude) can be observed on the RH graph inside the box. These correspond to moments of maintenance procedures of the monitoring campaign (i.e., when the box was open and the conditions of the air inside the box naturally mixed with those of the room). These events do not influence the average internal conditions and the test.

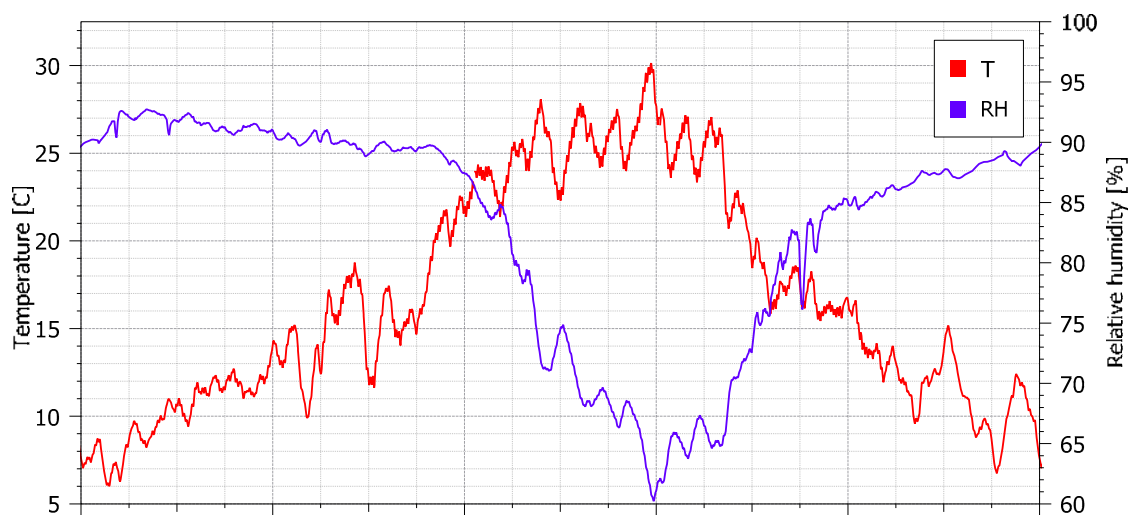
Figure 13. T (°C) and RH (%) profiles of the simulated wall in point C, during the 2nd year of simulation.

The simulation reaches a periodic behavior in the second simulated year. The graph (Figure 13) shows the monitored period (11 December–11 March), plus the drying period for the investigated wall. Hourly averaged simulated values of T (°C) and RH (%) are shown at the most critical part of the section [51], point C (Figure 9).

As can be observed, at the coolest moments, T (°C) was always above 5 °C, therefore, the risk of frost damage was not evidenced.

Concerning RH (%), although high values are exhibited during the studied wet period (11 December–11 March), it remains below 95%, the condensation risk threshold defined by the WTA Leaflet 6.5 [50], which indicates the absence of condensate. Moreover, Figure 13 illustrates a strong decrease of RH from the wet to dry period of the year, emphasizing a significant reduction of moisture content in summer. It reaches the driest value on 7 August. This fact is also visible in Figure 14, where a profile of RH during the most critical and the most favorable hours of the year are

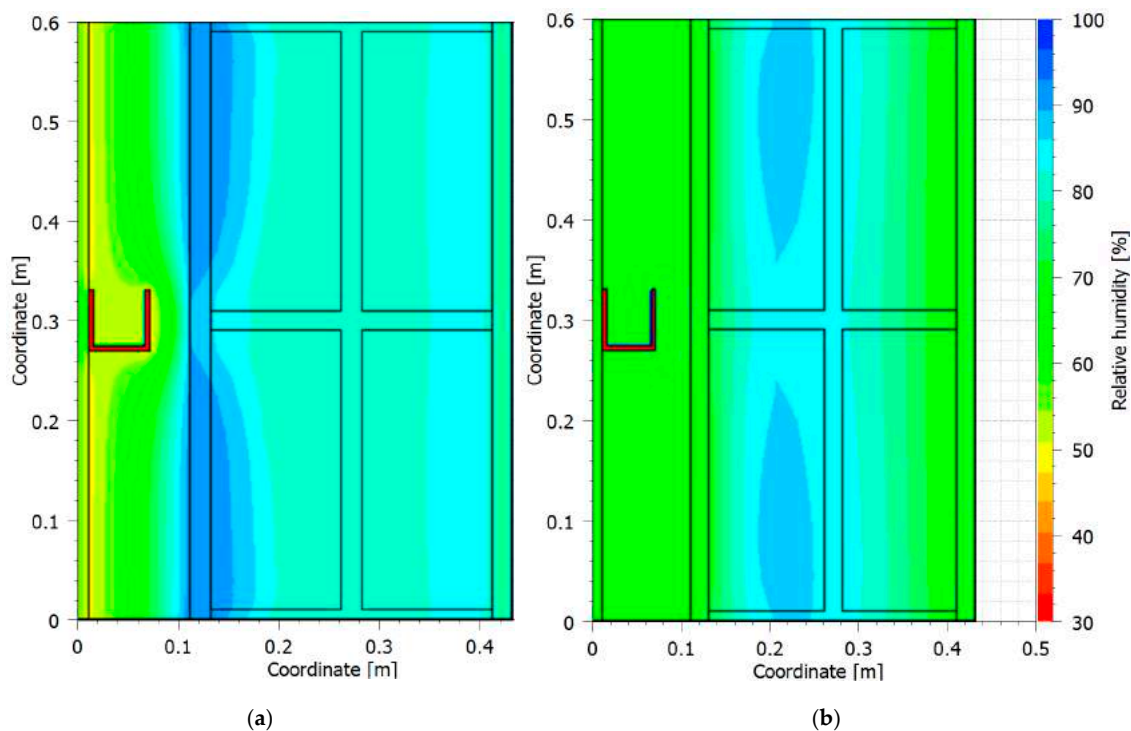
**Figure 14.** RH profile of the original simulated wall during the most critical (a) and the most favourable (b) hours of the year.

shown for the studied wall. In particular, in terms of moisture accumulation, it can be observed in Figure 14a the wall section during the wettest hour (on 26 January at 00:00) and in Figure 14b, the wall section during the driest hour (on 7 August at 12:00).

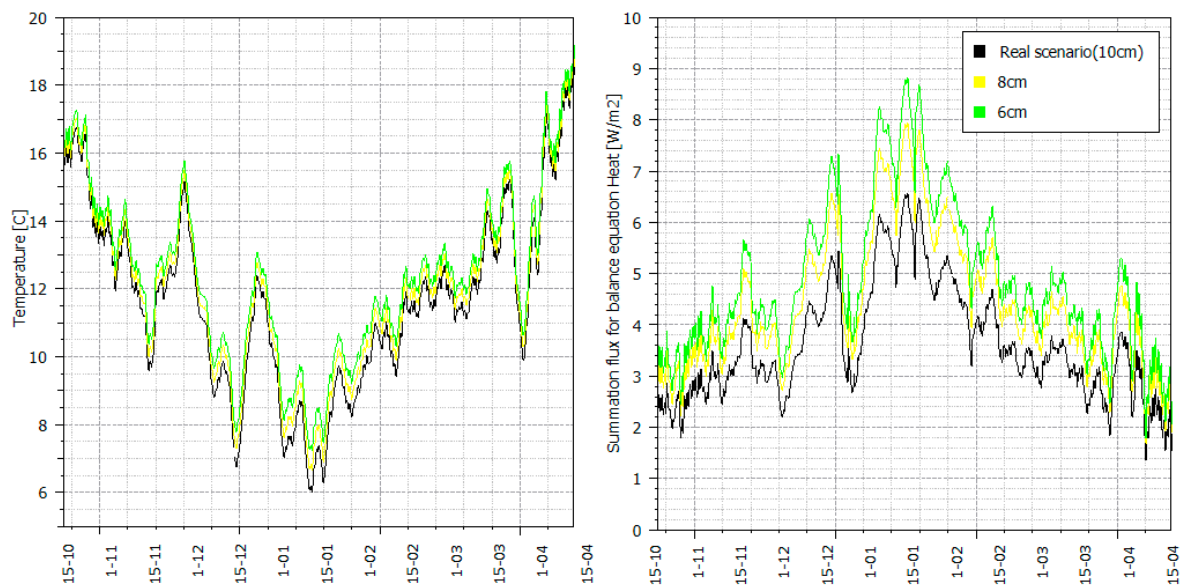
**Figure 15.** Left panel: hourly value of temperature in Point C (Figure 9). Right panel: hourly value of heat loss for the simulated walls, both during the heating period (15 October–15 April). Design scenarios of 6–8 cm of stone wool are included.

Although, on the one hand, we can see that the use of thicker insulation systems corresponds to lower heat losses, we expect to see higher moisture accumulation in the wall, as a result of this decrease of interstitial temperature. This issue was presented in the moisture accumulation analysis (Section 6.2.3). Figure 17 presents RH at the interface between the insulation system and the existing wall, recognized as the most critical part of the section [51]. As a general comment, alike for the base case simulation, RH remained below 95% for all the cases.

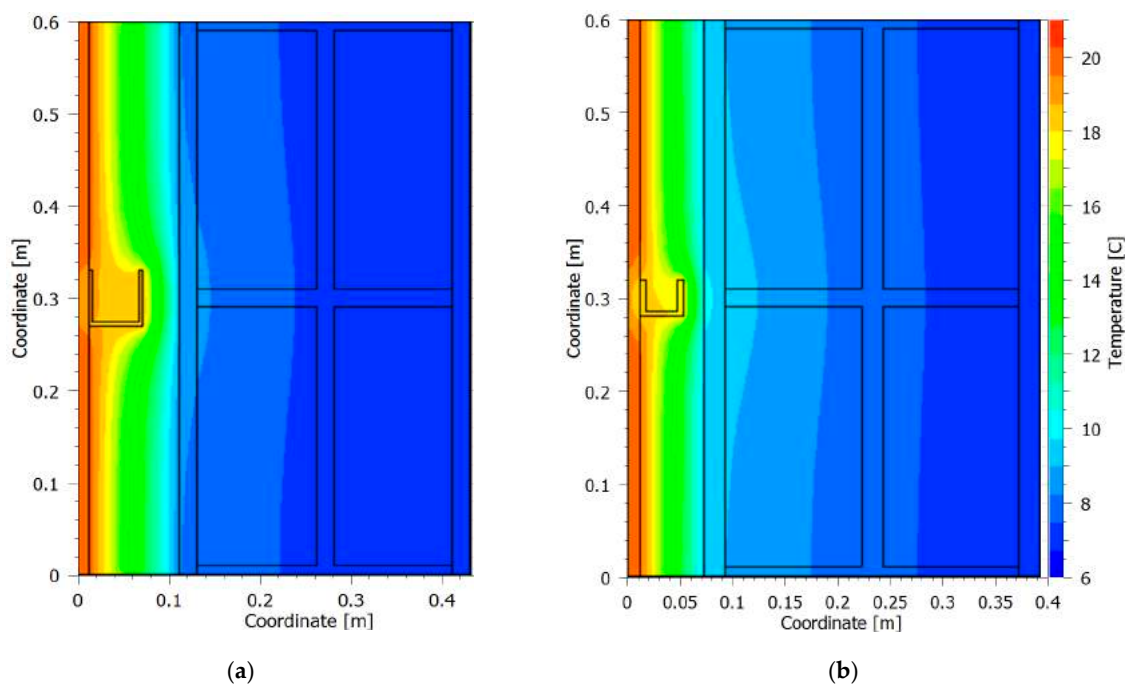
**Figure 16.** Temperature profile of the simulated wall during the coldest hour for 10 cm and 6 cm insulation scenarios.

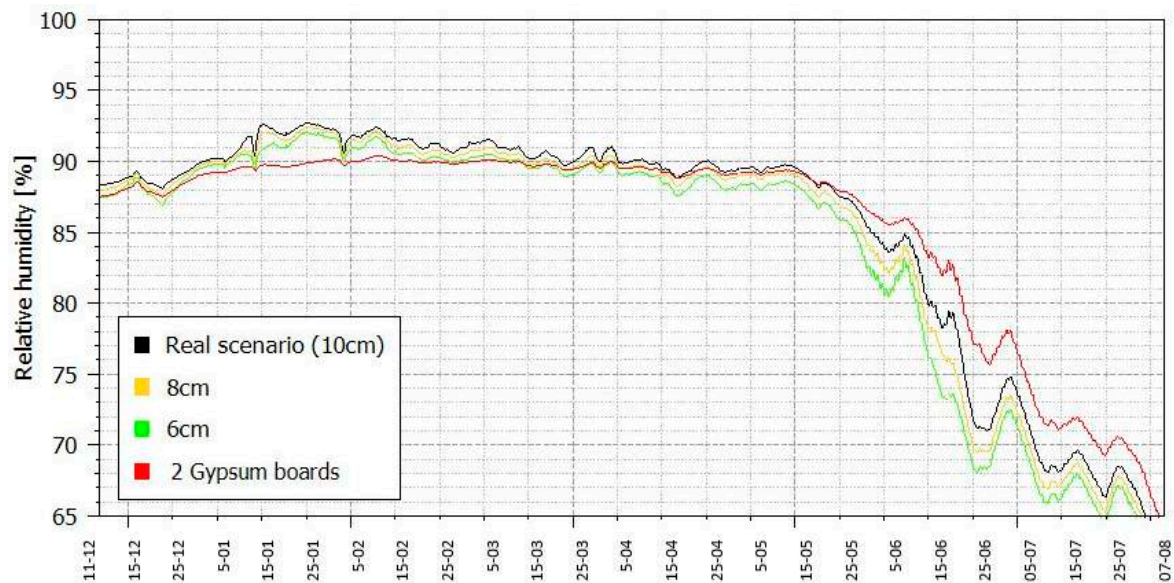
**Figure 17.** RH in point C (Figure 9) during the period 11 December–7 August, for the simulated wall. Design scenarios of 6–8 cm of stone wool and 2 gypsum boards as interior finishing are included.

Figure 17 shows RH behind the insulation during the monitored period (11 December–11 March), plus the drying period (12 March–7 August) for the investigated wall. Moreover, scenarios with 6–8 cm of stone wool and 10 cm with two gypsum boards as the internal finishing layer are also presented, in order to compare the impact of different interventions. All the scenarios confirmed the initial simulation results: a strong decrease of RH from the wet to dry period of the year, emphasizing a significant reduction of moisture content in the summer.

Contrariwise, in the third scenario, it resulted that improving the vapour resistance of the internal finishing with the use of the two gypsum boards, instead of one, may contribute to reduce moisture accumulation during the wetting period more efficiently than reducing the insulation thickness (Figure 17, first period).

Anyway, it is important to mention that, while the third scenario avoids reducing insulation thickness with consequent minor thermal losses, on the other hand, this design choice is responsible for a delay during the drying phase (Figure 17, second period). However, during the drying phase, moisture content significantly dries out from the interstitial area in all the studied cases. This phenomenon was also already visible in Figures 13 and 14 for the base case scenario.
