# FROM ART TO SCIENCE OF CONSTRUCTION: THE PERMANENCE OF PROPORTIONAL RULES IN THE “STRANGE CASE” OF THE 19<sup>TH</sup> CENTURY PONTE TARO BRIDGE (PARMA, ITALY)

**Keywords:** Historical masonry bridge, Proportional theory, Deformations, Crack pattern

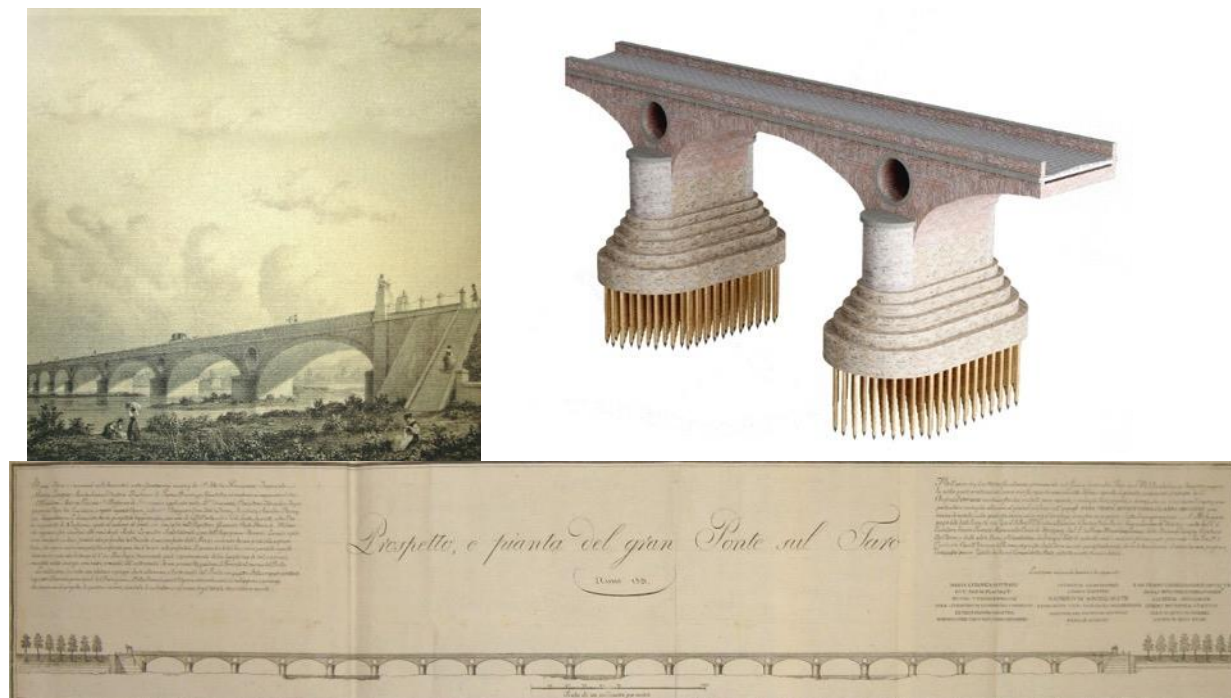
Figure 1. The Ponte Taro bridge: longitudinal prospect by Antonio Cocconcelli (below) and virtual reconstruction of the structure (above, right)

The construction of the Ponte Taro bridge, commissioned by Maria Luigia, duchess of Parma, to Eng. Antonio Cocconcelli, took place between 1816 and 1821. After several calculations and comparison with proportional rules [7], the final shape of this important infrastructure was articulated in 17 three-centered, lowered arches, with a 24 m span, supported by rectangular pillars (rounded on the two to longitudinal prospects in order to reduce the water impact) laying on 5 m long timber poles as foundations. This first project was changed in 1818, after a flood, adding three arches and deepening the foundations. Moreover, in the final 20 arches bridge, whose external brick structure unfolds an internal filling of river cobblestones mixed with mortar, Cocconcelli inserted an oculus above each pillar, thus easing the outflow of water (Fig.1).

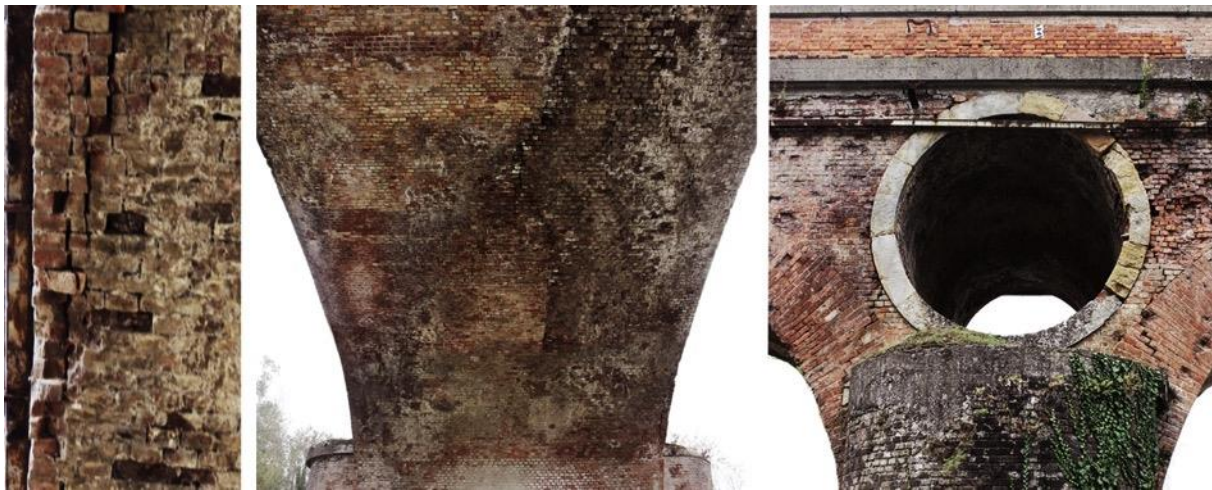
Figure 2: cracks caused by brickwork disposition, on the left. and structural fractures originated from differential deformations and settlements. In particular, in the center longitudinal crack on the intrados vault worsened by post-WWII reconstructions (span n.12) and, on the right, lateral cracks on the arch extrados (span n.17).

It is also interesting to notice that the position of the brick masonry areas more affected by missing parts appear related to the brickwork disposition: in particular, the edge between the vault and the arch front elevation in some cases shows the detachment of a more or less long masonry portion along the edge itself, whose boundaries seem related to the intersection between the header course masonry of the vault and of the arch, possibly also enhanced by structural stress concentrations (Fig.2, left). In some cases, the masonry portions are still in place, but already detached by a characteristic crack pattern at about 20 cm from the edges. Other cracks are clearly related to reconstructions, carried out after bombs hit the structure in World War II and after car accidents damaged the lateral walls.

Nevertheless, some other cracks in specific parts of the bridge can have a structural origin. These can be schematically divided in two typologies: cracks on the fronts, related to the arch mechanisms and cracks under the vaults, related to differential deformations. In the vaults n.2, n.5 and n.12, starting from the West end, longitudinal cracks are visible: these could be connected to different settlements of the North and South arches, possibly already during the removal of the centering in the building phase, as reported in some historical documents.

On the fronts, several arches show cracks on the extrados, laterally, in positions that are typical for depressed three-centered arches. When movements of the imposts (for settlements

or rotations) are present, the crack pattern loses its symmetry. In some cases, also the parapet shows inclined cracks, related to the settlement of the arches and of the supporting piers. Both for the piers and arches settlements, for a confirmation of these hypotheses it is important to check the actual present geometry, thanks to the precise survey, identifying deformations and loss of horizontality in the two directions.

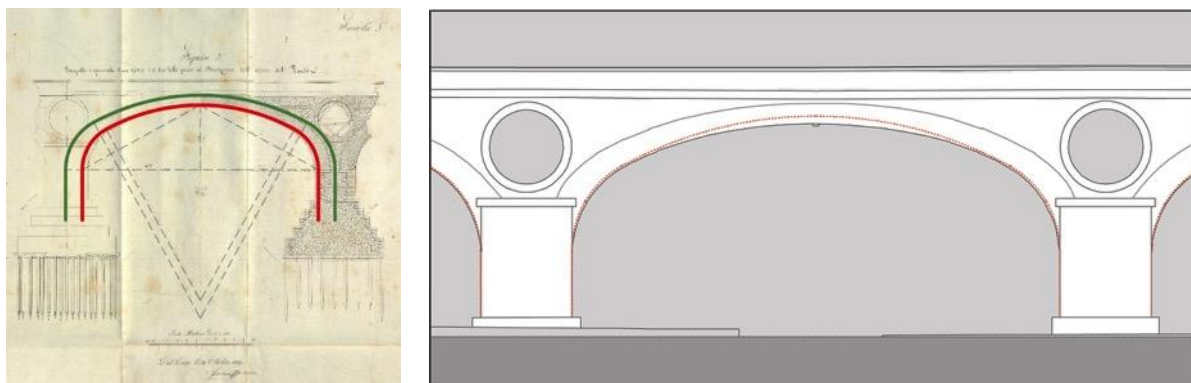
Figure 3: Differences of geometry between the original drawing by Coconcelli (on the left) and the surveyed one (on the right, arch n.12).

As far as the shape of the arch is concerned – and particularly its rise – a comparison was made between the survey and the design shape, as inferred by the descriptions and drawings of Coconcelli (Fig.3, left).

7 out of 20 arches show a lowering of the keystone higher than 30 cm (Fig.3, right): this value seems to be imputable to further movements after the physiologic lowering of the arches during the centering removal in the construction phase (quantifiable from literature in a range between 16 and 30 cm [9]). Moreover, in order to evaluate if the longitudinal cracks could be connected to some torsional effects, the levels of the keystones of the North and South arch of each span were compared.

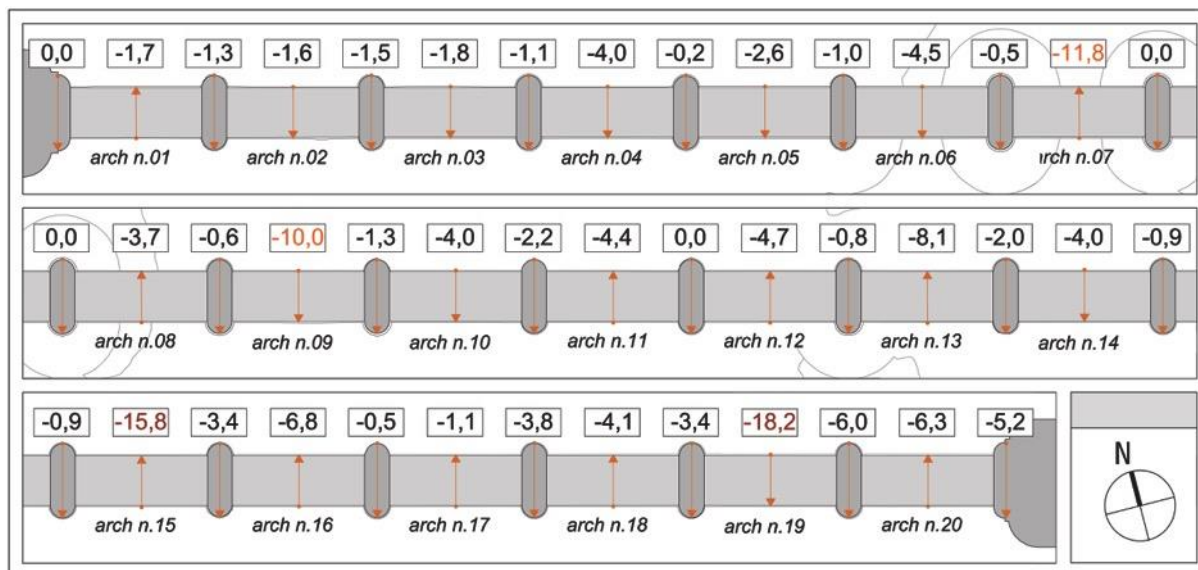
Figure 4: Comparison between the levels of keystones in the northern and southern side for each arch.

From the Figure 4 it's possible to see that the highest differences – between 15 and 20 cm - were measured in the arches n.19 (-18.2 cm) and n.15 (-15.8) while the arches n.7 and n.9 show differences between 10 and 15 cm. It is noteworthy that these level differences are not always in the same direction; anyway we can state that most of these inclinations are Southwards in the West Side of the bridge, changing Northwards in the East side (as represented by the arrows in Fig.4).

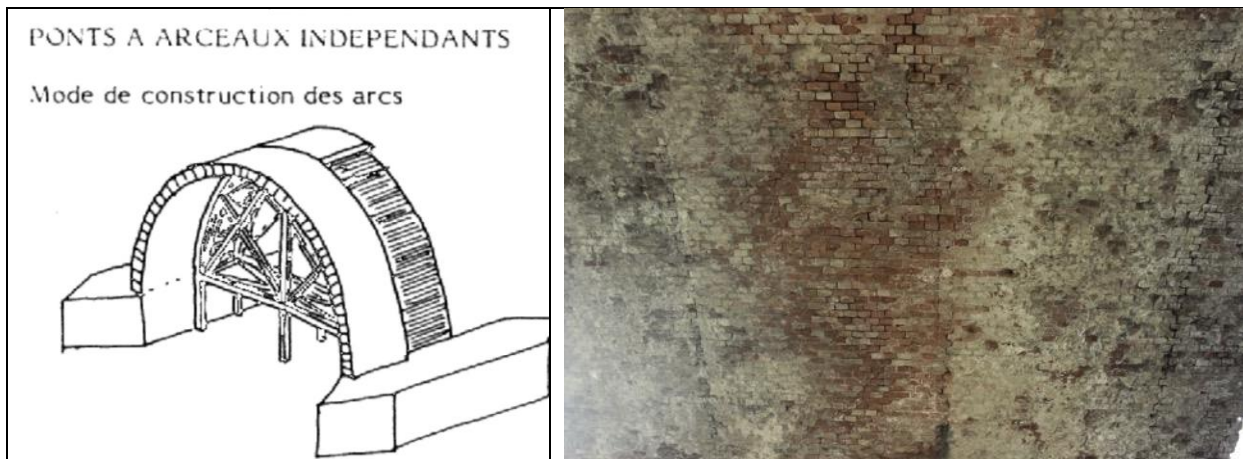
Figure 5: The longitudinal cracks below the arcades, imputable to as many mistakes in masonry apparatus during the construction phase (and the centering removal).

In conclusion, comparing the crack pattern with the deformation analysis, only in two arches it is possible to find correlations between the longitudinal cracks in the vault and the lowering of the keystone (n.12), as well as between the cracks in the extrados (arch n.9) and the settlement of the vault itself. This fact, together with the evidence of some loss in masonry apparatus and considering the possible mistakes during the construction phase (particularly important in the case of bridges with independent arches [10], as the case of study, Fig.5) leads to speculate that the cause of the damage is not structural but more reliably linked to local mechanisms ascribable to as many construction defects: only in these cases indeed, the question of resistance (otherwise not influential for the massive historic masonry constructions [11]) intervenes, showing local cracks.

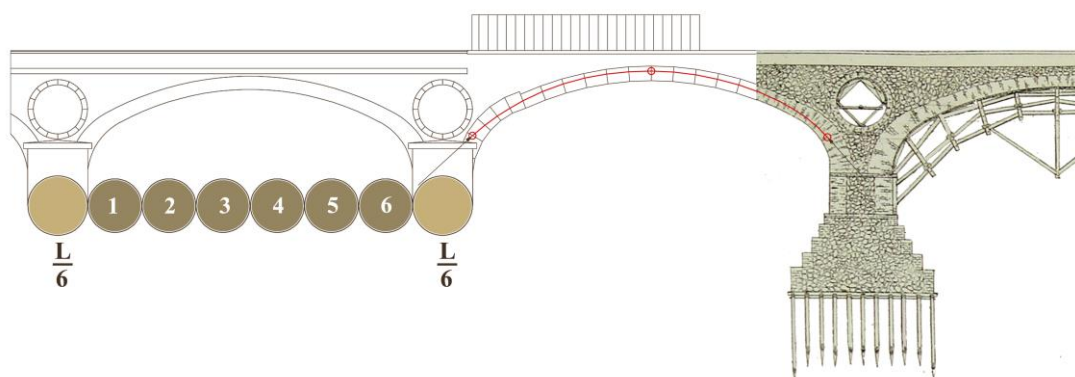
Figure 6: From the left, the analysis of the bridge: starting from the proportional theory to the “safe theorem” with the current loads.

In this case, the first “verification” has been the adherence of the dimensions of the bridge to the prescribed proportional rules recalled in the first part of this paper (Fig.6, left).

By analyzing the main dimensions of the span and the pillars, indeed, it can be seen that the prescribed ratio of  $p/L$  equal to  $1/6$  is verified, thus following the proportional method, as explicitly declared by Antonio Coconcelli himself in his project [7].

What we can notice is a slight “licence” in the thickness of the arches: Cocconcelli applied in his bridge a smaller ratio than the one prescribed by treatises, reaching – in the keystone – a thickness equal to  $L/18$ . This advancement certainly derived from the Mery’s method results, used during his calculations of the bridge, whose reliability is definitely confirmed by the evidence that, despite the load over the bridge has significantly increased in time (up to the current traffic), it has demonstrated, until now, a surprisingly high load bearing capacity.

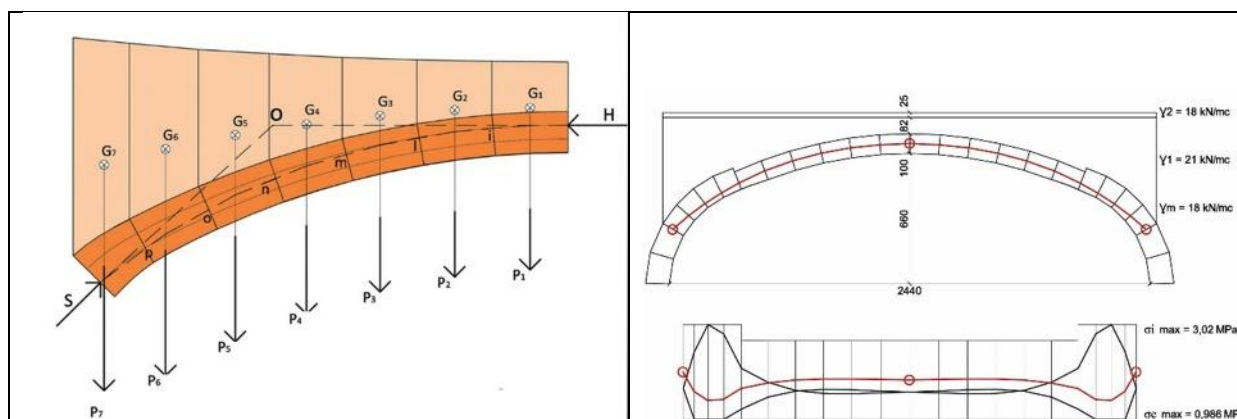
Figure 7: On the left, the result of the pressure curve with Mery’s static analysis method, applied to the arch subject to dead load (with filling). On the right the same condition analyzed by limit analysis method.

Therefore, recovering the Mery’s method, used by Cocconcelli for the primeval dimensioning of its bridge, the first step has been the validation of the arch by static graphic analysis (fig.7, left), considering only the dead load of the three-centered arch and the abutments, constituted by bricks (specific weight equal to  $18 \text{ kN/m}^3$ ) and the internal filling of river cobblestones mixed with mortar ( $21 \text{ kN/m}^3$ ), thus proceeding with a homogenization of the blocks. From this simple analysis, the curve of pressure was found to be all contained in the middle third of the arch thickness, thus guaranteeing the best behaviour of the masonry, within the imposed hinges at the extrados at the key and at  $45^\circ$  on the impost plane.

The same result has been obtained by applying simplified limit analysis to the complete arch, considering the abutments and the different thickness at the imposts (1,30 m in the key and 1,6 m at the abutments).

The “safety factor” obtained in this case (intended as a ratio between the thickness of the arch and the minimum one suitable to contain the pressure curve) was 3,88, thus well above the collapse limit stated by Heyman [14].
