Dick, Geoff; Ede, Mike; Nguyen, Duc; Wadsworth, Val The Wairau River Flood of July 2021

Hydrolink

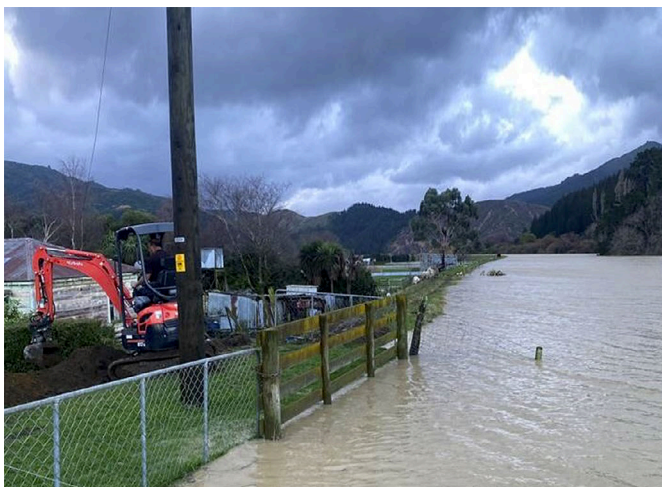
Figure 2 | Flood peak against a key stopbank (dyke) with emergency work to limit overtopping.

The storm affected much of Marlborough, with associated flooding and roading damage. However, the key Wairau flood protection scheme is considered to have performed well and consequently saved an enormous amount of associated flood damage across the lower Wairau plains (Figure 2). There were three stopbank failures and a number of sections of stopbank overtopping, causing flooding above the floor level of a small number of houses as well as restricting road access.

Of the three key stopbank failures, preliminary assessment suggests two were due to a combination of overtopping and poor to variable stopbank quality, and one due to piping under the bank via an underlying fine sand layer. As expected on a large, powerful fast flowing river like the Wairau there are now numerous areas suffering erosion, bank slumping, and silting of some drainage outlets.

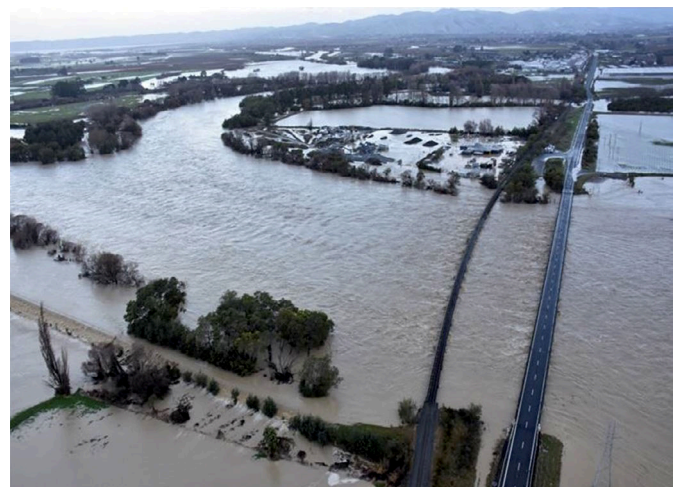
Figure 3 | Key transport links survived peak flows.

On the positive side, modern upgraded stopbanks stood up very well, withstanding significant overtopping in places. Also, the highway and railway bridges are the only links connecting the South Island to the North Island via the interisland ferry, and both appear to be undamaged (Figure 3).

Figure 5 shows the STIV surface velocities (blue line markers) measured across the standard cross-section at “Barnetts Bank”, some 500 m upstream (to the right) of the bridges shown in Figure 3. These velocities are compared with depth averaged velocities obtained by modelling. 2D modelling provides depth averaged velocities by dividing specific discharge (m^3/s per m) by depth, after which the chosen correction factor is applied to recognise that surface velocities are expected to be greater than depth averaged velocities. In this case a good fit (brown line) was obtained by dividing by 0.95 the model depth averaged velocities corresponding with a total discharge of $5,280 m^3/s$.

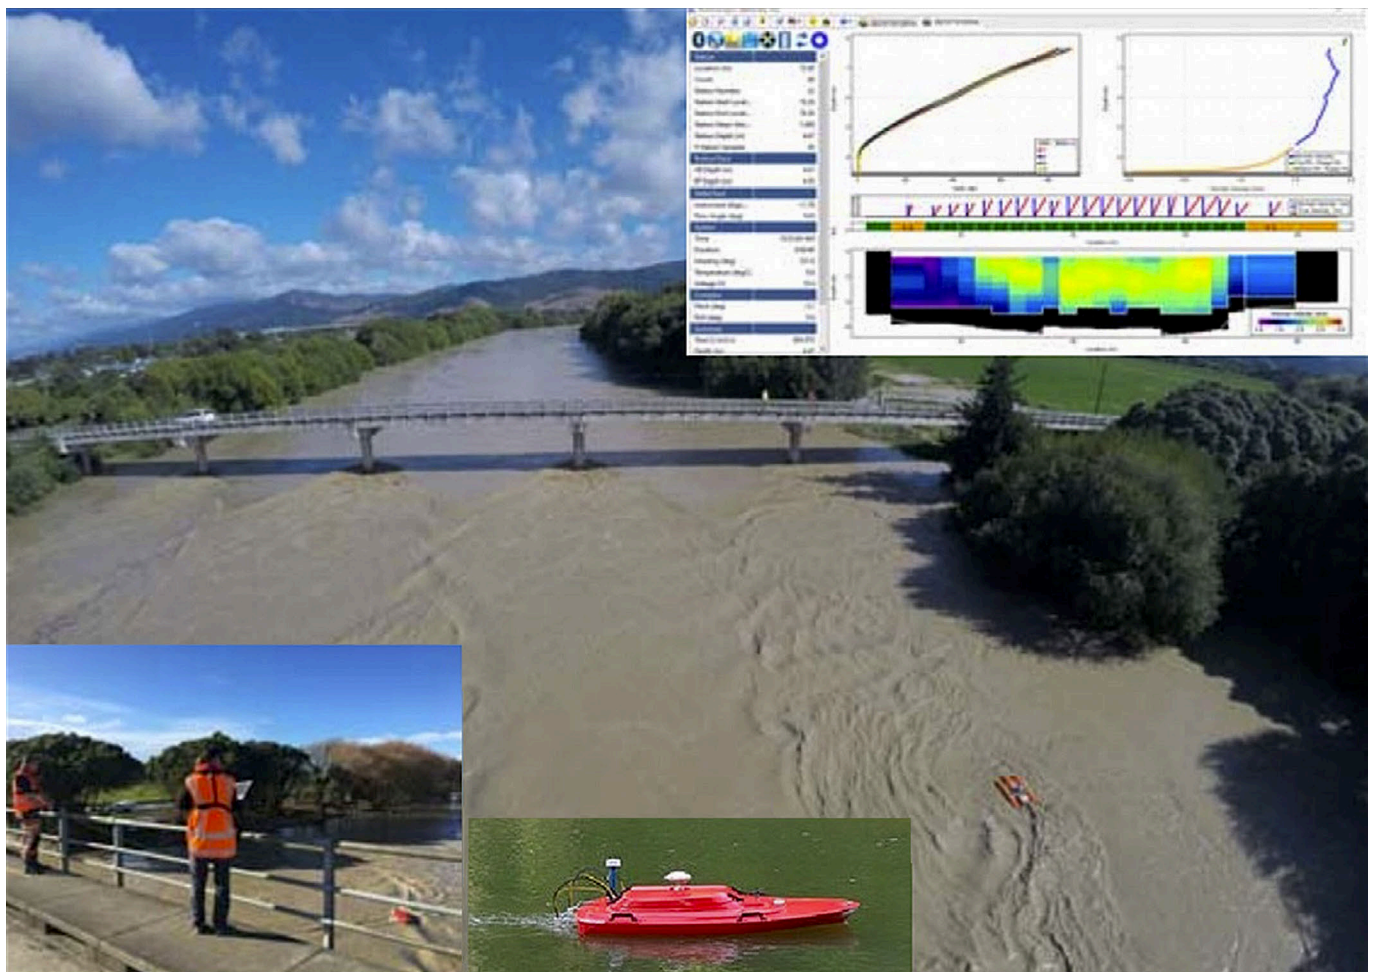
Figure 4 | ADCP gauging a major flood using a remote-controlled boat.

As well as traditional mechanical current meters, the Marlborough District Council has progressively been introducing Acoustic Doppler Current Profilers (ADCP) since 2007. Figure 4 shows an example of gauging using an ADCP unit installed on a small boat, which may be either remotely controlled or tethered to a structure such as a bridge. The use of ADCPs greatly speeds up the sampling of current velocities over an entire cross-section.

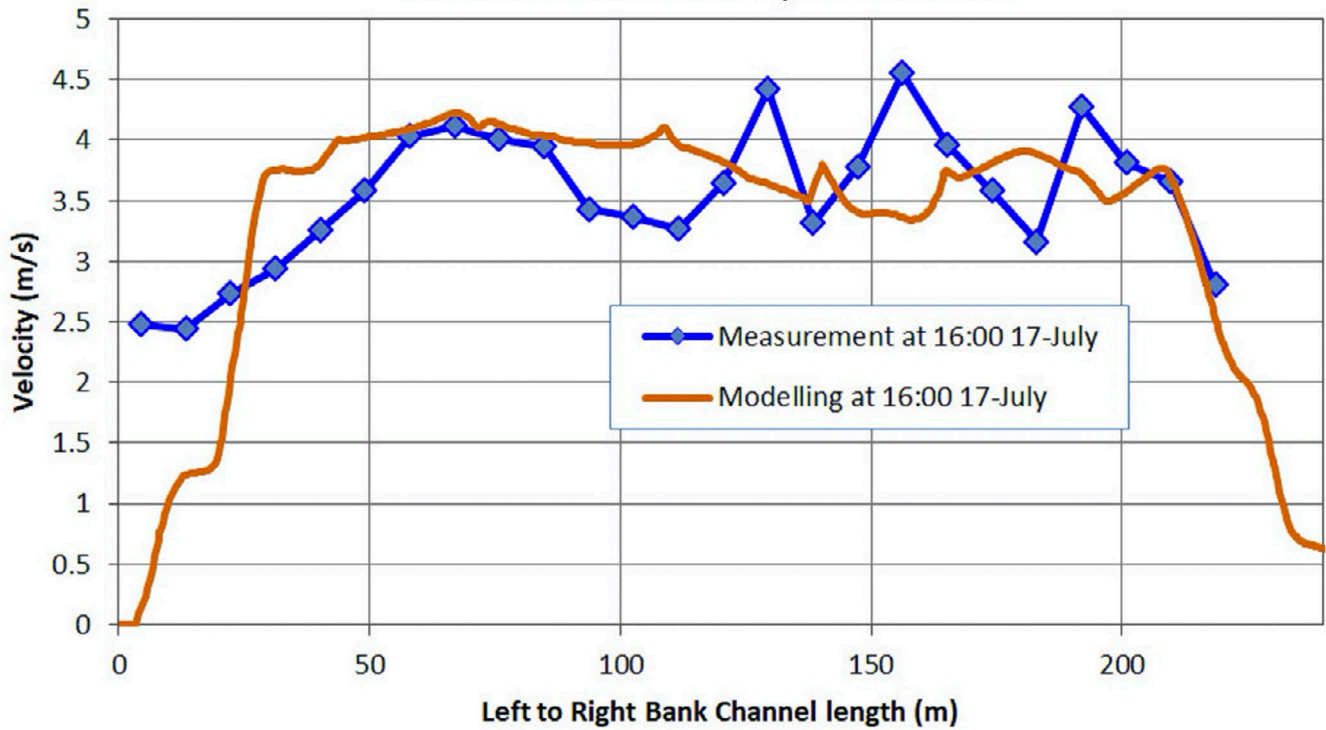
Surface velocity comparison between STIV measurement and modelling at Barnetts Bank for a $Q_{peak}=5,280 \text{ m}^3/\text{s}$

Figure 5 | Calibration of STIV velocity using model depth-averaged velocity.
