Ahn, Hong Kyu; Woo, Hyoseop; Rhee, Dong Sop; Cho, Kang Hyun
A Study on the Effect on River Habitat Change by small dam removal - A Case Study of Gokreung 2 & Gotan Small Dam Removal

Ahn, Hong Kyu; Woo, Hyoseop; Rhee, Dong Sop; Cho, Kang Hyun (2008): A Study on the Effect on River Habitat Change by small dam removal - A Case Study of Gokreung 2 & Gotan Small Dam Removal. In: Wang, Sam S. Y. (Hg.): ICHE 2008. Proceedings of the 8th International Conference on Hydro-Science and Engineering, September 9-12, 2008, Nagoya, Japan. Nagoya: Nagoya Hydraulic Research Institute for River Basin Management.

A STUDY ON THE EFFECT ON RIVER HABITAT CHANGE BY SMALL DAM REMOVAL - A CASE STUDY OF GOKREUNG 2 & GOTAN SMALL DAM REMOVAL –

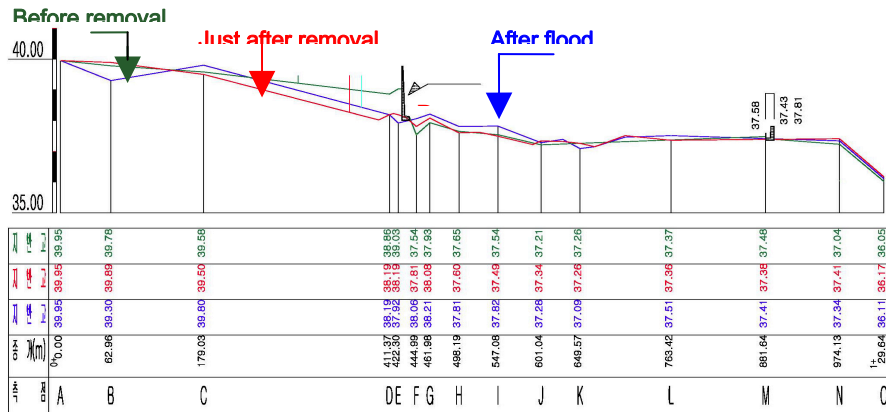
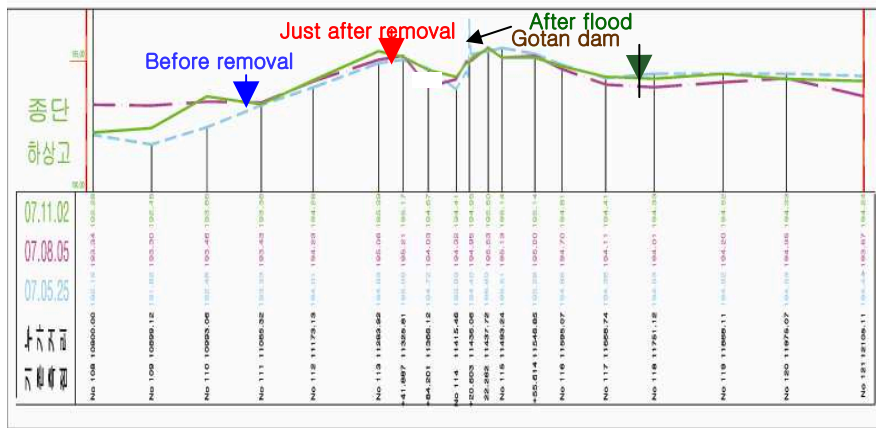
(Figure 2) Vertical changes of the riverbed in Gokreung 2 small dam(up) and Gotan small dam(down)

The comparison of the riverbed before and after the flooding showed that the upper reaches of the small dam degraded early after the removal and aggraded again, while sediments continued to accumulate in the immediate lower reaches of the both of dam after the removal and the riverbed continued to aggrade in Gokreung 2 small dam.

Conversely, although the flooding occurred, there were not any significant changes in the riverbed after the removal of the Gotan small dam in Hantan River. This seems to be the result that the riverbed consists of large particle stones and the change in the riverbed is happening slowly.

The analysis of the grain size distribution based on the analysis of the riverbed materials showed that, in the upper reaches of the weir, the grain size of the riverbed materials increased as the riverbed, which used to be a sedimentary layer, was eroded, while in the immediate lower reaches of the weir, sediments accumulated during the removal work was all washed away during the flooding, and the riverbed was full of cobbles, medium-to-fine gravels and coarse sands. In this sector the erosion due to the

flooding abruptly changed the riverbed materials, but is quickly stabilizing and returning to the original riverbed.

In the Gokreung 2 small dam in the Gokreungcheon whose riverbed was made up with sand, swamps in the upper and lower reaches of the weir quickly changed to rapids after the removal of the weir whereas swamps in the Gotan small dam in the Hantan River whose riverbed consists of gravel is very slowly changing to rapids.

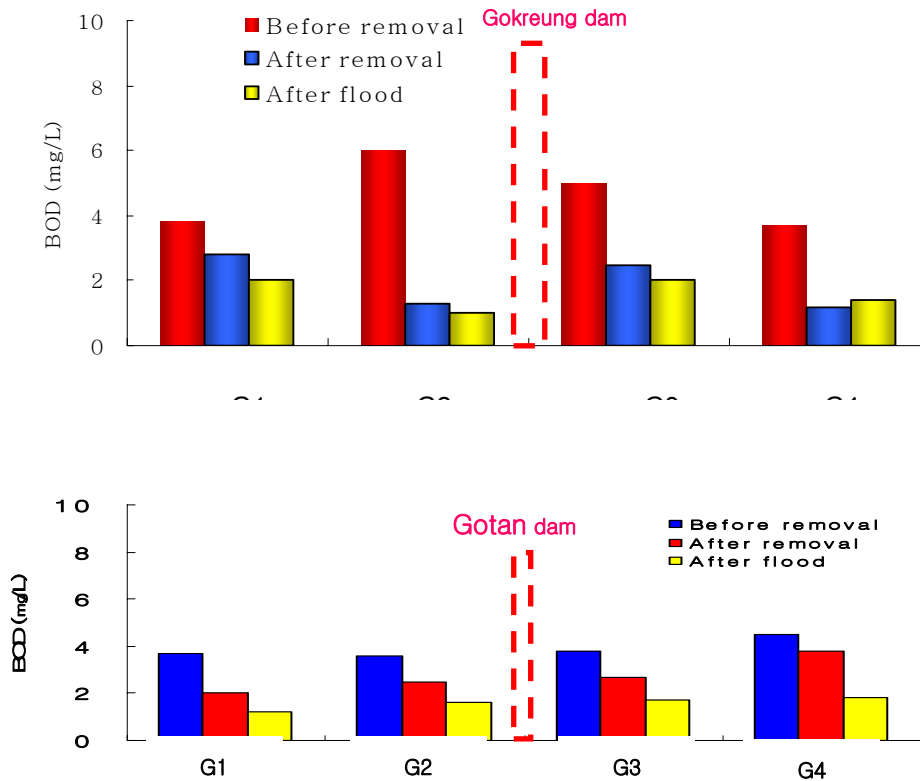
(Figure 3) Changes in BOD and SS concentration of Gokreung 2 small dam(up) and Gotan small dam(down) before and after weir removal

The analysis of the mean concentration of BOD, SS and TN and TP showed that the concentration of SS was lower after the dam removal than before the dam removal except for in the uppermost reaches of the small dam, and that of BOD had significant lower values of both of the after the dam removal than before the dam removal.

These results indicate that the water quality got better after the weir removal than before the dam removal. However, as the monitoring was conducted over a short period of time after the dam removal, it is too early to come to any quantitative conclusion, and a longer-term monitoring is in order.

As the density of BOD decreases through the removal of the weirs, the water quality has improved in the two areas.

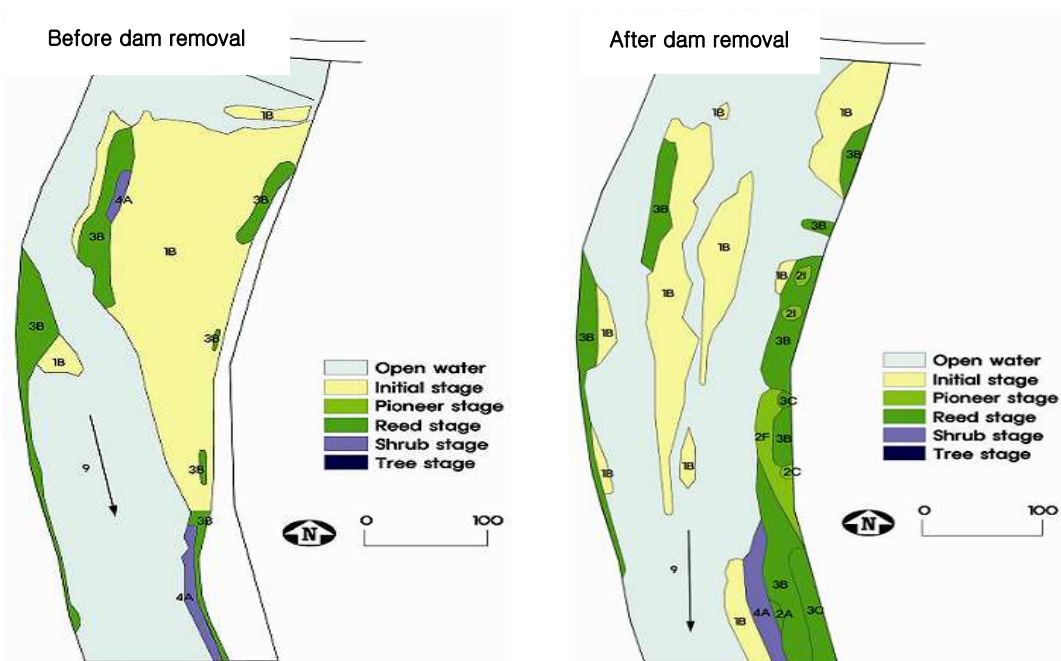
(Figure 4) Changes of vegetation illustrated in the vegetation cross section after the removal of Gokreung 2 small dam(up) and Gotan small dam(down)

In this area there used to be a swamp in the upstream. What used to be a detention pond before the weir removal showed the characteristics of a detention pond after the weir removal as well. As the water was drained from the ex-detention pond in the upper reaches of the weir, the part newly out of the water became a new habitat for plants, but only pioneer plants inhabit there in the early stage. In July there was a flood after the weir removal, and the topography of the low-flow riparian area was changed a great deal, and the habitat of the water-caltrop, a submerged plant, shrunk. As for new habitats emerging after the weir removal, in the early stage annual zone-of-disturbance vegetation appear in most cases, and as time passes, perennial vegetation is expected to succeed to the annual vegetation.

These biological changes in the habitats brought the creation of vacant lands right after the removal of the weir and noticeable invasion of introduced plants, but it is likely that the introduced varieties will be succeeded by indigenous ones in the future and caddisflies appeared which had not inhabited in the areas before the removal of the weirs.

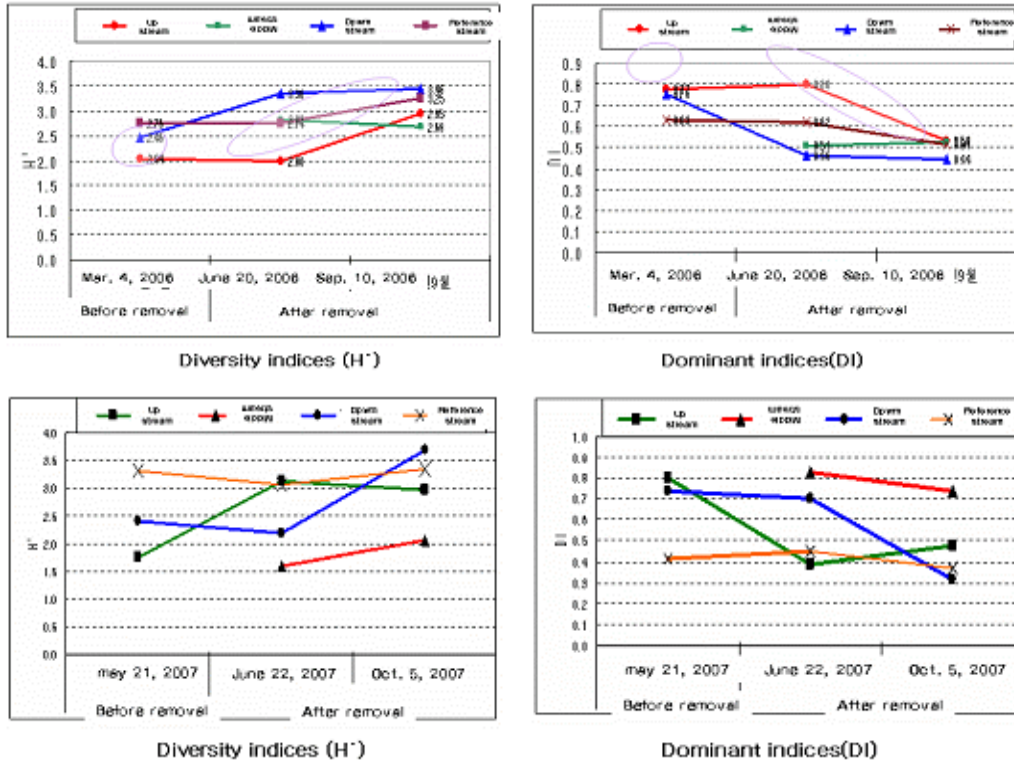
(Figure 5) Comparison of diversity and dominant indices of large benthic invertebrate after the removal of Gokreung 2 small dam(up) and Gotan small dam(down)

After the removal the static waters of the upstream changed to flowing waters, and as diverse particles from the riverbed materials, dragonflies and melanian snails, which used to be there, were not discovered, whereas trichoptera, which did not used to be there prior to the weir removal, appeared. There was some change to the species. Before the weir removal chironomids and tubifexes were dominant, but chironomids and mayflies were dominant after the weir removal.

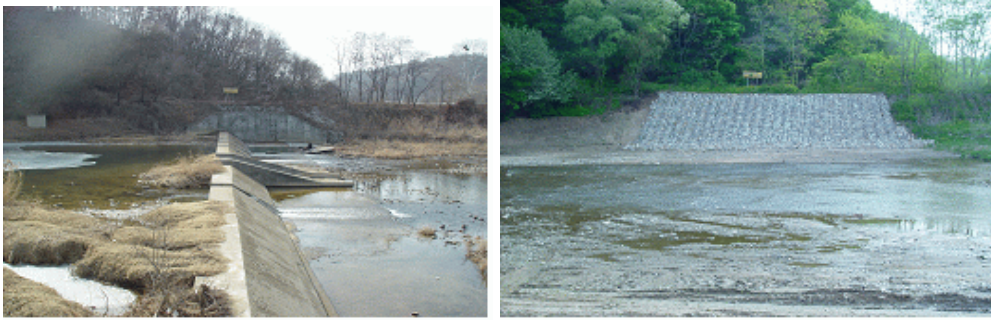
(Figure 6) The images of Gokreung weir 2 before (left) and after (right) the weir removal (left bank of the small dam)

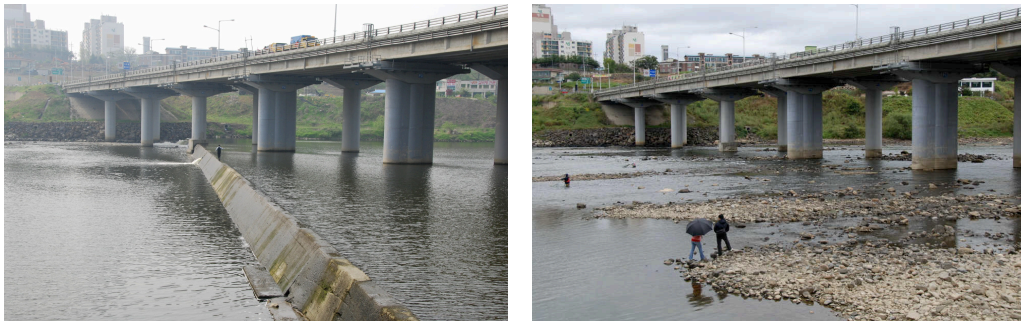
(Figure 7) The images of Gotan small dam before (left) and after (right) the dam removal (right bank of the small dam)
