STUDY ON THE TRANSPORT CHARACTERISTICS OF FLOATING GARBAGE IN HORI RIVER

Makoto TAKEDA¹, Morihiko HARADA², Akihiro TOMINAGA³ and Naoki MATSUO⁴

Keywords: Floating garbage, Hori River, Transport characteristics, Field observation, Numerical simulation

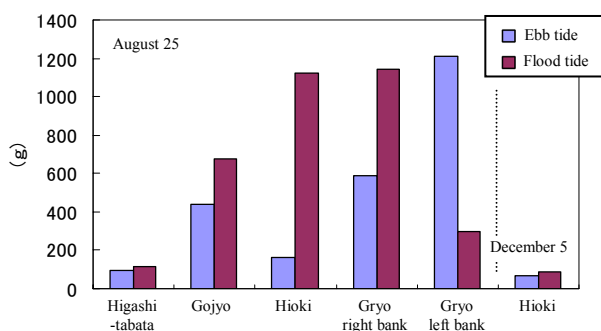
Figure 3 Total mass of floating garbage

Figure 3 shows the total mass of floating garbage at each bridge. From this figure, less garbage was observed in upstream area of the Hori River, and the volume of garbage increased toward downstream area of the river. In particular, exceptionally higher volumes of garbage were observed at the upstream area of Hioki Bridge during the flood tide than during the ebb tide. The transport characteristics of floating garbage in the Hori River caused by the presence of the water area in front of Matsushige

Lock Gate, which will be explained in subsequent sections. In addition, a large difference was observed in the amount of garbage collected at Hioki Bridge on August 25, 2006 and December 5, 2006. This difference is affected by rainfall of 33.5 mm per day on August 22 (maximum hourly rainfall: 17.5 mm).

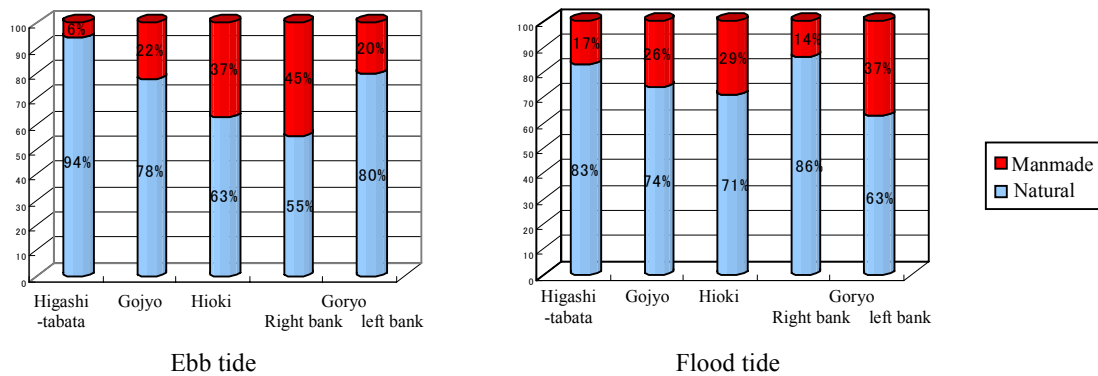
Figure 4 Volume ratio of manmade and natural garbage

The garbage was categorized into natural one such as leaves, and manmade one such as plastic bags. Figure 4 shows the volume ratio of natural and manmade garbage at each bridge during ebb tide and flood tide. From Figure 4, it is found that the volume of natural garbage is more than that of manmade garbage (averaging more than 70%), and the ratio of manmade garbage increases at downstream area of the Hori River. Furthermore, it was noticed that natural garbage was primarily composed of materials from outside the river such as fallen leaves and dead wood. The manmade garbage was composed of a number of plastic bags, and a number of discarded cigarette butts increased in downstream area. There was much vegetation surrounding the upstream area of the Hori River, while a large number of men were passing along the downstream area of the river, hence these situations of the Hori River are related to the observation results of floating garbage. The floating garbage in the Hori River are repeatedly transported to upstream and downstream by tidal flow, and flowed down gradually toward Nagoya Port in which the Hori River terminates. The results of this investigation clarified the transport characteristics of garbage in the Hori River. Additionally, the high volume of natural garbage such as dead leaves indicates that measures to control floating vegetation such as levee management and weed removal could help to improve the water environment of the Hori River.

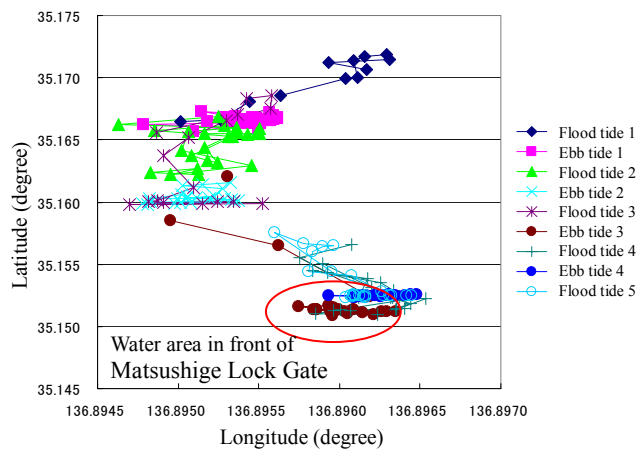
Figure 11 Transport trajectory of dummy garbage

In order to ascertain the transport characteristics of floating garbage in the Hori River, a dummy piece of garbage mounted with a GPS unit was released into the river. The recording time for the position of the dummy garbage is every 15 minutes. The observation period was from 6:00 January 9 to 10:00 January 11, 2007, and the release of the dummy garbage was started at Naya Bridge. The dummy garbage was collected at Hioki Bridge at 10:00 on January 11 2007. Figure 10 shows the tide level of Nagoya Port, and Figure 11 shows the transport trajectory of the dummy garbage during the observation period. As shown in Figure 11, the dummy garbage gradually moved to the southerly direction from flood tide 1 to flood tide 3. From ebb tide 3 to flood tide 5, the garbage moved in the same region. Matsushige Lock Gate is located at the southern edge of this movement. From these results, it was confirmed the water area in front of the Matsushige Lock Gate strongly influences the transport characteristics of floating garbage in the Hori River.

- 4) When a dummy piece of garbage mounted with a GPS unit was released into the river, it was found to circulate between the midstream portion of the Hori River and the water area in front of Matsushige Lock Gate.
