# Seismic vulnerability assessment of clustered historical centers: fragility curves based on local collapse mechanisms analyses

S. Taffarel, M. Caliman, M.R. Valluzzi, F. da Porto & C. Modena

*University of Padova, Department of Civil, Environmental and Architectural Engineering, 35131 Padova, Italy*

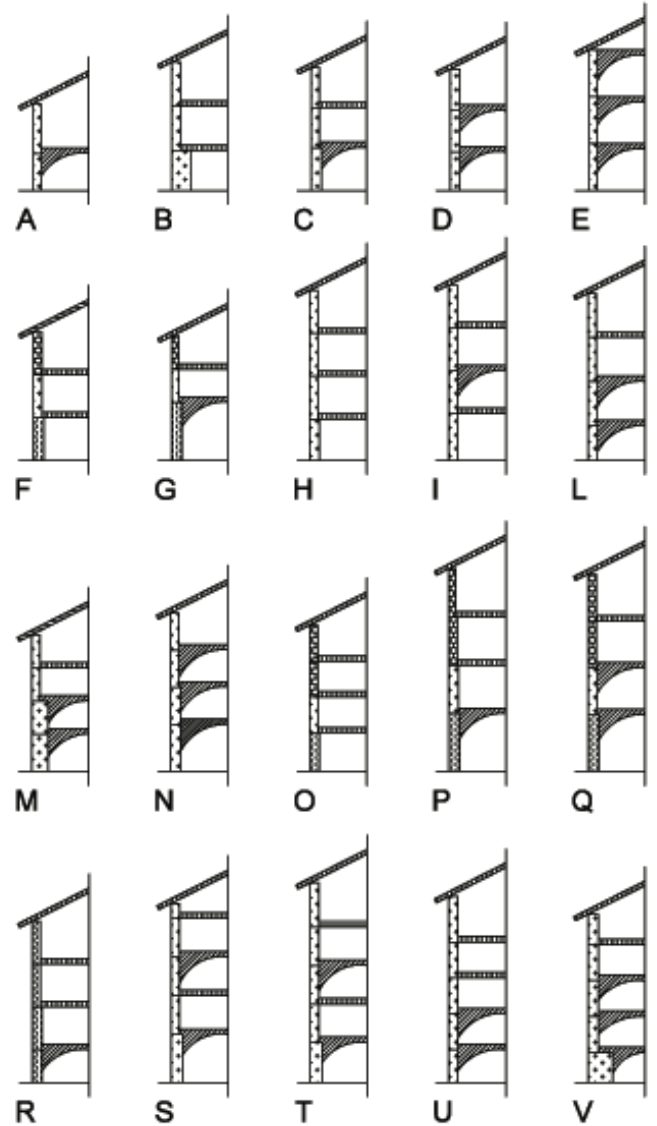
Figure 3: Typologies identified in the study.

Each clustered building was here studied supposing its historical evolution and identifying homogeneous SU. A total of forty-two SU were detected within the five analyzed municipalities. Moreover, geometrical, photographic, structural and constructive surveys were carried out. Those data were used for the typological analysis, whose purpose was the detection of recurrent characteristics among the analyzed SU. The collected data referred to: number of floors, prevalent vertical structures, prevalent horizontal structures, inter-storey height, wall thickness, planimetric module, vaults span, façade openings and floors bearing direction. The SU were then subdivided taking into account the number of out-of-ground floors and prevalent vertical and horizontal elements: twenty structural typologies were identified, named by letters (A-V). All SU were made of ashlars, except for those located in L'Aquila, which had different vertical structures (typologies F, G, O, P, Q and R). The typologies were defined by grouping prevalent horizontal structures depending on their weight (light, heavy, very heavy), which is one of the parameters affecting the kinematic analysis, and on their stiffness. Vaults were analyzed separately, because of their weight (quite high compared to the other horizontal diaphragms) and their horizontal thrust component. Inter-storey height and walls thickness values were assigned to each typology. Values were obtained by averaging the values measured for each level separately: the ground floor (often larger than the others), the middle floors and the fourth floor, usually having different characteristics from the others. In particular, the fourth floor was often an attic; therefore, its height was significantly lower than the one of the other levels. Other geometric and structural features were established by averaging the values obtained from the statistical analysis within each typology. The friction forces between walls and horizontal structures were not considered, since the assignment of a realistic value of the friction coefficient requires extensive studies on buildings, which are in contrast with a simplified and quick approach. The twenty detected typologies are graphically represented in Figure 3.

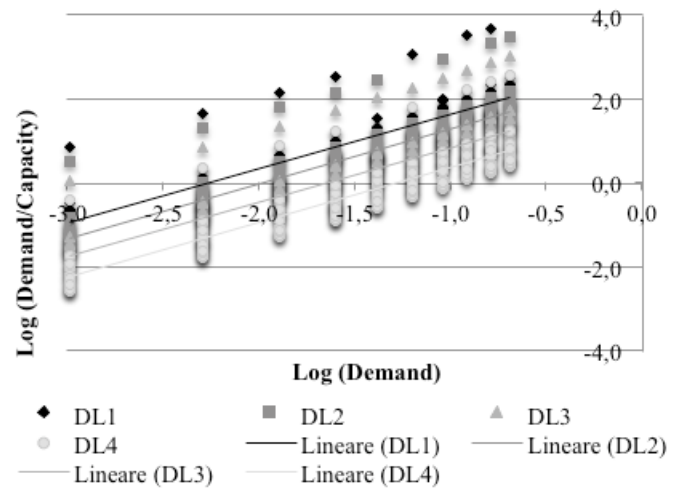
Figure 6: Regression line for Typology A, overturning of the wall substantially resting on the ground.

Grouping in a single graph the damage values obtained for the different PGAs, the coefficients A and B defined by the regression line (Figure 6) are obtained. In the ADRS plan the medium demand associated to each level of damage is defined by Equation 1:

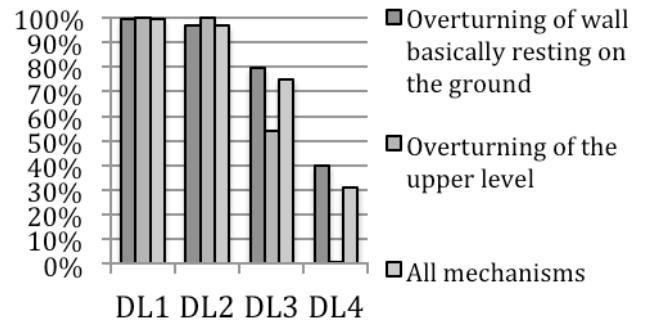
Figure 9: Exceedance probability for  $a/g=0.25$  - Typology A.

The obtained results can also be represented by using histograms, which show each level of damage related to the hinge formation level. Figure 9 shows the damage exceedance probability for the PGA value provided by Italian seismic code (0.25g). Values of PGA defining the 100% exceedance probability are reported in

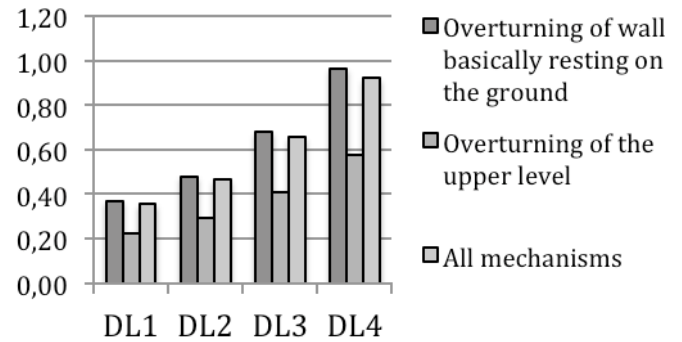
Figure 10: PGA for exceedance probability 100% - Typology A.

Figure 10. The exceedance probability for  $a/g=0.25$  was also grouped according to hinge formation level, so that typologies results could be compared (

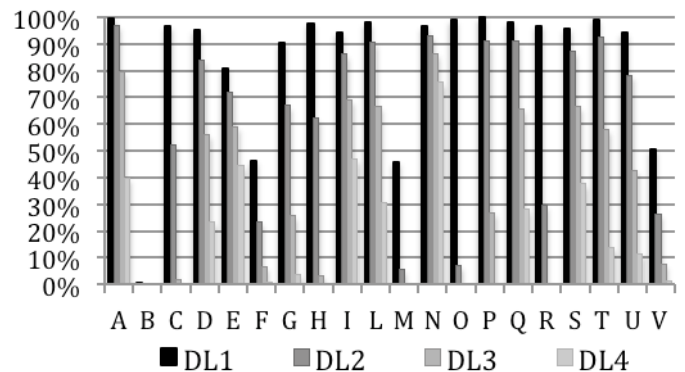
Figure 11: Exceedance probability for  $a/g=0.25$ , overturning of wall basically resting on the ground.

Figure 11, it is possible to note that many typologies were characterized by very high values of damage exceedance probability, in particular for damage level DL1. On the contrary, in other cases (for example typology B), the damage exceedance probabilities were very low for each level of damage. This comparison provided a preliminary identification of the most vulnerable typologies.

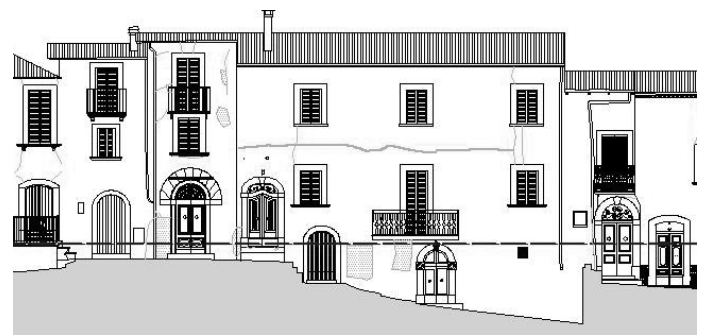
Figure 13: Villa Santa Lucia degli Abruzzi crack pattern.

In order to validate the procedure, a qualitative comparison considering damage information collected after the post-earthquake phases was carried out. A first comparison was referred to crack patterns, by examining whether cracks indicating the activation of an overturning mechanism coincide to an high probability of activation of the same local mechanisms for the corresponding typology. As an example, horizontal cracks identified at the base of top floors in Villa Santa Lucia degli Abruzzi aggregate building (

Figure 13) indicated that the overturning mechanism of the upper floor was activated. In this case, there was a good comparison with results obtained

by adopting the proposed methodology, since the exceedance probability for minor-moderate damage levels (DL1, DL2) increased proportionally to the height of hinge formation, but never reached collapse (DL4).
