Involvement of Metal Particles in Loosening of Metal-Plastic Total Hip Prostheses

Summary. Four loosened metal-on-plastic total hip prostheses and associated tissues were examined. Each implant showed an uncommonly high formation of metal particles produced by wear or corrosion of the femoral stem. The granulation tissue between bone and cement was characterized by macrophages containing metal particles. Histological, histochemical, and ultrastructural investigations have been performed to assess cellular reactions to ingested metal particles. Pathogenesis of loosening in these cases is discussed in relation to the role of macrophages in bone resorption.

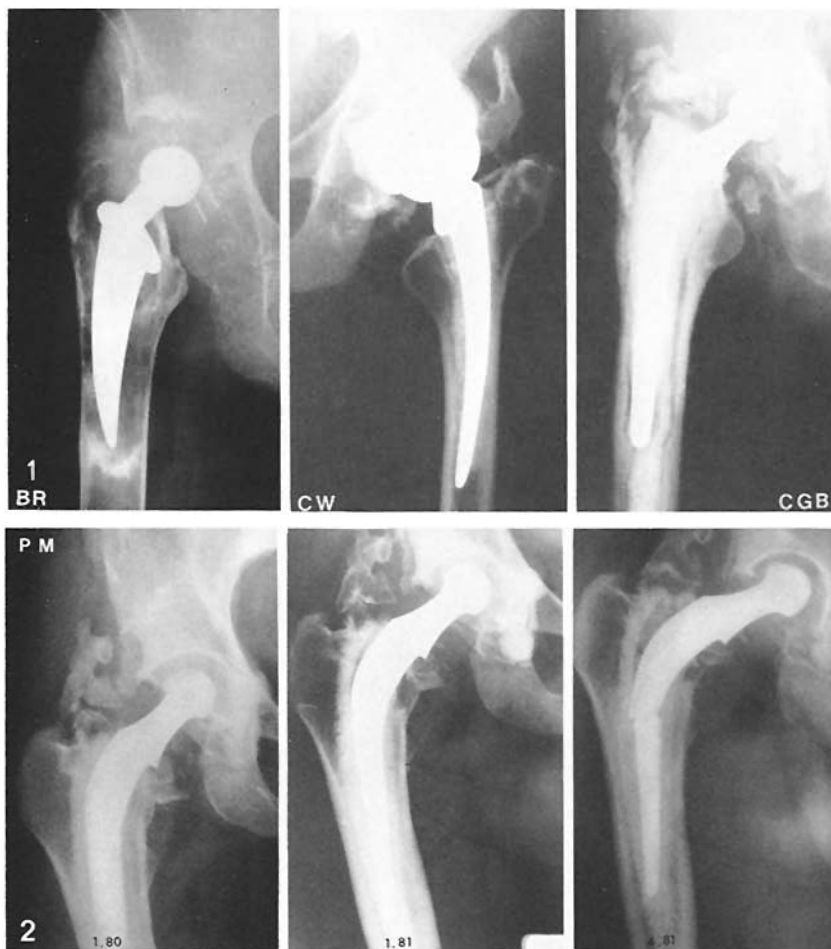
Fig. 1. Roentgenograms and scintigraphy of the removed prostheses. *BR* A radio-transparent cement was used, but loosening is nonetheless evident because the stem has sunk in the diaphysis. *CGB* A bilateral arthroplasty was performed. Only the loose prosthesis shows ipercaptation

2. *CW, male, aged 30.* In 1975 a Judet total-hip arthroplasty was performed for post-traumatic necrosis of the left hip. Because of pain the prosthesis was removed 1 year later and replaced with a Müller prosthesis. After 2 years the pain recurred. The patient was admitted for the first time to the Orthopedic Clinic of the University of Pavia in December 1978. X-ray examination and scintigraphy showed loosening of

the stem (Fig. 1). The prosthesis was removed and not replaced.

3. *BR, female, aged 73.* IN 1977 a Co-Cr prosthesis (Rizzoli type) was inserted for osteoarthritis of the right hip. After 2 years the patient started to complain of pain. Resorption of bone around both the cup and the stem was observed. She was admitted for the first time to the Orthopedic Clinic of the University of Pavia in March 1980. X-ray examination and scintigraphy showed a complete loosening of both the cup and the stem (Fig. 1). They were removed and replaced.

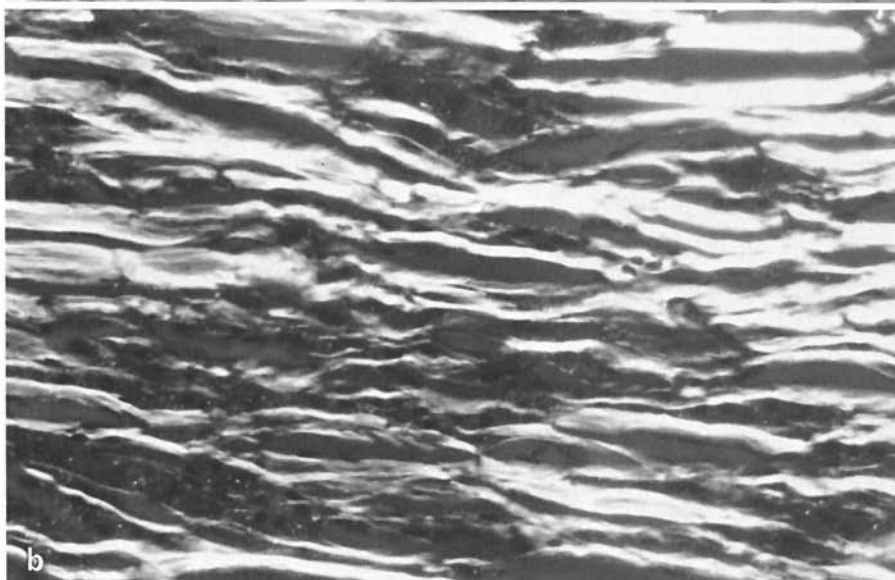
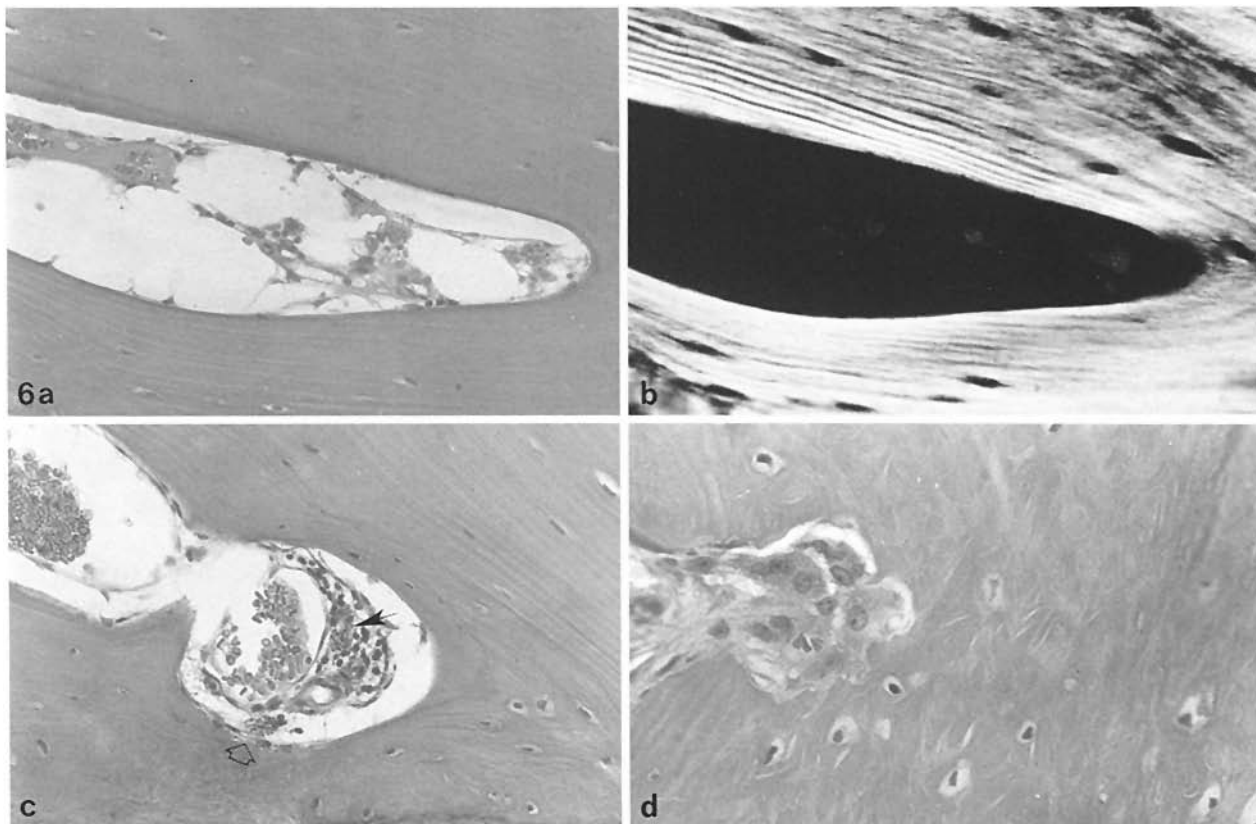
Fig. 5a, b. Tissue between bone and cement; H&E. **a** Mononuclear histiocytes with foamy cytoplasm and black particles between collagen fibers; $\times 187$. **b** The same field in polarized light; black particles are faintly birefringent

The tissue between bone and cement was moderately fibrotic, with collagen fibers following a predominant orientation, mainly parallel to the bone surface. There were few fibroblasts and many mononuclear histiocytes with a foamy cytoplasm containing black particles under 1 μm in size (Fig. 5). Small polyethylene particles were rare, and no giant cells or large polyethylene fibers were found here. The adjacent bone surface was smooth and the bone was dense and viable. The mononuclear histiocytes formed recesses in the bone (Fig. 6). These cells had the same cytoplasmic inclusions as those described above. The irregular surface which they presented to the bone suggests active resorption by them, and they proved strongly positive for acid phosphatase (Fig. 7).

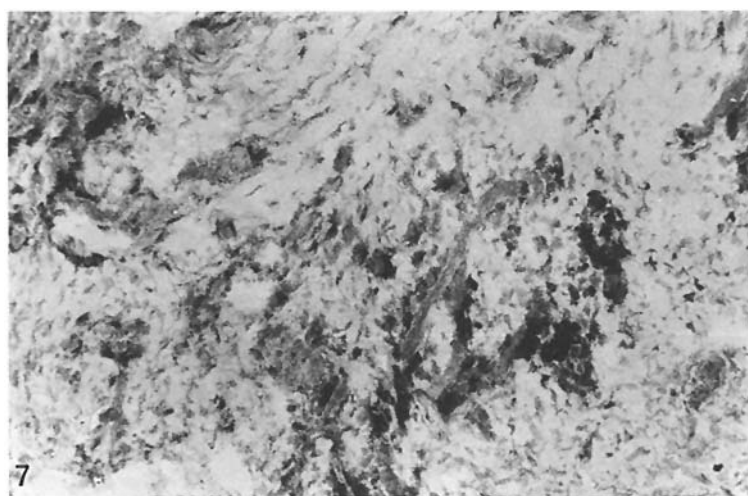
Fig. 6a-d. Relationships between mononuclear histiocytes and bone; H&E. **a** Mononuclear histiocytes with black inclusions inside vessels of bone; $\times 175$. **b** The same field in polarized light; some particles are faintly birefringent; $\times 175$. **c** A mononuclear histiocyte outside the vessel wall and in contact with bone (white arrow), another is observed inside the vessel (black arrow); $\times 175$. **d** Direct bone resorption by macrophages; $\times 220$

Damage to the bone-cement interface could also result from bone resorption. This process is normally associated with osteoclasts. Our results strongly suggest, however, that in the first three cases presented bone resorption by macrophages of inflammatory tissue has occurred to a significant extent. We are led to this conclusion by the absence of osteoclasts from bone surfaces in contact with inflammatory tissue, by the extensive lysosomal development within macrophages suggesting their potential to generate large quantities of hydrolytic enzymes, and by the presence of these acid-phosphatase-rich, mononuclear, phagocytic cells within bone recesses.

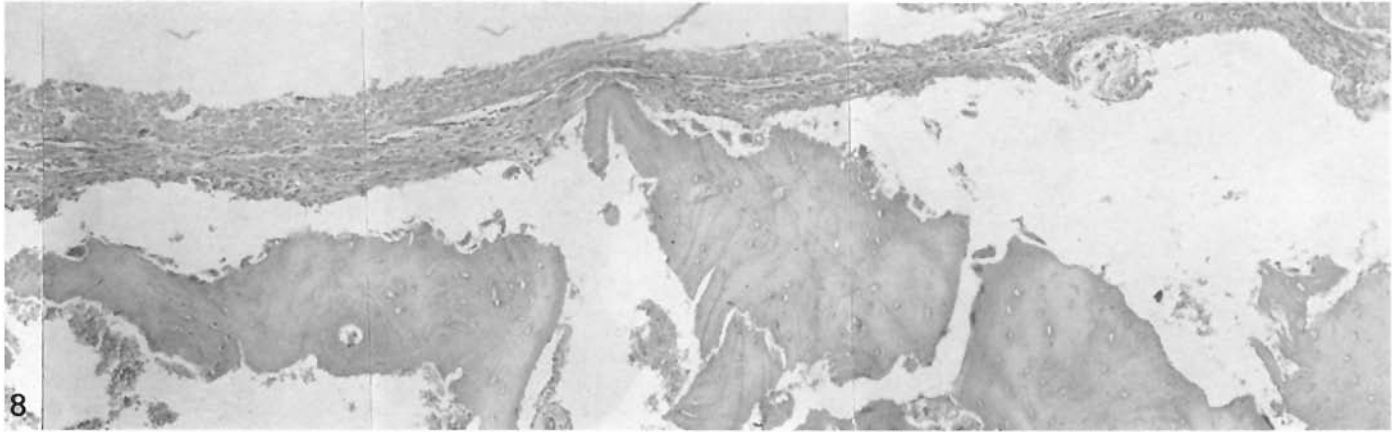
Fig. 8

Fig. 8. Tissue between diaphyseal bone and cement (but not from the calcar) of prosthesis PM. Many osteoclasts are present on the surrounding bone surface; H&E; $\times 73$

sions were identified here. Many osteoclasts were present on the surrounding bone surface, suggesting active bone resorption (Fig. 8).

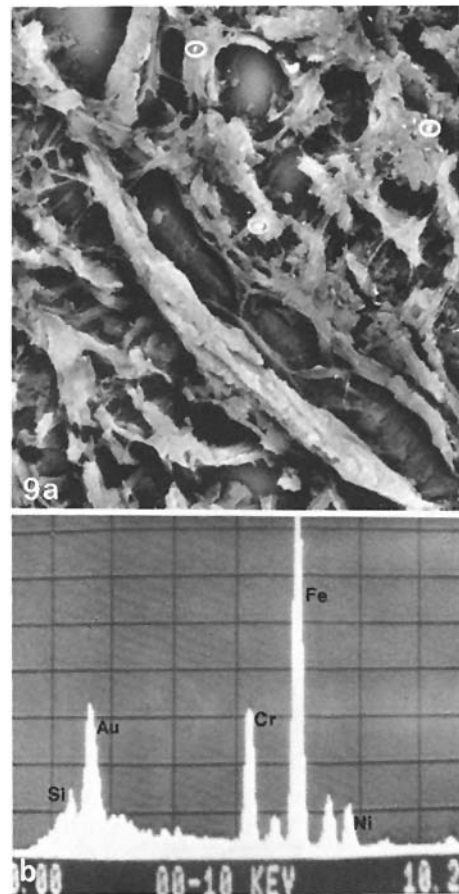
Fig. 9a, b. **a** Scanning electron micrograph (backscattered electron image) of a gold-coated histological section mounted on a glass slide (coverslip removed). Intracellular metal particles are revealed as bright spot (circles) against the darker background of the organic material; $\times 900$. **b** Typical X-ray analysis spectrum of the particles encircled in **a** showing the Fe, Cr, and Ni composition of stainless steel. The gold (Au) peak results from the coating and the silicon (Si) peak from the glass substrate

Scanning electron microscopy combined with X-ray microanalysis was used to identify the particles. The same macrophages observed by light microscopy appeared in the SEM (backscattered electron mode) to contain inclusions of high atomic number. X-ray analysis confirmed the Co-Cr-Mo composition of particles found within specimens of tissue close to Co-Cr alloy prostheses and the Fe-Cr-Ni spectrum for particles related to stainless-steel prostheses (Fig. 9).

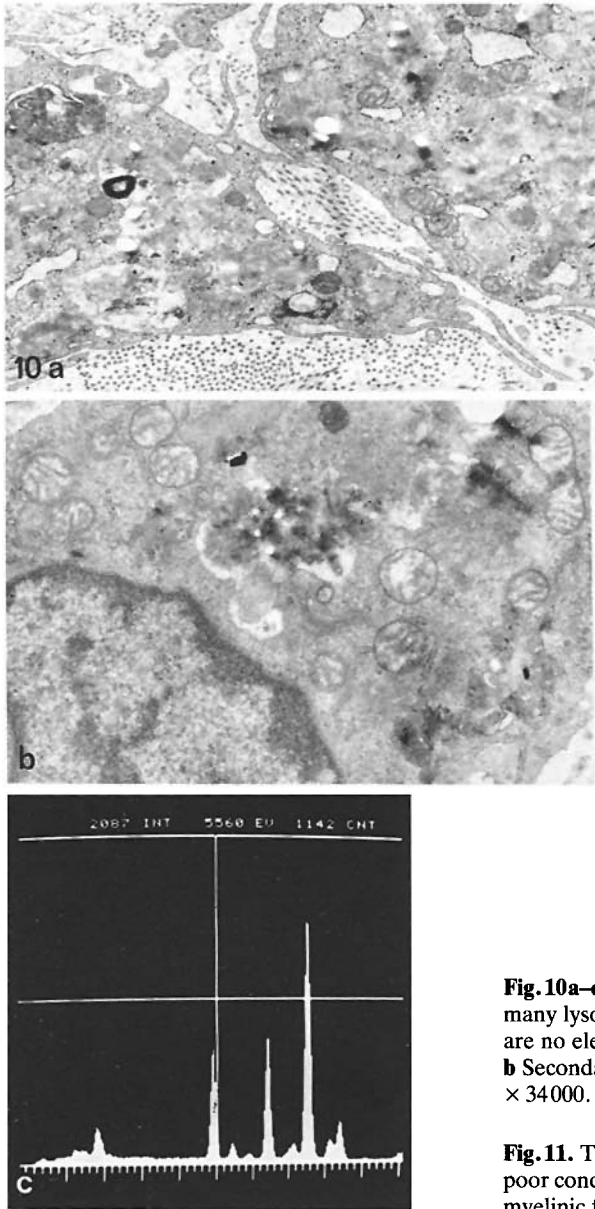
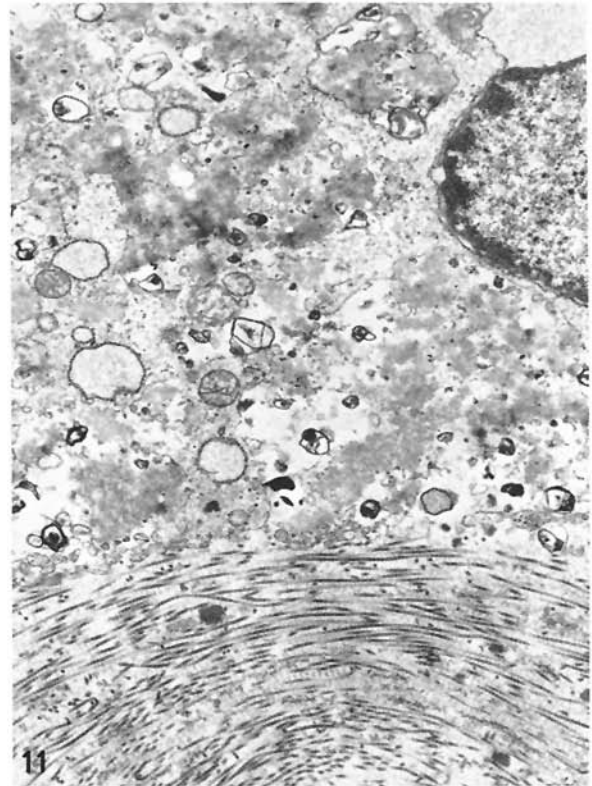
Fig. 10a–c. Transmission electron microscopy. **a** Mononuclear histiocytes with many lysosomal cisternae which contain highly electron-dense material. There are no electron-dense particles in the intercellular substance; $\times 12800$. **b** Secondary lysosomes with electron-dense particles at higher magnification; $\times 34000$. **c** X-ray analysis of electron-dense material indicates Co-Cr alloy

Fig. 11. Transmission electron microscopy. A mononuclear histiocyte in very poor condition with many large lysosomes, electron-dense particles, wide-spread myelinic figures, and a discontinuous plasma membrane; $\times 6400$

of the mononuclear cells. They exhibited many lysosomal cisternae containing highly opaque electron-dense material. Lanceolate spaces in lysosomes sometimes contained highly electron-opaque particles which varied in size up to 100 nm. Their appearance was not altered by staining with lead citrate or uranyl acetate. X-ray analysis confirmed the metallic nature of these particles. Many of the macrophages were in poor condition, with numerous large lysosomes, signs of cell necrosis, a discontinuous plasma membrane, and widespread myelinic figures (Figs. 10 and 11).

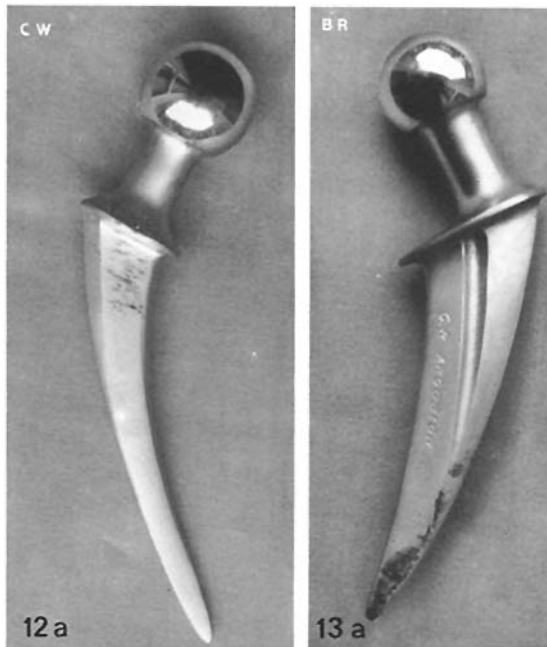
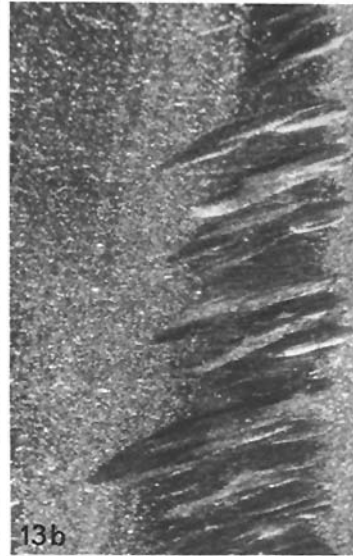
Fig. 12a, b. Müller Co-Cr alloy prosthesis of patient *CW*. Abrasion marks are evident on the stem; $\times 100$

Fig. 13a, b. Rizzoli Co-Cr alloy prosthesis of patient *BR*. Abrasion has occurred on the distal part of the stem; $\times 75$

The surfaces of the removed prosthesis were examined. Both Co-Cr prostheses (CW and BR) showed marks of wear on the stem, characterized by a reg-

ular parallel pattern of scratches (Figs. 12 and 13). One stainless-steel prosthesis (*CGB*) exhibited a wide area of pitting corrosion across the stem surface in contact with the cement (Fig. 14). The other (*PM*) showed an area of pitting corrosion on the distal part of the stem (the part still firmly fixed), while the loose proximal part showed wear marks but no corrosion (Fig. 15).

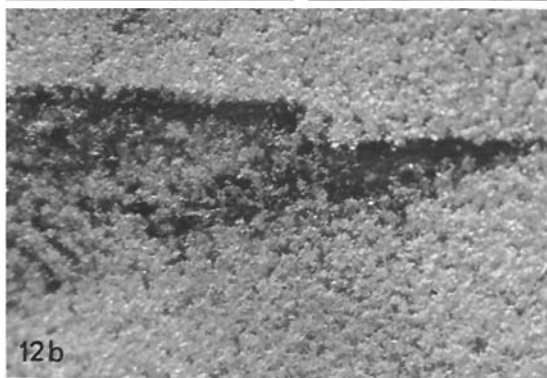
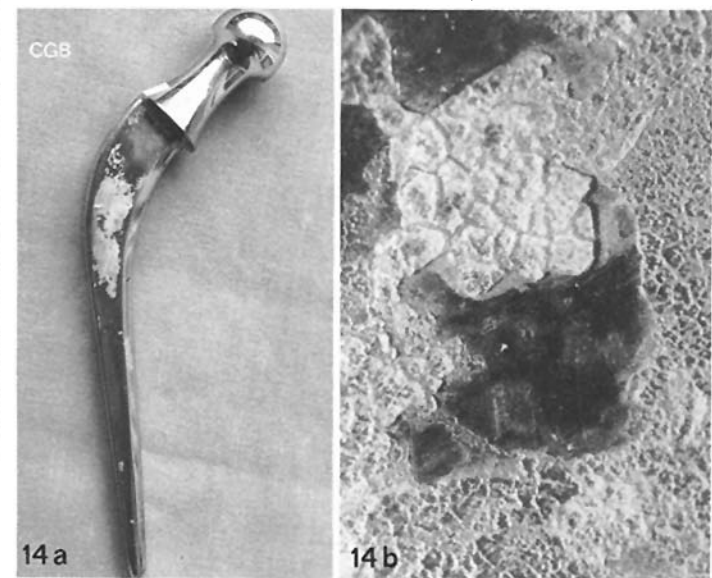
Fig. 14a, b. Charnley stainless-steel prosthesis of patient *CGB*. Areas of corrosion are evident on the stem; $\times 75$

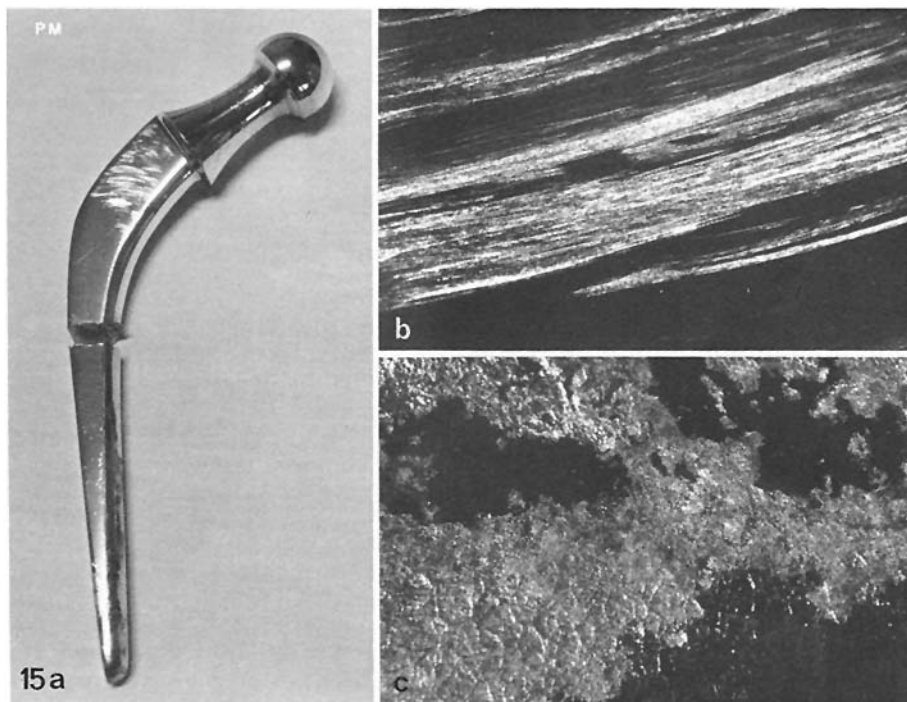
Fig. 15a-c. **a** Charnley stainless-steel prosthesis of patient *PM*. **b** Wear is evident on the proximal portion of the fractured stem; $\times 100$. **c** An area of corrosion on the distal part of the stem; $\times 75$
