Venkatesan, S., Setunge, S., Molyneaux, T.C.K and Gravina, R.J. *Towards a rule-based matrix for evaluating distress mechanisms in bridges.*
November, 2006, Brisbane. □ □

Towards a Rule-based matrix for evaluating distress mechanisms in bridges

S.Venkatesan, S.Setunge, T.C.K.Molyneaux & R.J.Gravina

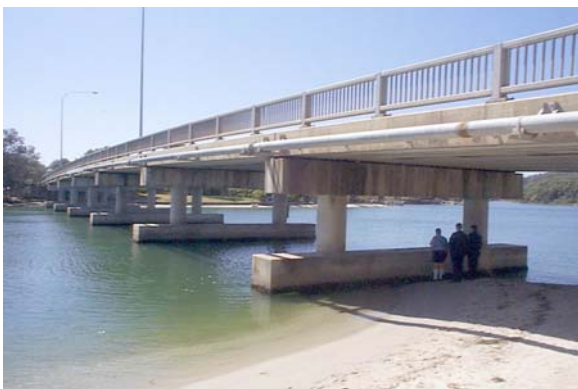
The bridge is a seven span structure consisting of 15 m long prestressed concrete (PSC) deck units supported by reinforced concrete cast-in-situ piers and driven PSC piles. Each pier comprises a head stock supported by two cylindrical columns, which in turn is supported by a pilecap. The headstocks, columns and pilecaps are all cast insitu concrete. Below each pier pilecap are ten 450 mm driven precast concrete piles. The outermost piles are raked outward (i.e. lateral to chainage) at a gradient of 1:5. The remainder of the piles are raked longitudinally in alternating directions at a gradient of 1:5. This bridge was constructed in approximately 1978 and is located at a critical position in the road network – the bridge is vital for the needs of tourists, council and the community. Photograph 1 shows a clear view of this bridge.

Photograph 1. General view of Bridge

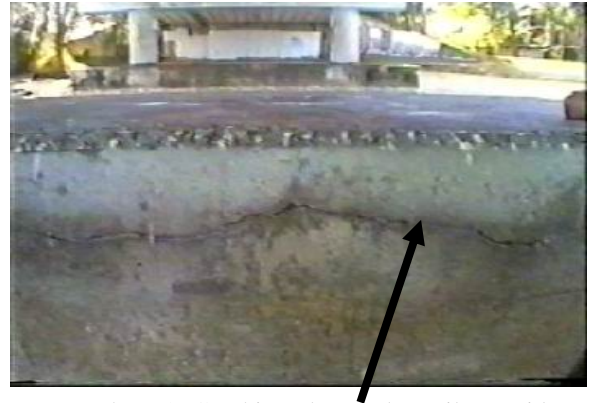
In 2001, severe cracking was noted within the top 300 mm of each pilecap during an inspection undertaken by means of boat access. Cracks were noted on the top faces, extending down to approximately mid-depth of each pilecap. Tapping with a hammer revealed that much of the cover concrete in these ar-

reas was delaminated. In Photographs 2 – 4, distress observed on the pilecaps is evident.

Photo 2. Cracking observed on pilecap sides

The delamination observed in the cover concrete was believed to be the effect of expansive corrosion of the reinforcement. The sizes of cracks and the extent of delamination varied from location to location and pier to pier. This was attributed to changes in the degree of concrete compaction, differences in concrete batching and variability in the depth of concrete cover. Thus construction issues were considered as “possible” causes. The type of cracking observed especially within the tidal zone (this refers to the height up to which the waves splash on the structure from normal water level) has been attrib-

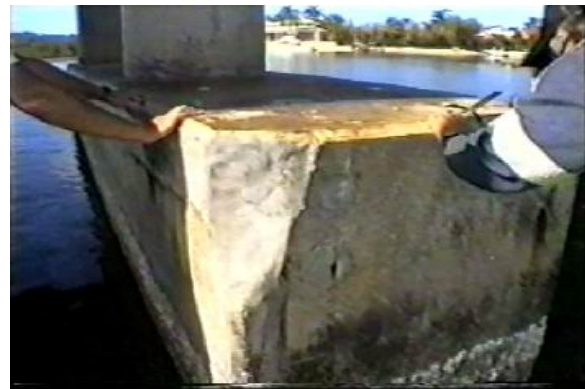
Photograph 3. Cracking and Spalling at the corners due to “Double diffusion”.

uted to the ingress of chlorides due to the saline water environment. Particularly the cracks taper with respect to the height within the tidal zone. In addition the similarity of cracking observed at the corners is attributed to the ingress of chlorides from both directions - known as “double diffusion”. (Refer to Photograph 3). Based on the above observations and hypotheses, ten concrete samples were extracted and analysed for chloride profiles, petrographic analysis, strength test and density tests. In particular, the chloride profile analysis (Figure 1) revealed that chloride contents in the concrete samples exceeded the “threshold” levels by a factor of 2 on an average. Threshold levels are determined based on the mix design and concrete content during the time of construction. Thus the mechanism affecting the pilecaps was confirmed to be chloride induced corrosion.

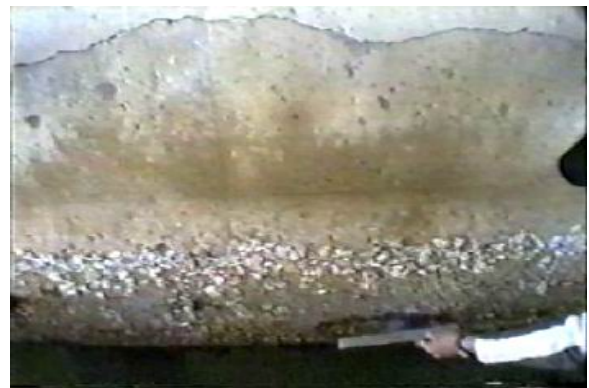
Photograph 4. Cracking and Spalling of concrete cover on sides of pilecap

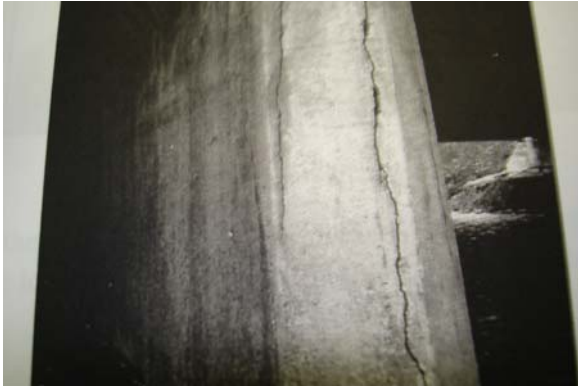
This (test) case study bridge was constructed in the 1940’s and subsequently widened in the 1960’s. It comprises a four-span RC deck, steel I-girder bridge, supported by pier walls founded on cast in-situ piles. The affected pier elements have vertical cracks at the chamfered edges (Refer to Photograph 5) and consistent symptoms of rusting, staining, delaminations are apparent (Refer to Photograph 6). The cracks and other associated distress are observed to be greater in the tidal zone.

Photograph 5. Cracking observed on the chamfered edges of the pier.

- The affected element is under the influence of the tidal zone.
- Significant cracks at the chamfered ends of the pier are due to the double diffusion of chlorides.
- Evidence of spalling, rusting, staining.
- Age of the structure.

Note that the first two are “High” probability rules and the following two are “Medium” probability rules. Since laboratory tests on concrete samples are not available, it was inferred that the distress could be attributed to the chloride induced corrosion and that further analysis of concrete samples could confirm the presence of this mechanism. These inferences were observed to be in complete agreement with expert opinions and were further confirmed based on inspection reports.

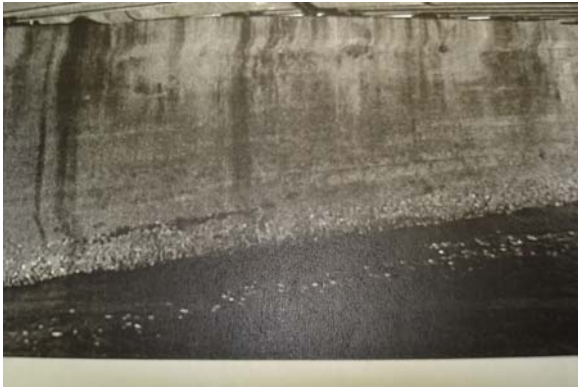
Photograph 6. Evidence of staining, rusting and delaminations on the sides of the pier
