The Causes of Morphological and Sedimentary Changes of Jajrood River Upstream of Latyan Dam

Abstract

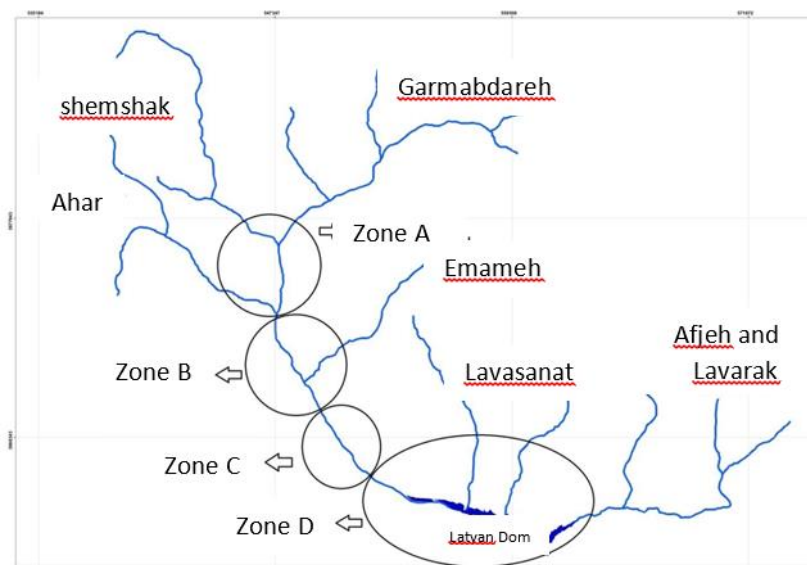
Figure 1 - Zoning map of Jajrood river.

In this research, Google Earth images and field visits have been used to collect the river information. According to Figure 1, Jajrood river is divided into four zones based on the network map of canals and field navigation and for ease of interpretation of laboratory results; A) the mountainous and highlands, B) the fragmented area affected by Masha-Fasham fault, C) the transition zone between the riffle and the mountains, D) and the end part of the river riffle and Latyan dam.

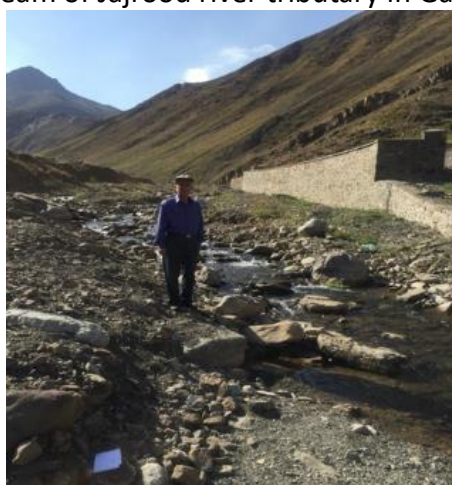
Figure 3 - Upstream of Jajrood river tributary in Garmābdar region.

In this part, the river is located in a high and mountainous area. The river is mountainous and carries large amounts of coarse-grained sediments from the highlands of its source (Figure 3). In the upstream areas and early parts of the watershed tributaries in the Kharsang area and in a very limited area, a straight river can be identified, which is very rare in nature. It should be noted that this classification is based on the classification of river channels (Rast, 1978; GhasemShirazi et al. 2014; Bazoobandi et al. 2016; Yazdi et al. 2019; Baratian et al. 2018), because their torsion is less than 1.5 and their parameters are less than one. After a short distance, the river has a torsion of more than 1.5 and a dam parameter of more than one (Table 1). Based on two parameters of dam and torsion, this river is of the braided type that is found in abundance in nature (Figure 4).

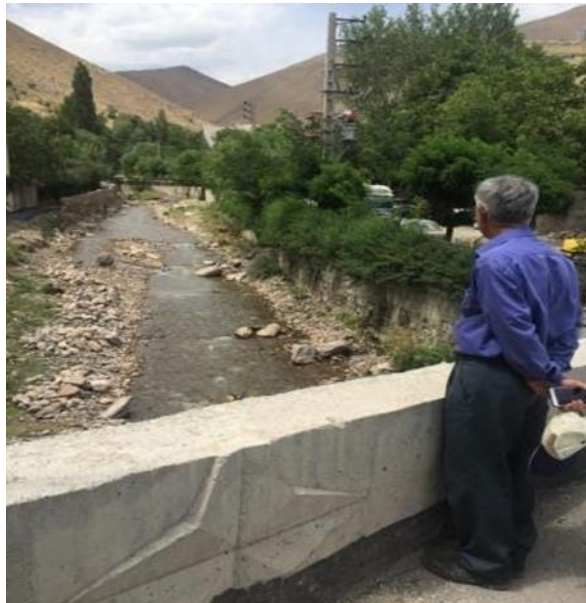
Figure 4 - Shemshak tributary (an example of a longitudinal dam)

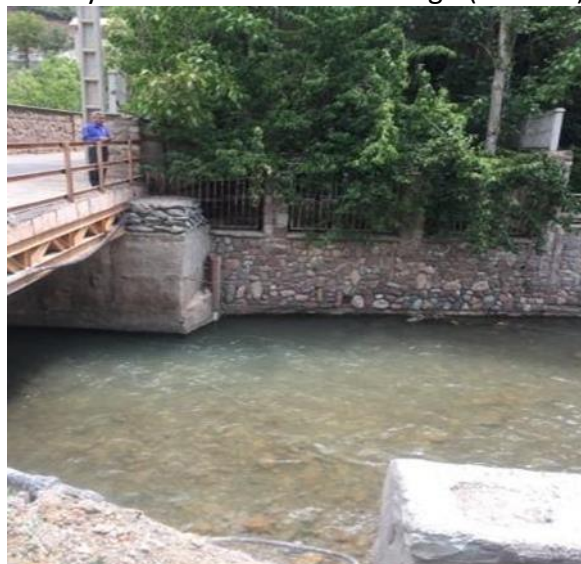
Figure 5 - Hydrometer scale in Bakhbagh (Fasham) área.

(The river is directly visible in a limited area)
 (Water velocity was estimated 0.9 m/s and flow rate was 3.82 m³/s in summer 2018)
 Source: Authors (2022).

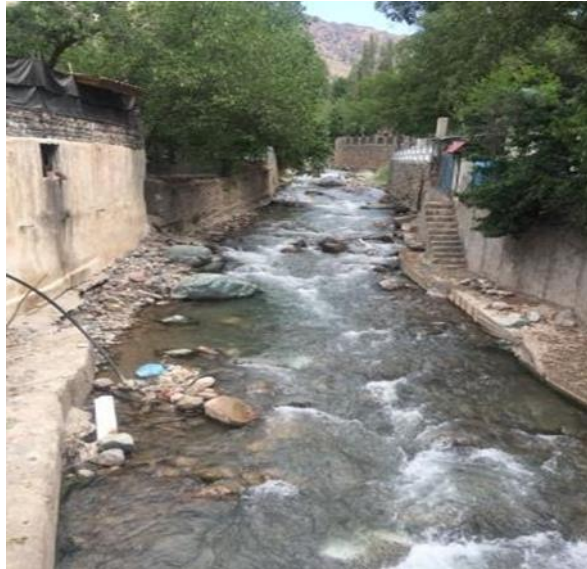
Figure 6 - The river at Ashkarchal site (near Fasham Square).

(Water velocity was estimated 1.38 m/s and flow rate was 3.03 m³/s in the summer of 2018)
 Source: Authors (2022).

Figure 6 shows the river channel at the site of Ashkarchal (near Fasham Square). Coarse-grained sediments have caused water to flow turbulently in this part of the river. Approximate estimates of the river debris in the summer of 2018 indicated a water velocity of 1.38 m/s and a water debris of 3.03 m³/s at the Ashkarchal site (Figures 5 and 6). This range continues from the river to the junction of the Ahar tributary. Coarse-grained sedimentary islands have been formed at the confluence of the Garmābdar-Fasham tributary with the Ahar tributary, and the predominant feature of the river is multi-tributary (Figure 7). Erosion along the river has also occurred due to the increase in river debris at the riffle of this range of the river (Figure 8).

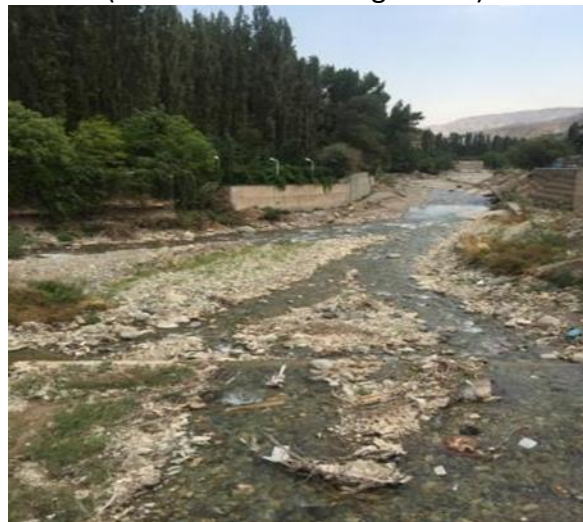
Figure 7 - The junction of Ahar river which originates from Tochal mountains and Fasham tributary (Erosion is seen along a river).

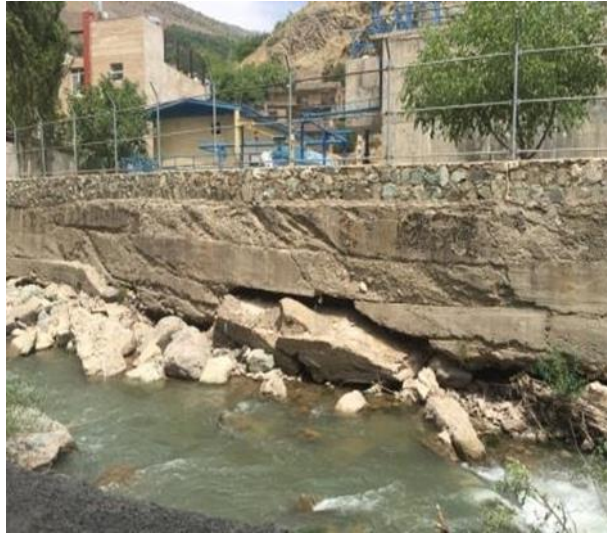
Figure 8. Erosion along the river at the site of Fasham refinery.

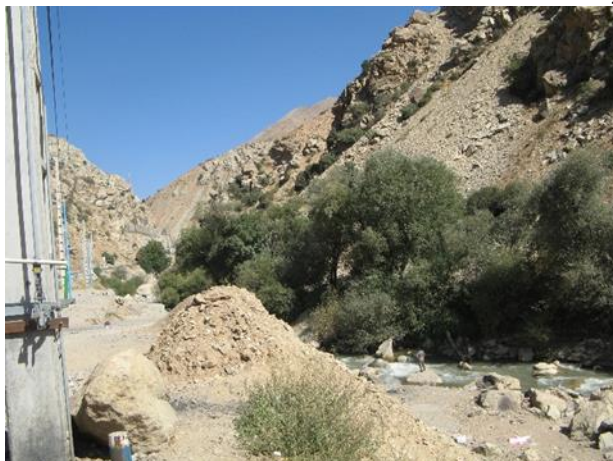
Figure 9 - Shredded area of Mosha Fasham fault in Hajjiabad.

(In this place, large rock falls are observed from the sides into the river channel).

In section B, the river passes through the fragmented zone of the Mosha -Fasham fault. The morphology of the river in this part is influenced by tectonic movements. As a result, in the course of the river, many small and large stone blocks caused by landslides can be seen from the sides of the river valley. Apart from lateral landslides, slopes with abundant gravel flows can also be seen in this section, which during the heavy rains and even sudden melting of snow, the occurrence of gravel flows is very likely, and suddenly, a large volume of mountain debris enters the main course of the river and has an increasing effect on the criticality of the area by blocking the water flow during floods (Figures 9 and 10).

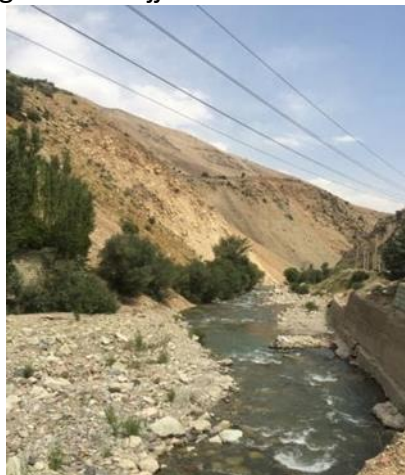
Figure 10. Hajjiabad shredded zone.

A large number of boulders can be seen along the river. In this section, a large volume of debris enters the river channel.

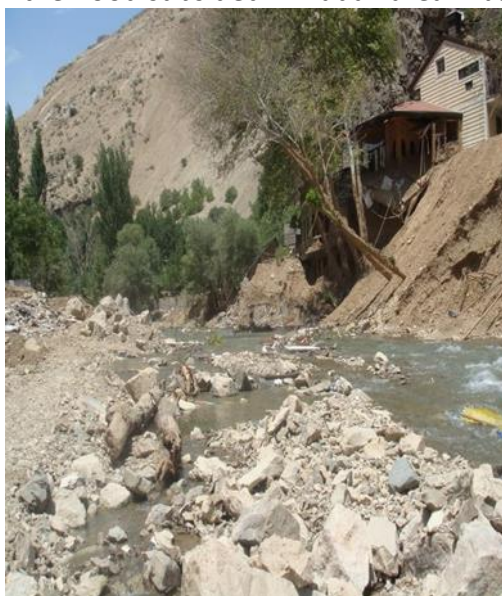
Figure 11 - Effects of river bank and villa demolition and accumulation of a large volume of bed load after the flood subsided in Rudak area in June 2018.

For example, during a field trip (2018) in the Rudak region on the slopes of Karaj Formation, landslides occurred after heavy rains, a large volume of solids entered the canal, and a terrible flood occurred and the river flow path deviated into the street.

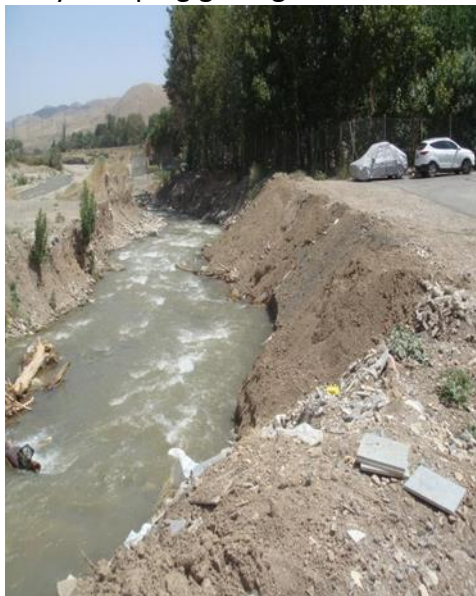
Figure 12 - Effects of tree trunks and destruction of river banks due to floods in 2018 and unfortunately dumping garbage into the river channel.

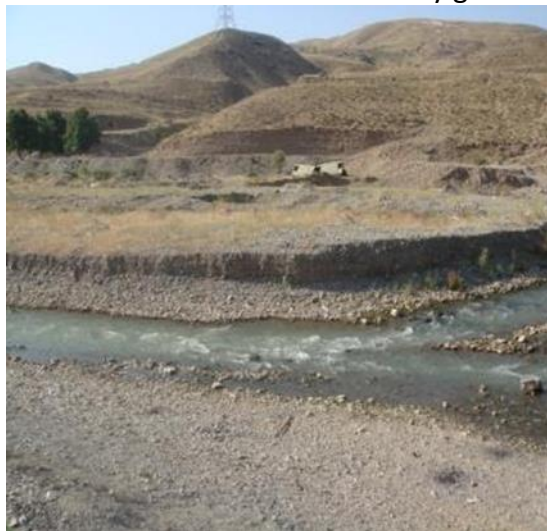
Figure 13 - Alluvial terrace with characteristics of sandy gravel sediments in Lavasan.

(The upstream altitudes belong to the conglomerate formation of Hezār Darreh).

The river continues its way to the dam through the conglomerate slopes of Hezār Darreh and at least one terrace is formed along the river (Figure 13). Lavasan Municipality has constructed dams along the river to prevent sediments from entering the dam reservoir and to create a space for tourism (Figure 15).

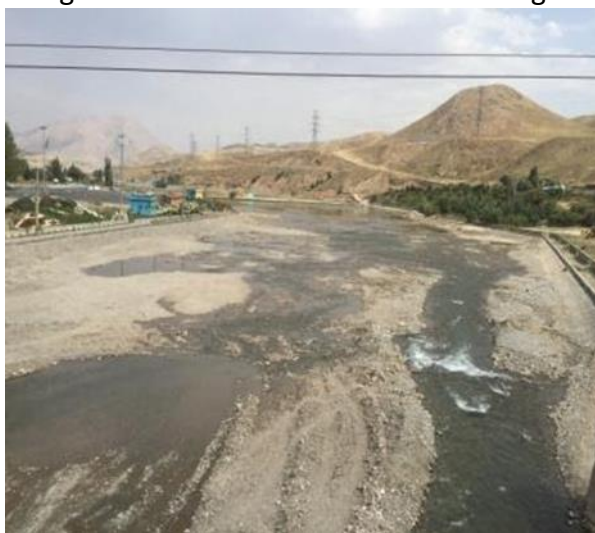
Figure 14 - River at Lavasan metal bridge.

(The width of the river increases and longitudinal and transverse dams are observed).

The river reaches Latyan dam lake in zone D. At the same time, the canals under Lavark and Afjeh basins enter directly into Latyan dam lake. The Kund tributary also joins the Jajrood River in this part. The river is wide in the form of a multi-tributary river upstream of the entrance to Latyan dam. Coarse-grained yields of upstream, especially in the Mosha -Fasham fault zone, and the sudden deposition of sediments due to the failure of the riverbed slope, have led to the formation of this morphological type (Figure 14).

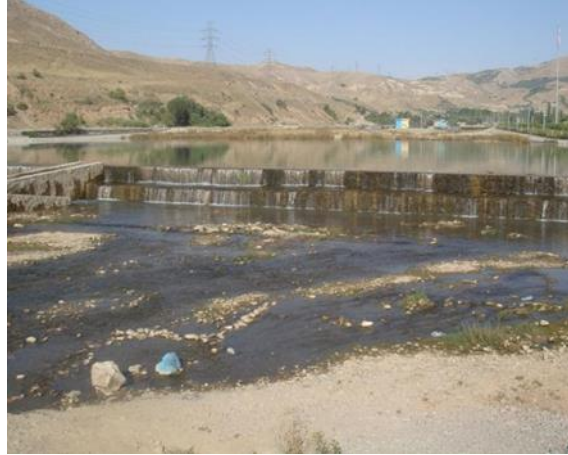
Figure 15 - Lavasan Municipality has constructed dams along the river to prevent sediments from entering the dam reservoir and has created a space for tourism.

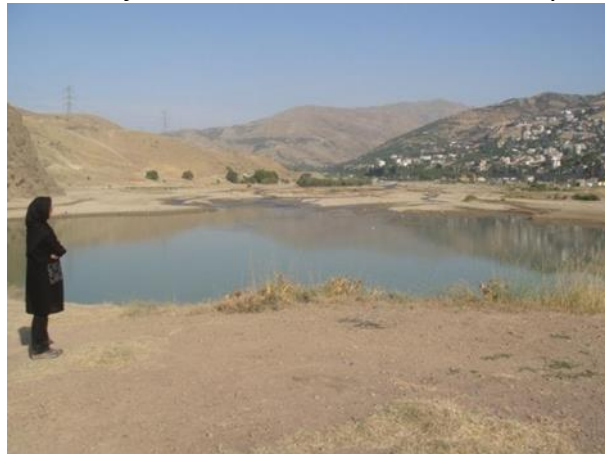
Figure 16 - Jajrood river at the entrance to Latyan dam.

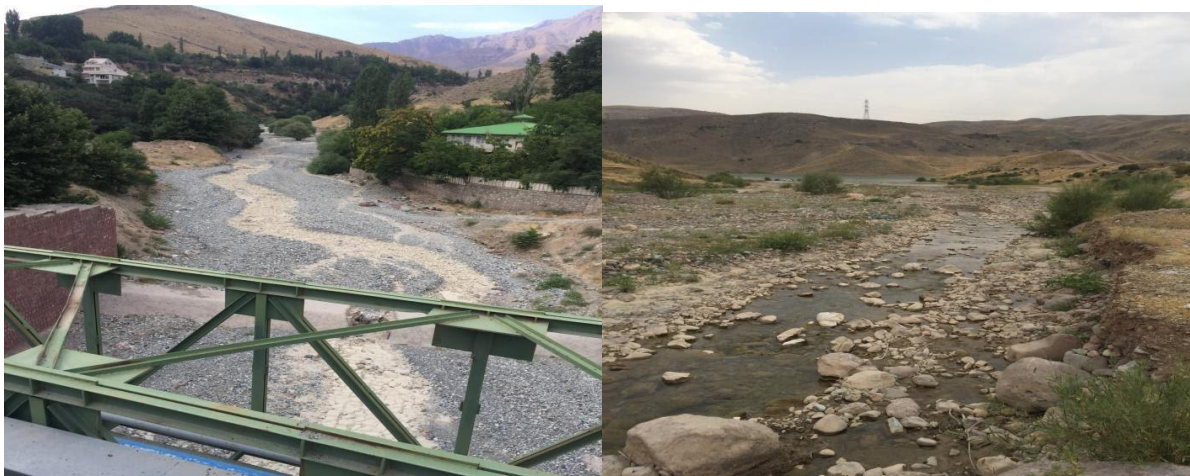
Figure 17 - Left, the seasonal river at the site of the Great Cebu, which had no water flow at the time of the visit.

(The figure on the right is a slow tributary entering straight into the Latyan Dam Lake).
 Source: Authors (2022).

While affecting the hydraulic and sedimentary parameters of the river, especially upstream, it has caused the pollution by stopping the water. At the end of this part of the river, large Cebu, Kund and Lavark tributaries are attached to the river inlet water to the dam (Figures 17

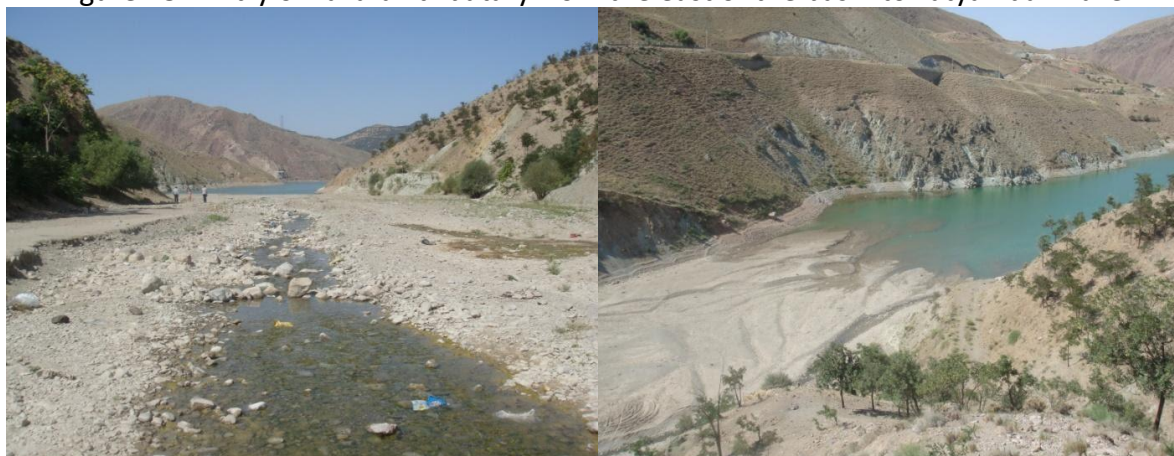
Figure 18 - Entry of Lavarak tributary from the east of the basin to Latyan dam lake.

The left side of the tributary in the site of Lavark with a bed of sand gravel and boulder parts. The major sediments carried by this tributary are of the bed load type. On the left bank of the river, a sandy river terrace is observed. In the figure on the right, the entrance of the Lavark tributary to the Delta dam lake is formed.

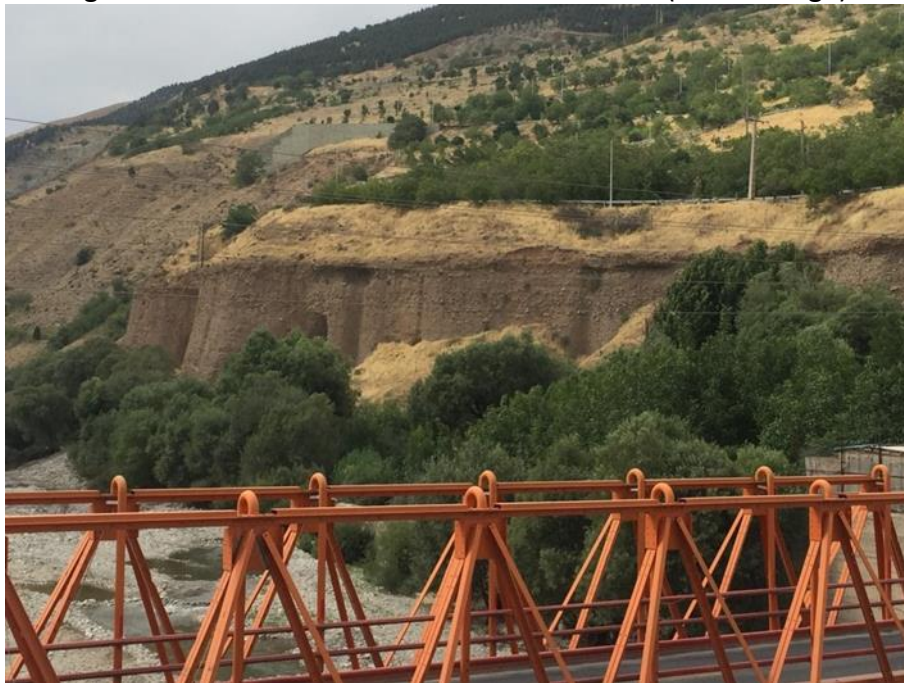
Figure 19. Old alluvial terraces in Lavasan area (Felezi Bridge).

alluvial terraces in the area of the Felezi Bridge (Figure 19) and at the edge of the main river channel indicates the tectonic uplift of the riverbed and intensification of canal bed excavation.

The river terrace is the rest of the old bed bottom that remains on both sides of the river after the river dug a newer bed. The rest of the alluvial terrace is the result of uplift of the region due to the north fault of Tehran. The height of the terrace is about 20 meters.

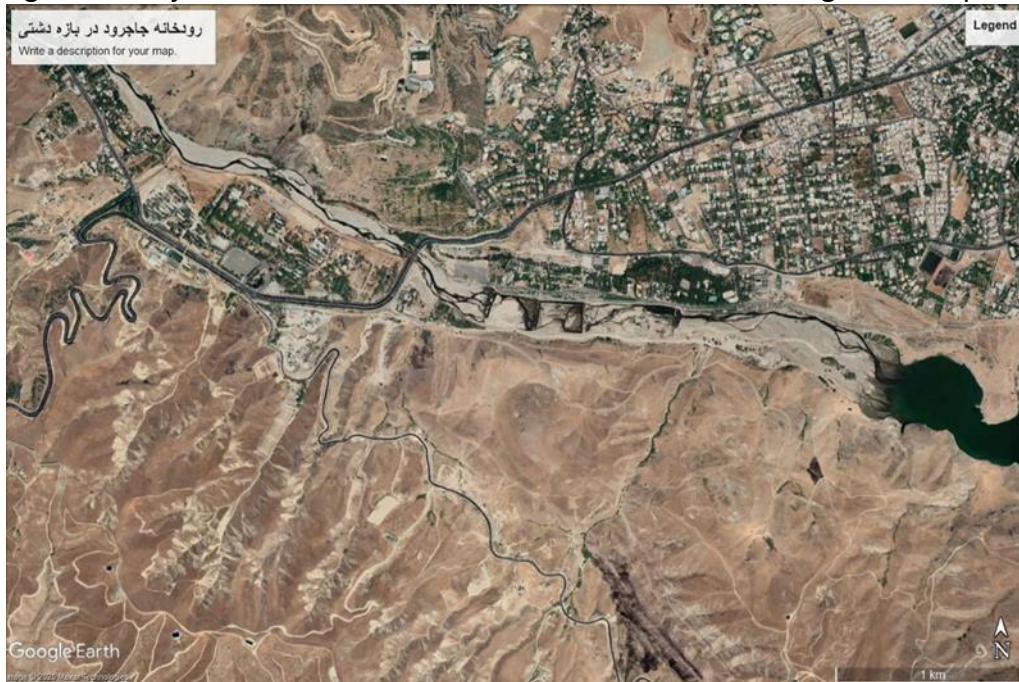
Figure 20 - Jajrood river at the exit of the mountain and entering Sardasht plain.

After leaving the mountain, the river flows on a wide bed with a sedimentary load on the floor and takes on a multi-torsional state. Lavasan county and successive dams along the river can be observed in the picture.

The erosion bed of the river follows the path provided by the lithological and tectonic structure of the river. Therefore, the main route of the river from Shemshak village to the dam site with a length of about 37 km, has a sinuosity coefficient of 1.06, which indicates that the river is of the straight type. Of course, it should be noted that the river flows on a wide bed after the Lavasan Kouchak bridge, leaving the mountain range with a sudden decrease in slope, and has loaded coarse-grained sediments and morphologically, manifests braided (Figure 20).

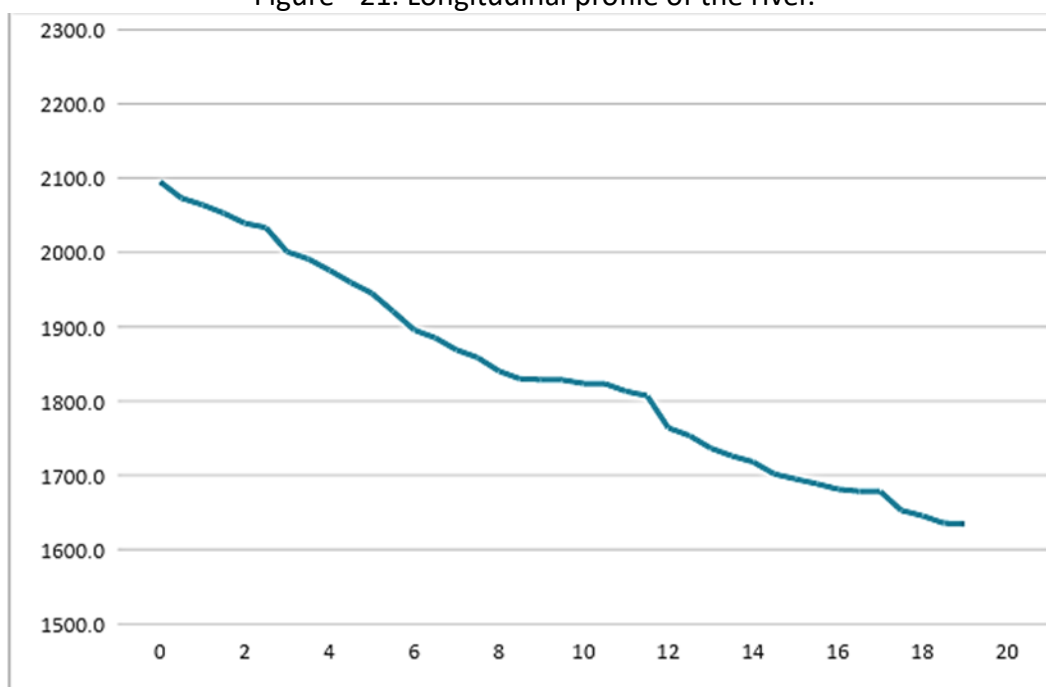
Figure - 21. Longitudinal profile of the river.

Horizontal axis: river length (kilometers); Vertical axis: height (meters)
 Source: Authors (2022).

The longitudinal profile of the river is illustrated in Figure 21. This profile is related to the main part of the river from the junction of Sarbandan and Shemshak tributaries downstream to the dam site. Since the middle part of this range of the river is affected by the Mosha Fasham fault zone, thus the bed level changes along with increasing slope in the river is due to the fault displacement of the region and the entry of large volumes of debris flow from the valley walls of river flows into the channel. The changes in the bed surface are also caused by land use change, destructive floods and tectonic activity.
