Using Drones to Evaluate Revegetation Success on Natural Gas Pipelines

**Thesis submitted
to the Davis College of Agriculture, Natural Resources and Design
at West Virginia University**

**The Master of Science in
Energy Environments**

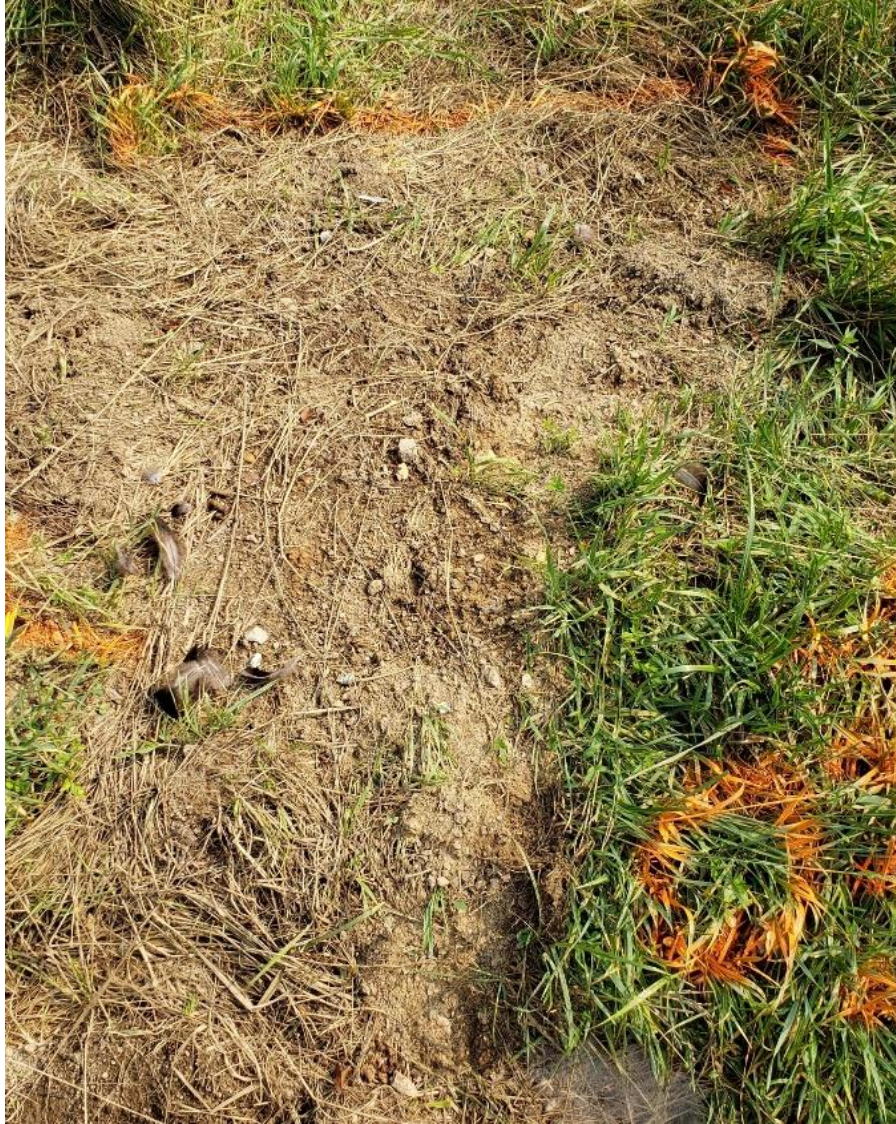
Figure 3. Example of training plot established to denote areas on pipeline that failed vegetative cover threshold. Plot is approximately 1m square and used a 2-digit identifier outside the bottom right corner

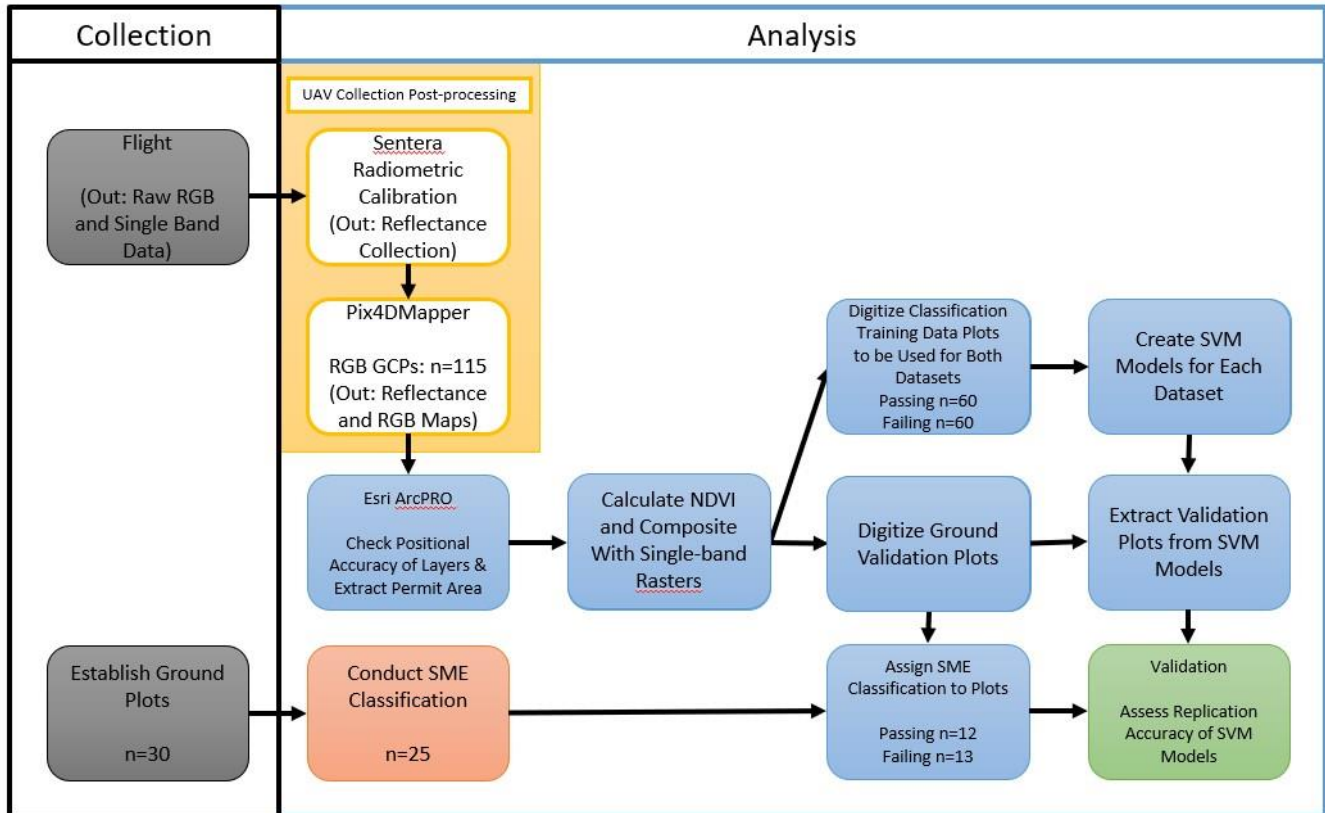
Figure 4. Workflow used to capture remote sensor data and ground sample points. Post-processing of the UAV data was conducted in two separate programs, with final analysis occurring in Esri ArcGIS Pro v2.9.2

Once sample plots were established, a DJI Matrice 200v2 quad-propeller drone with a direct interfacing Sentera 6x Multispectral sensor conjoined with an apex oriented solar sensor was used for remote data collection. The 6x Multispectral sensor simultaneously collects from 5 individual wavelengths: blue (475 nm), green (550 nm), red (670 nm), red edge (715 nm), and near infrared (NIR, 840 nm). Additionally, the 6x sensor is equipped with a 20MP RGB camera, which provides comparable data capture to the imagery collected by standard drone-based color-image sensors. The Sentera 6x sensor performs a simultaneous capture from all 6 sensors on a preset trigger period. For our collection, we set the trigger to occur every 2 seconds. Flight planning and execution was achieved with the UgCS Client. Through this software we could load in elevation maps, break each branch into transects, and generate a total flight path at a fixed distance above the terrain. The height above terrain used was 91.44 m (300 ft), and the sensor was oriented at nadir throughout the flight. Both flights occurred on the same day between 1130 and 1330 EST to minimize light variance and shadows. Immediately prior to collection, the multispectral sensor captured a series of calibration images of a Sentera Reflectance Panel for future radiometric correction. When the flights were completed, research moved into the analysis portion of the plan of study (Figure 4).

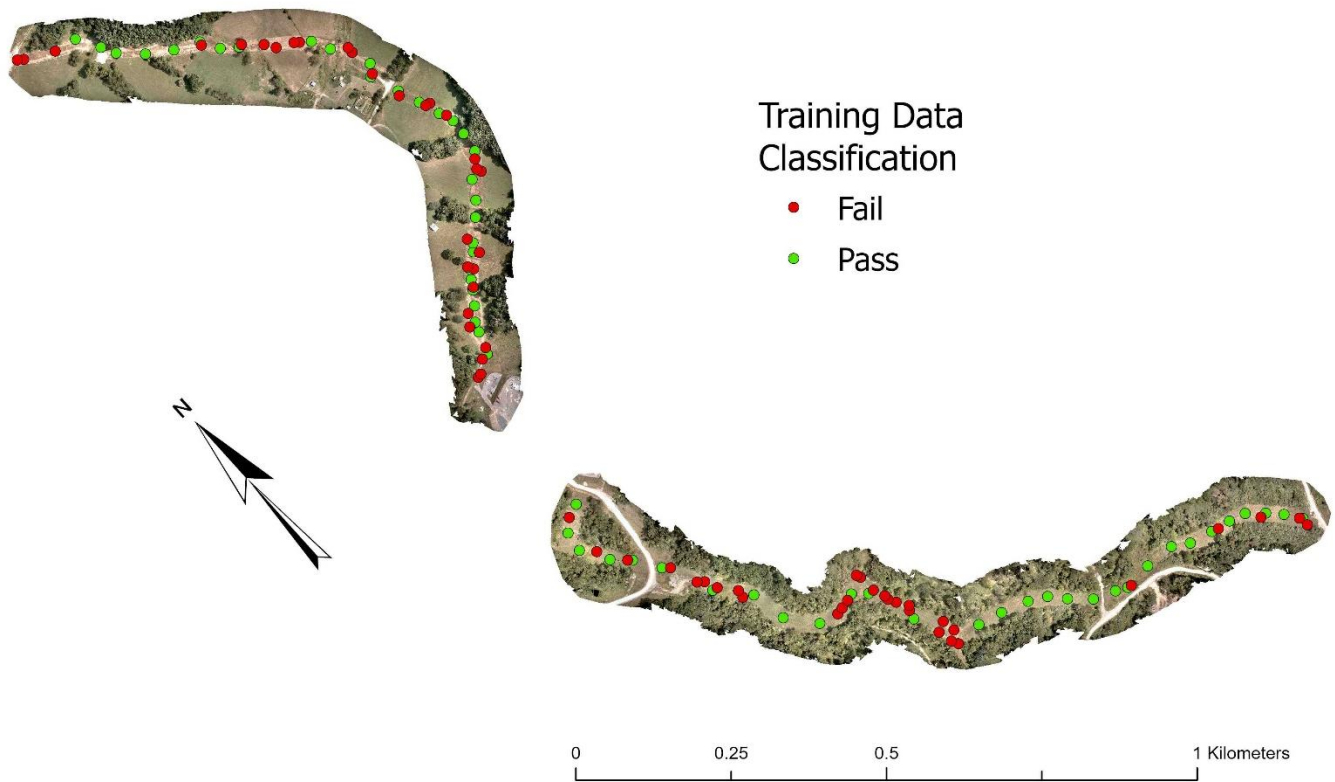
Figure 5. Manually digitized training data samples for SVM classification. Samples were created at a scale of 1:100. There were 120 samples created, 60 for each class, with 30 per class established in each branch of the pipeline.

setting the display scale to a fixed 1:100, a GIS technician manually digitized classification training data across the study site. Classes for this training data set were either pass or fail, with the associated values of 1 and 0 respectively. Training samples were to not include any of the digitized ground sample plots and were to be established across various areas of each branch. There were 30 features established each for passing and failing classes in each branch, totaling 120 training features for the study area (Figure 5).

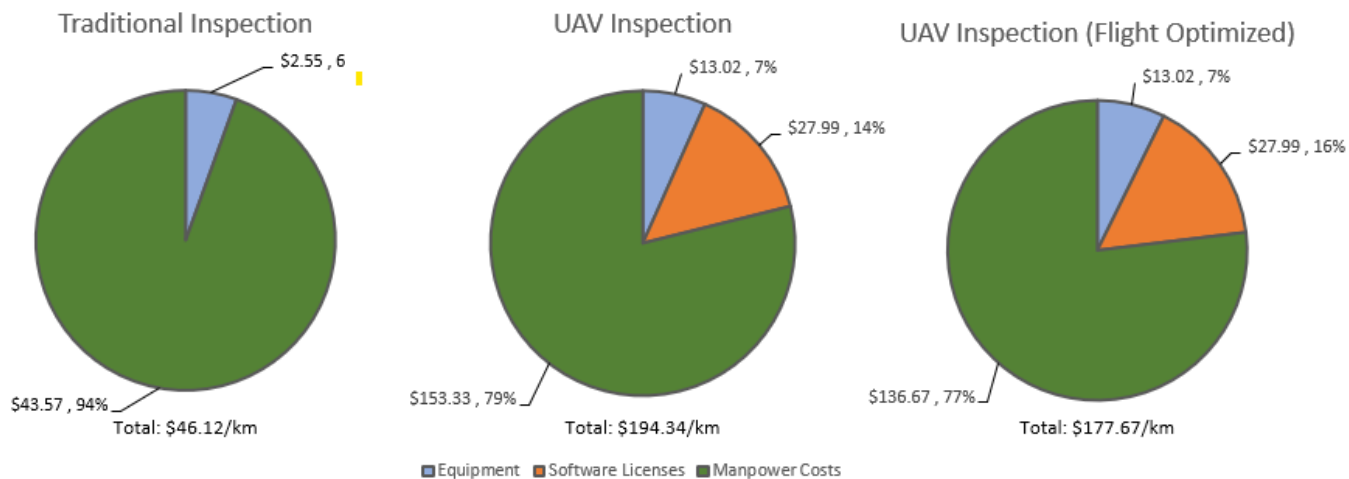
Figure 8. Charts depicting the proportion of each inspection method’s cost categories. The three categories depicted are equipment, software licenses, and manpower in blue, orange, and green respectively. Total per kilometer costs are given below each chart.

UAV manpower costs were over 3.5 times greater than the traditional inspection manpower cost of \$43.57/km. The largest portion of overall drone inspections cost was the GIS analyst, which accounts for \$121.25/km, or 62% of the total. In creating the dataset, the surface model, analysis of the model and report generation, the GIS analysis must spend a total of 2.43 hrs/km (Table 5). Projected reductions in processing times from a hypothetical increase in processing efficiency were generally unable to produce comparable costs to traditional methods, with exceptions being noted at and above 50% time reductions when compared to the slowest hypothesized traditional inspection speed of 0.25 mph (Table 6). At 50% reduction and 0.25 mph, costs were within 5% of each other, favoring the traditional method. The assessment of additional hypothesized drone inspection price reduction through flight optimization found a pilot time reduction of 51.6%, from 1.28 hrs/km to 0.62 hrs/km (Table 7). This reduction lowered the UAV inspection manpower costs 10.9%, to \$136.67/km (Figure 8). Including this

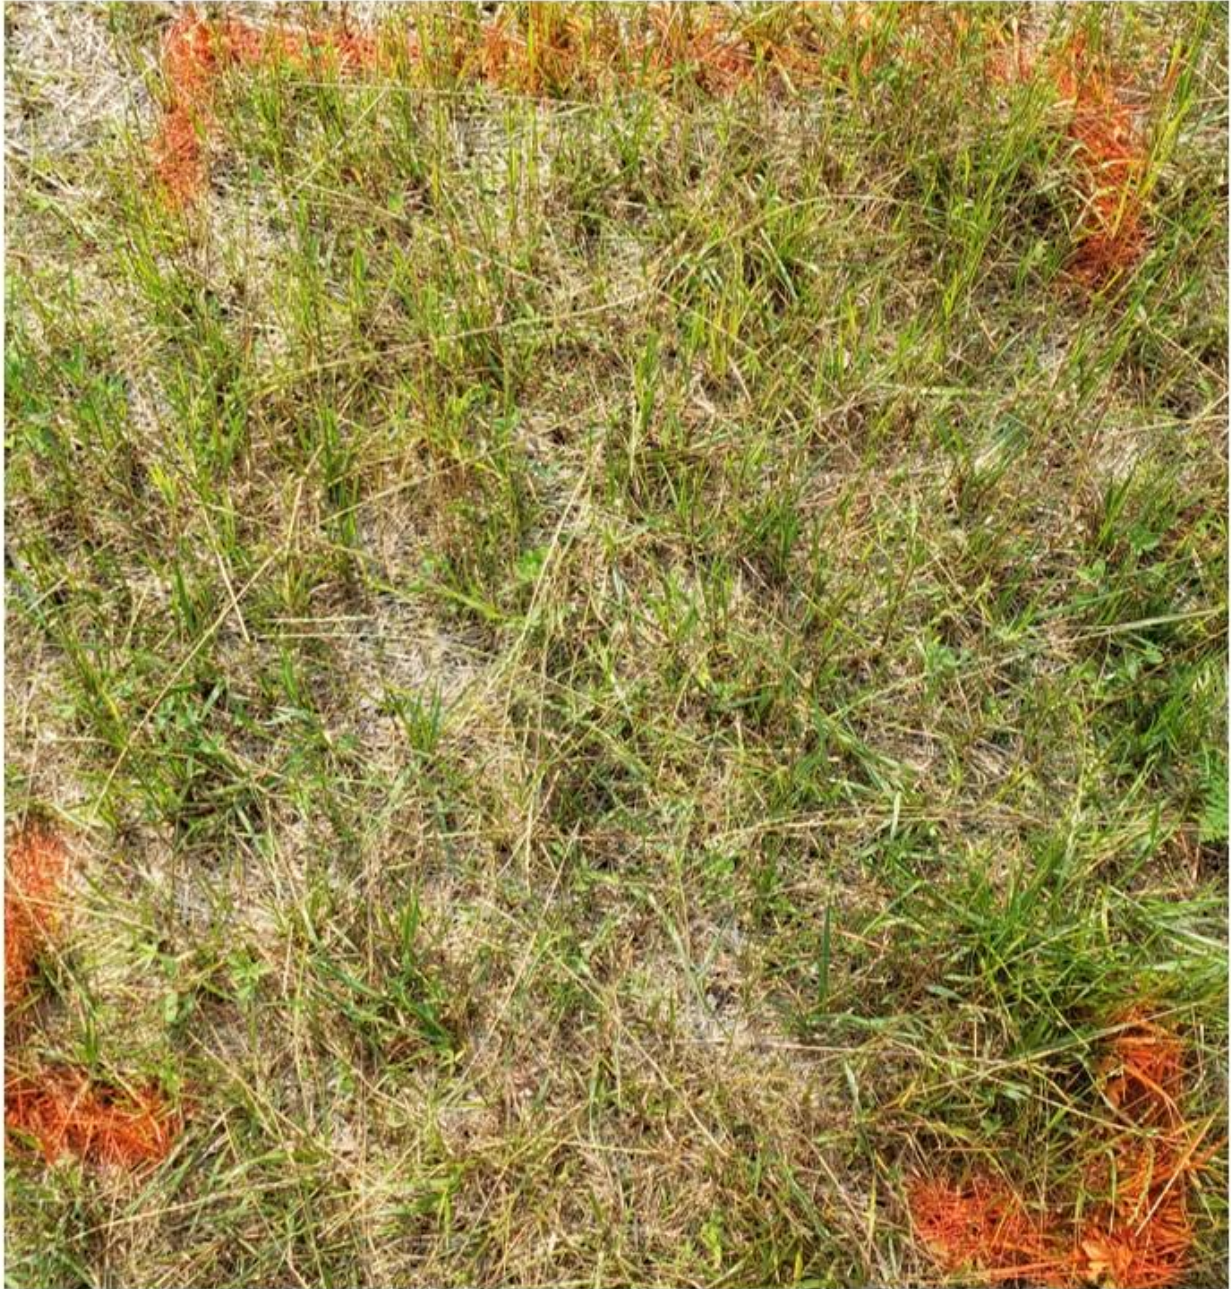
Figure 9. A detailed image taken immediately after ground plot establishment of validation plot 24. This was one of two plots misclassified by both models. SME classification determined this plot to be failing due to the presence of straw-laden erosion control matting between the present vegetation.

Of central concern is the fact that both dataset models misclassified the same two plots, ground samples 24 and 26. These two plots had different vegetation patterns from each other and were each unique in their own way from the rest of the validation plots. Plot 24 was noted to be marginal but failing during SME classification (Figure 9). Vegetation across this plot was rather evenly distributed, and no soil was visible inside the plot. The reason noted for this plot to be labeled failing in SME classification was the broad presence of erosion control netting in the areas between visible vegetation. Construction efforts often use this type of material to cover

bare earth it protects the surface layer of the soil from direct rain exposure, protects the complete displacement of applied seeds, offers some stability to the soil beneath, and is typically biodegradable, thus requiring minimal future maintenance. As noted by an SME, it is common to see this material on pipeline construction operations upon steep and otherwise difficult to revegetate surfaces. As this material is a permeable impermanent cover, inspectors treat it as bare earth in their assessments, leading this plot to be considered failing.

The material used at this site was made of a twine type netting interwoven with straw. Being vegetation derived materials, they were likely a significant contributor to the failure seen in both models. While there are spectral differences between living vegetation and dried vegetative material, those nuances were not adequately captured in the SVM's training dataset. Moreover, pipeline inspectors note that the presence of dry vegetation itself is not enough to fail a plot, and a more complete view of vegetation health must be taken for a proper assessment. Future studies concerned with inaccurately identifying erosion control should consider the creation of a third class of ground cover comprised of dry vegetation. While not yet assessed from our data, the hope is that areas of dry vegetative material would be flagged for further inspection without indicating them as outright failing or passing. Further, SVM may need to be evaluated against other machine learning models should a third class be created, as SVM is essentially binary in its classification design (Sheykhmousa et al., 2020).

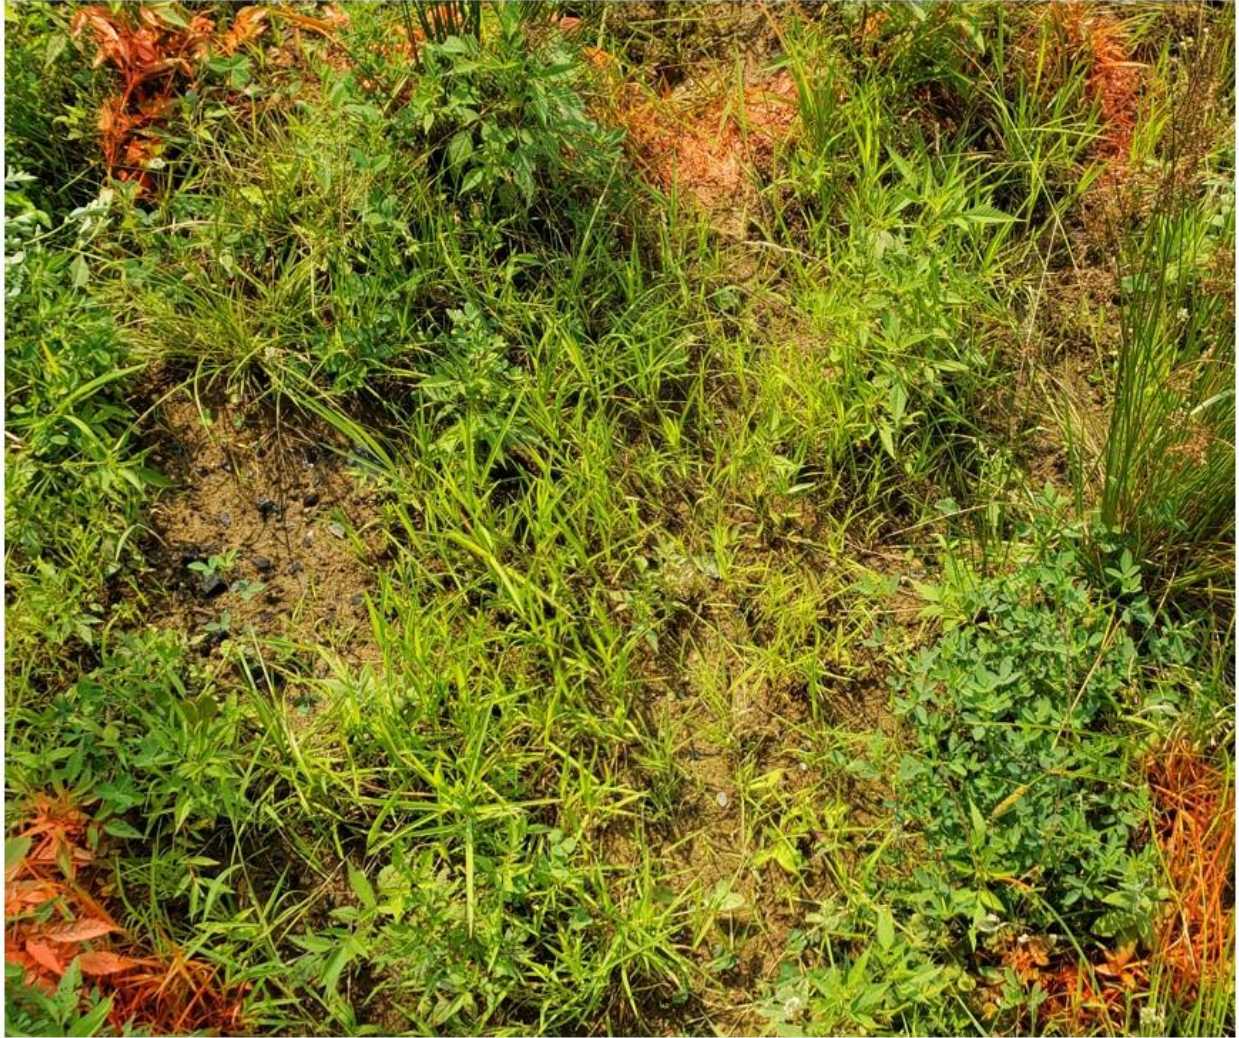
Figure 10. A detailed image taken immediately after ground plot establishment of validation plot 26. This was one of two plots misclassified by both models. SME classification determined this plot to be failing, as there were large portions of soil present within the plot. Note the darker color of the soil, caused by high moisture content.

Unlike plot 24, plot 26 did present bare soil in significant enough quantities as to be deemed failing (Figure 10). The form of the vegetation was larger and more clumped than plot 24, but the likely cause of misclassification is high soil moisture. Plot 26 was located downhill of a water seep which forms a marsh-like area on the pipeline. Water is noted for high spectral absorbency in the visible and NIR ranges of light, in turn reducing the soil reflections from this

plot. Detecting high soil moisture is possible in remote sensing with the collection of thermal data and calculation of NDVI from a site (Zeng et al., 2004), and would aid in avoiding this issue in the future. Sensors with simultaneous capture of thermal and multispectral data are not commonly available, with options like the Sentera 6x Thermal arriving on the market only recently. Future studies with access to such sensor technologies should consider conducting a soil moisture calculation for inclusion in surface modeling.

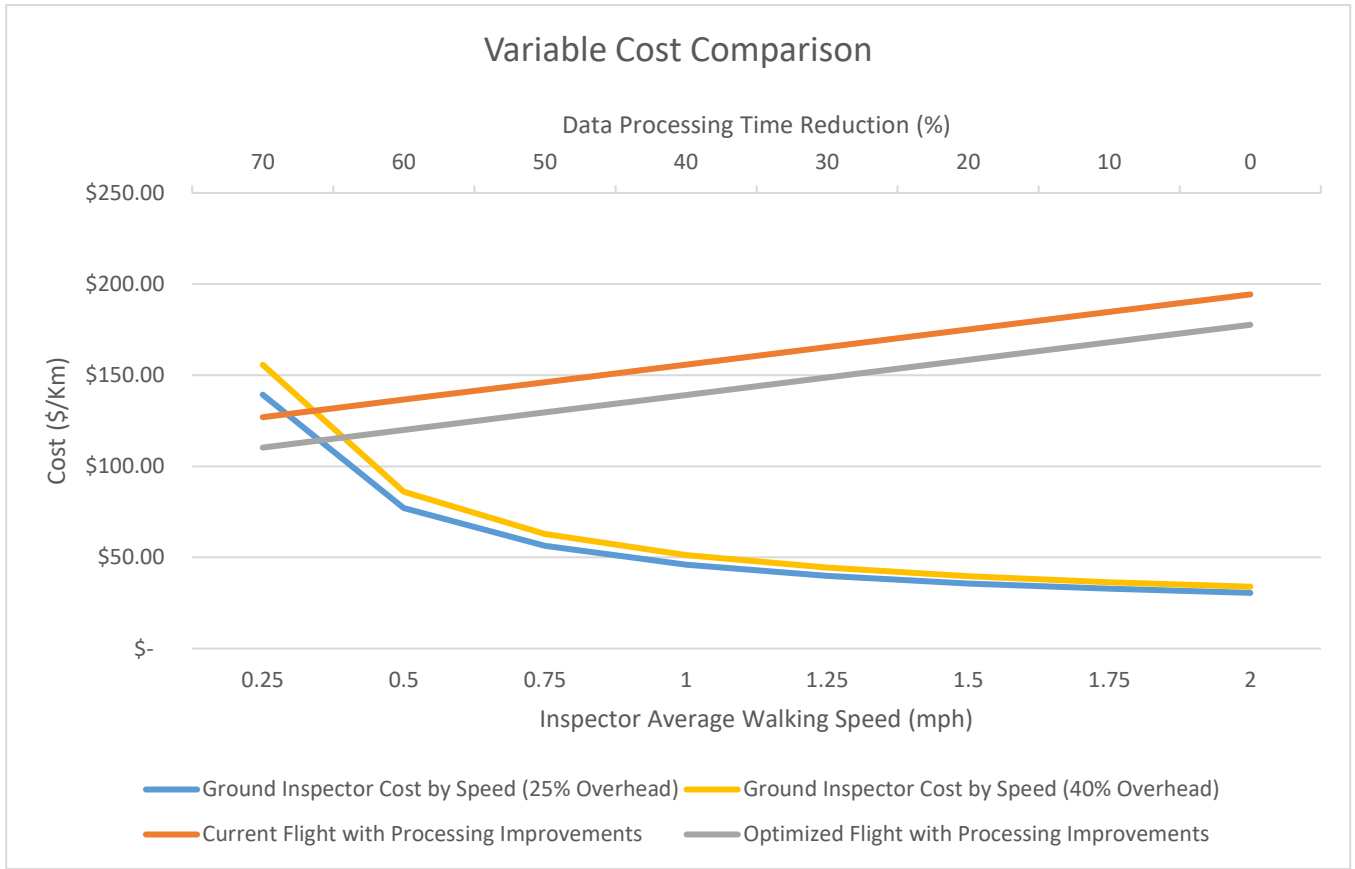
Figure 11. Cost trends per kilometer are shown including the variables of inspector speed and processing time reduction. Inspector speed is shown on the lower axis and increases from left to right. Data processing time reduction by percentage is shown on the upper axis and increases from right to left. Ground inspector plots show both a 25% overhead and 40% overhead in blue and yellow respectively. Similarly, drone cost with and without flight optimization are shown in grey and orange respectively. Note that the costs cross near 0.25 mph and 70% time reduction. This shows the point where cost per kilometer are lower using the drone inspection method.
