Assessment of building seismic risk in the environment of Ibn Khaldun University Bogor

Muhamad Lutfi, Nurul Chayati, Rulhendri Rulhendri, Denny Azhari

Civil Engineering Departement Ibn Khaldun University Bogor, INDONESIA

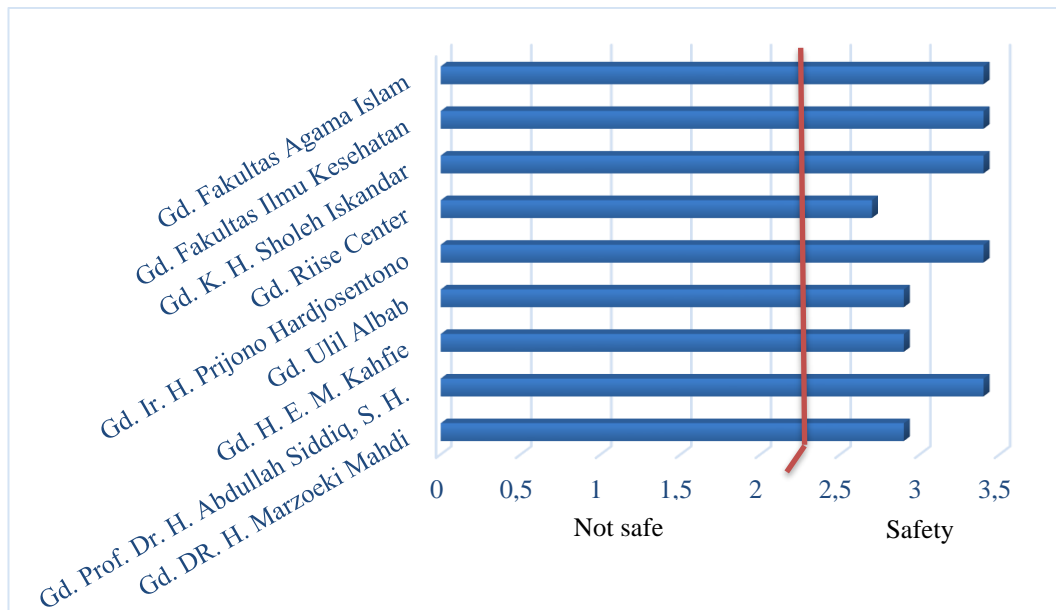
Figure 8. Graph of the final score of the vulnerability of buildings in the UIKA Bogor environment

From table 3 there are 5 buildings in UIKA Bogor that have the highest final score, namely the Prof. Dr. H. Abdullah Siddiq, S. H., Ir. H. Prijono Hardjosentono, K. H. Sholeh Iskandar building, Faculty of Health building and Faculty of Islamic Religion building with a final score of 3.4. The building that has the lowest final score is the Riise Center building with a final score of 2.7. even though it has the lowest final score of all buildings that have been researched, this value is still in accordance with the 2015 FEMA P-154 final score (SL1) regulation which has a minimum score of 0.5 so it is still classified as a safe building in the event of a shock or earthquake.
