Crack Control and Bond Performance of Alternative Coated Reinforcements in Concrete

CRACK CONTROL AND BOND PERFORMANCE OF ALTERNATIVE
COATED REINFORCEMENTS IN CONCRETE

In Partial Fulfillment
of the Requirements for the Degree
Doctor of Philosophy
Civil Engineering

by
Sachin Sreedhara
August 2022

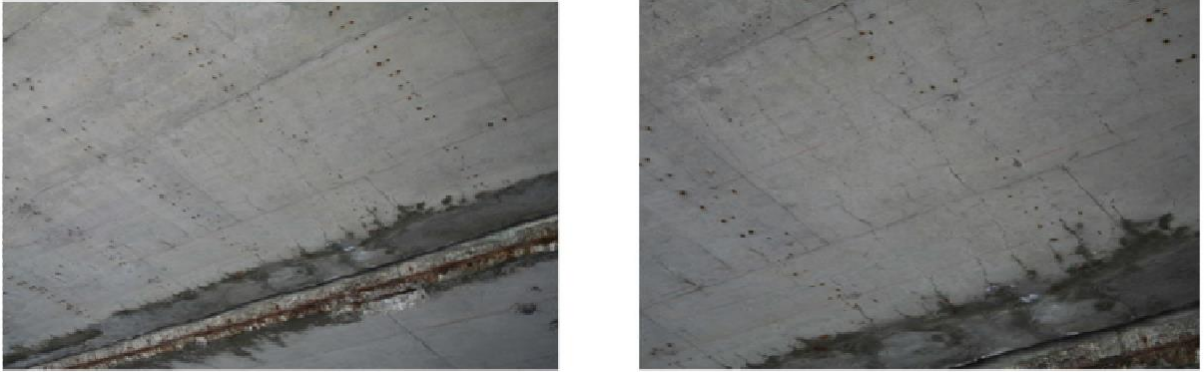
Figure 2. Photo of cracking in bridge under the deck (Figures from [7])

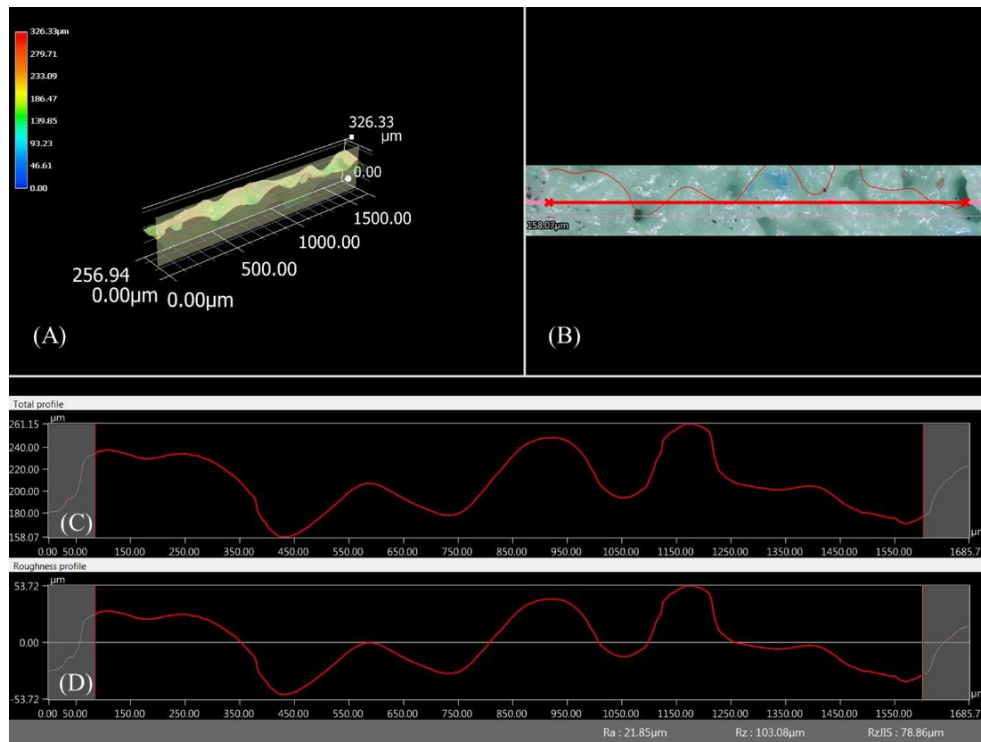
Figure 7. Measurement of Ra. A) The surface roughness of a given strip. B) Line through strip for determining Ra. C) Profile of surface along line. D) Profile surface normalized to the mean profile height. Ra is the average absolute deviation from the mean profile height.

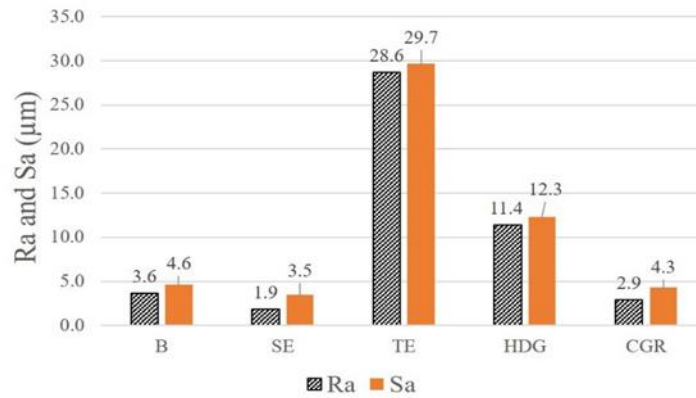
The average of measured values is shown in Figure 8. Values in the figure for a given coating type are the average of measurements taken at two locations on each of three bar samples. The values in the figure were corrected to account for the round surface of the bars, which impacted the microscope roughness measurements. The correction was automated in the software used to run the microscope.

Figure 8. Roughness measurements for each bar coating type

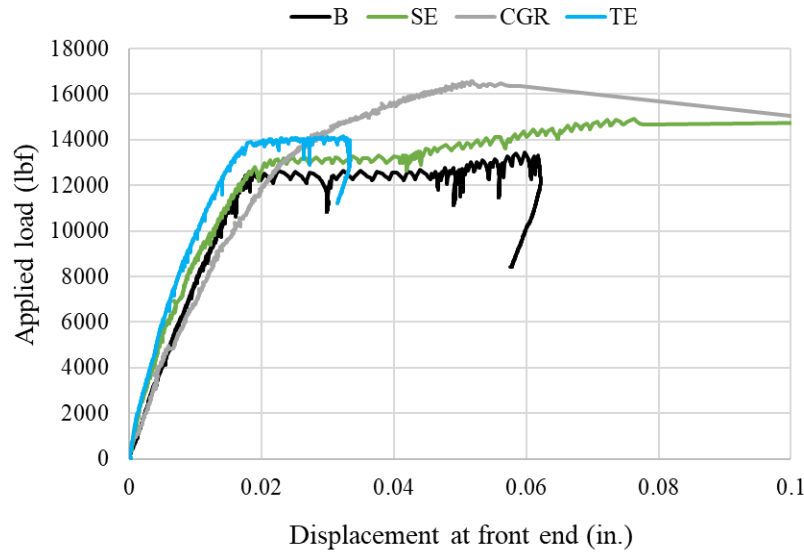
that 12 kips. At a given load level the displacement measured at the front of the specimen was always greater than the slip measured at the back. This is because the displacement measurement included elongation of the bar.

Figure 13. Load vs Displacement for series 1 with bonded length 6 in

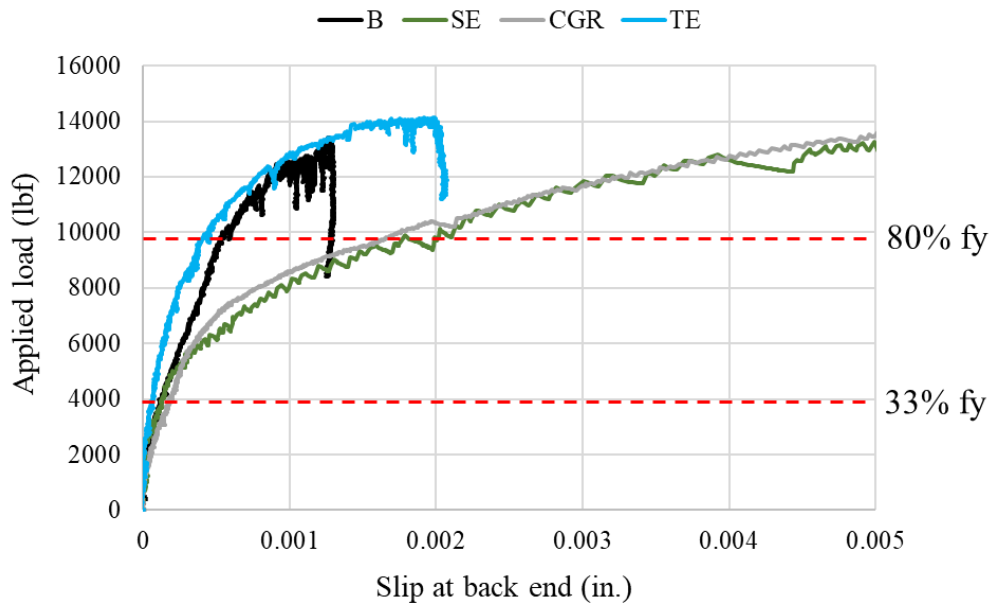
The data from the two potentiometers from the back end (Figure 10) is plotted again the applied load for series 1 in Figure 14. The amount of slip was small when the load was initially applied. The slip increased significantly as the load approached the specified yield strength of the bar.

Figure 14. Load vs Slip for series 1 with bonded length 6 in

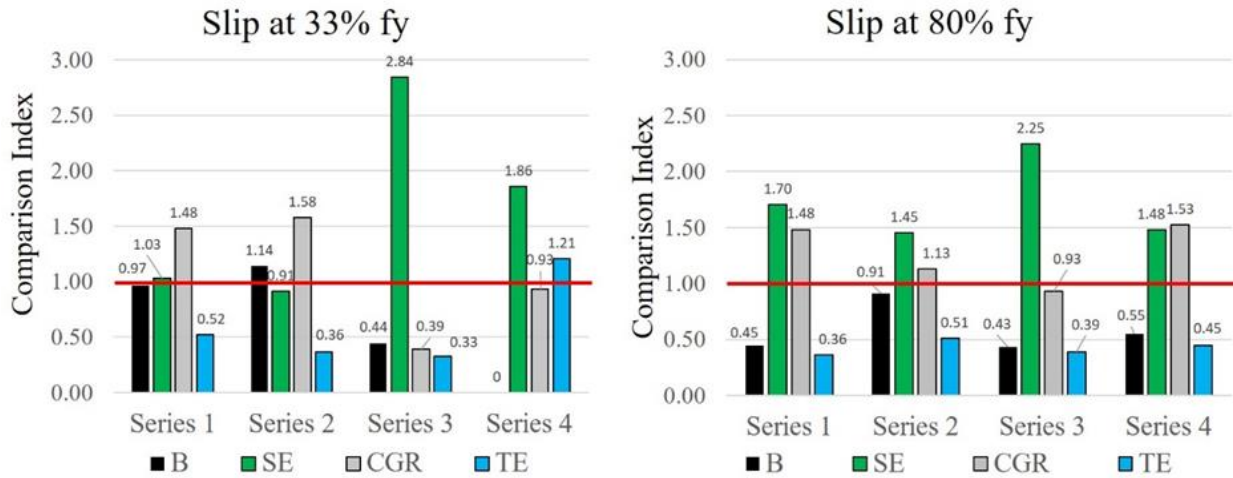
Figure 15. Comparison Index of bar slip at 33% f_y and 80% f_y stress levels. An instrument malfunction prevented measurement of slip in B4 at the 33% f_y level.

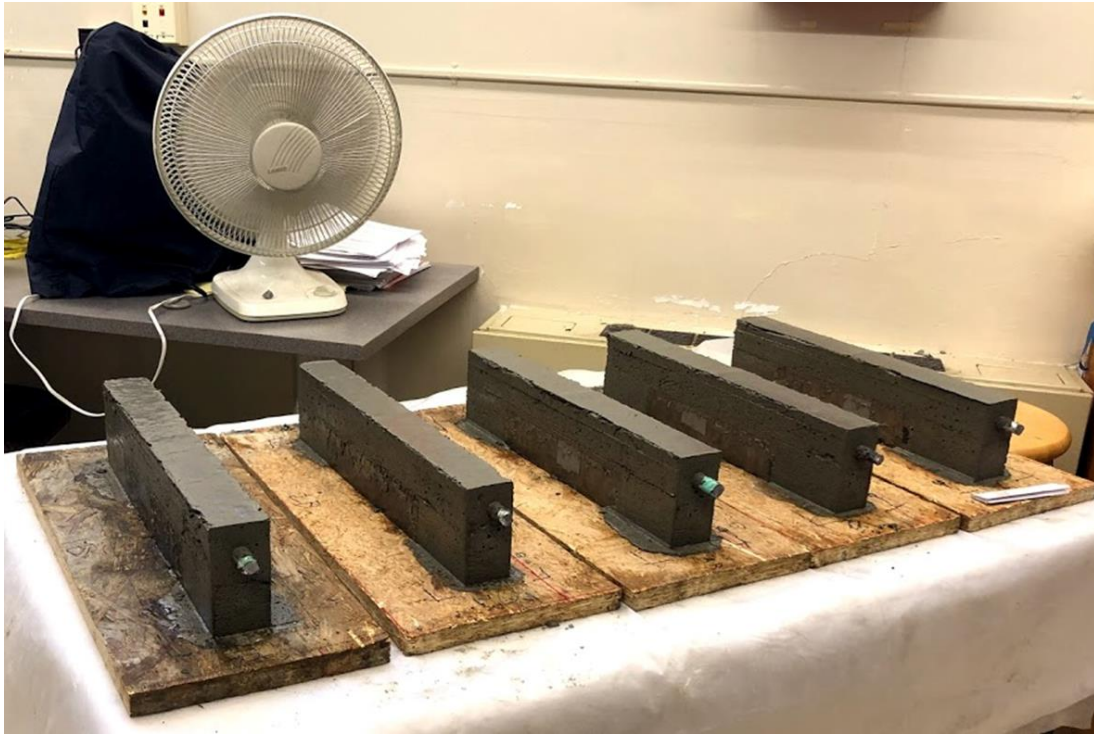
The formwork was removed approximately 2 hours after casting. To accelerate evaporation and to enhance the shrinkage and cracking, a table fan was placed to provide constant air movement over the specimens after the formwork removal (Figure 20).

Figure 20. Shrinkage cracking test set up

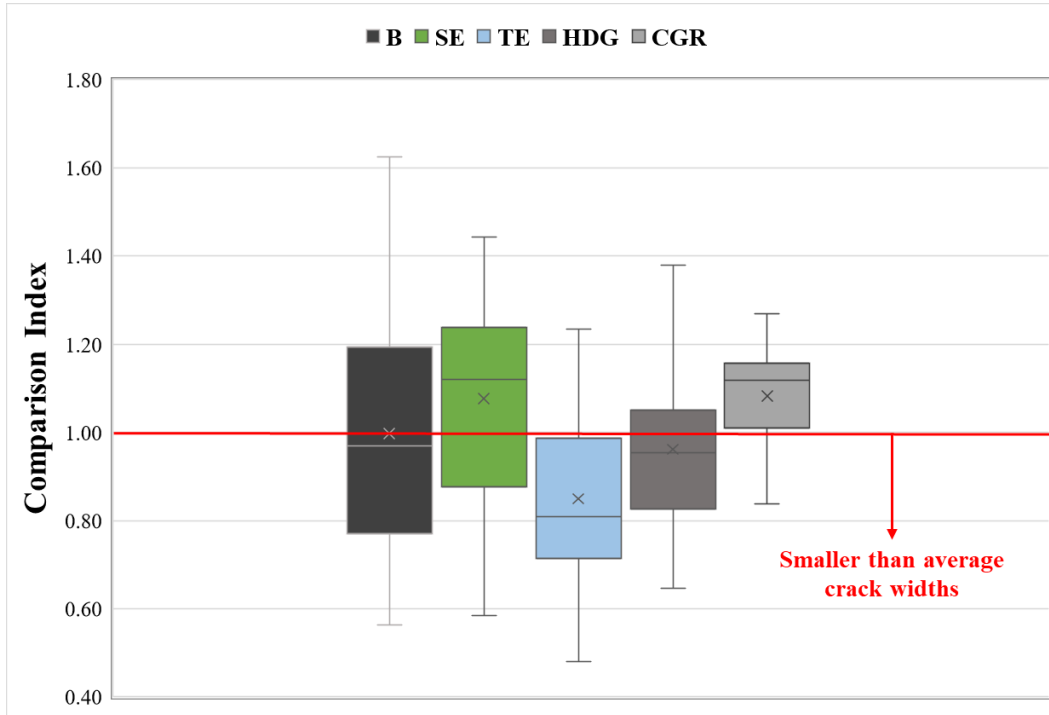
of 120 comparison index values. The “x” in the figure indicates the mean value and the horizontal line in the box indicates the median.

Figure 22. Comparison index of the average crack width from microscope and ImageJ, cracked area from ImageJ

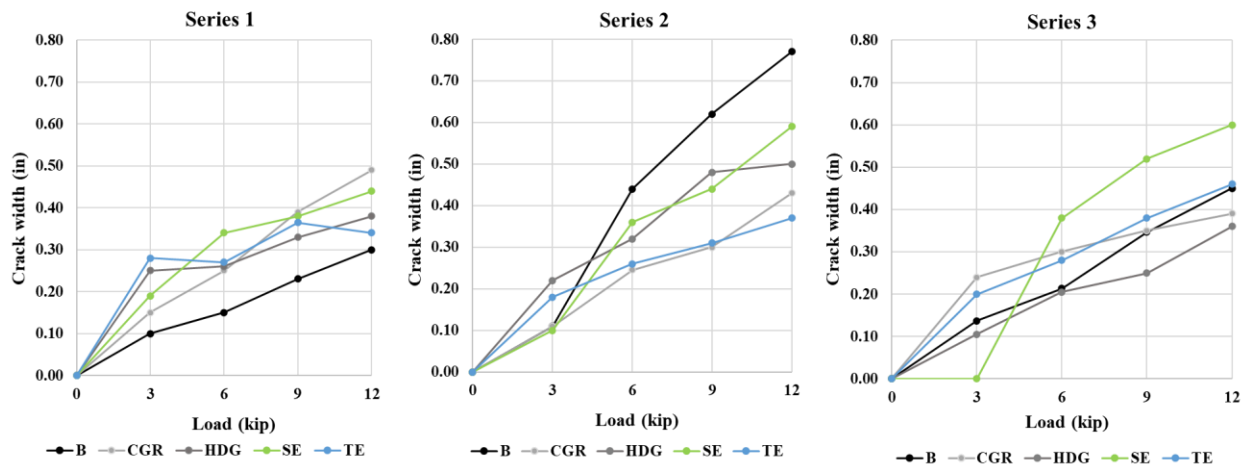
Consistent with all of the other tests reported in this dissertation, the level of scatter in the data made it a challenge to interpret results and identify trends. No discernable trends were observed from average crack widths determined through image processing; however, trends can be observed in microscope data and in the number of cracks. Microscope measurements for all the specimens in each series which is shown in Figure 25. Measurements reported in the figure are the average widths from the microscope readings while the specimen was under load. At higher loads multiple cracks had formed; in these instances, with largest average crack width is reported in the figure.

Figure 25. Crack width as a function of load level for each series. Data are from microscope measurements

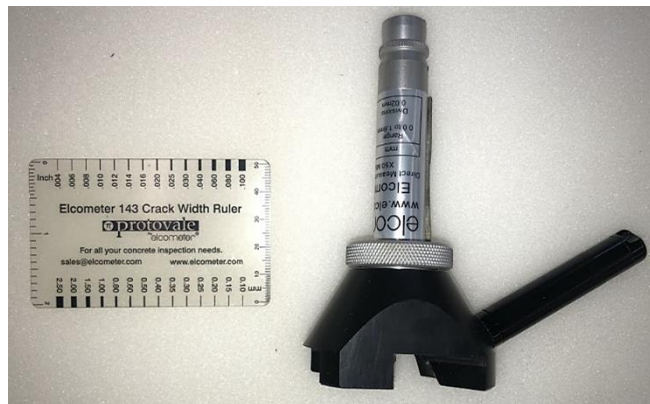
Figure 34. Crack gauge card and the handheld microscope

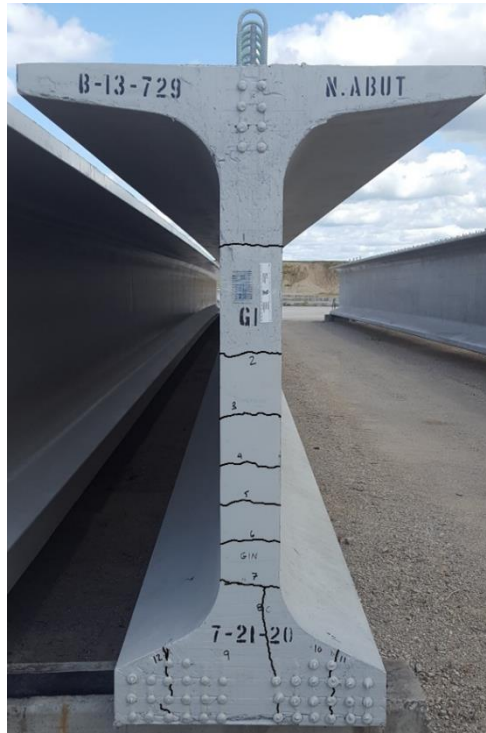
Figure 36. End region cracks in one of the girders from the field study. Lines are marked adjacent to each crack in the photo for emphasis.

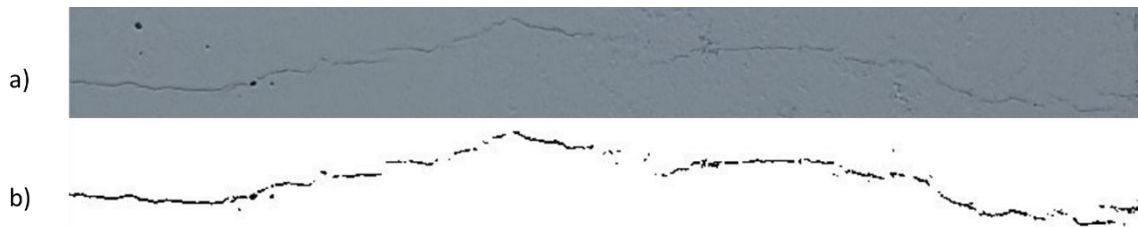
Figure 39. Crack segment analysis: a) duplicate of crack segment selection, and b) isolated crack after 8-bit conversion and threshold adjustment of a crack segment

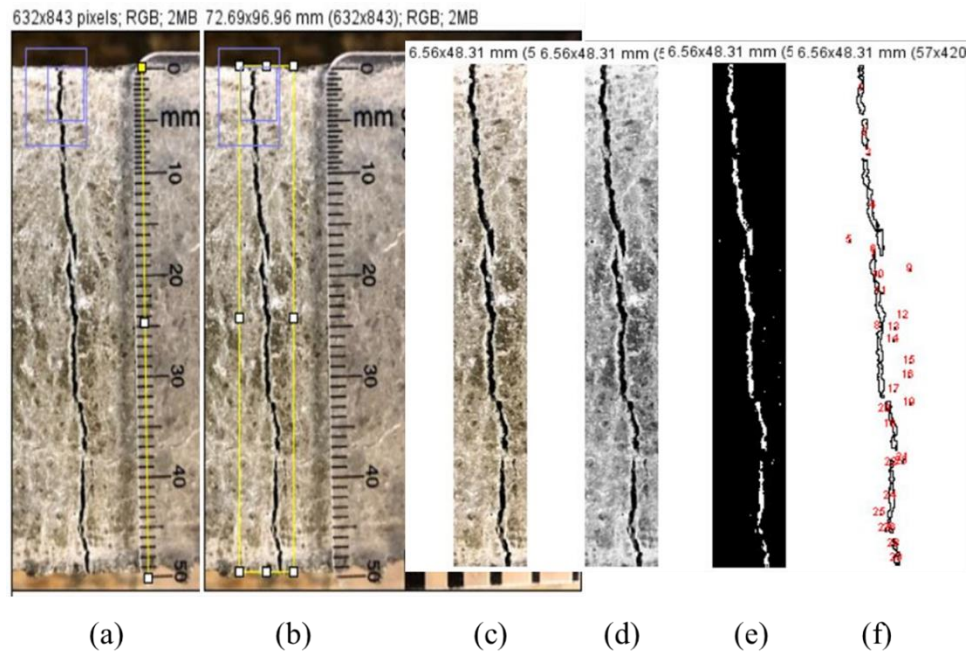
Figure 43. Graphical representation of the ImageJ procedure in steps (a) through (f)
