## Investigating Lateral Displacement of Pile Groups under Construction Loads and Excavation—A Case Study

# Investigating Lateral Displacement of Pile Groups Under Construction Loads and Excavation - A Case Study

This paper presents a case study related to lateral deformation of pile groups under excavation and construction loads with measured data of the damaged piles from a construction site. With the measurements collected at the time of failure, this case can be considered as a full-scale test. Analysis and discussions of the failure of the piles are presented, and numerical analysis was carried out to analyze the effects of construction procedures on pile head displacement under the in-situ condition. Plaxis 2D was used to simulate the pile groups and excavation slope from the project, and different construction scenarios were modeled and analyzed for recommendations on construction procedures.

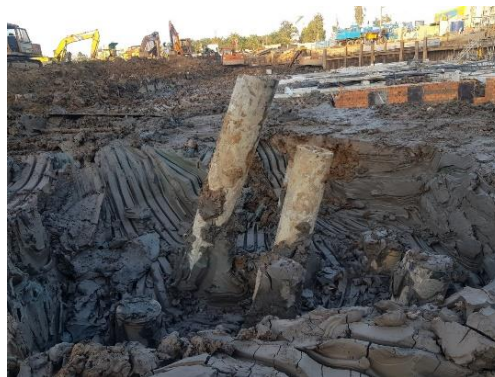
When area B2 was excavated, large lateral displacements of pile head were noticed, especially pile groups B2 and C2 (on February 12, 2020) and measured data were recorded at the same day. At that time, the installing machine was working at Axis D, and the excavating was almost done at Axis B. Most piles visibly leaned side way from the vertical positions, with the displacement of the pile heads up to 2.2 m. The large lateral displacement of piles and soil can be seen in Figures 4 and 5, with the measured data of the maximum lateral displacement of piles at groups B2 and C2 are shown in Table 2. Pile integrity test (PIT) was used to discover the crack locations along the piles. Most of the piles that have the head displacement of more than 1.6 m were cracked. The cracks were found at about 5.8 m from the top of the piles, or 8.8 m from the ground surface. The soil moved laterally, causing cracks on the road as shown in Figure 6. The combined effects of excavation and installing load near the piles could be the major cause of the large lateral pile displacement and soil movement.

Figure 4. Pile displacement at Axis B during excavation

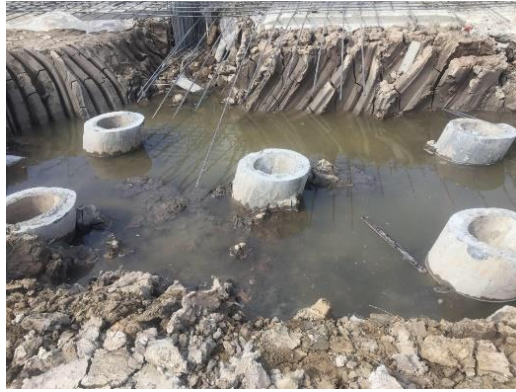
**Figure 5. Pile displacement at Axis A during excavation**

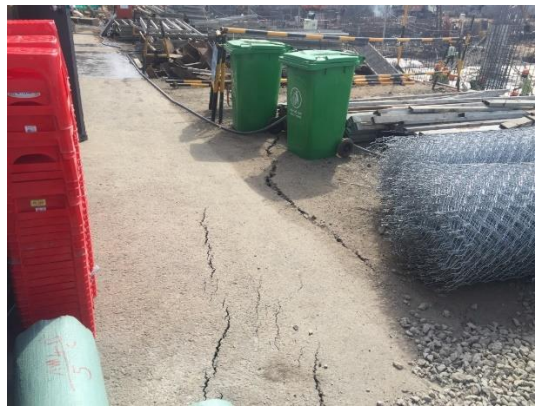
**Figure 6. Road with soil cracks near the excavation**

*Global stability of the excavation:* The configuration of the excavation with installed piles and loads are shown in Figure 8 with the excavation slope of 45 degrees, and depth of 4 m. To determine the factor of safety of the slope due to the excavation, the “C-phi reduction” function from Plaxis was used. With the installing load of 32 kPa, the excavation slope reached near critical condition, with the calculated factor of safety of 1.02. When the load increased to the actual value of 32.7 kPa, the soil collapsed, and FS should be less than 1.0. The simulation results matched with what was observed at the site, when soil moved laterally and the roads around the excavation show cracks as shown in Figure 6.

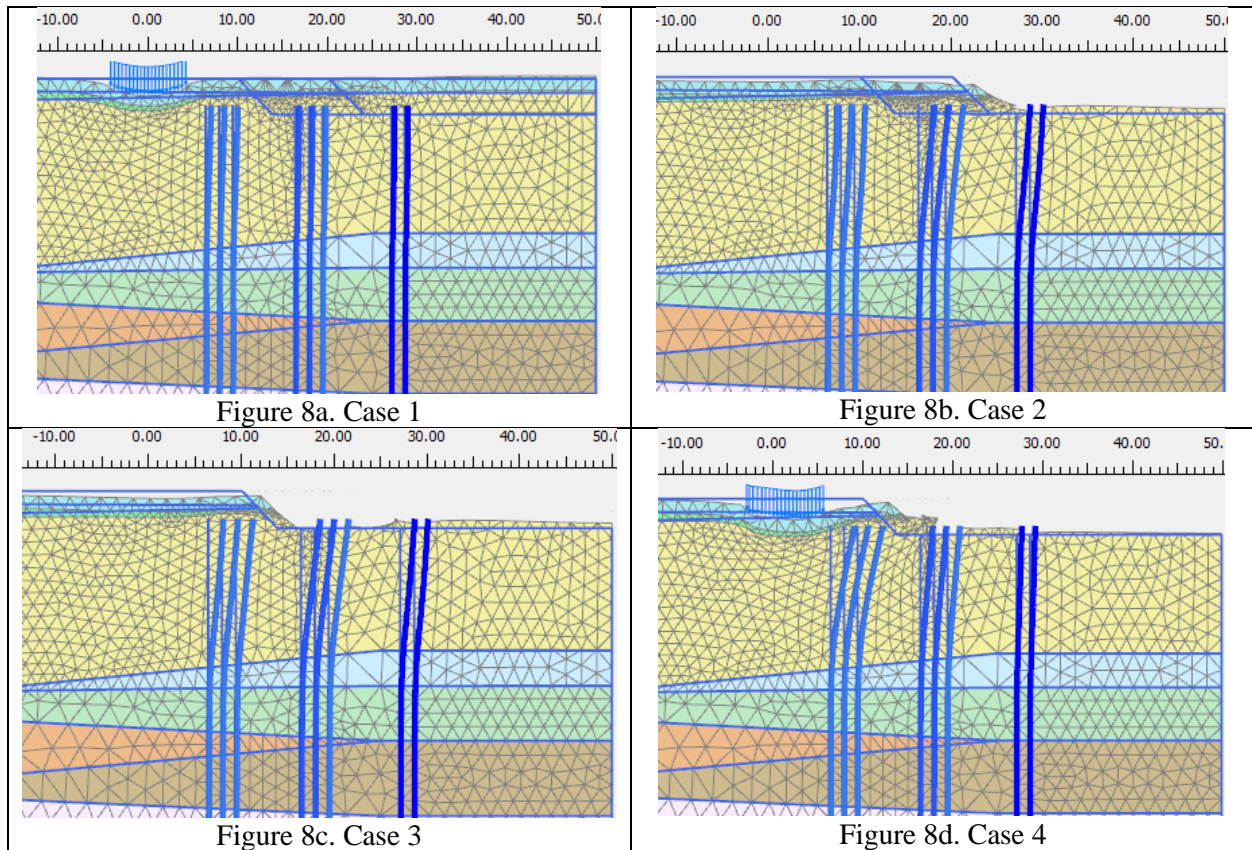
Case 1: The application of only the installation machine load of 32 kPa at Axis D without excavating at Axis A or B to see the effect of the installing load on the installed piles (Figure 8a).

Case 2: Excavation at Axis A area without any loads (Figure 8b).

Case 3: Excavation at Axes A and B area without any loads (Figure 8c)

Case 4: Combination of both installing load and excavation at both Axes A and B (Figure 8d).

Case 1 was analyzed to understand the effects of the installation equipment load only, without excavating the surrounding soil, the model shown in Figure 8a was used to determine the displacement of piles and surrounding soil. The resulting displacement of typical piles at group B2 and C2 are presented in Figure 9. The simulation results show that the maximum lateral displacement of the pile heads at groups B2 and C2 are as small as 0.009 m and 0.012 m, correspondingly. These displacements are acceptable, and these values are less than 1.5% of the measured maximum displacement of the pile heads at the site, which are 0.636 m and 1.451 m respectively, which were caused by both pile installation equipment load and the excavation.

**Figure 8. Deformed mesh for 4 cases**

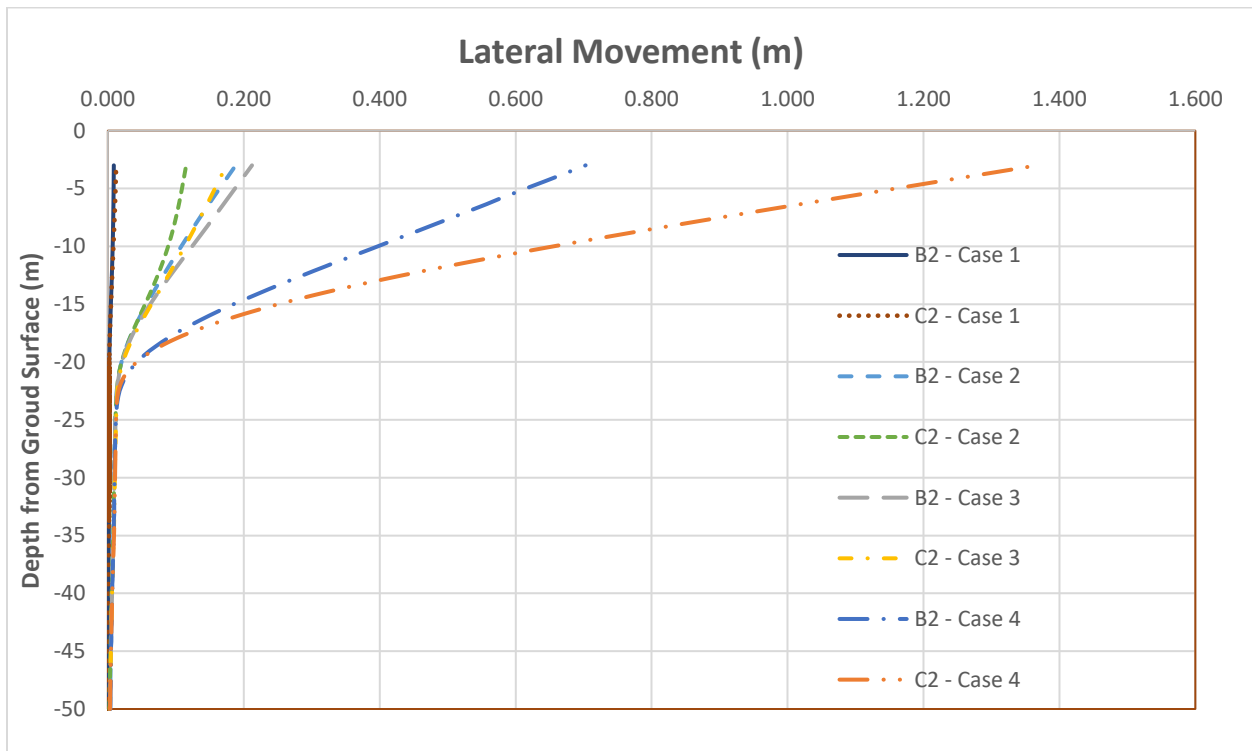
Case 2 and Case 3 were analyzed to find the effects of excavation only. It was found that the lateral displacement of piles due to excavation at axes A and/or B is relatively large, the maximum lateral displacement of pile heads at groups B2 and C2 are 0.174 m and 0.212 m, correspondingly. These values are much larger than what obtained from Case 1, showing that the effect of excavation is larger than that of installing load. The simulated pile head displacements are about 15% to 27% of the maximum measured data at the field.

Case 4 is to examine the combination effects of both installing load and excavation. This case models the actual activities at the site with the pile head displacements that were recorded. For both groups B2 and C2, good agreement was found between the simulation data and the measured data for pile head displacements. The difference between simulated and measured data is about 5% to 10%. In the field, several piles were collapsed. PIT was used and the location of detected cracks of piles in group C2 are at about 8.8m from the ground surface. The piles were broken because maximum material strength (bending moment or shear) was reached due to the large lateral displacement. From the numerical analyses, piles in groups B and C have the maximum bending moment at the depth of 18.0 m from the ground surface (Figure 10). The maximum shear stress was at the depth of 9.5 m. It is possible that the piles failed by shear, since 9.5 m is at the depth close to the crack locations of 8.8m. All FE results of four cases and comparison were summarized in Table 4 and Figure 9. Note that the comparisons were made on piles that are not damaged or cracked, because displacements after failure cannot be predicted.

**Figure 9. Lateral displacement of pile groups B2 and C2. Case 4 has largest displacements.**

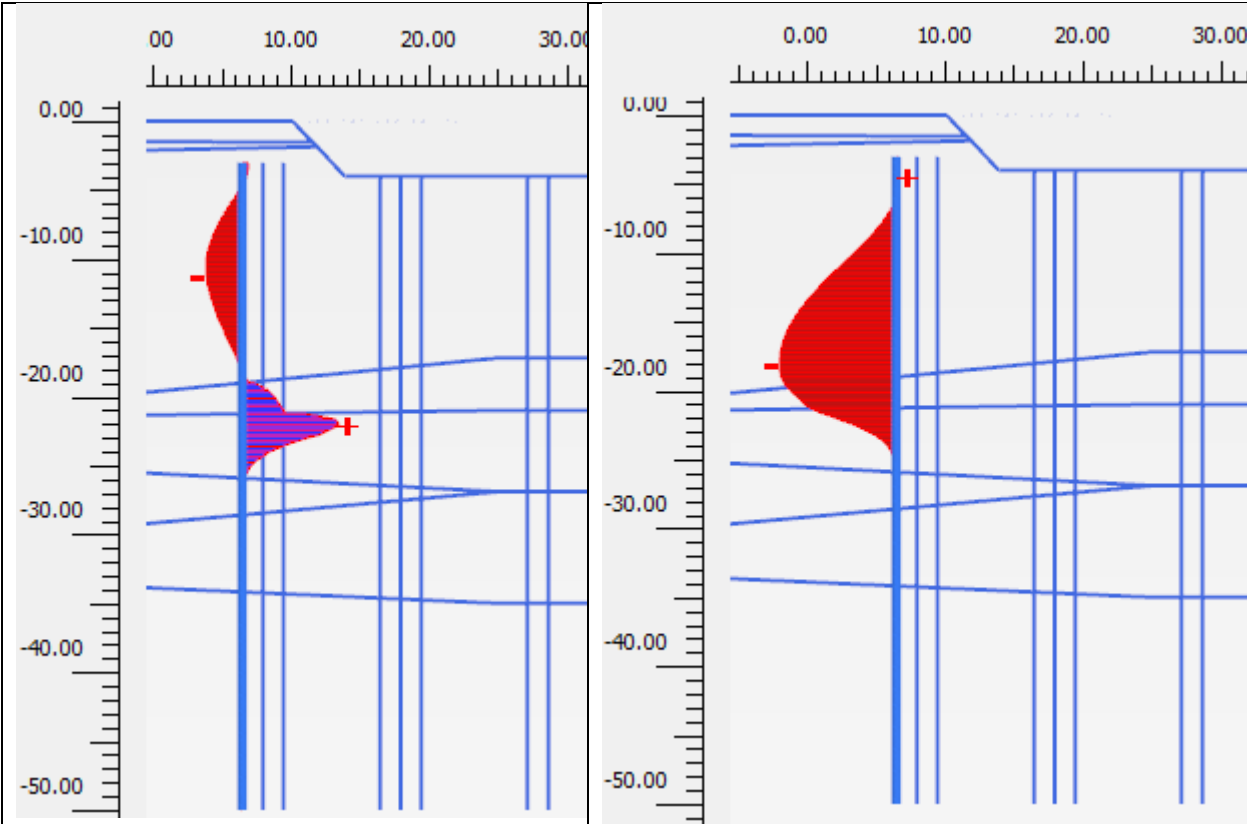
Figure 10a. Shear stress at pile row 1 in group C2 ( $Q_{max} = 140\text{kN/m}$ )

Figure 10b. Bending Moment at pile row 1 in group C2 ( $M_{xmax} = 423\text{ kN m/m}$ )

**Figure 10. Internal stress profile of piles row1 at Group C2 for case 4**

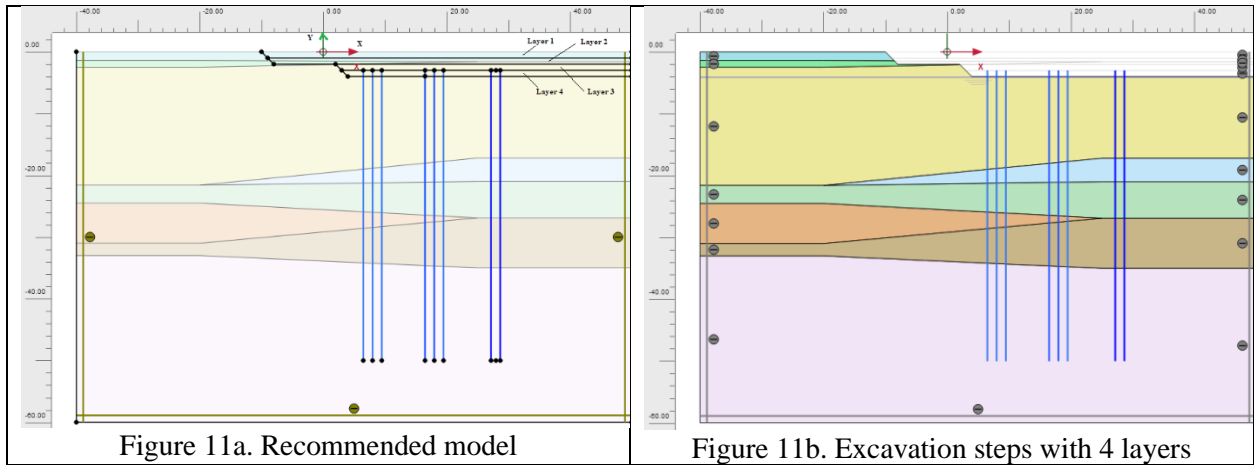
**Figure 11. FE model for recommended construction procedure.**

Procedure 2: Install all piles first, then excavate soils for the whole foundation area by layers of less than 1m each (Figure 11). The thickness of each excavation layer should be determined based on the specific soil conditions and the adjacent structures at the construction site. This procedure can eliminate collapse or damage of piles and reduce over 90% of the excessive lateral displacement of the piles (Figure 12).

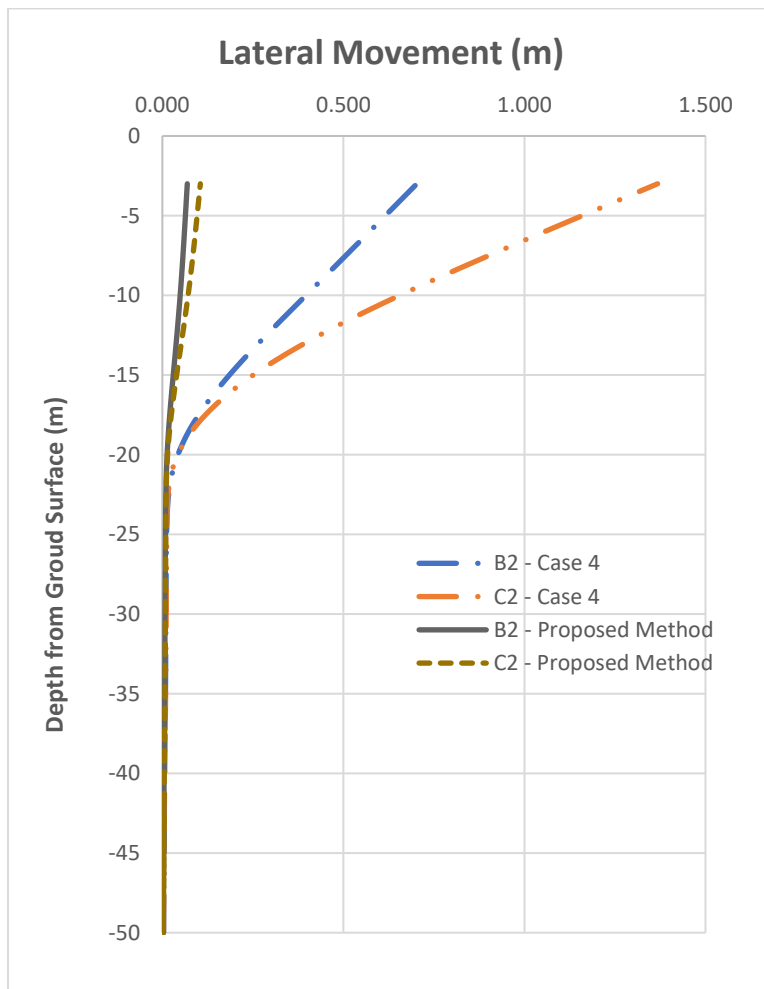
**Figure 12. Comparisons of pile lateral displacement of recommended and used procedures**  
**RECOMMENDED CONSTRUCTION PROCEDURES**
