Giovanni Tosatti*

The “unusual” Ca’ Bonettini landslide (Province of Modena, Italy)

Abstract

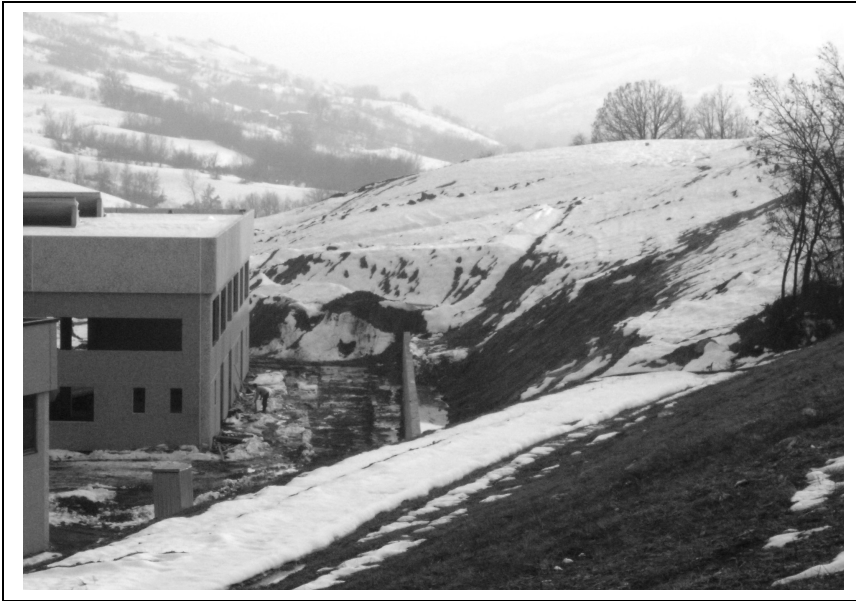
Fig. 5 – Slope cut at the foot of the Ca' Bonettini landslide and containment wall (March 2004)

After the first reactivation and the analysis of seismographic and other instrument data, it was clear that the causes of slope instability were to be found in the excavation and building activities carried out at the foot of the landslide. Therefore, a series of remedial measures was planned in order to increase stability and, at the same time, safeguard the new constructions directly threatened by the movement. The first consolidation works consisted in remodelling the landslide toe with the insertion of drain pipes to reduce pore water pressures, but it was soon obvious that these measures were not sufficient to reinstate the lost stability. Subsequently, a containment wall anchored to the ground by means of 50 m long piles, was constructed uphill of the new buildings (Fig. 5) and surface drains were placed all over the landslide body in order to reduce water absorption.

Although these interventions have considerably reduced the displacement rate of the Ca' Bonettini landslide, the risk of new movements still persists as witnessed by inclinometer data. Therefore, in order to guarantee the survival of the inconveniently constructed new industrial area, adequate monitoring systems must be constantly activated and other, more expensive measures will probably have to be implemented in the near future.
