1520. Shaking table tests on deformation and failure mechanisms of seismic slope

Keywords: shaking table model tests, dynamic responses, seismic slope behavior, seismic sliding surface, Wenchuan earthquake.

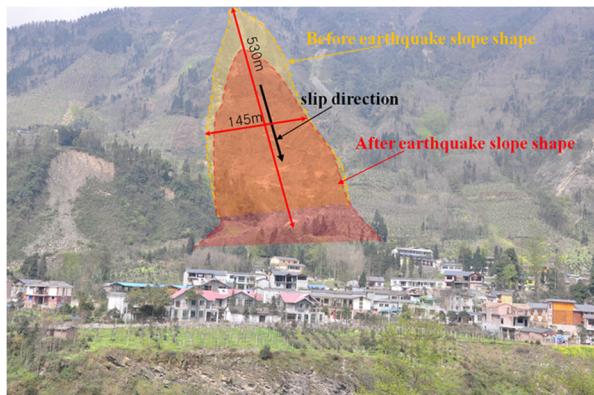
Fig. 1 illustrates a slope failure of relatively small size that occurred at Tazhiping in Dujiangyan City at the location (103.375°E, 31.629°N) in the Hongse village, Hongkou Town. It is evident that the slip plane is rather straight, suggesting that the weak materials at the surface fell under seismic excitation. There were many similar events associated with straight slip planes in the Wenchuan earthquake-hit region. The Tazhiping landslide was triggered by the main shock of Wenchuan earthquake and caused at least 1 fatality. The elevation of the landslide ranged from 1107 m to 1370 m. Its length was about 530 m, and the width was about 145 m. The landslide lithology was fragmentary rocks and the surface was covered by silty clay and gravel. The space distribution of slippery bodies was thick in the center and thin near the perimeter, and the estimated thickness of the sliding mass was 20 m to 25 m. The estimated volume of the landslide was about $116 \times 10^4 \text{ m}^3$. The landslide angle was around 32 degrees.

Fig. 1. The Tazhiping landslide

Fig. 8 illustrates the failed shape after 700-Gal shaking at 10 Hz frequency. The square grids in the photo clearly indicate that shear failure or slippage took place at some depth below the surface, as expected by using 1 % moisture content. The linear shape of the shear plane was similar to the failure of the prototype slope as shown in Fig. 1.

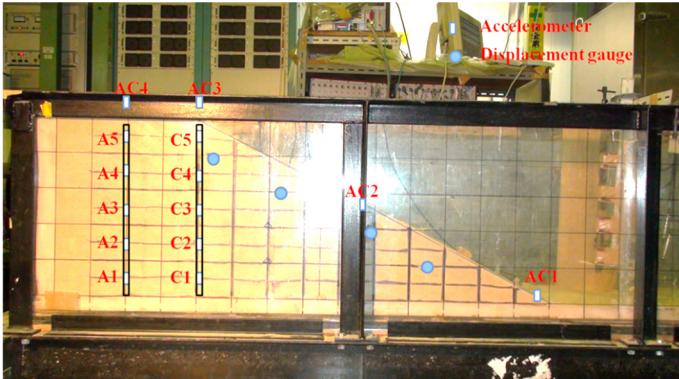
The shaking table at the Geotechnical Engineering Laboratory, University of Tokyo, is 2 m wide and 3 m long, and is capable of applying bi-directional horizontal accelerations. The bearing capacity of the shaking table is 7 tons, and the maximum applied acceleration is 1,000 Gal ($\approx 1 \text{ g}$) frequencies up to 50 Hz. Soil slope models were prepared in a soil container with 3 m in length,

0.4 m in width and 0.6 m in depth. This container was tightly fixed onto the shaking table so that there was no slippage between them. A total number of 14 accelerometers and 4 displacement gauges were installed to measure horizontal dynamic responses during the experiments (inclinometers were prepared by making a column of accelerometers) [14-16]. Fig. 2 shows that the accelerometers were installed in vertical arrays below the crest and the shoulder as well as along the slope to measure the distribution of accelerations inside the slope model. It is also seen that square grids with color were installed in the vertical glass wall to demonstrate visually the dynamically-induced deformation of the model.

Fig. 2. Slope model with accelerometers and displacement gauges

Fig. 4 shows detailed acceleration time histories. Fig. 5 plots the ratio of maximum acceleration (amplitude) along the vertical array in the slope (A1 to A5 in Fig. 2) to the shaking table acceleration. The case of 500 Gal shaking under frequency of 10 Hz exhibits more remarkable amplification than others, as shown in Fig. 5(a). This is most probably due to the nonlinear stress-strain behavior of sand in that the elastic modulus decreases as the dynamic stress and shear strain increase, leading to varying natural periods in the model. This point is examined in more detail in Fig. 5(b), in which the variation of amplification with shaking frequency is plotted for base acceleration with input seismic wave of 500 Gal. Fig. 5(b) shows that the case of

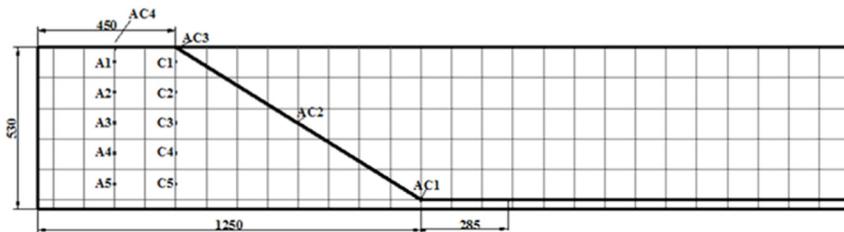
Fig. 3 shows the dimensions of the straight-slope model. As in the aforementioned Tazhiping case, the slope angle of the model was 32 degrees.

Fig. 3. The tested model slopes (unit: mm)

The time histories of the displacement of AC4 and AC3 (as indicated in Fig. 3) are shown in Fig. 16, and correspond to the maximum shear strain in the slope. The displacement at the shoulder of the slope (AC3) is nearly consistent with that from the experiment result (Fig. 11). However,

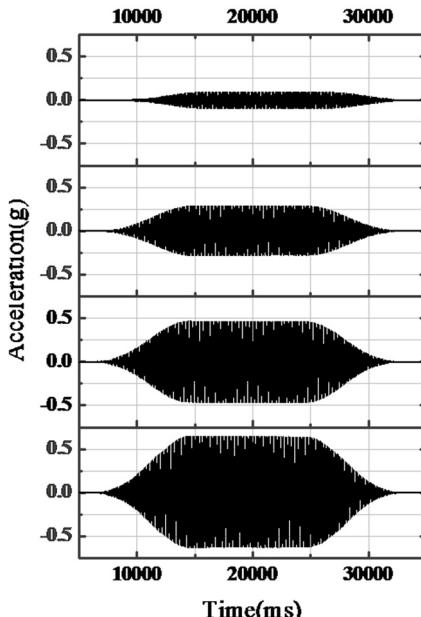
Fig. 4. Time histories of acceleration along the slope

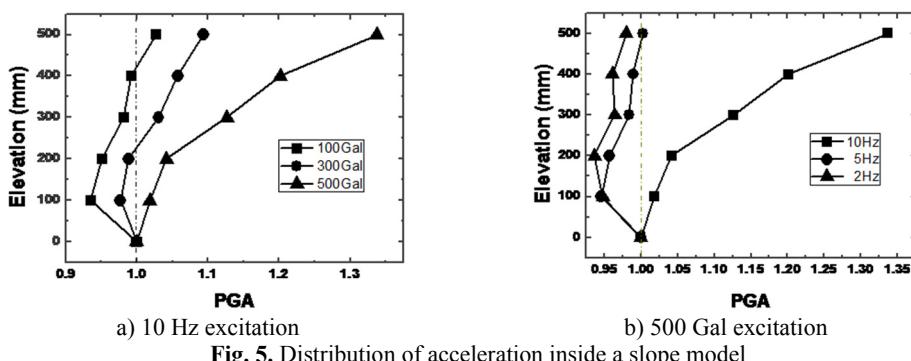
10 Hz is probably closer to the resonance frequency of the model, exhibiting more remarkable amplification than the other cases.

Fig. 5. Distribution of acceleration inside a slope model

Fig. 15 shows the peak acceleration within the slope and at its surface (corresponding to AC1-AC4 and A1-A5 in Fig. 1), respectively. Compared with the model tests (Fig. 5(a)), the calculated accelerations under this relatively weak shaking are similar to the experimental findings. Therefore, the FEM approach is suitable for calculating the acceleration in the slope when the whole slope is intact.

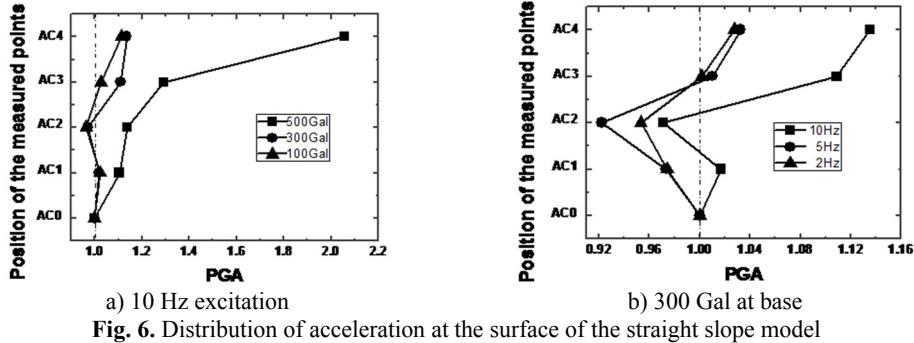
Fig. 6(a) shows the ratio of the maximum acceleration (i.e. amplitude) at the surface of the slope (AC1 to AC4 in Fig. 3) to that applied the base with amplitude up to 500 Gal. This allows study of the effects of nonlinearity of soils in greater detail. Actually, shaking at 700 Gal caused slope failure and thus the corresponding results are not included in Fig. 6. AC4 at the crest shows more significant amplification than the other cases. The amplification at the slope shoulder (AC3)

is large as well but smaller than that at the crest (AC3 < AC4). This is consistent with the findings after the Wenchuan earthquake that many cracks formed in the back scarp of the slope, although the main body of the slope was intact (Fig. 7). Fig. 6(b) illustrates that with increasing height (AC1 to AC4), the acceleration at the slope surface decreases and then increases at the mid-height of the slope.

Fig. 6. Distribution of acceleration at the surface of the straight slope model

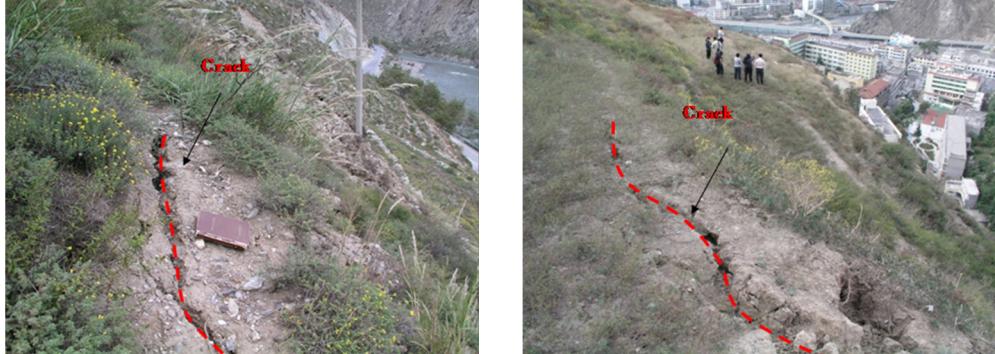
Fig. 7. Two cracks in the back scarp of the slope

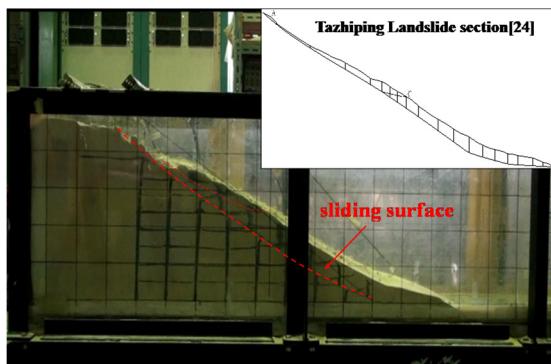
Fig. 8. Failed straight slope with 32-degree gradient subjected to shaking of 700 Gal and 10 Hz for 30 seconds

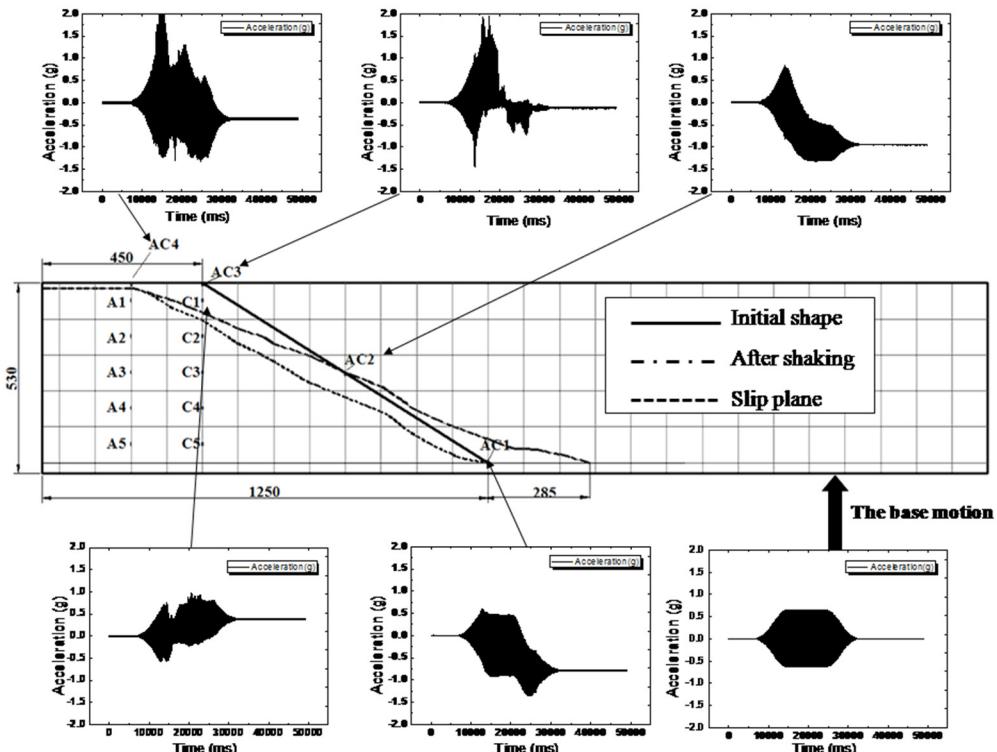
Fig. 9. Acceleration response along the surface of a straight slope (32 degrees, 700 Gal, 10 Hz)

Fig. 9 compares the shape of the slope before and after shaking. The model slope, nearly intact under 500 Gal shaking, suddenly developed cracks and then slid at shallow depth below the slope under 700 Gal shaking. In the same figure, the time histories of horizontal acceleration along the slope surface are shown. The bias from zero is due to tilting of the transducer after slope failure. From the amplitude of acceleration at the slope surface, it is found that the shaking was weaker in the lower part of the slope (AC1 and AC2), and stronger in the upper half (AC3 and AC4). The increasing acceleration towards the top was caused by energy concentration at the narrower slope, as observed in reality. Moreover, the acceleration in the slope shoulder (C1) became less than that at the surface.

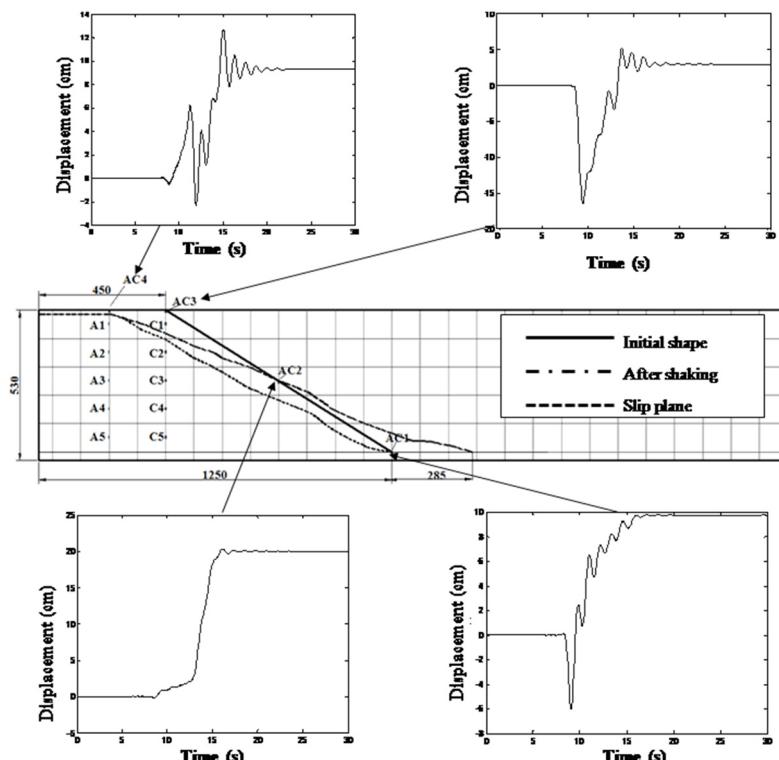
Fig. 10. Time history of displacements derived from the measured accelerations

The recorded acceleration was integrated twice and the effects of tilting and other baseline errors from the acceleration were removed to obtain the time history of displacement, as shown in Fig. 10. Clearly, the displacement amplitude, which was closely related to the local shear strain amplitude, increased from the bottom (AC1) to the shoulder (AC3) and the crest of the slope (AC4), indicating more nonlinearity and extent of yielding of soils at higher elevations. The significant shear strain induced large deformation. The failure was initiated at AC4 at the crest and then proceeded to AC1 at the bottom of the slope. Fig. 11 traces the development of slope failure with time. The displacements in this photo are consistent with the findings in Fig. 10.

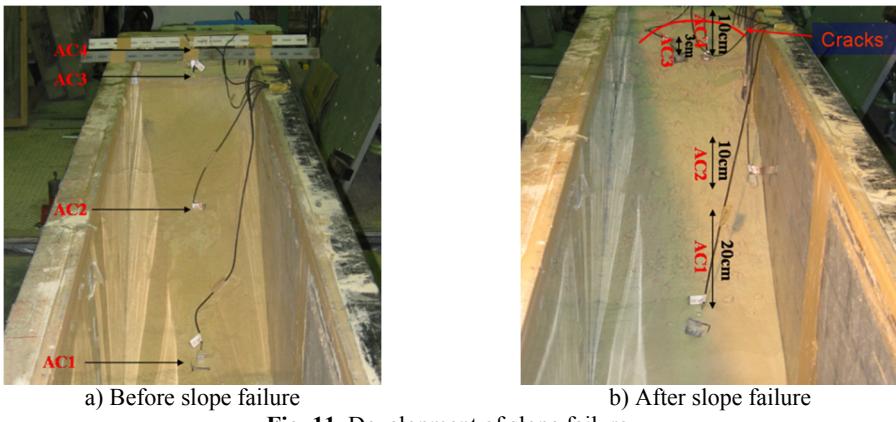
Fig. 11. Development of slope failure

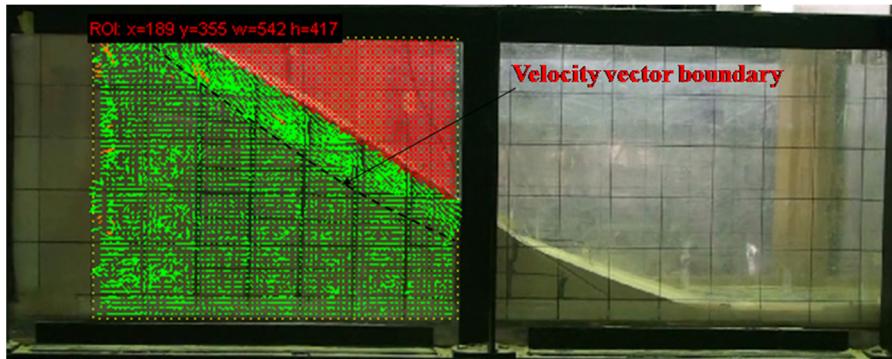
The results show that the PIV technology could effectively measure the displacement of any point at any time with accuracy within the observation region. Furthermore, more information

about the process of deformation development could be obtained, such as the formation of strain localization and the whole failure process of slopes under earthquake.

Fig. 13. PIV analysis results with velocity vector boundary of slope

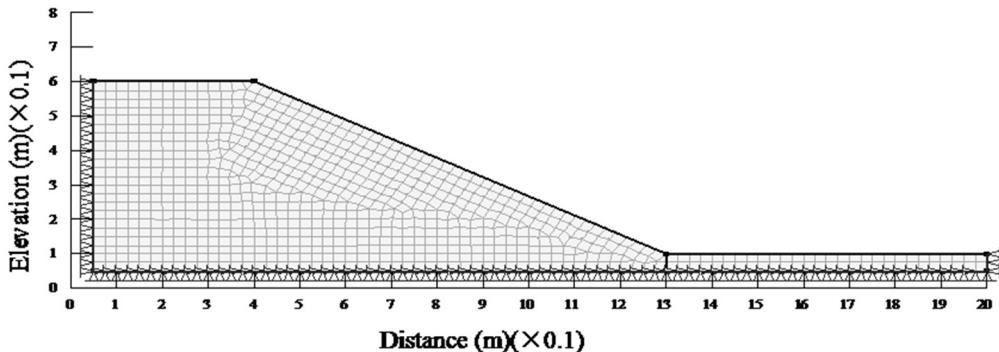
To compare the dynamic failure of slope model in shaking table tests, a finite-element dynamic analysis was performed. The total number of elements was 804 with 886 nodes, as shown in Fig. 14. For this analysis, an elastic-perfectly plastic constitutive model with the Mohr-Coulomb failure criterion was adopted for soils. The input parameters for slightly wet Toyoura sand are shown in Table 1 [21]. The sand parameters will be discussed later. 300 Gal (10 Hz) and 700 Gal (10 Hz) seismic wave inputs were applied at the bottom of the numerical model, which was consistent with the shaking model tests (see Fig. 2). The duration of shaking was 30 seconds.

Fig. 14. Finite element model of a slope

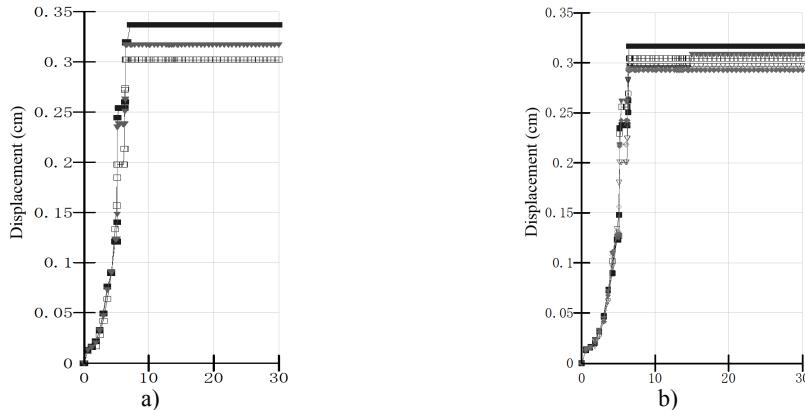
Fig. 15. Time history of accelerations in the numerical analysis (300 Gal, 10 Hz, a) at the surface of a straight slope (AC1-AC4) and b) within a straight slope (A1-A5))

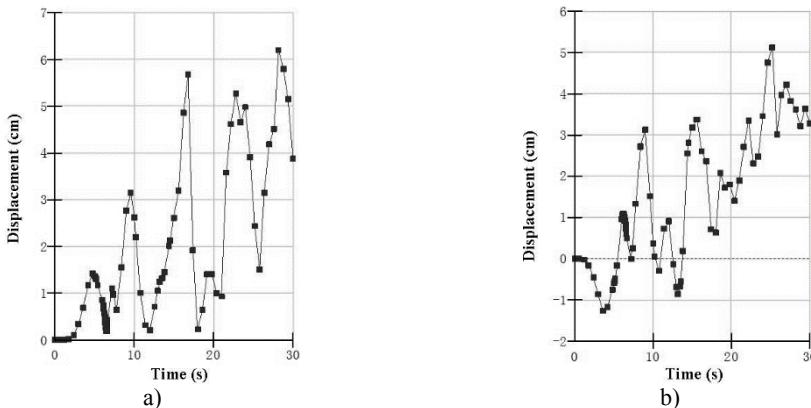
at the crest of the slope (AC4), the calculated displacement is smaller than the experiment result. This implies that the simulation is not suitable for evaluating the failed shape of a slope, because conventional FEM cannot properly deal with large deformation.

Fig. 16. Time history of displacements in the numerical analysis (700 Gal, 10 Hz, a) at the crest AC4 and b) at the shoulder AC3)
