Performance of Residential Buildings during Nepal Earthquake

Abstract: Earthquake do not kill people, unsafe the buildings do. Earthquake is a naturally occurring process in which tectonic plates release strain developed in them over years. Earthquake cannot be avoided. Nepal Earthquake of magnitude 7.8 once again reminds us the need of earthquake resistant design and construction. Extensive loss of human life and property occurred due to this earthquake. In this paper, an effort is made to study the probable cause of failure of buildings in Nepal. Different types of buildings and structures are observed with various structural irregularities and defects. Thus, Safety measures to prevent future damage due to earthquake are also suggested.

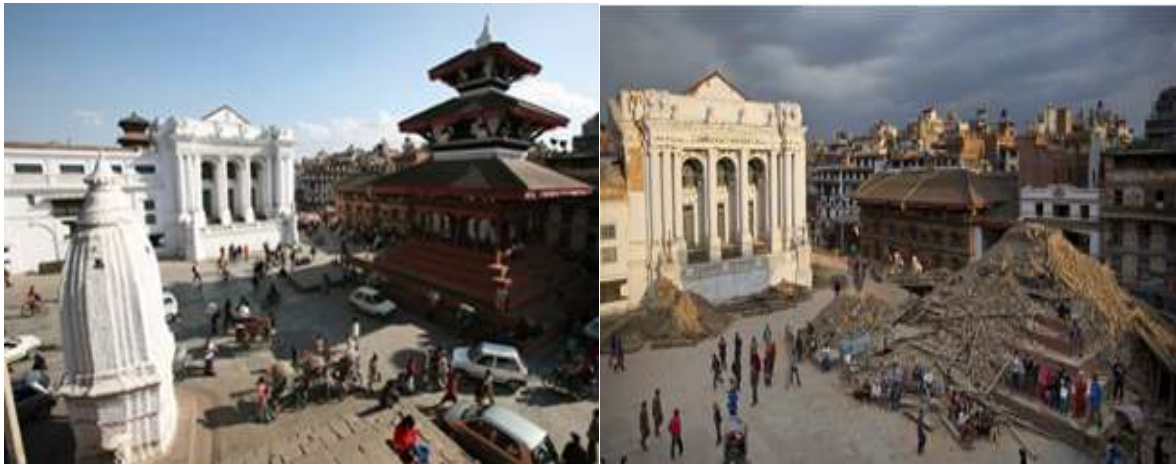
The Following building failed in Nepal earthquake due to poor construction practices like lack of brick bonds, higher thickness of mortar joints and perpend in two consecutive courses matching.

Fig. 2 Kathmandu's historic Basantapur Durbar Square, before and after the 7.8-magnitude earthquake which reduced it to rubble^[1]

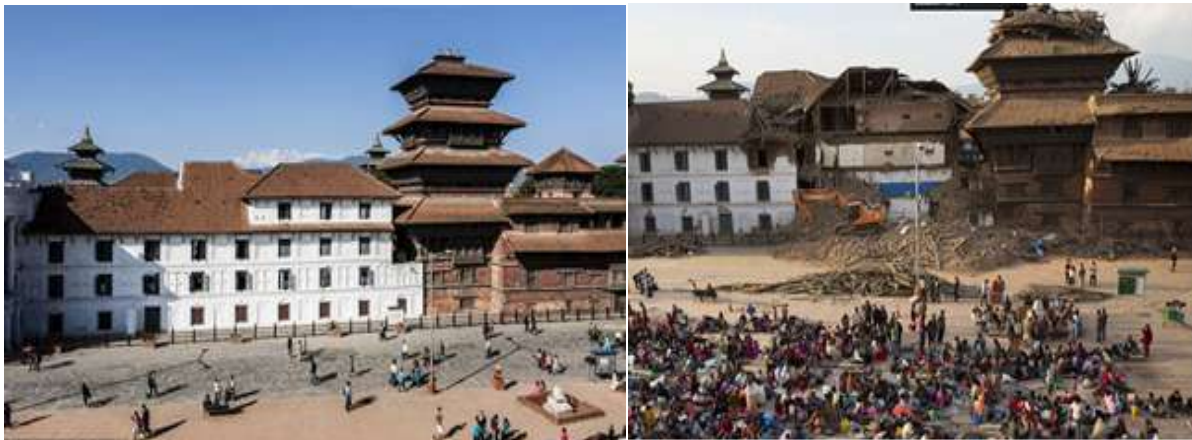
Fig. 3 People gather in Durbar Square for security reasons. Complete masonry failure^[1]

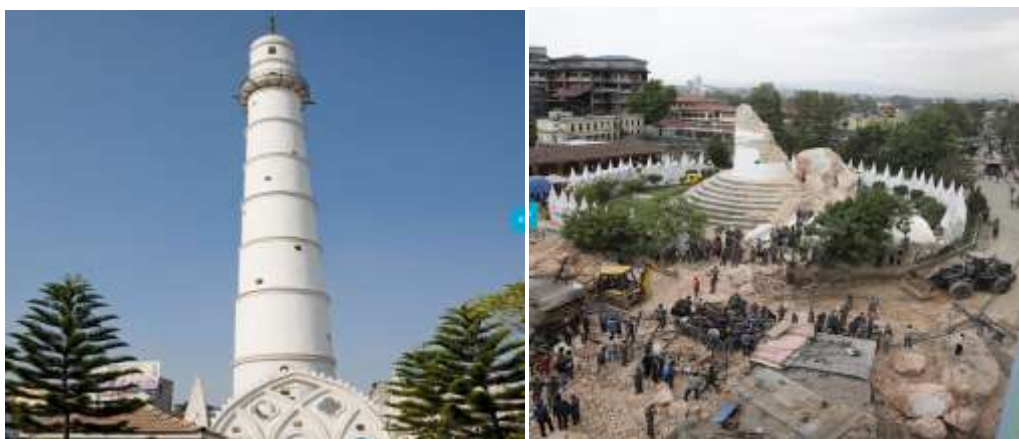
Fig. 4 The Iconic Bhimsen Tower before and after the earthquake^[1]

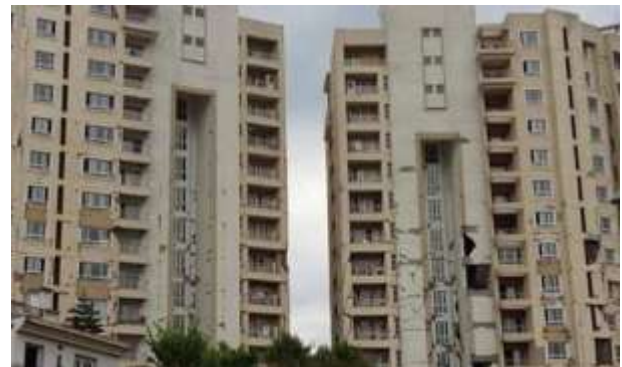
In masonry walls without openings, shear failure often takes place in wall piers and spandrels. Shear failure is likely to occur in wall elements with small height-to-length ratio. Shear failure tends to be brittle, with low energy dissipation capacity and severe strength degradation due to load repetition^[5].

The building failed in Nepal earthquake due to poor construction practices diagonal shear failure is occurred in the masonry walls.

Fig. 5 Shear failure in masonry wall after earthquake in Nepal^[11]

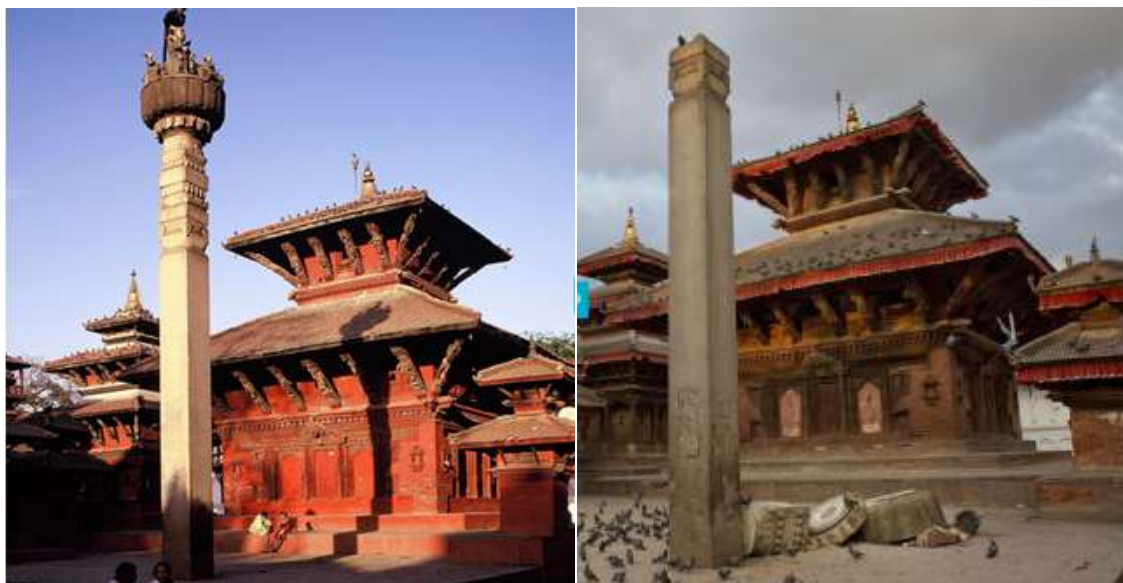
This failure is occurred due to heavy mass placed on the top of minaret cause the excessive deflection and acceleration during earthquake in Nepal.

Fig. 6 Failure of minaret due to poor construction^[11]

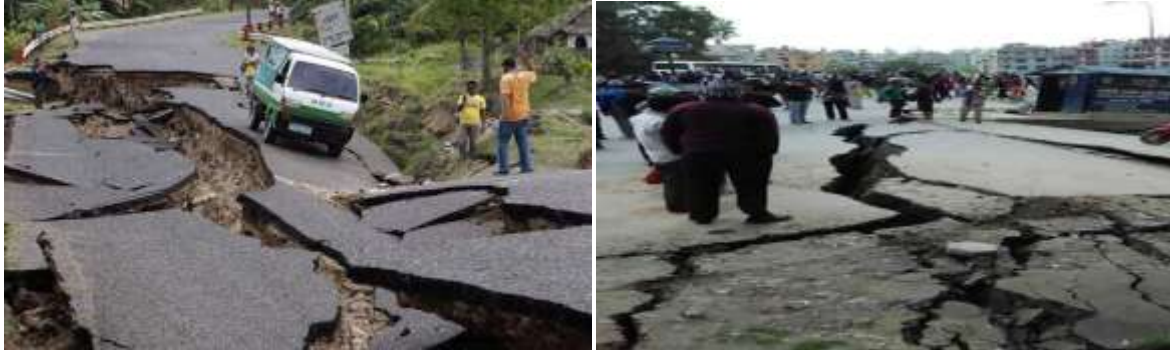
Fig. 7 A huge cracks have opened up in this road after the Nepalese capital was rocked by a 7.8-magnitude tremor [11]

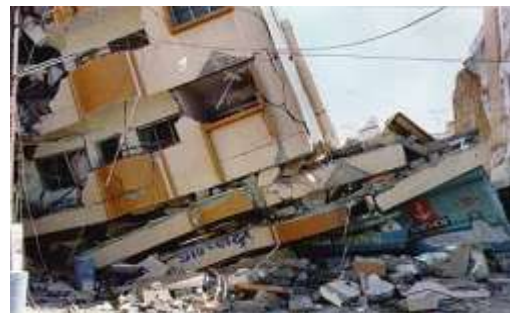
The stiffness irregularity arises when there is a substantial reduction in lateral stiffness in any storey with respect to that in upper storey. The storey with reduced stiffness is called soft storey. According to IS 1893:2002, A soft storey is one in which the lateral stiffness is less than 70 percent of that in the storey above or less than 80 percent of the average lateral stiffness of the three storeys above. Figure 9 shows the failure of soft storey [6].

Fig. 8 Collapse of soft storey [11]

As per IS 1893:2002, special arrangement needs to be made to increase the lateral strength and stiffness of the soft/open storey. Dynamic analysis of building should be carried out including the strength and stiffness effects of infill walls and inelastic deformations in the members, particularly, those in the soft storey, and the members designed accordingly. Alternatively, the following design criteria are to be adopted after carrying out the earthquake analysis, neglecting the effect of infill walls in other storeys [6]:

- i. The columns and beams of the soft storey are to be designed for 2.5 times the storey shears and moments calculated under seismic loads.
- ii. Besides the columns designed and detailed for the calculated storey shears and moments, shear walls should be placed symmetrically in both directions of the building as far away from the centre of the building as feasible; to be designed exclusively for 1.5 times the lateral storey shear force calculated as before.

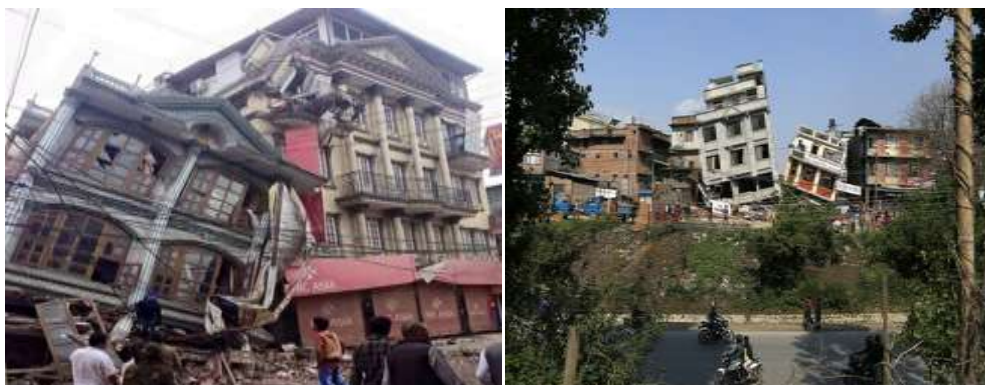
The Following buildings are pound to each other during Nepal earthquake due to closed construction of two buildings.

Fig. 9 Building deflects due to pounding effect during earthquake vibrations [11]

When two buildings are located very close to each other or when seismic expansion joints exist, pounding is occurred. So, it is necessary to provide enough space between neighbouring structures so that they do not pound each other. Extra distance is provided between two adjacent buildings in addition to the sway of the buildings in computing lateral displacement, it is necessary to consider plastic deflection, soil-structure interaction and other factors besides elastic deflection [8]. The pounding effect can be easily seen in highly populated cities. This effect can be controlled by placing elastic materials between adjacent buildings or by reinforcing structural systems with cast-in-place reinforced concrete (RC) walls. As per IS 1893:2002, two adjacent buildings, or two adjacent units of the same building with separation joint in between shall be separated by a distance equal to the amount R times the sum of the calculated storey displacements, to avoid damaging contacts when the two units deflect towards each other.

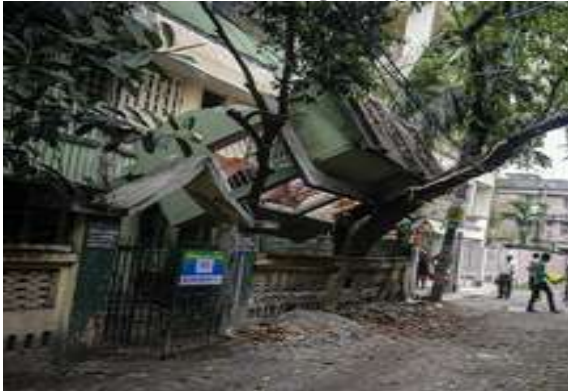
Fig. 10 Balcony of the building toppled ^[11]

When there is substantial difference in mass between two storeys, it is called as mass irregularities. Although mass irregularities are not commonly observed, it may exist in a particular floor due to heavy equipment placed there. This can be seen in Figure 10 where the balcony contains some heavy mass due to which it got detached and toppled. According to IS 1893-2002, mass irregularity shall be considered to exist where the seismic weight of any storey is more than 200 percent of that of its adjacent storey. The irregularity need not be considered in case of roofs.

All horizontal projections like cornices and balconies shall be designed and checked for stability for five times the design vertical coefficient.

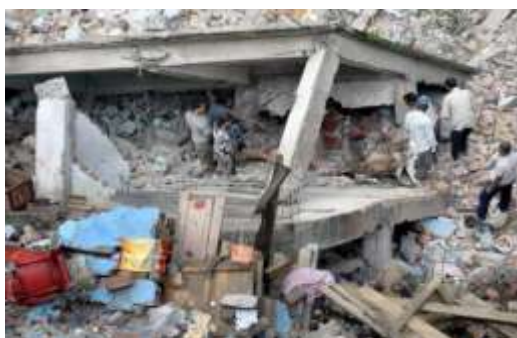
Fig. 11 Column failure during Nepal Earthquake ^[11]

The seismic inertia forces generated at the floor levels are transferred through the beams and columns to the ground in the RC frame. The correct building components need to be made ductile. The failure of a column can affect the stability of the whole building, but the failure of a beam causes localized effect. Therefore, it is better to make weak beams and strong columns. This method of designing RC buildings is called strong-column weak-beam design (Fig.12).

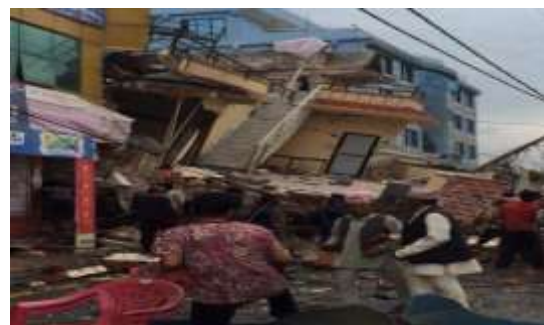
The twisting of buildings causes different portions at the same floor level to move horizontally by different amounts. Generally it occurs due to Irregularities of mass, stiffness, and strength in a building can result in significant torsional response. Torsion arises from eccentricity in the building layout when the centre mass of the building does not coincide with its centre of rigidity. If there is torsion the building will rotate about its centre of rigidity due to the torsional moment about the centre of structural resistance.

The Figure shows the effect of twisting of stair in a building due to the excessive load causes change in eccentricity of building during Nepal earthquake.

Fig. 13 Twisting of building during Nepal Earthquake ^[11]
