# A holistic methodology for the non-destructive experimental characterization and reliability-based structural assessment of historical steel bridges

## O. Bouzas<sup>\*</sup>, B. Conde, M. Cabaleiro, B. Riveiro

ABSTRACT

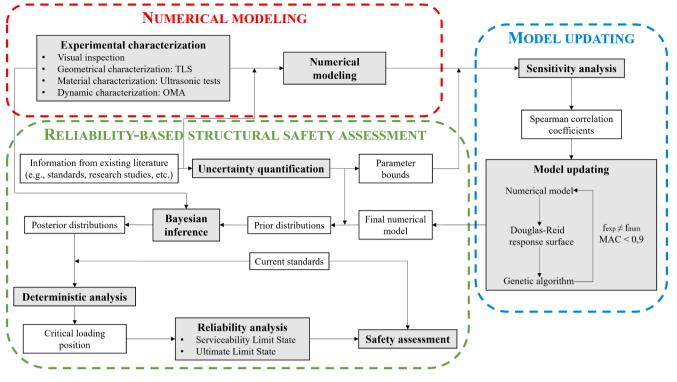
Fig. 1. Flowchart of the proposed methodology.

In Fig. 1, all steps of the proposed methodology are schematically outlined:

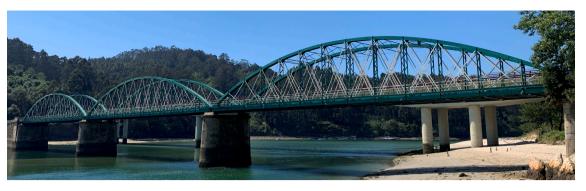
Fig. 2. Overall view of O Barqueiro Bridge.

O Barqueiro Bridge is a three-isostatic-span riveted steel arch bridge (Fig. 2). Each span has a length of 48.1 m, comprising thirteen panels of 3.70 m long, a maximum height of 7.5 m, and a width of 6.4 m (Fig. 3 (a) and (b)). All original bridge elements are built-up members of different steel plates and L-type profiles (Fig. 4 and Table 1), initially connected by rivets and now partially substituted by bolts and welding in a few locations.

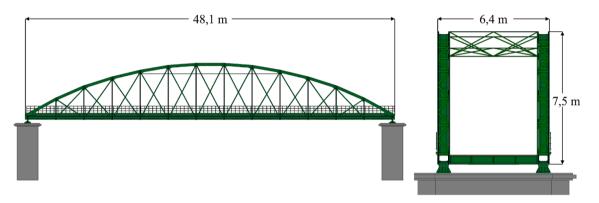
Fig. 3. O Barqueiro Bridge: (a) lateral view and (b) cross-section.

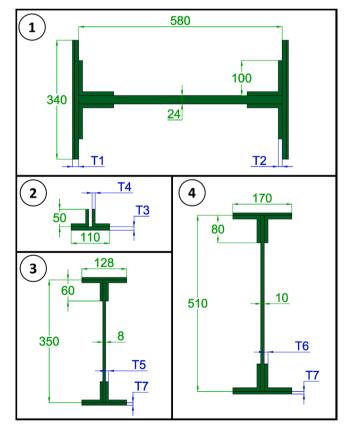
Fig. 4. Cross-section of steel members.

The arch rib and the tie girder were built using I-shaped sections

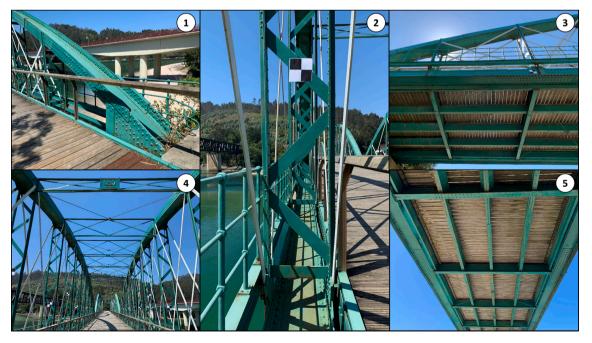
Fig. 5. Details of O Barqueiro Bridge: (1) arch rib (2) vertical hanger (3) stringers (4) sway systems (5) crossbeams.

The bridge's deck comprises sixty-five stringers equally divided into five rows. These members are joined to fourteen crossbeams, which are in turn linked to the tie girders and vertical hangers. The stringers and crossbeams are I-shaped (Fig. 4, sections 3 and 4, respectively). All the crossbeams and central stringers have two reinforcement steel plates on the top and bottom sides to increase flexural capacity. Several circularshaped lower lateral bracings connect the crossbeams longitudinally. Moreover, after rehabilitation, the original road pavement was replaced by rectangular wooden planks. Fig. 3(b) shows the bridge cross-section, while Fig. 5 provides some details about the actual structural configuration.

The bridge presents corrosion in almost all its elements, caused by the high concentration of saltpeter in its location, although, in general terms, this corrosion might be regarded as primary uniform. The exceptions are local areas where dimples and holes can be found and some steel connections between crossbeams, vertical hangers, and tie girders. Most corroded elements are located at the bridge parts where the moisture, water, and saltpeter remain for a long time, such as in the stringers and crossbeams due to the contact with the timber deck, and the arch ribs and tie girders, where organic residues are deposited (see Figs. 5 and 7).

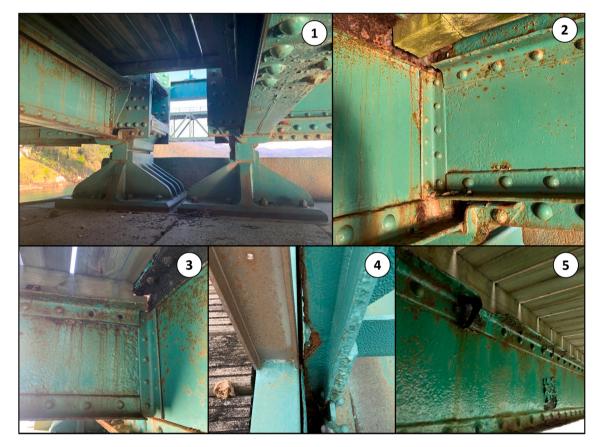
Fig. 7. Details of the current condition state of the bridge: (1) simple support and the gap between spans (2) connection between stringers and crossbeams (3) lack of rivets in a stringer (4) heavily corroded retrofitted vertical hanger (5) corrosion in a crossbeam.

Finally, the retrofitting works were observed. During the rehabilitation performed in 2006, the structure was painted for aesthetic and protection purposes. Besides, several rivets were replaced by bolts, and twenty-six cross-bracings and twelve vertical hangers were retrofitted or replaced. Indeed, new L-type sections were employed, which were connected to the old steel plates by welding instead of bolts. Remarkably, the vertical hangers that were joined by welding present a more severe corrosion state than the other hangers in the bridge. A brief detailing of all these issues can be observed in Fig. 7.

rotations of the stringers. Two different criteria were adopted for the main bridge connections, i.e., those involving vertical hangers, crossbeams, and tie girders. According to the visual inspection (see Fig. 7), pinned joints were assumed for the highly damaged connections, thus disregarding any bending moment capacity; while for the slightly damaged connections, rotational springs were introduced to allow the modeling of a semirigid behavior. On the other hand, regarding the contribution of other bridge components, the timber deck was introduced in the model as a dead load distributed on the crossbeams and stringers, assuming a density of 500 kg/m3, while the mass of the gusset plates was considered in the form of point masses acting at the different joints.

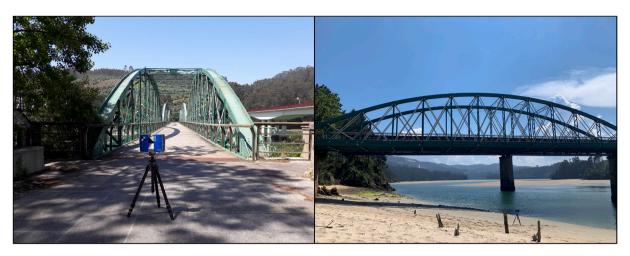
Fig. 8. Geometry data acquisition using Terrestrial Laser Scanner (TLS) technology.

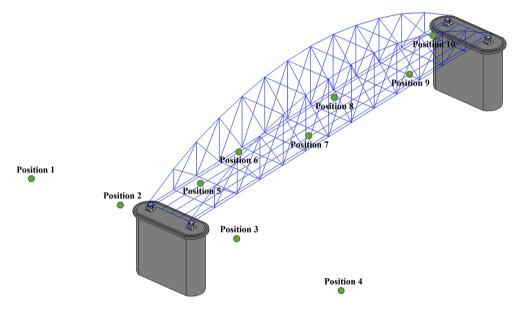
Fig. 9. Scheme of laser scan positions.

ease the posterior registration in a common coordinate system of all laser scans. Ten scan positions were recorded, six on the deck and four under the bridge (see Fig. 9). All laser scans were post-processed in the CloudCompare software [27]. A final point cloud comprising 12,431,238 points was obtained, which provided a detailed geometric description in the form of an "as-built" model that renders information not only about the overall geometry but also regarding the type and dimensions of steel profiles and their assembly. Furthermore, in the case of high-density laser scans, the associated point cloud can be additionally used to cross-check the cross-section dimensions of steel members.

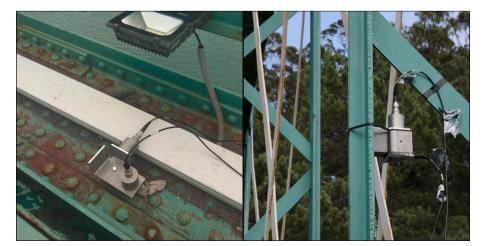
Fig. 11. Accelerometers placed on the tie girder and a vertical hanger.

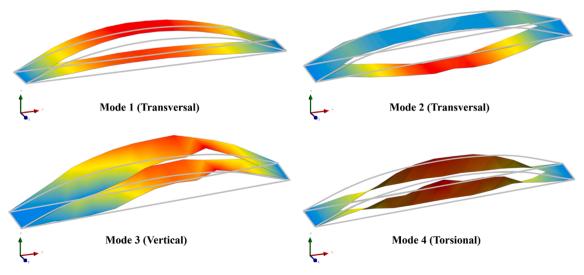
Fig. 13. Vibration modes obtained from the OMA test.

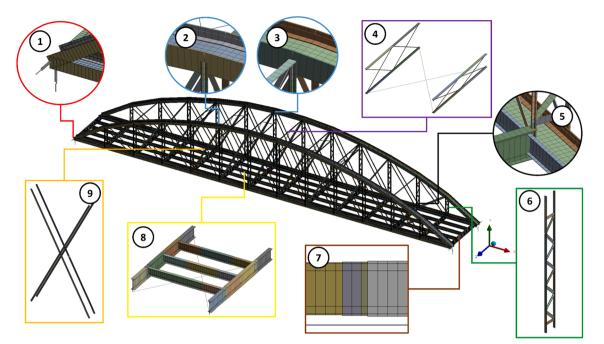
Fig. 14. FE model of O Barqueiro bridge.

The Finite Element (FE) model was developed in the ANSYS software package (see Fig. 14). The vertical hangers, crossbeams, and stringers were meshed by using second-order Timoshenko beam elements. For the cross bracings, since a stress-stiffening response is expected, they were modeled as tension-only two-node truss elements. For the arch ribs and tie girders, a mixed modeling approach was adopted where second-order quadrilateral isoparametric shell elements were used for the webs and second-order Timoshenko beam elements for the L-shaped flanges. In all cases, the complex shapes of the cross-sections of the beam elements were defined based on the experimental geometrical characterization (see Fig. 4). For the resulting arbitrary cross-section types, the crosssectional analysis was performed via the Finite Element Method (FEM) in order to obtain the warping independent and dependent properties. It is worthwhile to note that the actual position of the centers of gravity of the beam elements was accounted for by using suitable offsets from the supporting CAD axes (see details in Fig. 14). The mesh size of the FE model was derived from a sensitivity analysis aimed at guaranteeing an equilibrium between computational efficiency and accuracy. In this regard, a total of 11,667 beam elements, 140 truss elements, 11,412 shell elements, 70 beam end releases, 24 rotational springs, and 8 translational springs were employed.

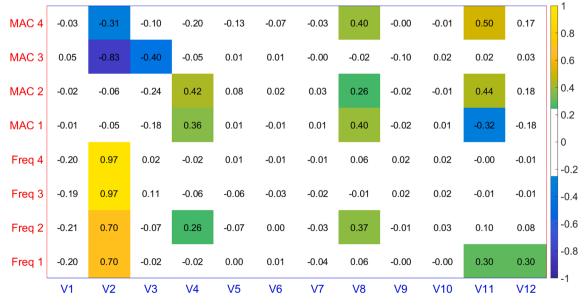
Fig. 15. Matrix of Spearman correlation coefficients relating input parameters to output responses.

stiffness of the slightly damaged steel connections, and the supports' translational stiffness in the transversal direction are the most influential parameters into the bridge modal responses. Hence, all of them were considered in the following model calibration process.

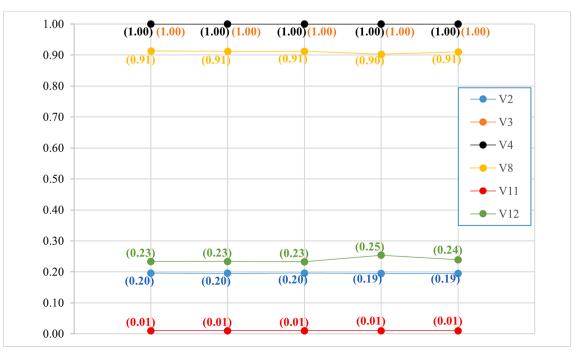
Fig. 16. Normalized values of the calibration parameters for the different genetic algorithm runs.

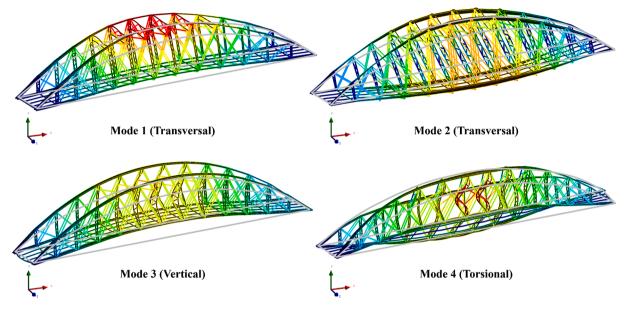
Fig. 17. Numerical mode shapes after model calibration.

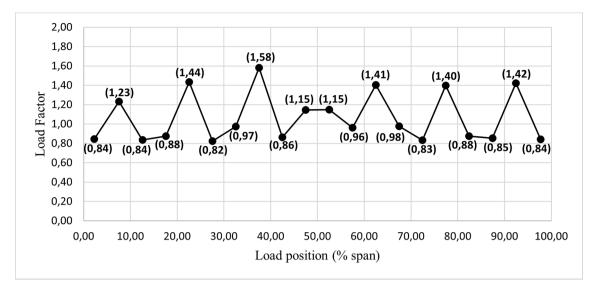
Fig. 19. Failure load factors for the different loading positions along the span length of the bridge in the deterministic analysis.

The results per loading position are indicated in Fig. 19. In this figure, an asymmetry in the failure load factor results can be noticed. These deviations can be attributed to the damaged condition of the steel connections involving the tie girders, vertical hangers, and crossbeams. For the critical loading scenario (sixth position), the failure mechanism of the bridge is shown in Fig. 20. The failure is triggered in the stringer positioned in the middle of the load model application. The live loads deform this structural element until a hinged mechanism is formed, leading to a flexural failure. No significant bending moments are transferred to the connected crossbeams despite the appreciable bending of the stringer. This is due to the action of the beam-end releases, which mimic the actual steel connections, allowing free in-plane rotations.

The obtained failure load factors seem to indicate that the roadway traffic can not safely cross the bridge. Nevertheless, reliability analysis, which explicitly considers the parameter values uncertainty, should be used to compute the ultimate load-carrying capacity more accurately. This way, a more reliable judgment about the actual safety condition of the bridge can be emitted.

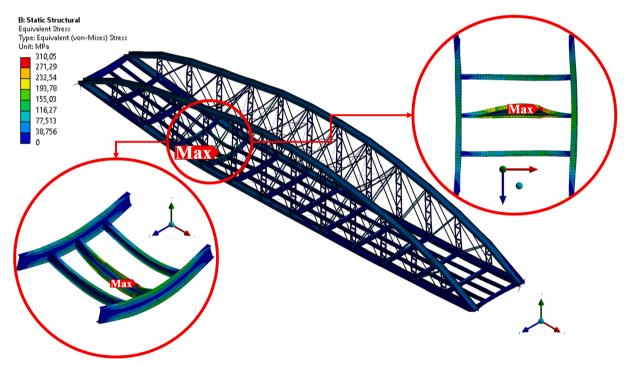
Fig. 20. Detail of the bridge failure mechanism for the critical loading position.
