IN-SITU DEFECT DETECTION USING ACOUSTIC VIBRATION MONITORING
FOR ADDITIVE MANUFACTURING PROCESSES

A Thesis
presented to
the Faculty of California Polytechnic State University,
San Luis Obispo

In Partial Fulfillment
of the Requirements for the Degree
Master of Science in Industrial Engineering

by
Ali Harake
June 2022

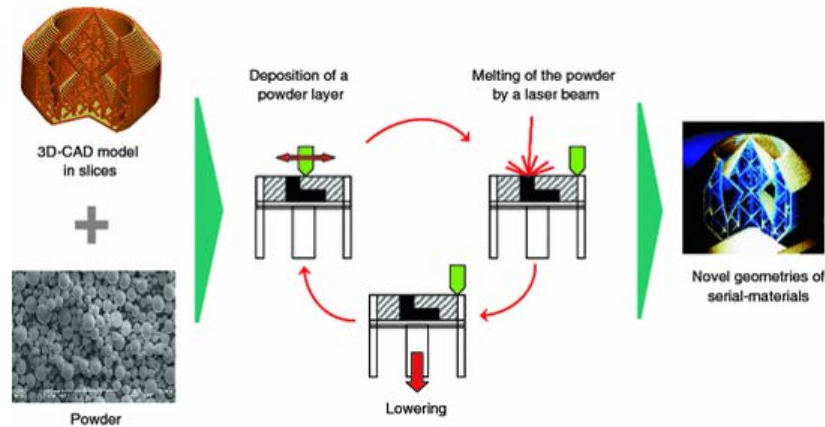
Figure 1.1: Simplified PBF printing process

metallic powder together to effectively grow parts. An example of the process can be seen in Figure 1.1 (TWI-Global 2022).

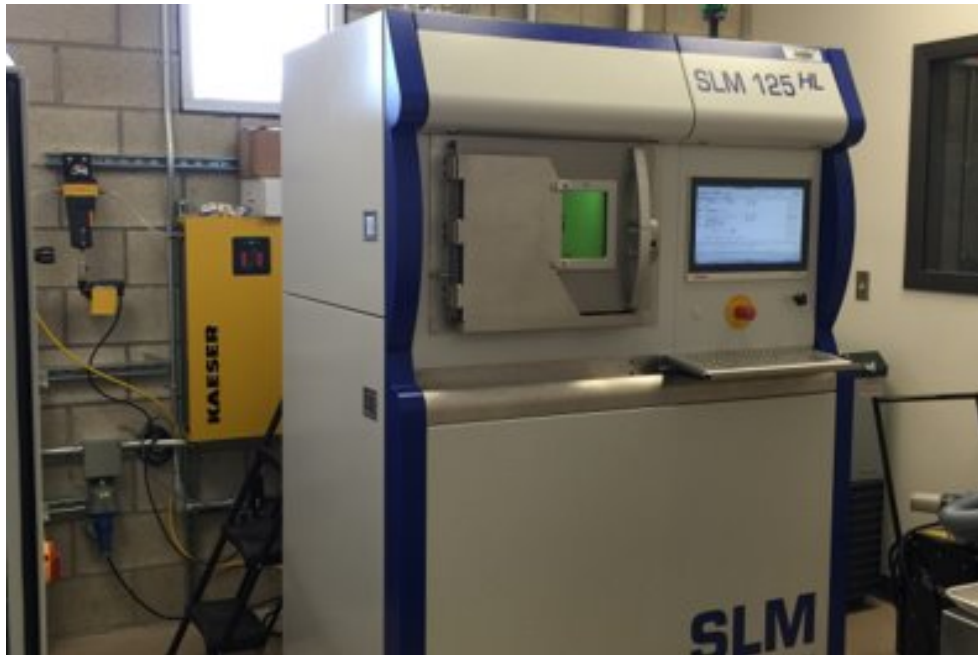
At California Polytechnic State University – San Luis Obispo, or Cal Poly for short, the Industrial Engineering department operates and maintains a SLM Solutions 125 HL, shown in Figure 1.3. This machine was donated to Cal Poly by Lawrence Livermore National Lab in 2017 and its primary purpose is to aid research and senior projects. The SLM 125 features a 125mm x 125mm x 125mm build envelope, which is enclosed in an airtight, argon purged chamber during builds. As seen in Figure 1.4, the build chamber features a powder recoater in the +Y direction that recoats powder after each layer by moving in the -Y direction and then back to its home position (Swartz, 2019). The build plate moves down with each new layer to accommodate for the parts' growth while the argon continuously flows in a laminar fashion across the X axis throughout the build. The build plate can also be set to heat up to a max temperature of 200 °C by the operator depending on what is being printed. Through the SLM software all the print settings can be monitored and output through a .csv file. The printing media that is used is stainless

steel 316L powder from SLM solutions. It is loaded into a top hopper approximately 22kg at a time and is recycled through an in-house sieving unit. There is a laser unit that provides the heat source for melting the powder. This laser can reach a maximum power of 400 W. To create a perfect part, many parameters may need to be manipulated and set during each build. These parameters may include: laser power, layer height, build plate temp, scan speed, fill pattern, hatching distance, etc. Another important feature of this printer is the camera within the build chamber. This camera is normally used to analyze the powder coverage across the build plate by taking pictures after the recoater has moved and just before the laser begins to scan. These images are saved after each build and can be used for outside analysis such as defect or error analysis during a build.

Figure 1.3: SLM solutions 125 HL at Cal Poly

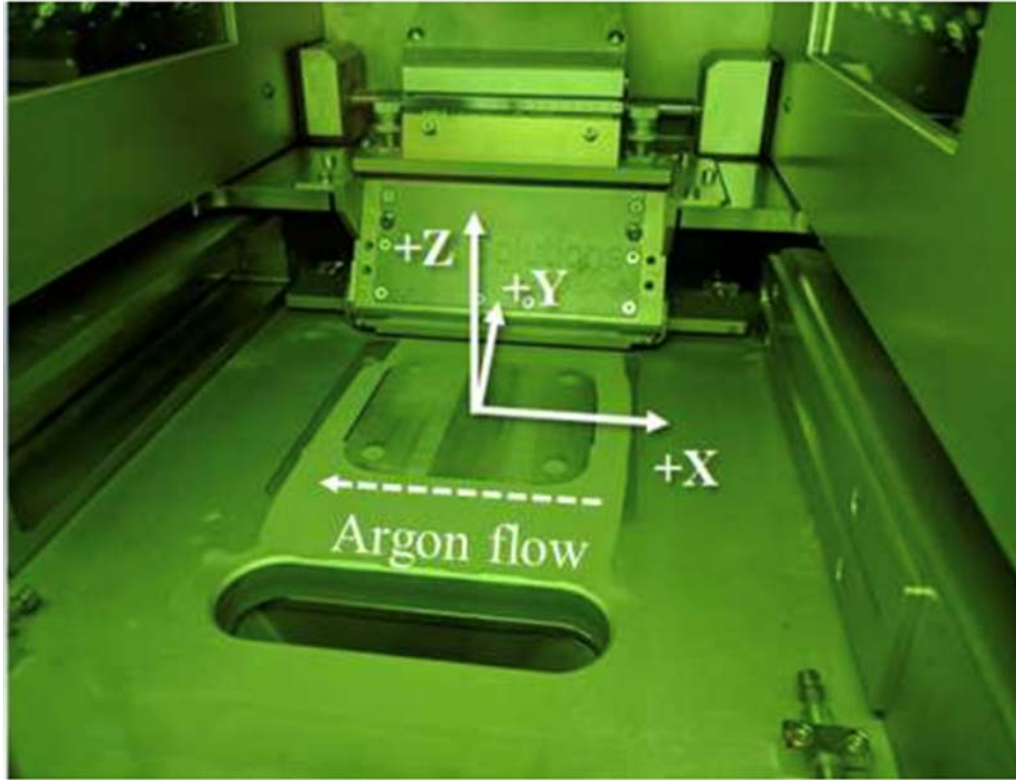
Figure 1.4: SLM 125 build chamber with build coordinate system and gas flow direction

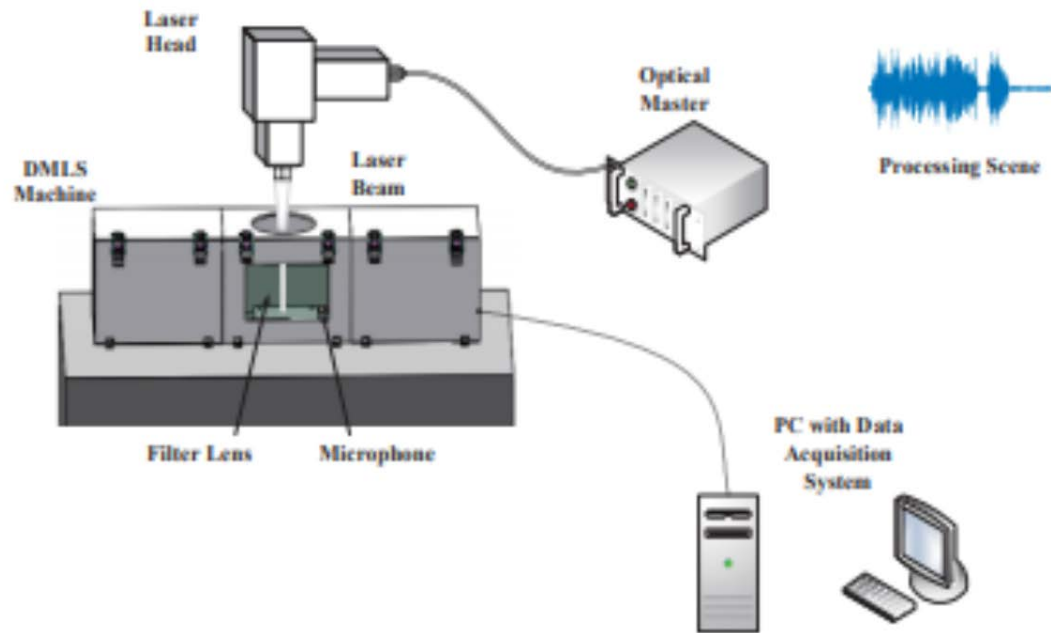
Figure 1.6: Basic setup of acoustic monitoring on a LPBF machine

for data interpretation are only just beginning to be understood for use in AM processes. A simple setup of acoustic monitoring set up on LPBF machine can be seen in Figure 1.6 (Shevchik et al., 2019).

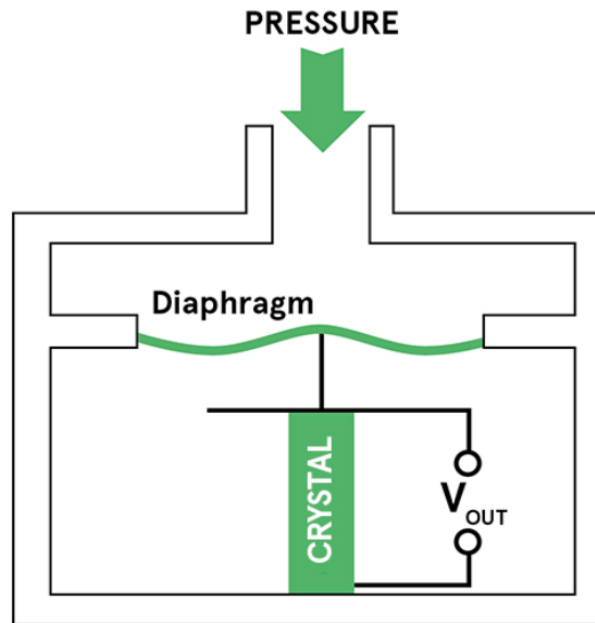
Figure 1.11: Inner workings of a piezoelectric sensor

piezoelectric sensor can be seen Figure 1.11 (Avnet, 2021). This pressure can take the form of sound waves, force, pressure, and frequencies. These types of sensors are good at measuring small changes in pressure, even in high pressure situations. A downside is that these sensors are limited to operating below temperatures of 120°C. Also, the high impedance output of this type of sensor means that the circuit is sensitive to noise caused by poor connections, movement, and RF interference. For these reasons, this type of sensor was strongly considered but was not chosen for this design.

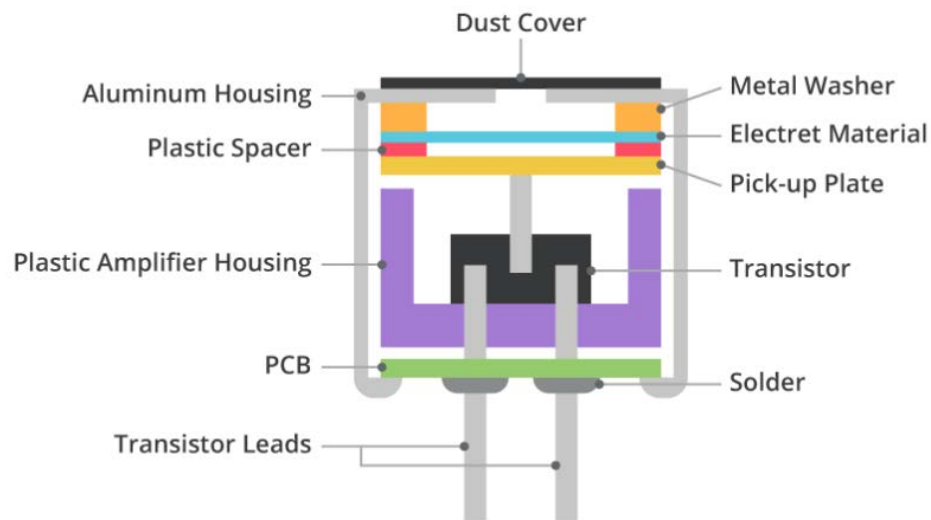
Figure 1.12: Electret condenser microphone inner workings

polarizing voltage to operate successfully. A diagram of this type of sensor and the inner workings is shown in Figure 1.12 (ECM, 2021). Electret condenser microphones are most commonly found in telephones, global positioning systems (GPS), and hearing aids. They can be used for high frequency acoustic measuring, while maintaining a high caliber of protection from elements like dust and moisture. This is ideal for the current parameters of our experiment, so the chosen sensor for this project was an electret condenser microphone. The chosen sensor was a Devmo LM393 module, as seen in Figure 1.13.

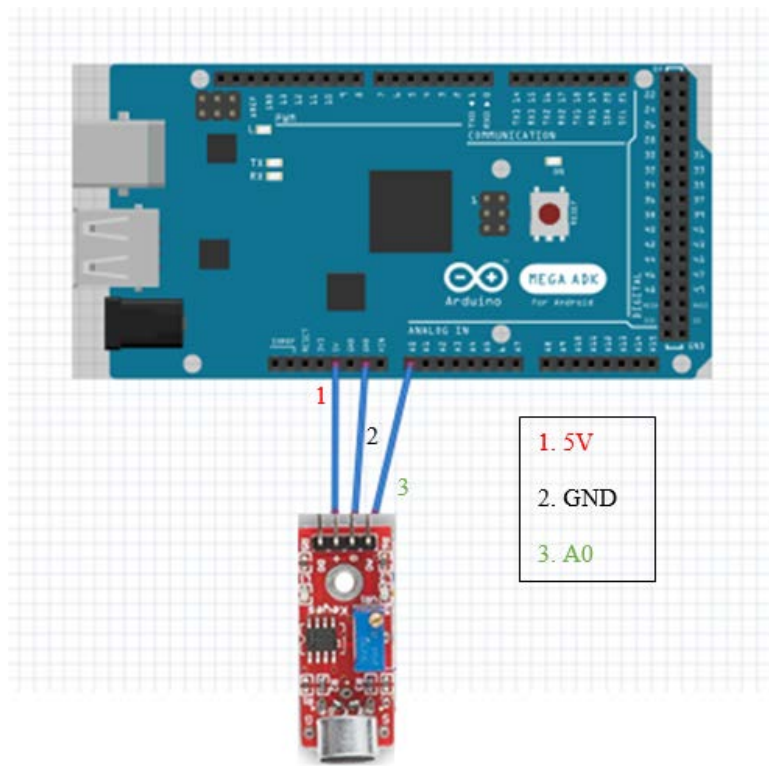
Figure 2.1: Fritzing diagram of Devmo sound sensor to Arduino connection

The current design incorporates the use of an Arduino Mega 2560 coupled with a Devmo LM393 electret sensor connected together using male to female jumper wires. A Fritzing diagram can be seen in Figure 2.1, which illustrates the necessary inputs from the Arduino that the sensor needs. In order for the sensor to output data through the A0 analog connection, it requires a 5v input and a grounding wire to operate properly. The sensor is activated through code within the Arduino. The code will be explained in more detail in section 2. The two components are housed in separate 3D printed enclosures which will then be mounted onto the SLM 125. These two components can be seen together in Figure 2.2. These components collect the data and process it, it is then fed into a Raspberry Pi which organizes the data and then uploads it to a OneDrive folder where it is then ready for processing.

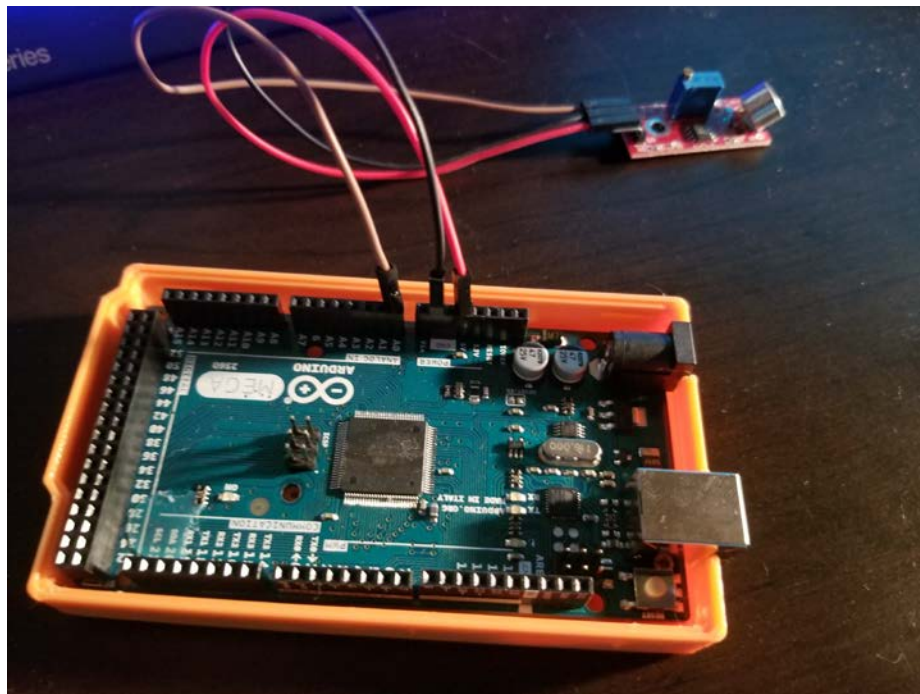
Figure 2.2: Arduino Mega 2560 signal converter connected to Devmo sound sensor

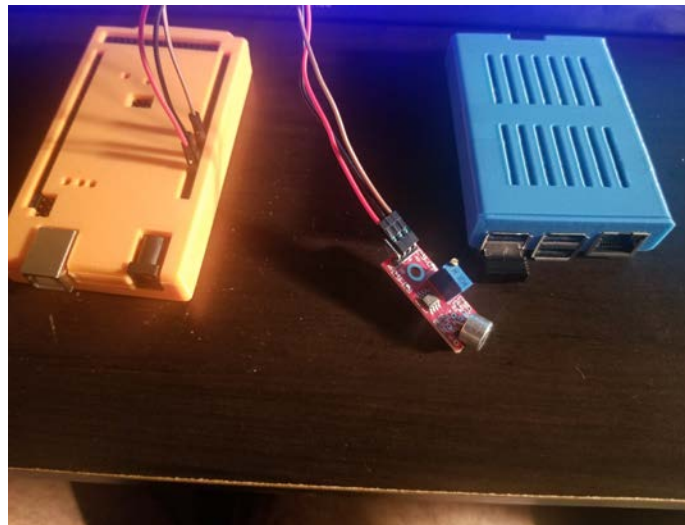
The data collection and organization portion of this experiment is handled by a Raspberry Pi 3. This device is a low cost, miniature computer that can be connected to Wi-Fi or ethernet. The versatility that this connectivity provides opens up the possibilities for companies to keep their information internal to their servers or visible to the open web. The reason for connecting the Arduino to a Raspberry Pi is to both create a smaller footprint for the device as well as enable the Arduino to solely focus on deciphering the data, while the Raspberry Pi can handle the majority of the processing/interpretation. The Raspberry Pi is secured in a 3D printed enclosure and connected to Arduino using a USB A to USB B connector. The 3 main components (Arduino, Sensor, and Raspberry Pi) can be seen in Figure 2.3. These three components are then mounted onto the additive machine of choice in a position that is close enough to the build chamber to pick up the different frequencies that may occur during the build.

Figure 2.3: Arduino (Left), Devmo sound sensor (Middle), and Raspberry Pi (Right)

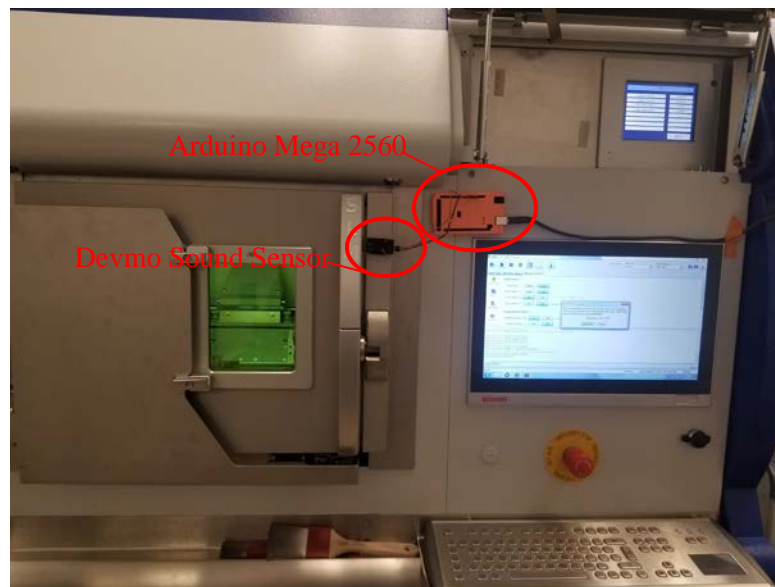
Figure 2.4: Image showing mounting positions of sound sensor and Arduino

The sound sensor assembly is attached to the SLM 125 using Velcro strips so that it can be removed for updates or maintenance. Each piece is secured in a strategic location that will not interfere with the operation of the machine nor any doors that may need to be opened periodically. The wires are temporarily taped to prevent any potential to be accidentally pulled. Figure 2.4 shows the location of the sound sensor and the accompanying Arduino. This location is the closest to the build chamber while still being outside of the chamber, in an ideal situation the sensor would be within the chamber and away from outside noise pollution. Some fine tuning will be necessary to create an average ambient noise frequency, in order for the sensor to be able to detect anomalies. Figure 2.5 illustrates the chosen mounting position for the Raspberry Pi on the topside of the machine. In Figure 2.6 the monitor setup can be seen off to the side of the machine. These components connected in series make up the entirety of the monitoring system.

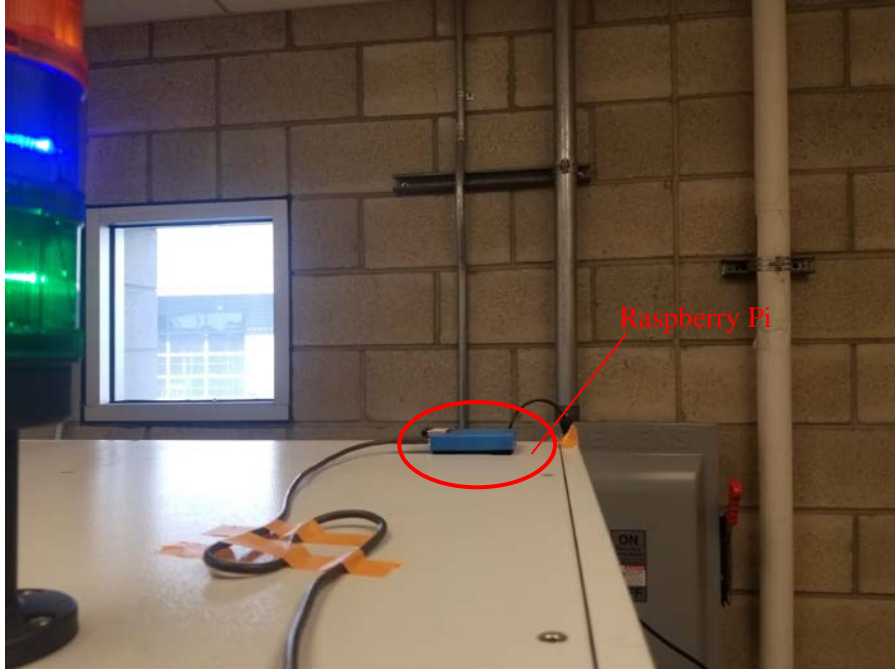
Figure 2.5: Image showing mounting location of Raspberry Pi (Top side of SLM 125)

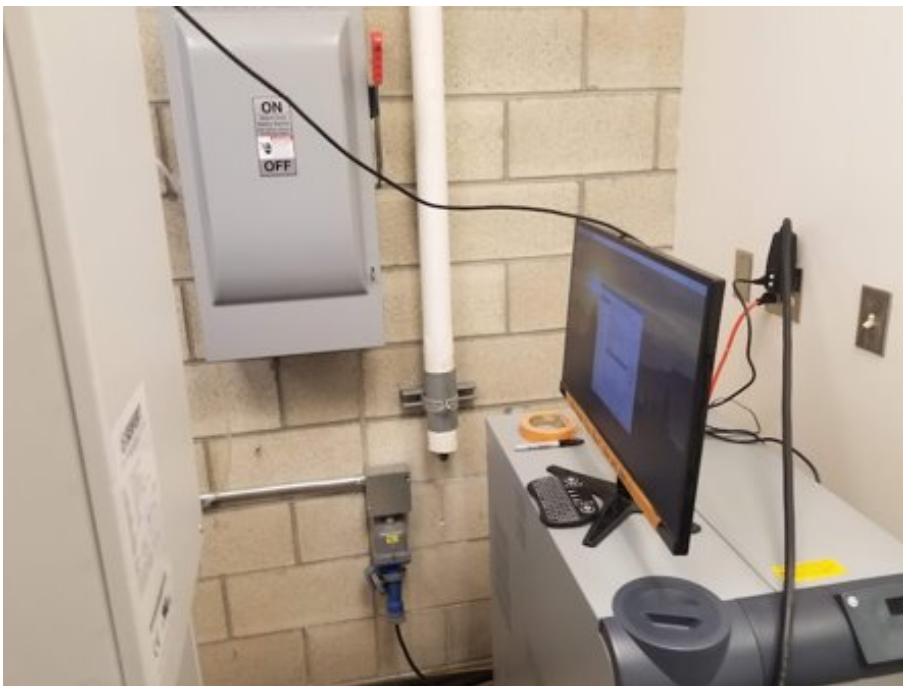
Figure 2.6: Monitor setup to visually analyze data and interface with Raspberry Pi

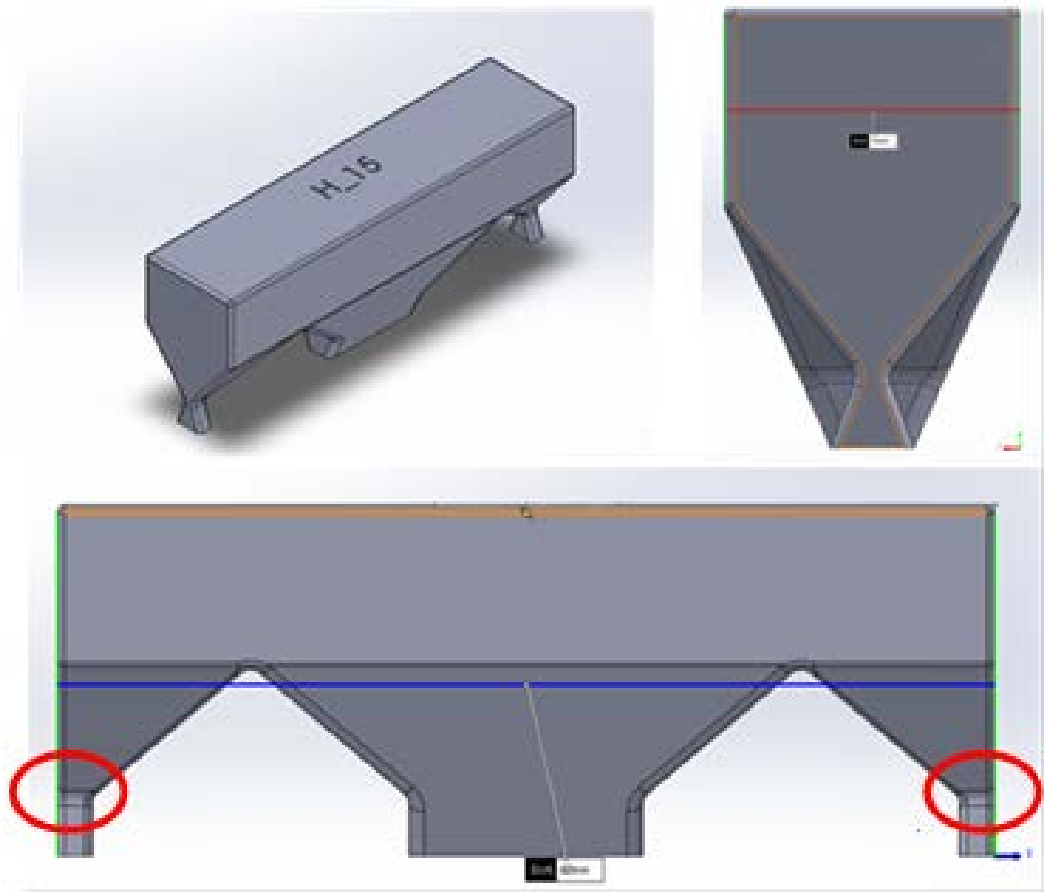
Figure 2.10: Modified DOE coupon, designed to fail at red outlined areas

Originally, there was a planned design of experiments which incorporated a modified test coupon originally designed for a previous project. This coupon can be seen in Figure 2.10 and was designed to fail by cracking at the outlined red areas. The failure would be induced by a lack of efficient heat transfer due to the drastic diameter change. This failure would be catastrophic for the part and would produce an audible sound that would be picked up the sensors. The height of this failure could be controlled, and a test plan could be developed to correlate the failure with any triggers from the sensors. As

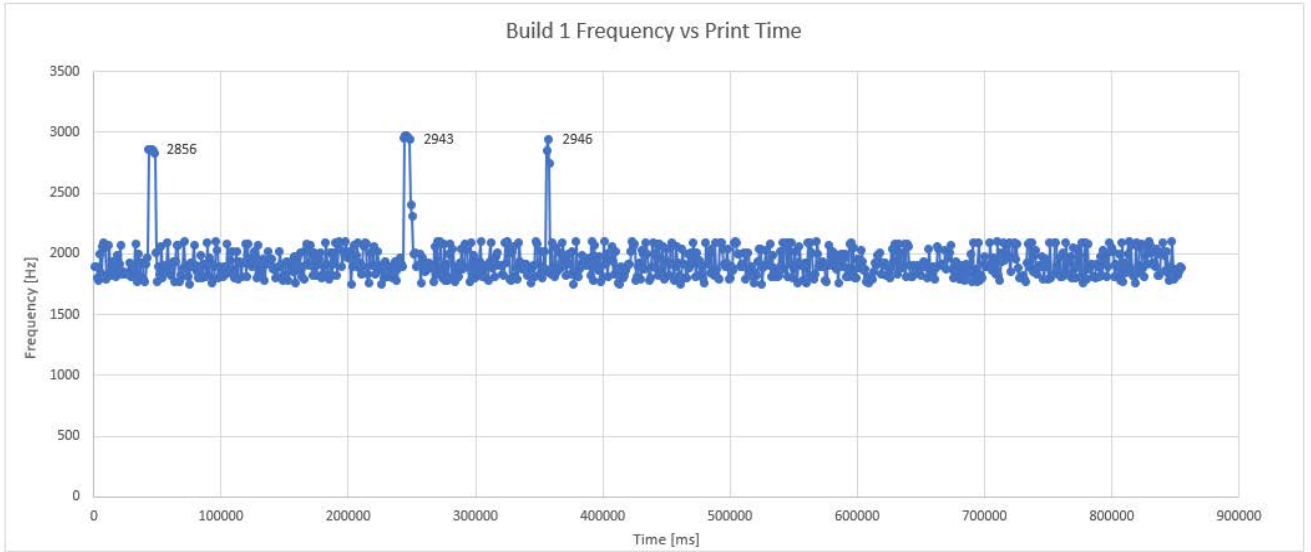
Figure 3.1: Build 1 frequency vs. print time plot (11-03-2021)

This preliminary data shows promising results as the system appears to identify deviation from the ambient decibel conditions surrounding a standard print. Although there are no images to support these anomalies, the frequency response from Build 1 and

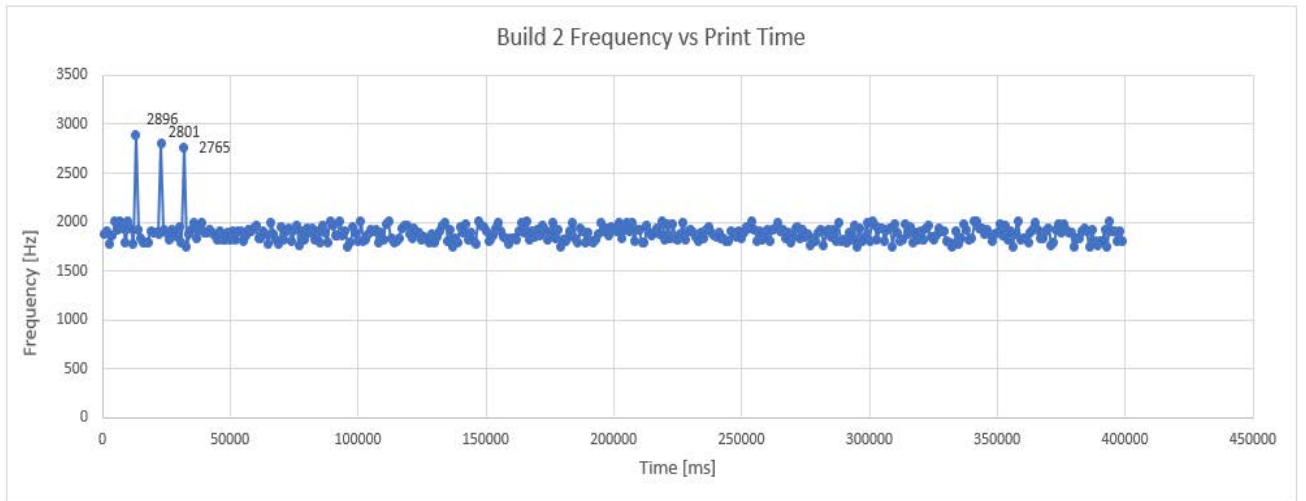
Figure 3.2: Build 2 frequency vs. print time plot (12-15-2021)

Build 2 demonstrate that it is possible to isolate some type of natural sound, whether it is caused by the print or some outside variable, requires further validation and testing.

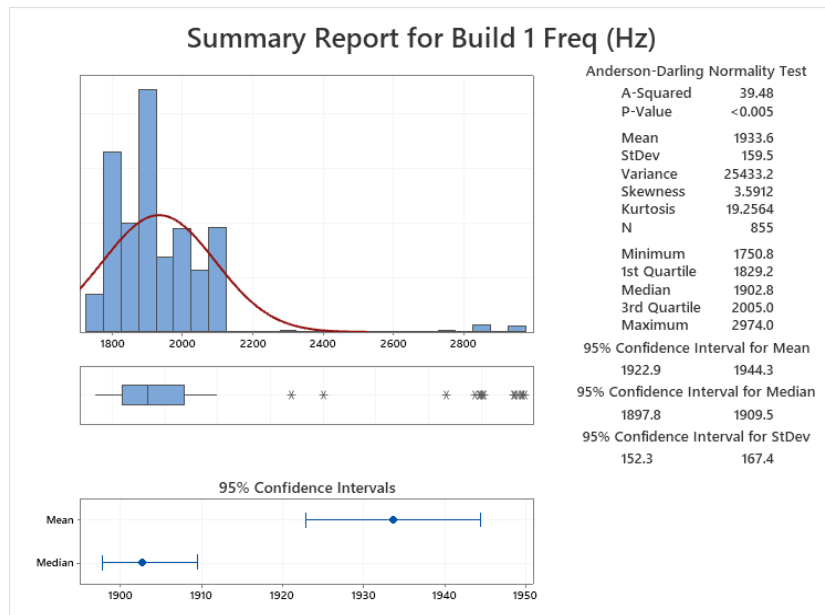
Figure 3.3: Descriptive statistical analysis for homemade system using Minitab - Build 1

Using the Anderson-Darling normality test, seen in Figure 3.3 and Figure 3.4, we can reject the null hypothesis ($p < 0.005$), therefore, the data is not normally distributed. A 1-sample sign nonparametric test was then conducted to estimate the median of the population (Figure 3.5). According the 1-sample sign test, we are 95% confident that the median frequency falls between 1897 and 1909 Hz, any values that are more than 3 standard deviations from the median are significantly different. The same pattern is found in the statistical analysis of Build 2. These experiments yielded preliminary anomalous readings that may correlate to significant events within the build. Frequencies that exist above the original ambient measurements may indicate defects within the build. However, more data is required to fully confirm this

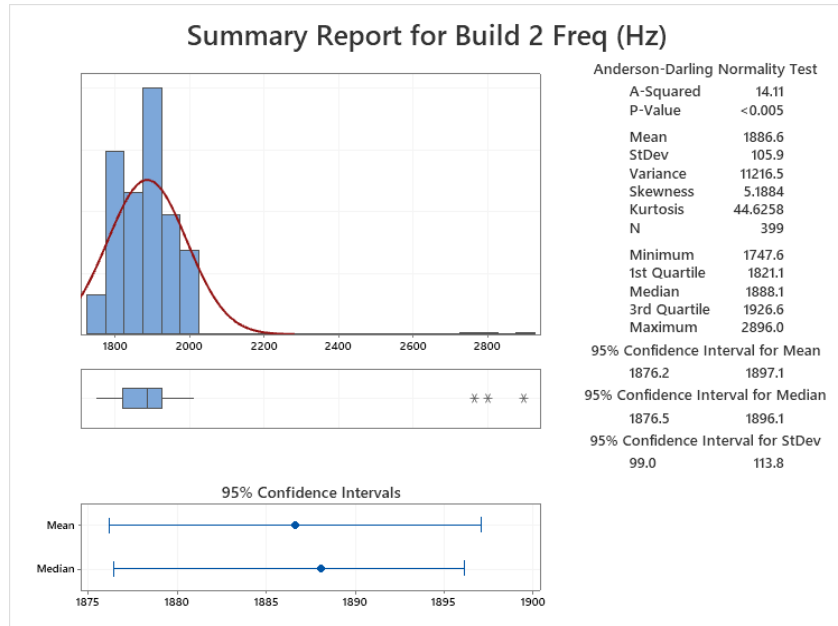
Figure 3.4: Descriptive statistical analysis for homemade system using Minitab - Build 2

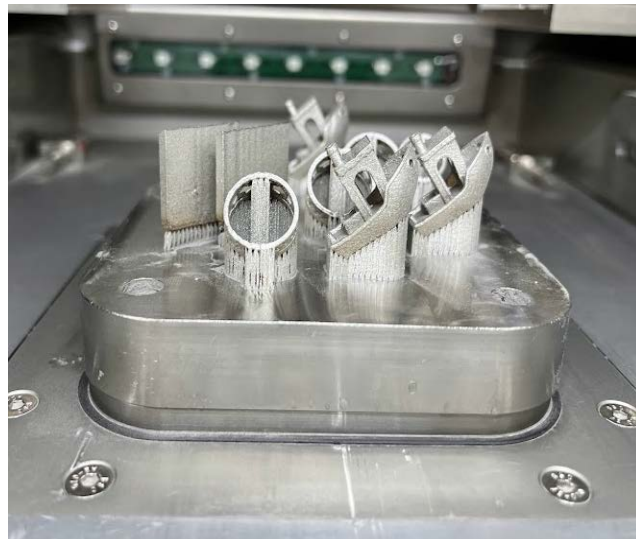
Build 3 began as a starter build to build momentum for the print team as we began the quarter. The goal was to print a few items that were not particularly complicated, but still valuable in the context of building confidence in operation of the machine and verification of the parameters and material. This build consisted of standard “benchys” FDM stress test parts, orthogonally designed rings, and two AM welding flat coupons. The print was optimized to minimize difficult to reach internal support structures (Figure 3.6). From the figure below, the quality of the finished build appears good, with minimal discoloration and/or warpage. The sensor data was collected parallel to the removal of the build and was processed into a scatter plot (Figure 3.7). The sound sensor appears to pick up some sort of disturbance during the beginning of the build, which is indicated by the jumps in frequency values in what appears to be systematic increments. This timing roughly correlates to the rake’s movement between sessions.

Figure 3.6: Completed Build 3 with parts on build plate (Welding coupons, rings, and benchys)

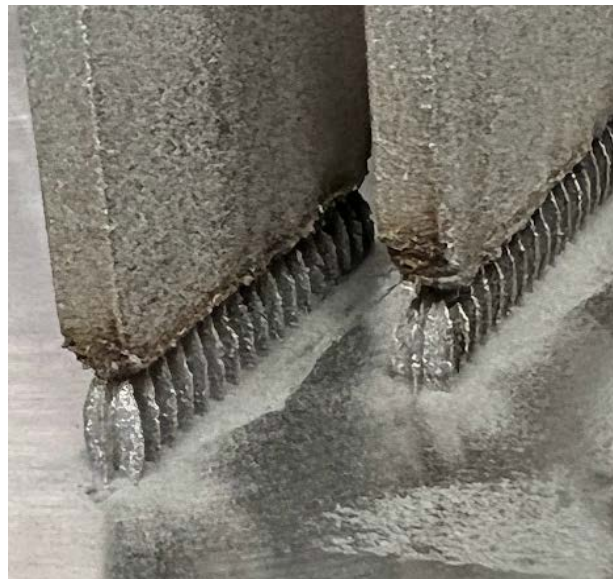
Figure 3.8: Enhanced image of welding coupons, emphasizing the delamination between the part and support structures

When the parts were examined, there were some visible adhesion issues between the welding coupons and the support structures at the edge of the part. This can be seen more clearly in Figure 3.8, and may indicate some issues with heat dissipation from the part to the build plate or a lack of powder in the mating surface between the part and support. Another potential hypothesis for edge separation is the lack of support structures present on the curvature of the part.

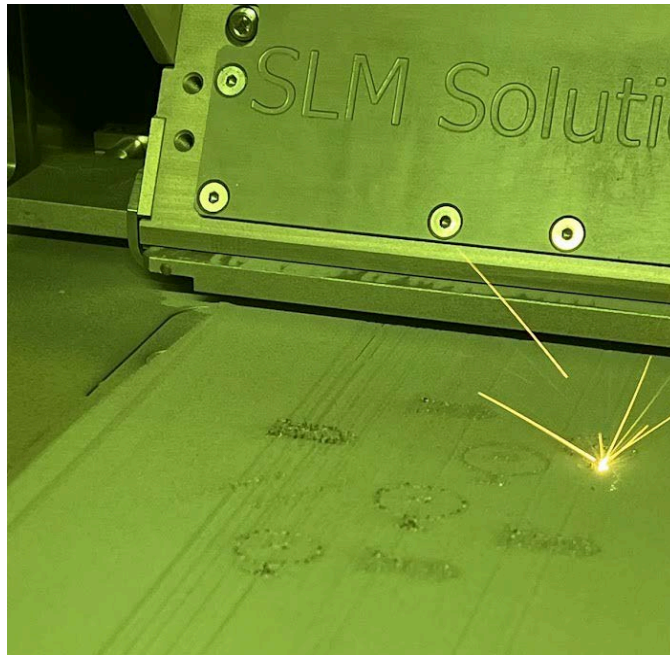
Figure 3.9: Image of the first few layers of build 3 in which the support structures in front of the welding coupons were overexposed due to an issue in preprocessing

Upon further examination of the processed build file, it was determined that the file had overlapped STL files, causing the software to overexpose the support layers during the first 25 layers. This resulted in a buildup of material in a few areas. The original overlapped parts were corrected early in the print, but this initial correction did not seem to prevent issues as the parts grew in the Z-direction. Figure 3.9 shows this issue during the first few layers of the build; the streaks were later determined to be the main cause of the part's delamination. These physical observations led to a deeper analysis of the data provided by the acoustic sensor during the first 50 layers. The zoomed in version of the above plot can be seen in Figure 3.10. Initially it appears as though there is a consistent ping that occurs at similar intervals. These intervals occur every 40 seconds and likely correspond to the movement of the rake across the build platform. An interesting situation happens after several minutes as it appears that the sound disappears and then reappears. This can be attributed to a few possibilities as the introduction of powder flowability may contribute to a decrease in the amount of powder across the raised areas which would cause them to not interact with the rake. After the first few layers, the issue was corrected on the software and the program resumed without the overlapping support structures. This fixed the interference issue but continued to leave streaks in the powder as the rubber rake had already been sufficiently damaged.

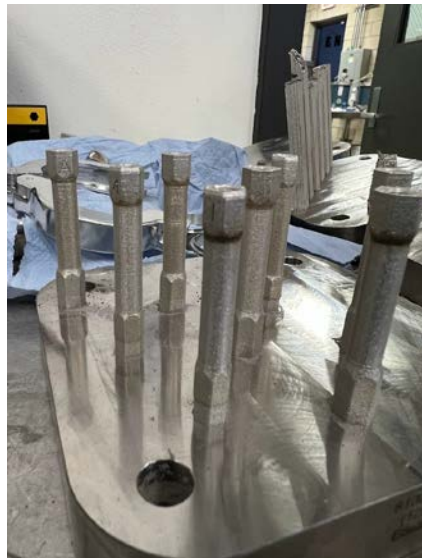
Build 4 consisted of several iterations of a thin walled pressure vessel. These vessels were designed to test the minimum wall thickness required to prevent leakage of air through the body of the part. As can be seen in Figure 3.13, the vessels were aligned in a staggered formation to prevent overpressure of the rake during powder spread. For the most part, the test specimens appear to be uniform in color and build. Upon further inspection, it can be seen that the intersection between the main body and the topmost hex mating surface shows signs of discoloration or lack of proper heat dissipation. This discoloration can potentially be a sign of delamination at this intersection, which could allow for leakage. The zoomed in image showing the discoloration up close can be seen in Figure 3.14. These parts took approximately 16 hours to print, during which data was collected using the sound sensor setup. The compiled data appears to provide some potential insight on the timing of anomalies that occurred and their correlation to the timing of the layers of interest.

Figure 3.13: Build 4 thin-walled pressure vessels test coupons

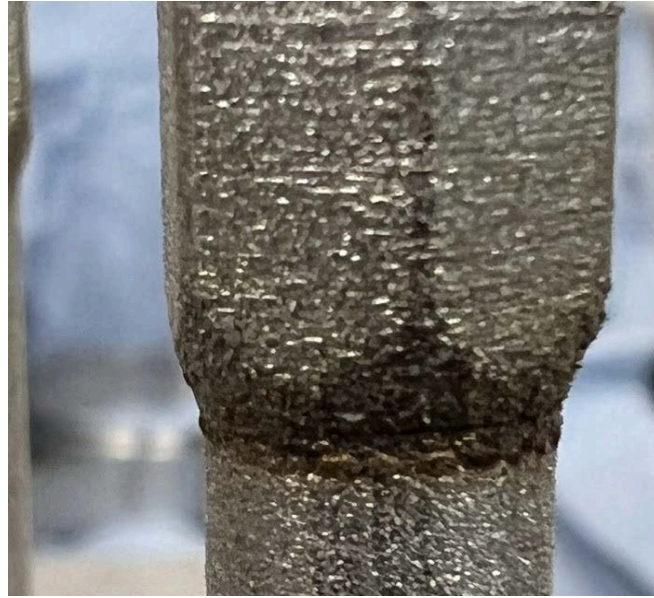
Figure 3.14: Zoomed in image on intersection between hex and main body showing discoloration and potential leak points

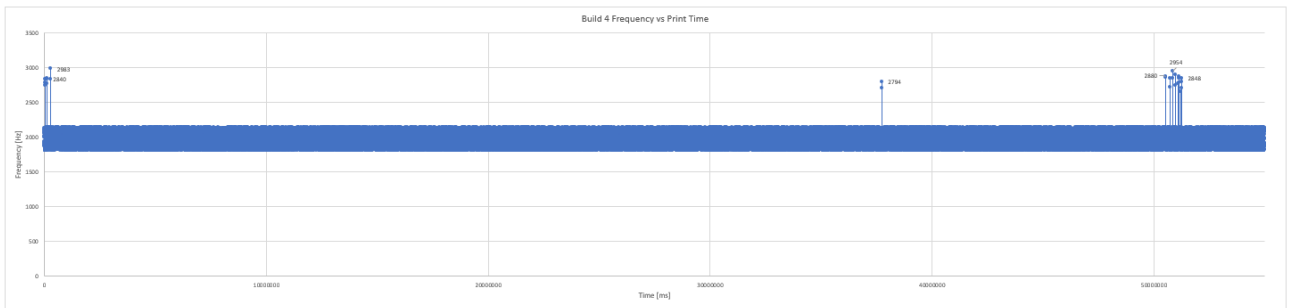
Figure 3.15: Build 4 frequency vs. print time plot (02-22-22)

From the plot in Figure 3.15, there appear to be some irregularities at the beginning and at the end of the build. There is also a single trigger $\frac{3}{4}$ of the way through the build. This single irregularity was inspected further and deemed inconclusive as there were no visible surface defects on the parts, nor were there singular leakage issues that could be pinpointed to this layer. The sections that appear to have issues happen between 0-9 minutes and 830-860 minutes. By zooming in on these two time periods, it can be seen that there are definitive frequency fluctuations at these slice layers.

During the first 9 minutes of Build 4, a significant frequency change was recorded 3 separate times. These spikes in frequency could have been the result of potential cracks or breaks within the support layers in the first 20 layers (Figure 3.16). This can be common within the early layers depending on the support type chosen or the asymmetry of the powder distribution process. Another potential reason for these spikes could be that students or techs were in the room during this time and created metal on metal noise

Within the 830-860 minute timespan there are substantially more spikes in frequency. This series of events appears to correlate to the transition period between main body and the hex threaded section. In Figure 3.17, the signals seem to have some methodical rhythm as though they trigger in conjunction with the rake moving back and forth. A theory in correlation with this observation is that the laser is creating a slightly raised surface that is coming into contact with the recoater on the forward and reverse passes. This could be due to the lack of heat dissipation due to the large change in mass from the thin wall to the full thickness hex threaded area. The timing of this change in frequency correlates with the anomaly found on the parts, however, coincidence cannot be ruled out as a possibility.

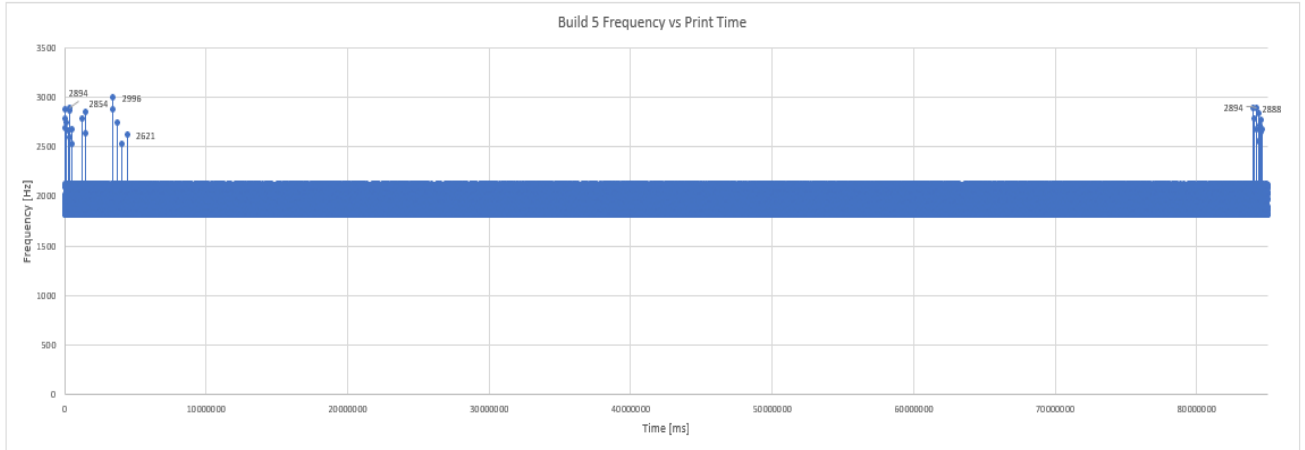
Figure 3.20: Build 5 frequency vs. print time plot (02-24-22)

The acoustic monitor was able to pick up distinct alerts at 3 separate time intervals from 0-27 minutes, 53-83 minutes, and 1397-1430 minutes. These intervals can be seen collectively in Figure 3.20 and correspond to layers 0-62, 113-177, and 2884-2954, respectively. These layers were pulled from the print log files by correlating the times with the layer height in the log. This method was also used to pull the images of the build, so that they could be compared with the acoustic analysis. Within these intervals, there are many potentials for an alarm to be raised as there could have been internal stresses, support structure movement, or crackage.

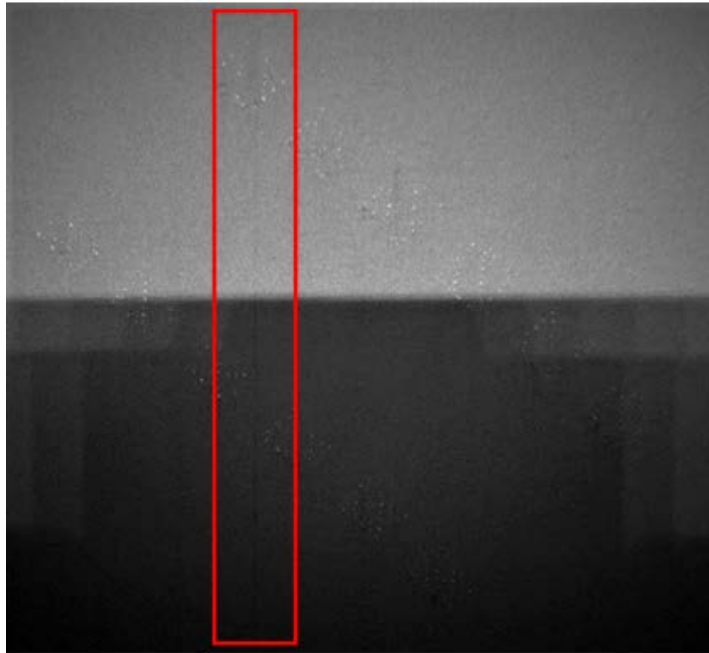
Figure 3.24: Build 5, Layer 36 first signs of rake deterioration with streak appearing

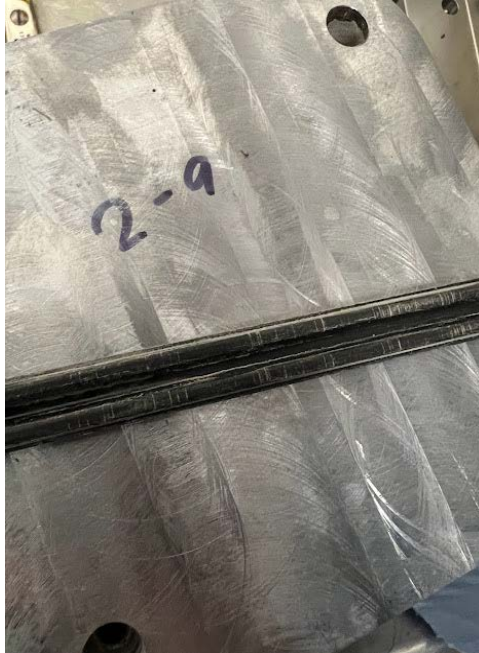
Figure 3.25: Damaged rubber recoater blade indicated by the lines filled with powder

size and spread throughout the recoater blade. It is apparent that the recoater has been damaged and will need to be replaced (Figure 3.25).

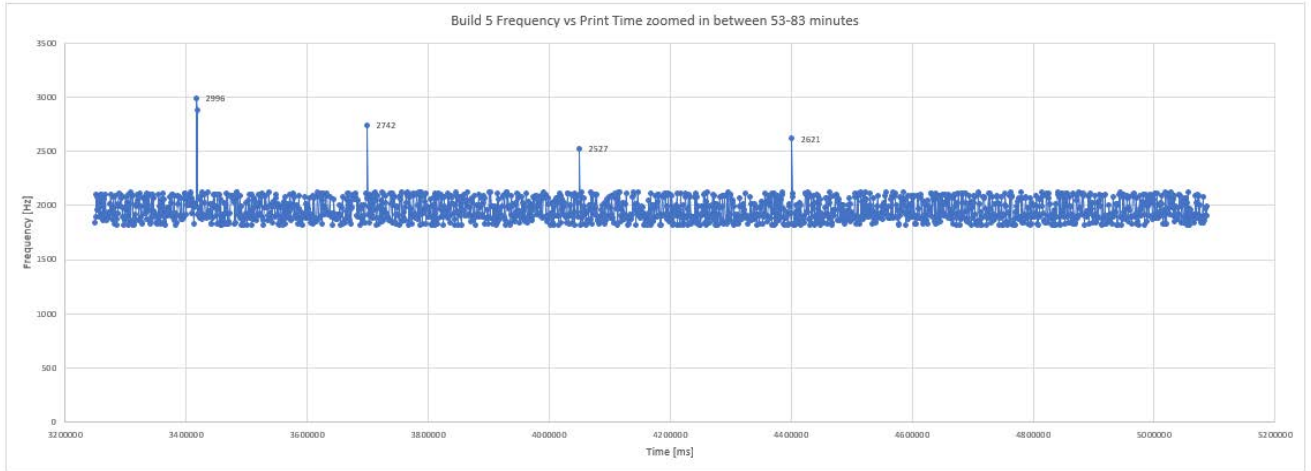
Figure 3.26: Build 5 frequency vs. print time zoomed in during 53-83 minutes (02-24-22)

Another interval that triggered a few responses was between the times of 53-83 minutes equating to layers 113-177. These layers were during the actual build of the parts with some sections still building support structures. From Figure 3.26, it can be deduced that there were a few notable pings that were registered within the software. When coupled with the images taken during this time, there are noticeable streaks that appear throughout the build plate, as seen in Figure 3.27. These streaks could have triggered some frequency response if an elongated support structure caused damage to the recoater blade and the underlying metal. In Figure 3.28, a few sections are highlighted to illustrate their change in height compared to the surrounding areas. These spots appear to be higher since they cast a faint shadow behind them on the powder. This intriguing phenomena is difficult to replicate as over time it sometimes self corrects these issues, potentially due to the particle grain distribution and natural flowability around the parts.

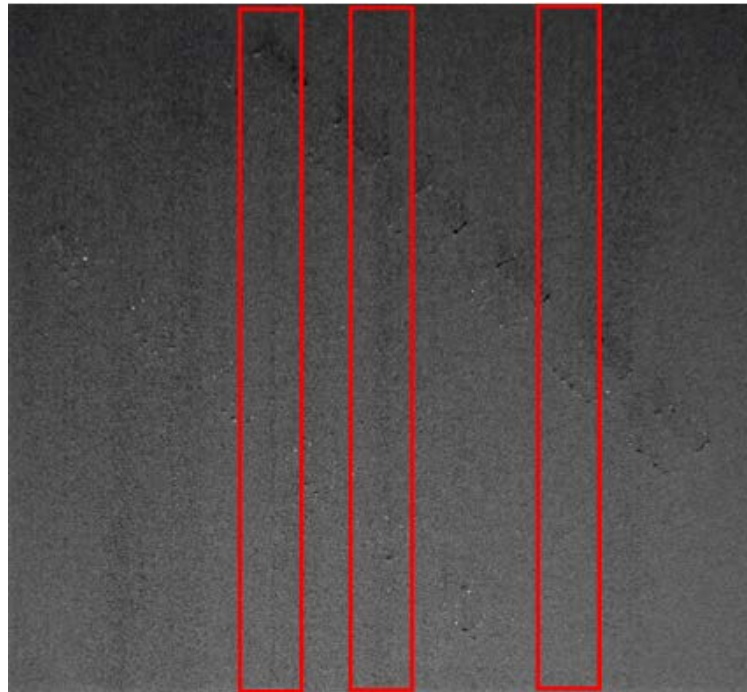
Figure 3.27: Build 5, Layer 131 multiple streaks present outlined in red showing locations that the recoated blade has been damaged

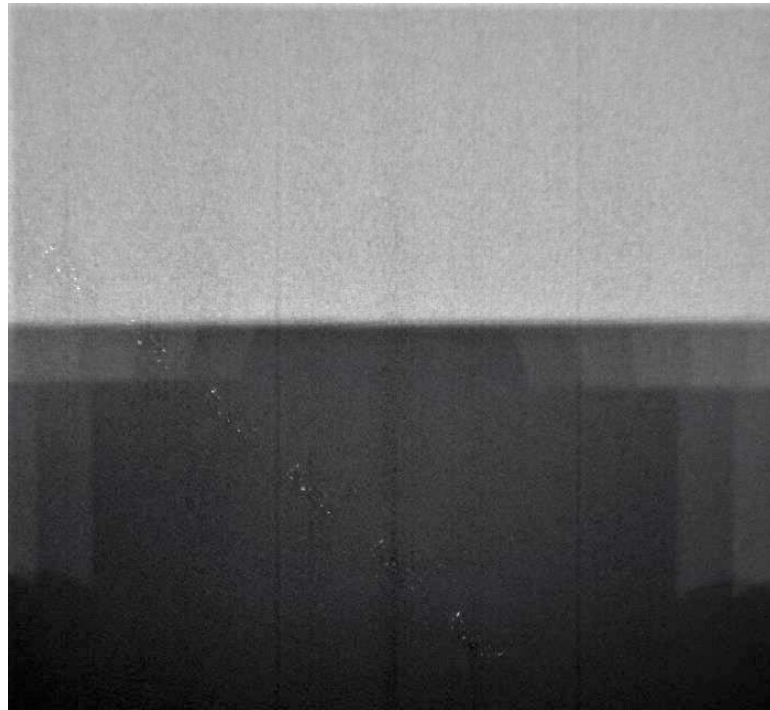
Figure 3.30: Build 5, Layer 2289 evident streaking and melted material protrusion from build plate

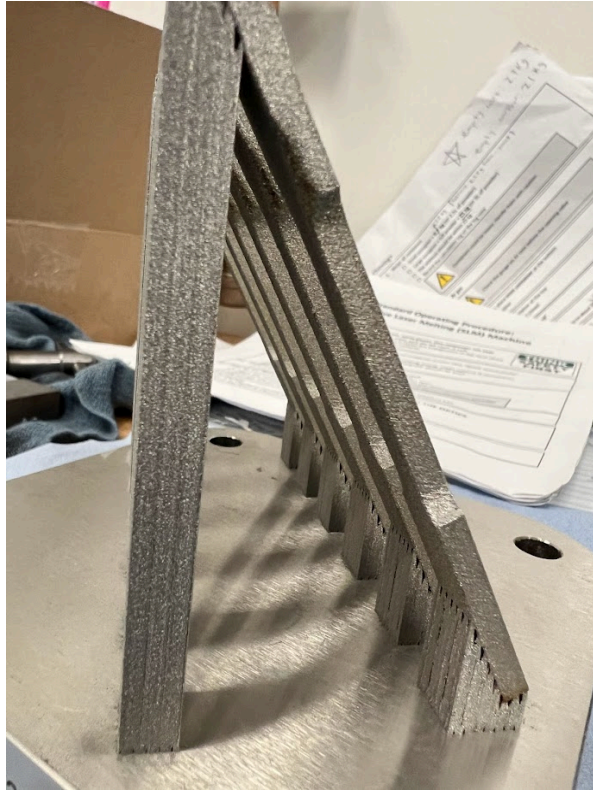
Figure 3.31: Side shot of Build 5 highlighting quality of build with minor discoloration at overhang

Overall, this build seemed to complete properly without any visible surface defects or issues. From the side profile seen in Figure 3.31, minor discoloration can be seen from the transitional section between the upper radius and lower main body section. This is to be expected as the part goes from a larger mass to a smaller cross sectional area. The dissipation of heat can cause discoloration and, in this case, the discoloration is minor.

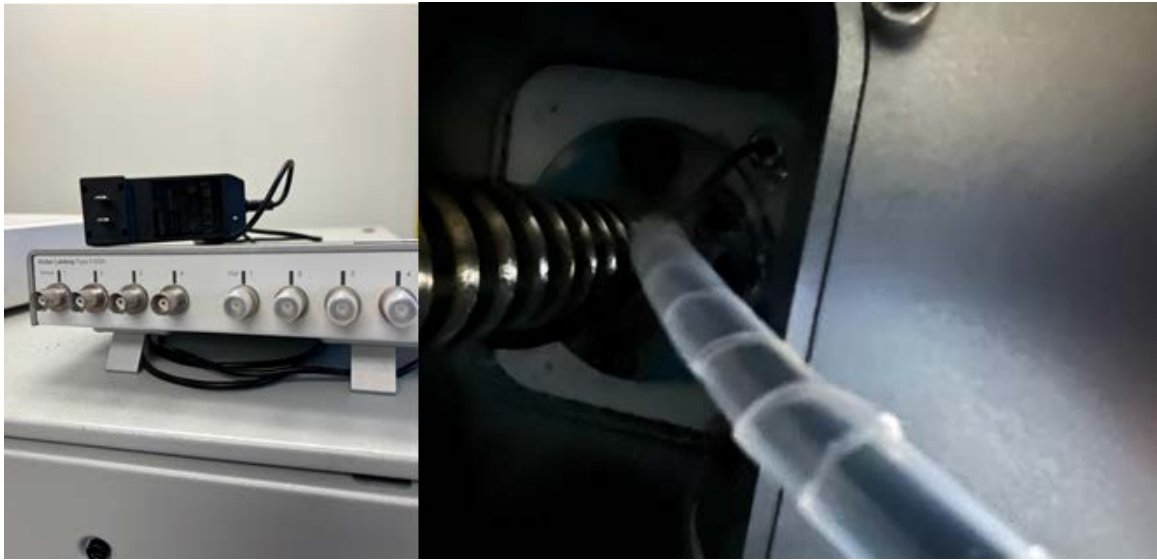
Figure 3.33: Kistler DAQ system (Left), Mounting location under build plate for accelerometers and sound monitor (Right)

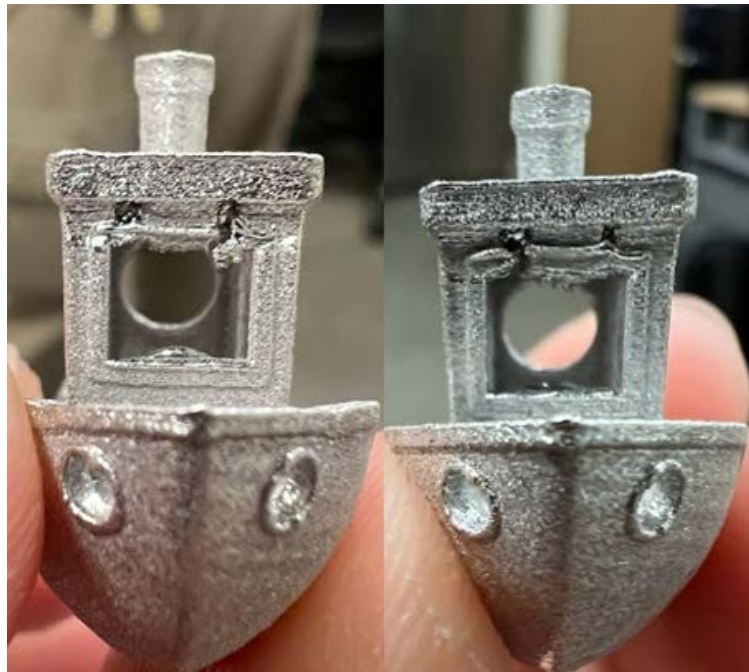
Figure 3.35: Picture of overhang failure on non-supported roof
