IN-SITU DEFECT DETECTION USING ACOUSTIC VIBRATION MONITORING
FOR ADDITIVE MANUFACTURING PROCESSES

A Thesis
presented to
the Faculty of California Polytechnic State University,
San Luis Obispo

In Partial Fulfillment
of the Requirements for the Degree
Master of Science in Industrial Engineering

by
Ali Harake
June 2022

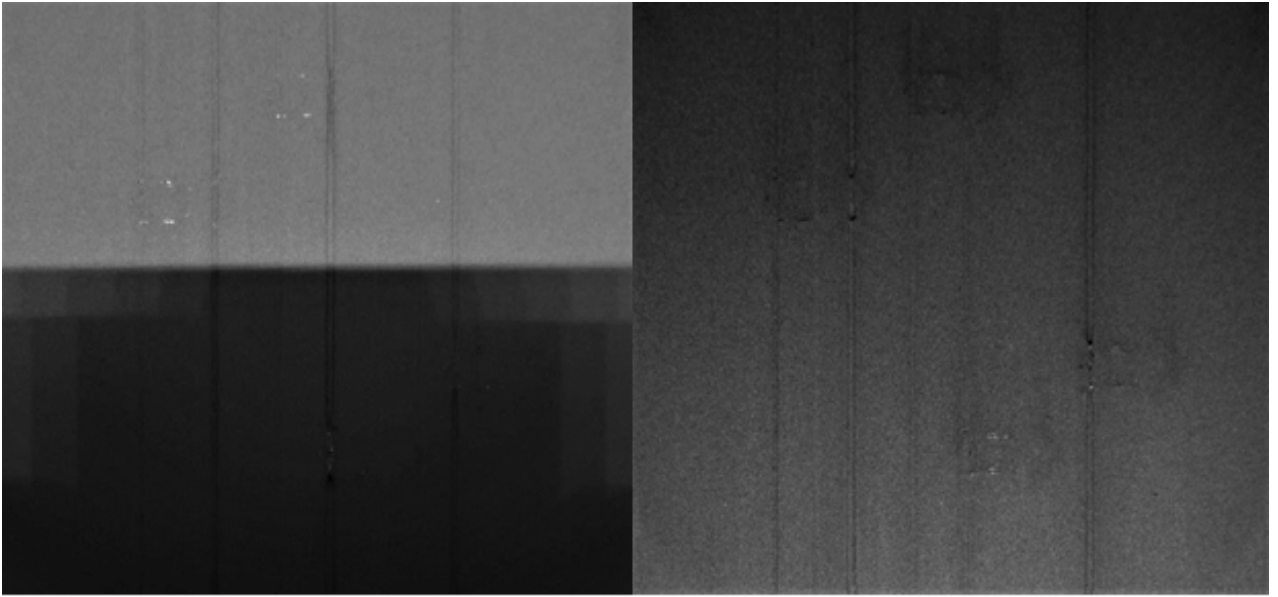
Figure 3.41: Build 6, Layers 812-813 minor anomaly detected, these layers appear to be the lower end of the benchy roof

to minimize and even out, as seen in Figure 3.41. This is recorded in the sensor system by reading a lower frequency ping for these particular layers.

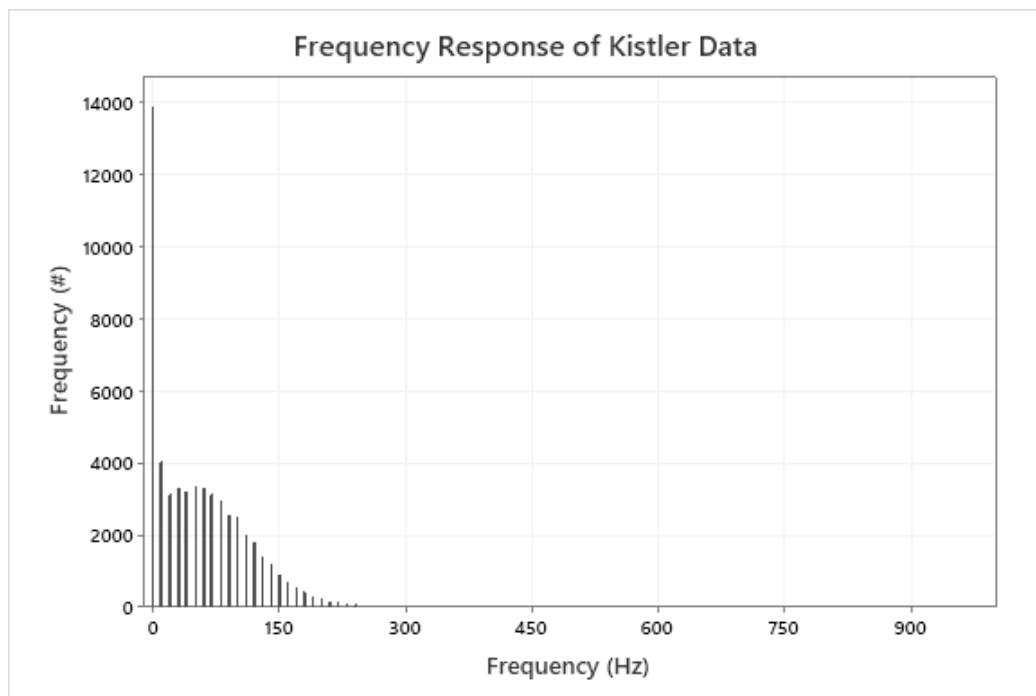
Figure 4.1: Frequency response plot using Discrete Fourier Transform analysis

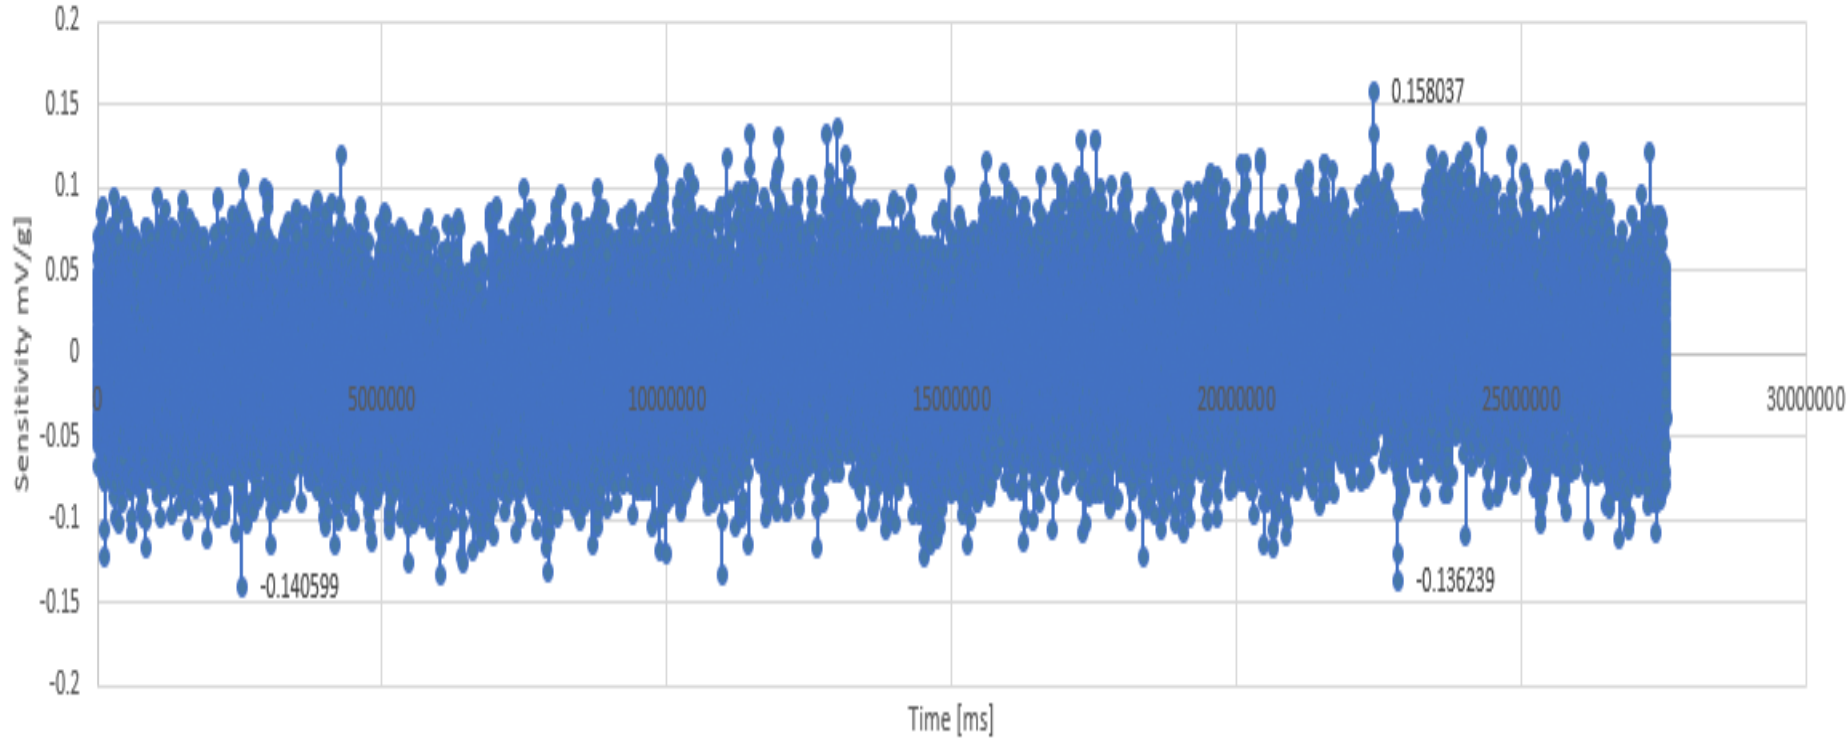
Build 6 Sensitivity vs Print Time using Kistler DAQ
