High resolution 3-D modelling of cylinder shape bodies applied to ancient columns of a church

Giuseppe Casula¹, Francesco Cuccuru², Maria Giovanna Bianchi¹, Silvana Fais^{2,3}, and Paola Ligas²

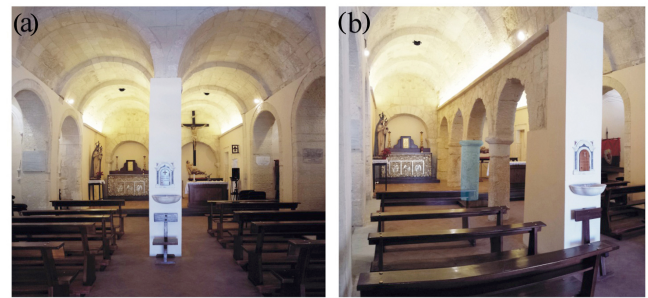
Figure 2. The interior of the church of Saints Lorenzo and Pancratio: (a) the two barrel vaulted naves; (b) the columns that support the round arches (the investigated column is highlighted in light blue).

The monument was built with local limestone ashlar and is characterized by two barrel vaulted naves (Fig. 2a) divided by round arches that rest on squat columns. The investigated column (Fig. 2b) is in the Doric order. It is built with the local Pietra Forte limestone, which was widely used in the past for its excellent geomechanical characteristics.

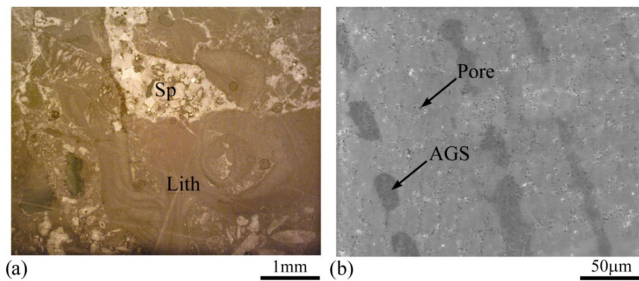
Figure 3. Textural characteristics of the Pietra Forte limestone: (a) lithotamium algae (Lith) and sparry calcite cement (Sp), OM plane polarized light; (b) microporosity and algal growth structures (AGS), SEM image.

The first step of our methodology is an accurate microscopic examination of petrographic thin sections and a scanning electron microscope (SEM) analysis of the above carbonate materials to identify their textural characteristics and especially the nature and distribution of their porosity. Knowledge of these rock properties is fundamental to interpret the acoustic behaviour of the study carbonate rocks (Fais et al., 2019a) while providing the best criteria for understanding their alteration processes. The Pietra Forte represents the top facies of the upper Miocene Calcari di Cagliari Auct. (Gandolfi and Porcu, 1967; Cherchi, 1974). This lithology is characterized by well cemented and poorly porous biohermal and biostromal shelf limestones. According to the Dunham classification of carbonate sedimentary rocks (Dunham, 1962) Pietra Forte can be classified as boundstone, mainly made up of Lithotamnium algae and organogenic mollusc remains cemented by sparry calcite (Fig. 3a). Microscopically,

Pietra Forte is a very compact carbonate with micropores less than $4\ \mu\text{m}$ in size, mainly related to the algal structures (Fig. 3b). The amount of micropores is about 1%–4%. However, this lithotype is also characterized by secondary pores due to post-diagenetic dissolution processes that develop in karst cavities at the macroscale. The amount of macropores is relative because it depends on several factors, such as the degree of fracturing and water circulation which favours the karst phenomena.

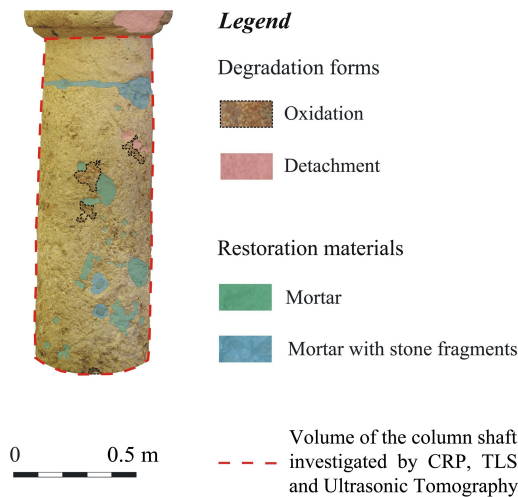
Figure 4. Shallow macroscopic characteristics of the investigated column.

At the preliminary macroscopic observation (Fig. 4) the studied column is characterized by shallow chemical alteration such as oxidation which colours the building material red, mainly at the base of the shaft. In the capital some material detachments occurred due to physical causes. The signs of previous restoration works are clearly visible in various sectors of the shaft (Fig. 4). These include mortar applications at times combined with stone fragments as filling materials.

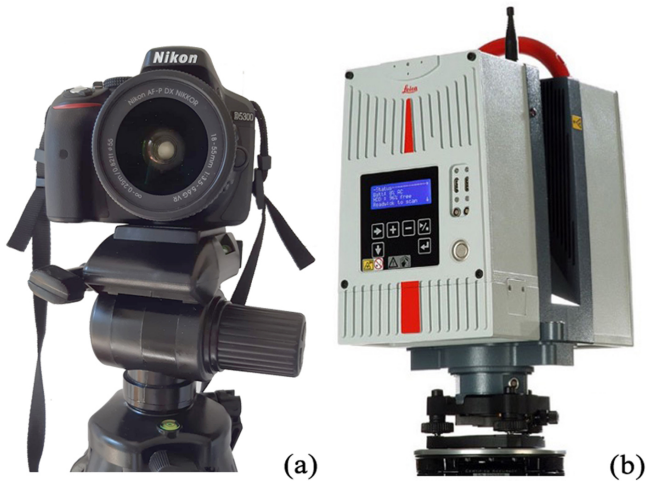
Figure 5. (a) The Nikon D5300 Camera. (b) The Leica HDS-6200 TLS.

In this study the photogrammetric survey was carried out using a Nikon D-5300 Single-lens Reflex digital camera mounted on a tripod (Fig. 5a). A set of about 50 high quality 2D images was acquired evenly spaced all around the study column with a good level of exposition and successive images were acquired with an overlap of at least 30%. Images are first visually inspected and processed with Agisoft Metashape[®] software. After a fine registration procedure of the images a unified point cloud is generated using the algorithm of the structure from motion (SfM) photogrammetry and formatted as input for the JRC 3D Reconstructor[®] software by Gexcel, which is used for cloud processing and is applied in the following stage of the processing.

In this work the TLS survey was planned and carried out with a Leica HDS-6200 phase shift TLS (Fig. 5b). In practice, after an examination of the target object, the survey was scheduled to select the best place to locate the station points. The survey was carried out on 4 station points inside the church evenly spaced around the studied column. We collected four points cloud (one for every station point) of some millions of points. Every station point cloud was rotated and translated with respect to each other; one of them was used as an intrinsic reference system (IRS). The clouds

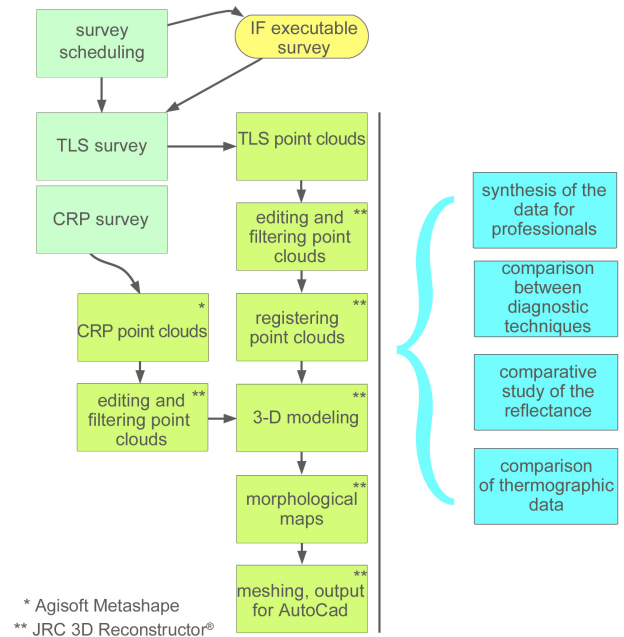
Figure 6. Flow chart of the TLS and CRP data acquisition and processing.

elaboration process of TLS data is performed with the aid of JRC 3D Reconstructor[®] by Gexcel and can be summarized as follows: point cloud input and format conversion, point cloud pre-processing and automated filtering or manual editing with the elimination of data out of tolerance and unusable points, cloud to cloud draft alignment and fine registration with bundle adjustment algorithms, cloud aggregation, 3D modelling and computation of morphological maps, output in a format suitable for input on AutoCAD[®] styled facilities (Fig. 6).

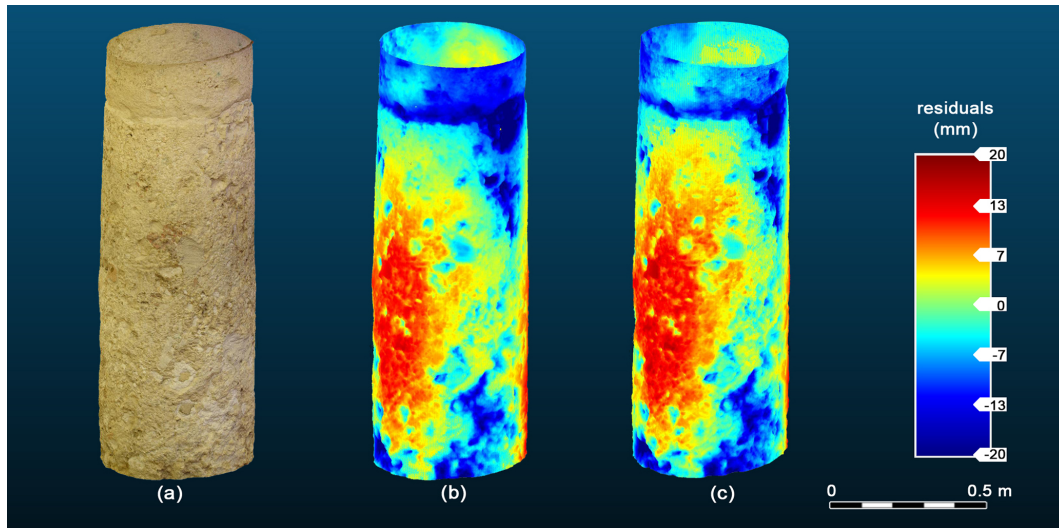
Figure 7. Detail of the body of the column object of this study. (a) 3D model derived from the synergistic application of CRP and TLS; (b) geometrical residuals (m) obtained by comparison of the CRP 3D model with the reference shape of a regular cylinder; (c) geometrical residuals (mm) obtained by comparison of the TLS 3D model with a regular cylinder. The comparison between the two techniques shows there are no significant differences between TLS and CRP. The differences are visible in the small details: in panel (c) the more prominent parts are more visible (graphic elaboration with JRC 3D Reconstructor[®] and CloudCompare, 2020).

point clouds pertaining to this monument is represented. The radiometric information represented in colour scale denotes the geometrical anomalies pattern of the materials of the outer surface of the investigated column and are expressed in mm.

was the study of the cylindrical shape of the previously described column that was 3D modelled by CRP and TLS techniques and analysed very precisely. The residuals of CRP and TLS 3D models, computed as the difference with respect to a meshed cylinder of a 1×1 mm step fitted to the unified clouds and taken as a reference, are comparable in dimension and shape and vary in the range ± 20 mm. In Fig. 7 the areas coloured in blue represent negative anomalies, while those in red represent the zones of the material characterized by positive anomalies compared to the regular cylindrical geometry adopted as a reference. The resulting CRP and TLS surface anomalies (Fig. 7) show the altered parts and defects of the shallow materials. Weathering and alteration zones, material detachments, heterogeneous distribution of macroporosity and variations in the texture of the stone material cause strong morphological irregularities on the shallow materials and are characterized by the transition between negative to positive values of the geometrical surface anomalies detected with TLS and CRP. This surface high data scattering (see red coloured area in Fig. 7) also reflects the internal conditions of the material as can be seen clearly in the 3D tomographic image (Fig. 9) where the velocity zones lower than 2000 m s^{-1} prevail and correspond to bad quality materials. Consequently, the flaws and damage patterns highlighted by the CRP and TLS models develop from the surface to the inner part of the column as seen from the 3D tomography model. The percentage of the defects in the carbonate building material comparing the 3D models from the CRP, TLS and ultrasonic tomography is about 60 %.

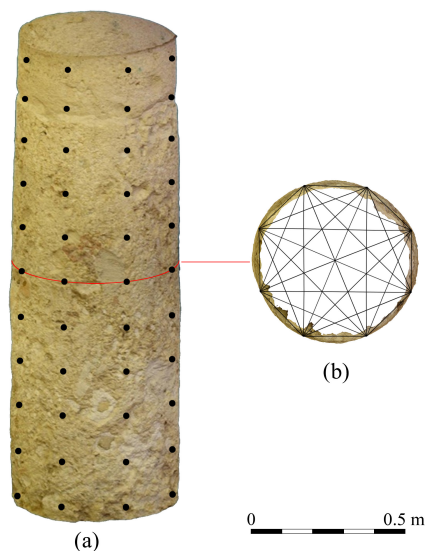
Figure 8. Ultrasonic tomography data acquisition: (a) transducer positions used for the tomographic reconstruction located on the 3D CRP-TLS model of the column; (b) 2D cross-section of the straight ray paths from the 3D acquisition scheme assuming a homogeneous material.

Ultrasonic measurements were carried out by the transmission method according to the ISRM (2007, 2014) using a Portable Ultrasonic Non-Destructive Digital Indicating Tester (PUNDIT Lab Plus) device (Proceq, Schwerzenbach, Switzerland). The output signals were recorded by a portable oscilloscope (Fluke 96B) interfaced with a laptop. The transducers were piezoelectric with a frequency of 24 kHz. Considering that the surface of the column is quite rough and irregular due to natural causes, special care was used in choosing the best coupling between transducer and material. As coupling agent silicone snug sheets were used. This kind of coupling agent is especially advantageous in contributing to a better transmissibility of the ultrasonic signal, filling the irregularities at the interface while avoiding soiling the material and interfering with it. Moreover, in carbonate materials such as Pietra Forte, which is often affected by a different kind of porosity the use of visco-liquids such as epoxy or grease should be avoided because they can penetrate into the pores and induce variations in the longitudinal velocity propagation. The wave velocity between source and receiver transducer pair can be directly estimated by considering the source-receiver distance divided by the travel time. This velocity is the result of effects of the characteristics of the material along the ray path. In a complex situation, automated arrival picking techniques could not consistently detect first arrivals. We therefore carefully hand-picked arrivals of P-waves for the tomography analysis. In order to obtain the spatial variation of the longitudinal wave velocity within the column, inversion of the velocity (i.e. tomography) is necessary. Travel time of the longitudinal elastic waves was measured along a great number of measurement paths between stations located on the perimeter of the investigated column (Fig. 8a), and each station was alternatively used as a transmitter and a receiver. For each travel time a minimum of five measurements were assessed. The acquisition scheme also assured a good ray coverage of the investigated material volume (Fig. 8b). Therefore, the column to be imaged was crisscrossed by a great number of discrete rays (1800). Each ray

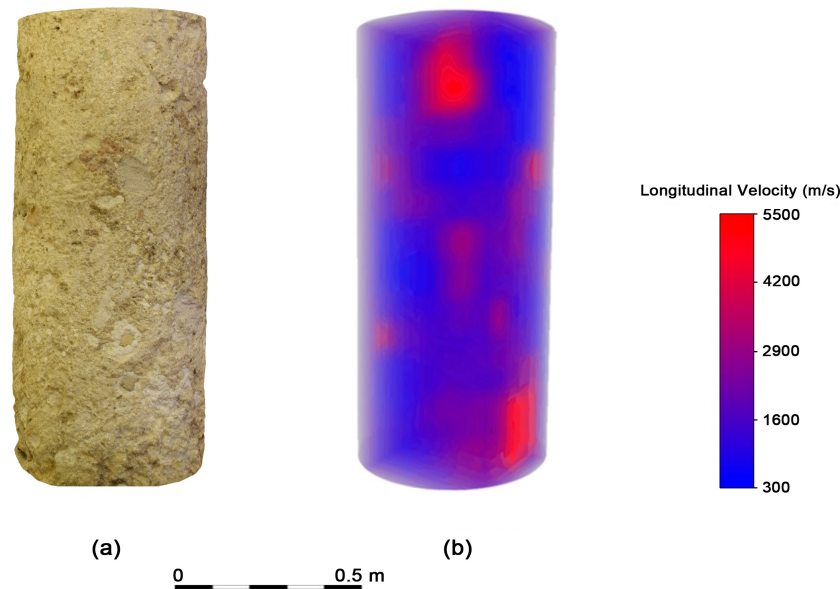
Figure 9. (a) Natural coloured textured 3D model of the column derived from CRP; (b) 3D ultrasonic tomography for the central column of the Saints Lorenzo and Pancratio church.

The resulting 3D high resolution image is shown in Fig. 9. The colour scale in the figure varies from blue to red representing the great variation in longitudinal velocity inside the column.

The ultrasonic longitudinal velocity presents a great variability between 300 and 5500 m s^{-1} , denoting great variabil-

ity in the elastic characteristics of the carbonate building material. The elastic characteristics are generally poor due to the presence of macropores (e.g. small karst cavities) and discontinuities in the Pietra Forte. The pattern of the longitudinal velocity deduced by 3D tomography (Fig. 9) shows the intrinsic heterogeneity of the carbonate rock (Pietra Forte) in the shallow and inner part of the shaft of the investigated column. In sound carbonate Pietra Forte stone the longitudinal wave average velocity changes in the range of 5200–7000 m s^{-1} as seen from the laboratory measurements described in previous works (Cuccuru et al., 2014; Fais et al., 2018, 2019b). The macropores (e.g. small karst cavities) and the discontinuities within the column shaft caused a marked decrease in longitudinal velocity values as results from the 3D tomography (Fig. 9). In a compressive element such as the investigated column, the multitechniques diagnostic process assumes particular importance.
