LIBS analysis to define the alteration processes on the surface of ancient stones: the case study of Romanesque medieval monuments (Italy)

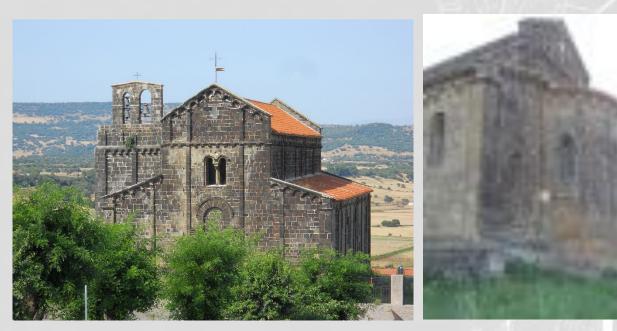
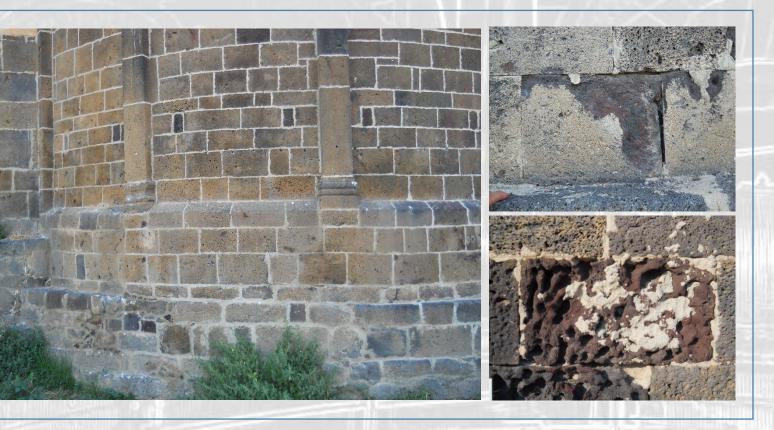
Santa Maria del Regno di Ardara (consecrated in 1107)

Sample	Provenance	Lithology
SMR14	S. Maria del Regno di Ardara (SS)	"Basalts"
NST23b	Nostra Signora di Tergu (SS)	Pyroclastite

SMR14: the upper yellowish part is made up by whewellite - $Ca(C_2O_4) \cdot H_2O$, quartz - SiO₂, gypsum - CaSO₄ · 2H₂O, and carbonate-hydroxyapatite - $Ca_5(PO_4)_{2.5}(CO_3)_{0.5}(OH)$.

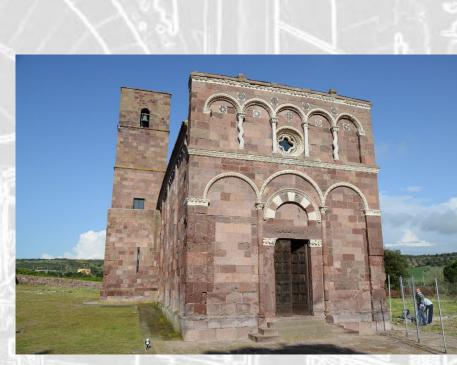
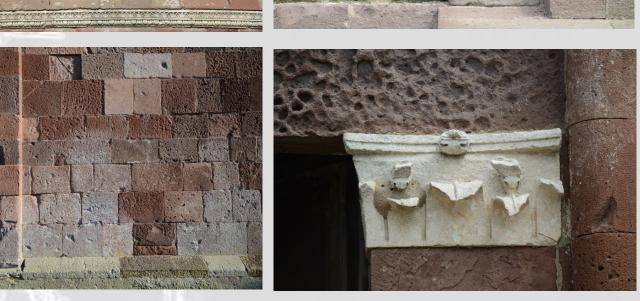
Nostra Signora di Tergu (consecrated in 1117)

NST23b: in the upper part, sanidine - K(AlSi₃O₈), quartz - SiO₂, cristobalite - SiO₂, gypsum (tr.) - CaSO₄ · $2H_2O_1$, weddellite (tr.) - $Ca(C_2O_4) \cdot H_2O$ were identified.
