Art Collections 2020, Safety Issue (ARCO 2020, SAFETY)

Protecting the archaeological heritage from structural risks: some significant cases.

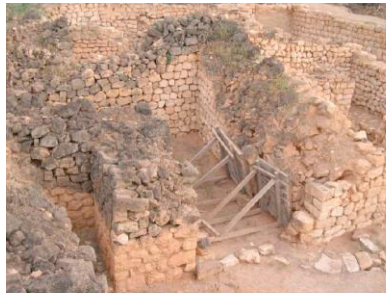
Rotation of walls

Fig. 2. Structural problems of walls in Sumhuram city.

The main structural vulnerabilities of Sumhuram city walls, observed by the author in 2004, were the following:

- The walls were originally constructed with high percentage of clay as mortar joints, exposed by reduction of its cohesion during Monsoon season, in case of a bsence of plaster and deck.

- The top of walls, after diggings, were not protected from rain penetration.
- The archaeological excavations were not conducted following bilateral sequences, inducing transverse forces as a retaining wall.
- Local inhabitants used the archaeological site as a «stone cave».
- Lack on maintenance works after excavations by local authorities.

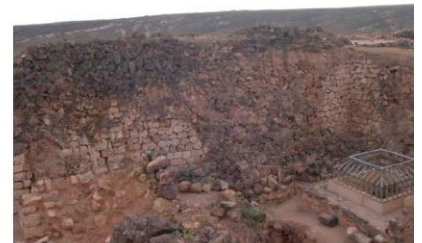
Landslide effect

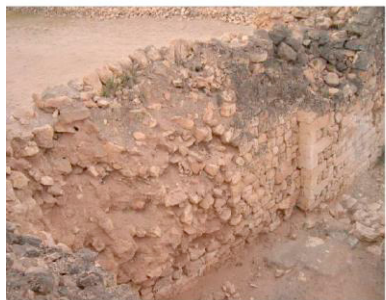
Collapse of external layer

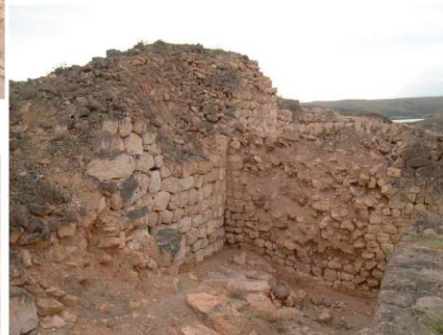
Interacting collapses

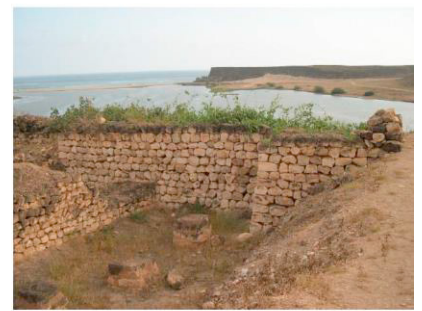
Vegetation

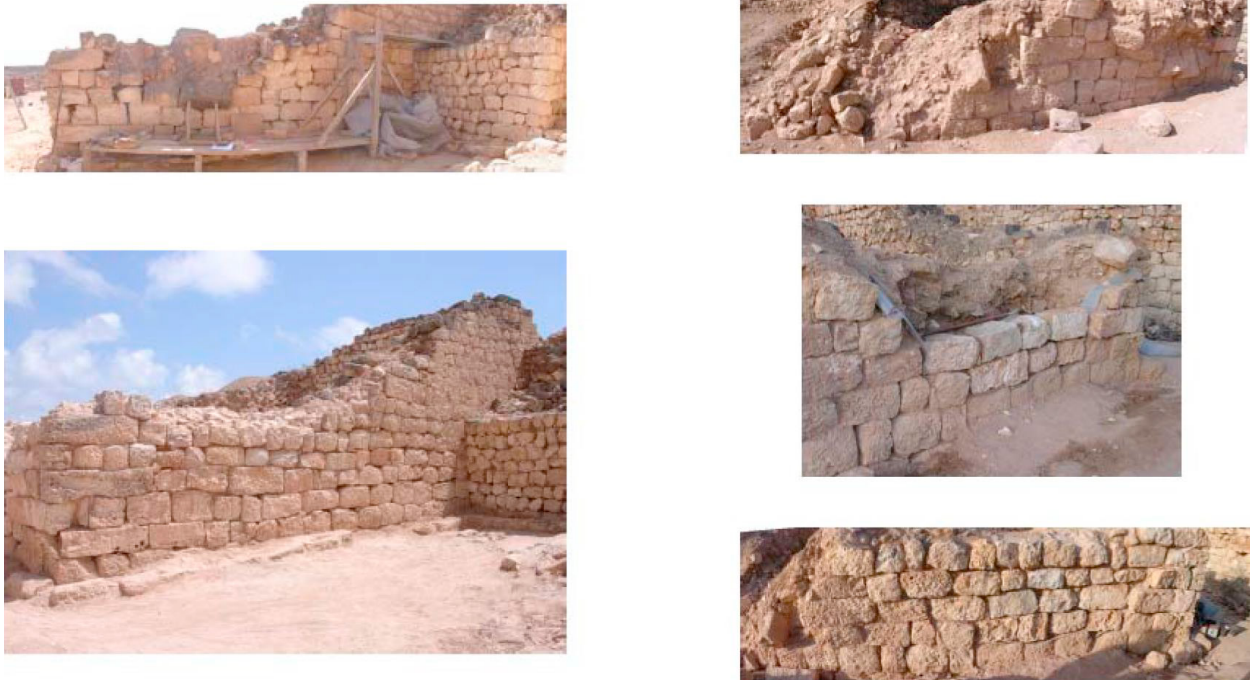
Fig. 3. Reconstruction phases in Sumhuram city.

The procedure was then experimented to the easiest archaeological wall (M1), consisting on the isolated masonry panel in front of the main gate. The several phases were the following:

1. Disassembly with care the collapsing zones (conserving the sequences of the blocks);
2. Removal of the clay components from collapsing walls;
3. Application of a geotextile foil to separate existing by reconstructed walls;
4. Reconstructing the walls using new weak mortar (lime - NHL) with same colors of the existing clay mortar;
5. New filling inside the walls using stones, gravel and sand from the nearby;
6. Construction of a «deck» at the top of the walls made by weak mortar (lime - NHL) to avoid rain penetration;
7. Beautification of the top of the walls creating «ruin effect» by stones and gravel with weak mortar (lime - NHL).

The works involved a large number of the walls, permitting a further activity of archaeological diggings in safe conditions and finally the preparation of the path for visitors. A numerical model was then assessed to determine the main mechanical parameters of the masonry, through a back analysis of the observed failures, based on the collapse law of Mohr Coulomb (Sassu et al 2013), in order to assess the level of efficiency of both original and reconstructed masonry elements. The entire textures of block were carefully replaced to maintain their existing features.

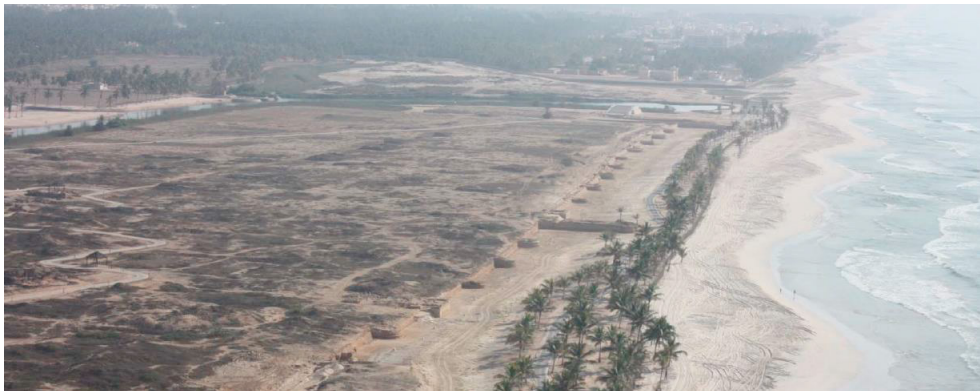
Fig. 4. Aerial view of the waterfront city walls of Al Balid (Zafar in “Il Milione” of Marco Polo).

The second example was in Al Balid. In that case the texture of the urban walls consisted of dry-stone masonry structures. They were made by double facing with regular blocks and clogging small stone fragments. A magnificent military waterfront of about 1,3 km, built around XI A.D., was discovered by the archaeologist J. Zarins in 2007. It was restored in 2010-2012 to ensure conditions of historical integrity and safe conditions for archaeologists and visitors (Sassu et al 2017). It was possible to identify a series of masonry components: a) walls; b) bastions; c) towers; d) columns; e) piers-breakwater; f) gates; g) stairs and slopes. For each component a proper procedure was performed to follow the cited Three R strategy. The constructive sequences for consolidation were: I) survey; II) cleaning; III) preparation; IV) re-construction; V) finishing activities. After geometrical survey of wall, bastions, towers and piers, the cleaning activity was the removal of the top soil and each unsafe stone by hand. The preparation consisted of the laying geotextile foils to recognize the original parts from the repositioned ones, followed by choice of stones from the storage area, based on similar nature, color and size.

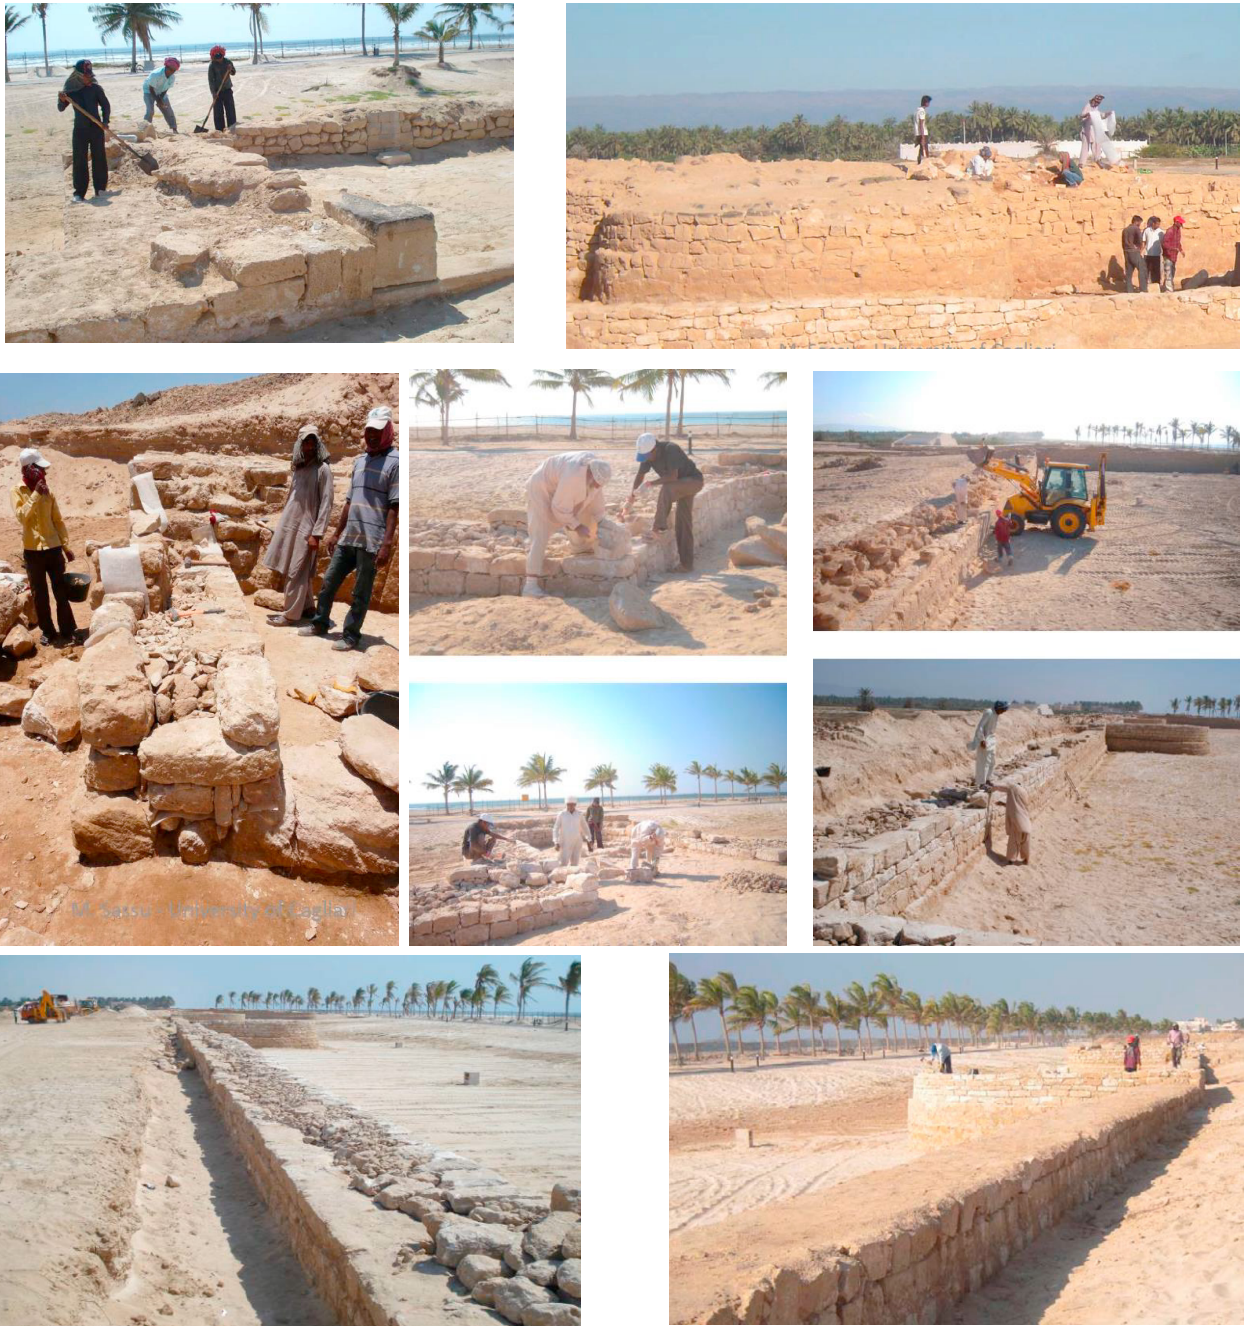
Fig. 5. Cleaning, preparation and re-construction phases in Al Balid city walls.

Great attention was devoted to replace the same texture during re-construction phasis, due to the fact that it testify the technological level of the original manufacturers. In this sense, it occurred a hand-made processing of the stones on site with a “dry” reconstruction of the missing masonry parts. The finishing phases consisted of filling the interlock zones with small “dry” stones (without soil), to ensure permeability in case of rain, followed by the application of a double layer of silt and sand, wet and beaten, to create a "surface crust" on the top of the walls. For this last aspect it was used the same lime available in the nearby.

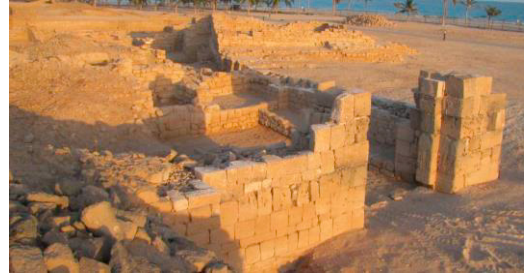
Fig. 6. Re-construction of the main gate in Al Balid city walls.

The re-construction of the main gate, made by large regular blocks, involved an activity similar to the composition of a puzzle. Each stone was surveyed and virtually replaced to simulate the best location, in view to a proper replace.

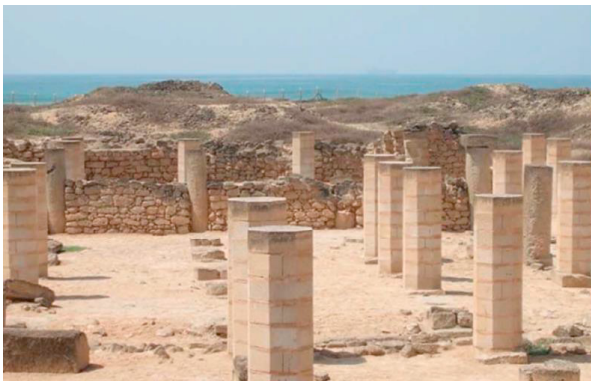
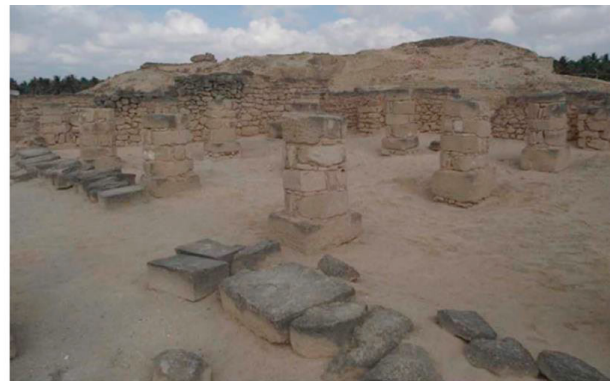
Fig. 7. Replacement of columns: (left) the approach in 2001, (right) the approach in 2008 (Great Mosque in Al Balid).

The replacement of the columns in the Great Mosque held in 2008 followed the principle of limiting the re-construction by only the stones available in the nearby, respect to the approach used in 2001 (Fig.7)
