**ATINER's Conference Paper Series
ARC2015-2123**

**Interdisciplinary Knowledge for Conservation of
Ruins: Stratigraphic Investigations of San
Giovanni Battista Church (Sardinia, Italy)**

**Donatella Rita Fiorino
Professor
University of Cagliari
Italy**

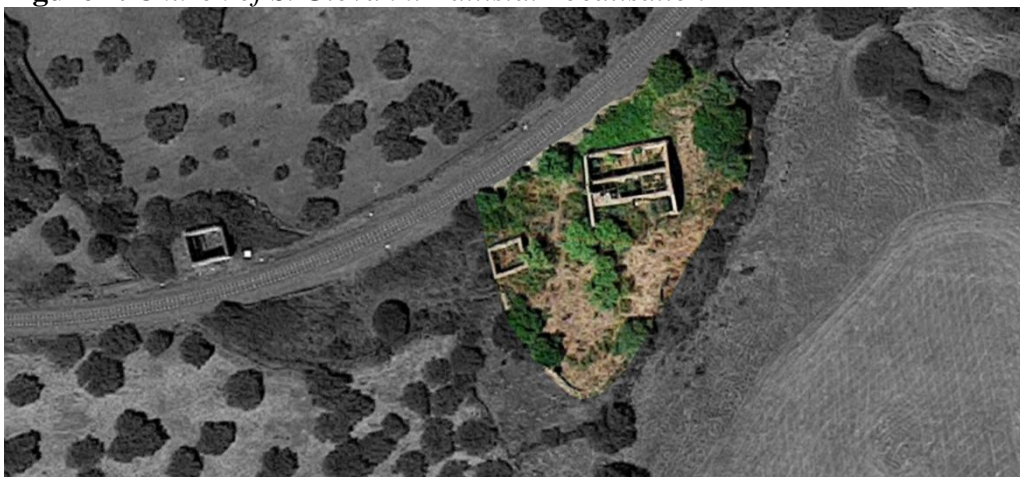
Figure 1. *Church of S. Giovanni Battista. Localisation*

The rural church of S. Giovanni Battista (Figure 1) is located in the countryside of Bortigali, a small village in the northeast of Sardinia near Macomer, at the foot of the Santu-Pedre Mountain. In the medieval period, the town was included in the ancient Marghine department also called Feud of the Maghine's Contrada or Incontrada, inner the Logudorese Giudicato⁷, and it would have had a great importance for its position being cited by numerous travel writers.

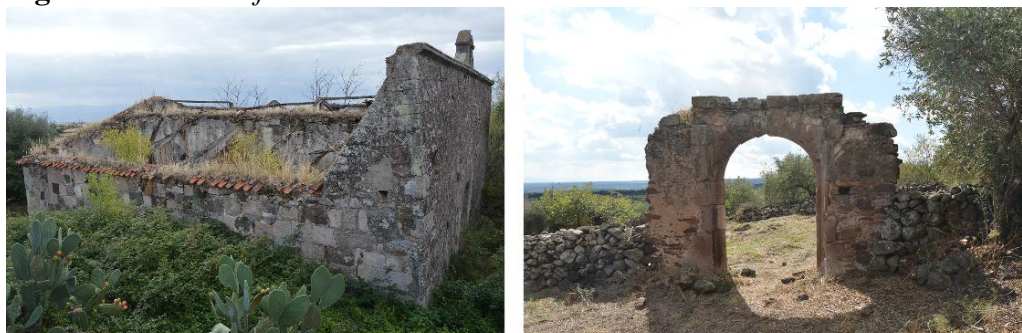
Figure 2. Church of S. Giovanni Battista

Actually, the church is completely in a state of ruin (Figure 2). Its walls are in part collapsed in places and partially unstable, while the roof is completely collapsed. The vegetation infests the building and compromises its legibility even more than its stability, both outside and inside. Plasters and mortars are lacking and for the most part are detached and the structural collapses create an irregular floor, more instable in the south access.

Regarding the traditional building materials, they are characterized by rhyolites and basalts outcropping locally in the area, cemented by an earthen mortar and covered by various kinds of lime plaster and recently in concrete. They are suffering from the natural but fast process of damage that characterized every building in state of abandon.

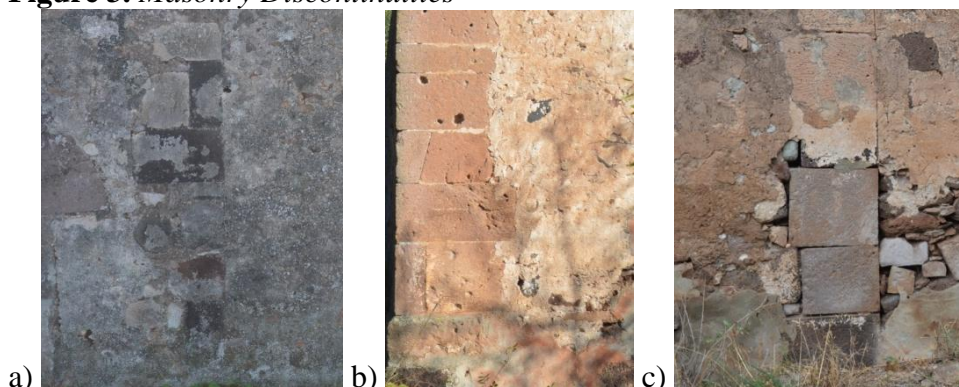
Figure 3. Masonry Discontinuities

(Figure 5). Since the first definition of the stratigraphic units, this analysis has revealed a series of interesting discontinuities and interfaces that dividing similar typologies of masonries have made the chronological interpretation difficult to understand (Figure 3).

This could mean that in the past the original body of the church was composed by the current middle nave, with a further later addition of the northern nave and after of the vestibule on the south.

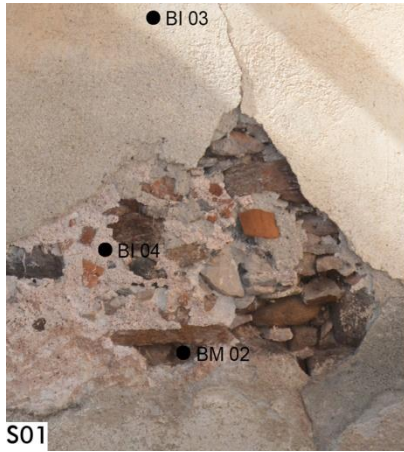
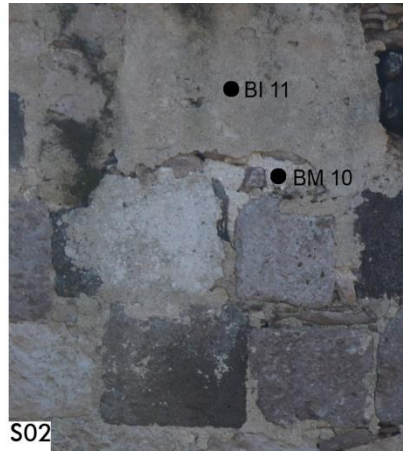
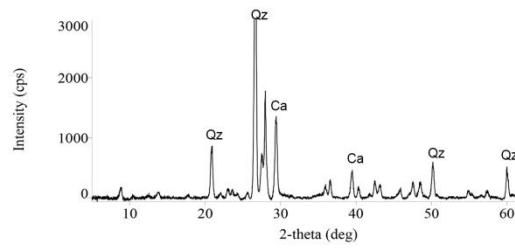
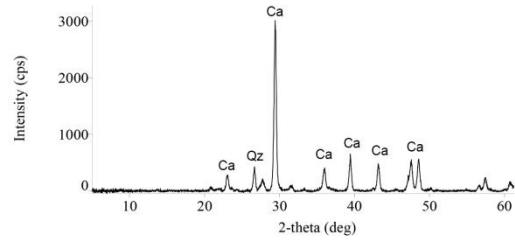
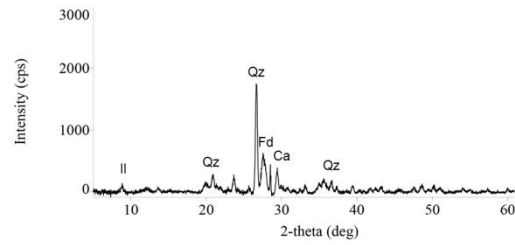
Figure 6. Plan of Samplings, and Images of the Thin Sections under the Optical Microscope in Transmitted Light and X-Ray Diffraction Analysis

The analyses show that all the mortars were made of soil (BM02), as it is clearly visible in the internal north façade (Figure 6b: S01), while a little percentage of lime was added in the mortars realised in the hypothetical phase of reconfiguration (BM10). All the masonries were made of local lithotypes: rhyolites and basalts, different in shape and dimension. As can be seen from the masonry samplings, all the internal masonries were made in rubblework with a prevalence of rhyolites (Figure 6a, b, c), softer than basalt in the phase of cutting. The same typology can be found outside (6c) where the presence of concrete and lime plasters with modern mixture confirms the later addition of the vestibule on the south. Instead, a middle phase of construction could be represented by the masonry technique on the external north façade made (Figure 6b) where squared blocks of rhyolite and basalt define a regular weave.

Overall, these construction techniques were used in different periods in different sections of the building. As a consequence, it is difficult to ascribe with certainty a single construction technique to a phase, as the techniques were used indifferently. For that, the same masonry could appear in more than one stratigraphic phase, and the only way to recognize the chronological sequence is to identify the discontinuities in terms both of mutual relationships between structures and changes in the mortar composition.
