Advanced Signal Processing of Wayside Condition
Monitoring of Railway Wheelsets

Eleni Giannouli

DOCTOR OF PHILOSOPHY

University of Birmingham

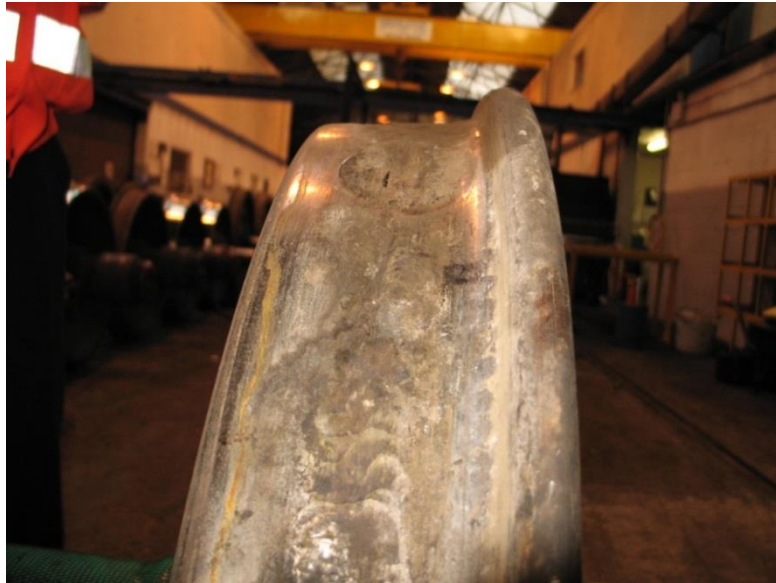
Figure 2.1 shows a railway wheel with multiple wheel defects.

Figure 2-0-1: Photograph showing multiple wheel flats

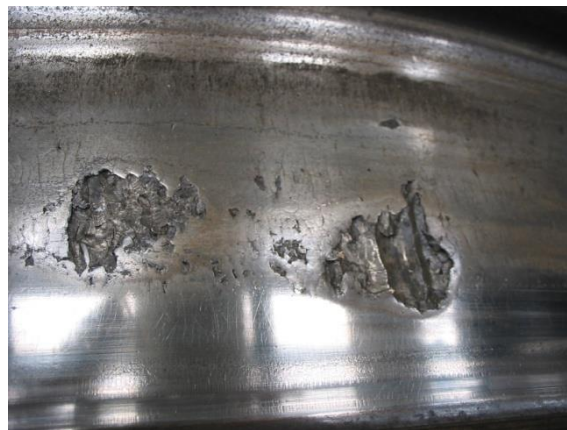
Shelling is manifested when large pieces of metal along the surface of the wheel break off. Wheel shelling is developed from surface or/and subsurface cracks initiating by localised stress concentration areas within the wheel rail contact zone due to high axle load and creep forces (Saferail). Figure 2.3 shows shelling on wheel tread (M. Papaelias et al. 2014b).

Figure 2-0-3: Photograph showing shelling on wheel tread (M. Papaelias et al. 2014b)

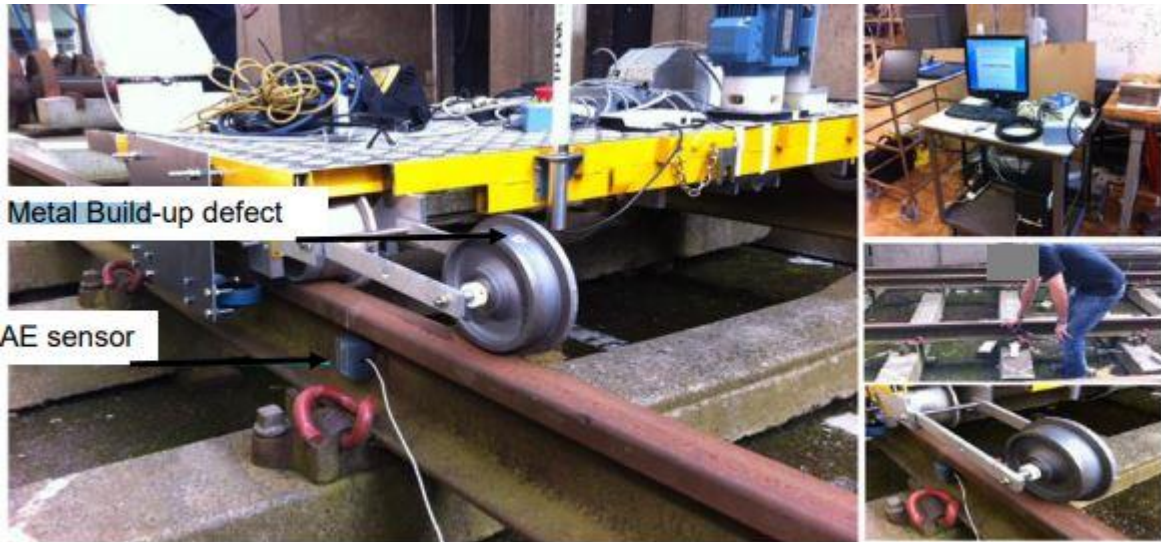
Figure 2-0-4 shows wheel with metal build- up defect during AE experiments at University of Birmingham (Amini et al. 2016a).

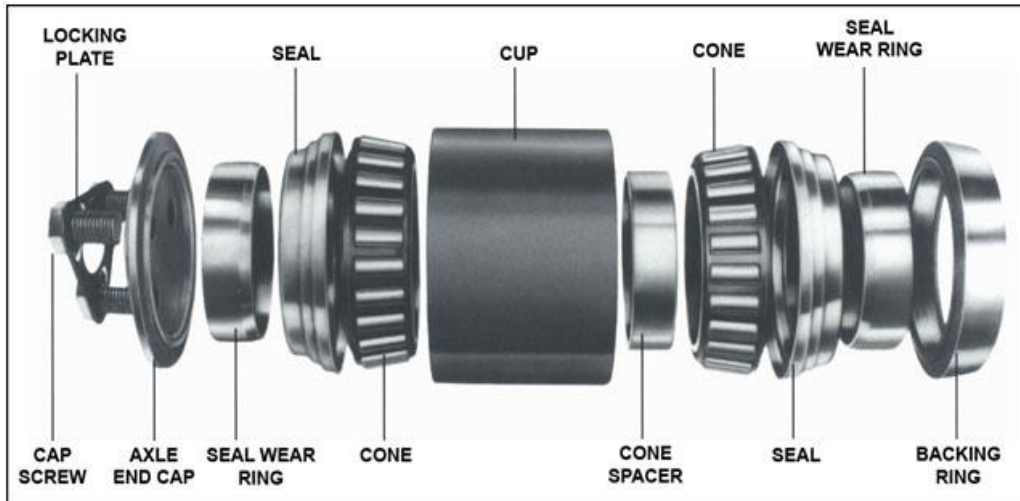
Axle bearings are lubricated rotating components installed between the axle and the wheel. They are critical components in any rotating machinery. Tapered roller bearings are widely used in the rail industry (Z. Huang et al. 2014b) and are the type of the bearing design that has been considered in this study . The schematic diagram in figure 2.5 illustrates a tapered roller bearing assembly(Timken 2015).

Figure 2-0-5: Schematic of a tapered roller bearing (Timken 2015)

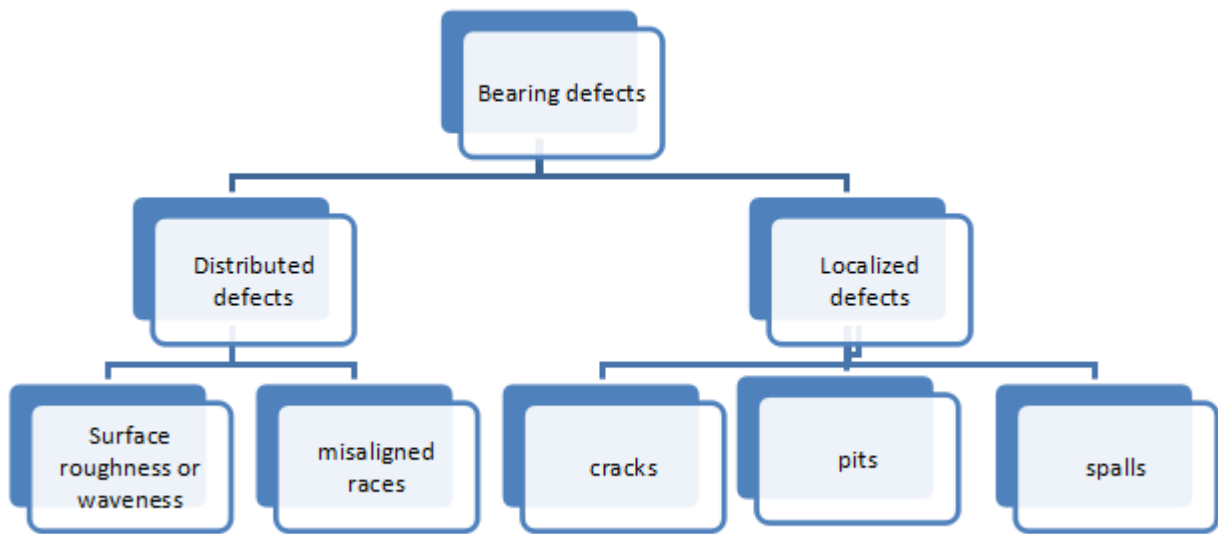
Table 2.1 : Schematic summarizing the common types of bearing defects

Table 2.1 summarizes the common types of bearing defect.

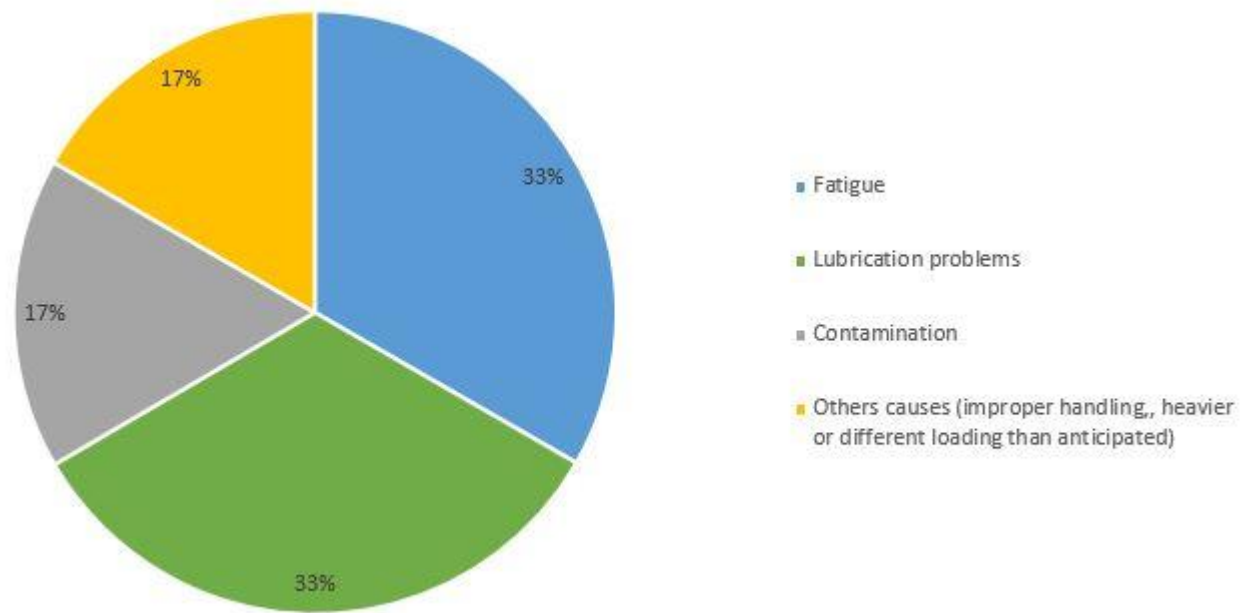
Figure 2-0-6 : Photograph showing bearing failure causes (SKF 2017)

Generally, a bearing will eventually fail due to the material fatigue. Material fatigue begins from both surface and sub-surface initiated failures (Symonds et al. 2015). When an axle bearing is about to fail, its immediate removal is the only possible option (Snell and Nairne 2008)

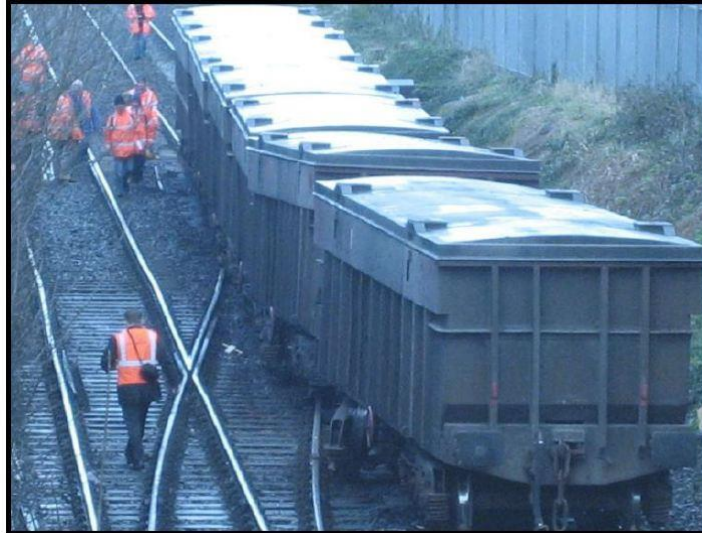
Bearing failures are responsible for train accidents around the world (Z. Huang et al. 2014a). For example, the derailment of Tara Mines freight train at Skerries on 10/01/2008 was caused by a bearing failure (figure 2.7). No temperature alarms were reported by the hot axle box detectors (HABDs) leading to bearing heat up bearing seizure and eventually train derailment (Railway Accident Investigation Unit 2009) .

Figure 2-0-7 : Photograph showing derailment of Tara Mines freight train at Skerries on 10/01/2008

Train derailments caused by faulty axle bearings are associated with axle journal rupture. Once a bearing becomes stuck, one of the wheels is blocked and the other continues to rotate as normal resulting in axle journal rupture after a few kilometres due to the high stresses arising from the abnormal motion of the wheelset (Amini et al. 2016a).

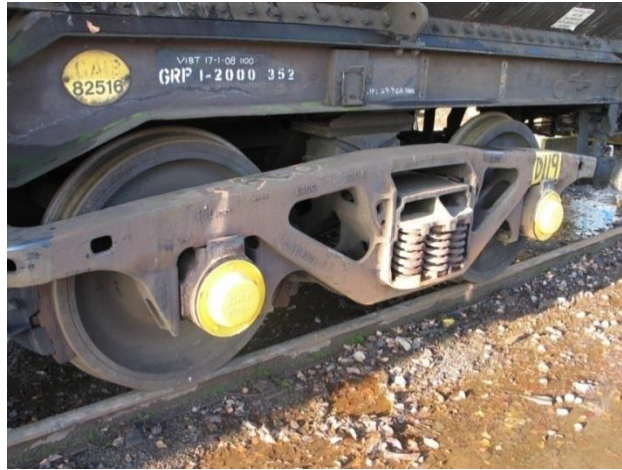
A typical bogie consists of two wheelsets, primary and secondary suspensions and a brake system (Z. Huang et al. 2014b). The primary suspension is responsible for absorbing shocks between the bogie, the frame and the axle bearing, whereas the secondary suspension is responsible for absorbing shocks between the bogie and the rail vehicle body. Defects either in primary or secondary suspension could lead to the reduction of passengers' comfort due to continuous vibrations, increasing the likelihood of an axle bearing defect or severe wheel damage, and hence possible derailments (Vallely 2015). The photograph in figure 2.9 shows a typical bogie suspension.

Figure 2-0-9: Photograph showing a typical bogie suspension

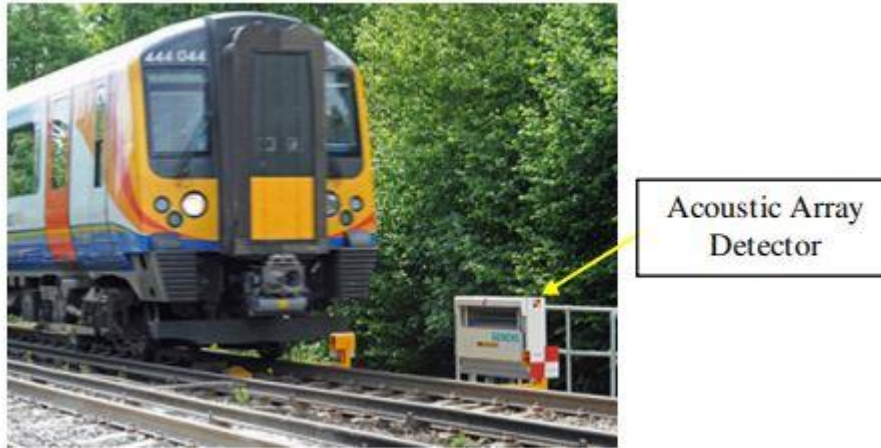
Since 2012, AAD systems have been installed in 3 locations in the UK's rail network and are currently undergoing evaluation (Vallely 2015). The cost per instrumented site (around 0.5M Euro) is also a major consideration for its installation. In figure 3.7 the installation site of one of the RailBAM systems on the UK railway network is shown.

Figure 3-0-7: AADs trial in the UK network near London. The photography is courtesy of SIEMENS (M. Papaalias et al. 2014a)

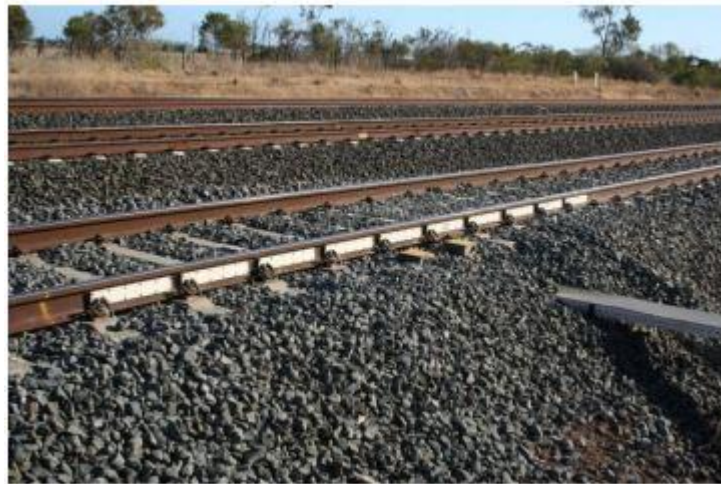
WILDs are used to identify wheel tread defects such as wheel flats, metal build-up and shelling (M. Papaalias et al. 2014b). Timely detection of a wheel thread defects can prevent structural damage in other rolling stock elements, on rails and crossing. In particular, since axle bearing faults are precursors of the wheel thread defects, WILDs may assist to reduce

bearing fault development. The strain gauges of a WILD attached on the rail is shown in figure 3.8.

Figure 3-0-8: WILD based on strain gauges (photography courtesy of Markus Wong)

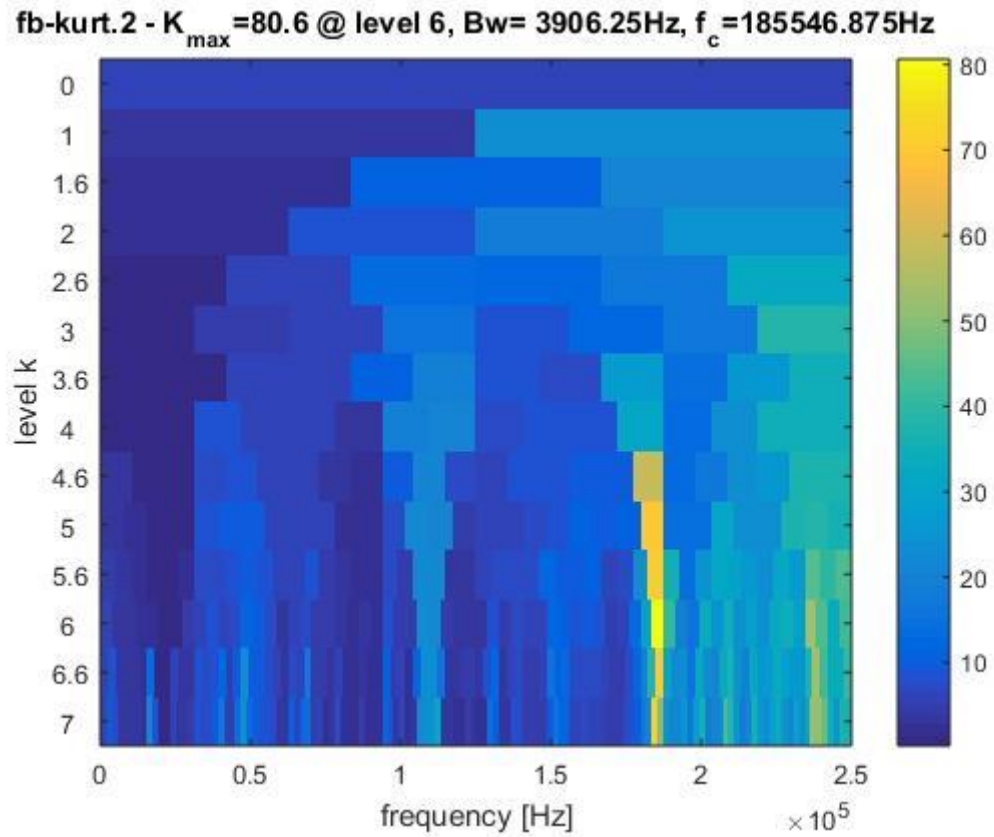
Figure 5-0-5: Kurtogram of a raw AE signal from the Cropredy tests

Figure 5.5 shows a typical example of fast kurtogram (J. Antoni 2007) illustration from AE signal obtained by this study. A band-pass filter can be designed based on the results below. The centre frequency will be 185546.875 Hz and the Bandwidth 3906.25 Hz.

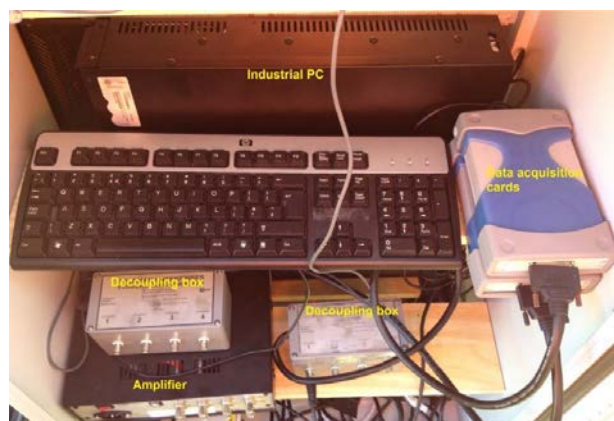
The present chapter discusses the experimental procedure employed in this study. A customised integrated RCM system has been built for the tests (shown in Figure 6-1). This novel system consists of the following components:

- High frequency accelerometers with a sensitivity of 100mV/g manufactured by Wilcoxon (W. S. Technologies 2020b),
- A 2531A Agilent 4-channel data acquisition card with a maximum sampling rate of 2MS/s in single-channel mode (K. Technologies 2020a) ,
- A 4-channel decoupling hub manufactured by Agilent
- AE analogue amplifiers manufactured by Krestos
- Pre-amplifiers manufactured by Physical Acoustics Corporation (PAC) (Acoustics' 2020),
- An accelerometer power supply manufactured by Krestos
- R50 α resonant AE sensors manufactured by PAC (Acoustics 2020)
- An industrial computer with a customised data logging and analysis software developed in collaboration with other colleagues written in Matlab.

Figure 0-0-0-1: The customized data acquisition equipment used during laboratory and field trials (Amini 2016b)

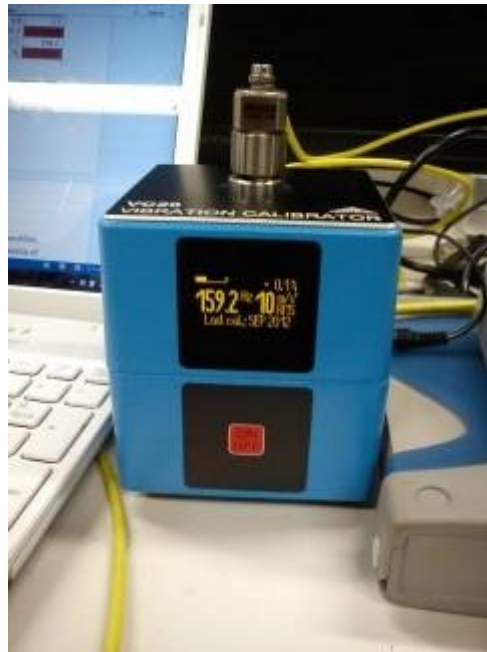
a)

A Wilcoxon 712F piezoelectric accelerometer with has sensitivity of 100mV/g and a 4-channel power supply manufactured both by Krestos were employed for the vibration data acquisition. The operational frequency range of the accelerometer is between 1.5 Hz - 15 kHz. Figure 6-3 a shows the calibration process of the Wilcoxon 712F piezoelectric accelerometer during the experiments of this study. Figure 6-3 b shows the frequency spectrum that confirms the accurate calibration of the piezoelectric accelerometer.

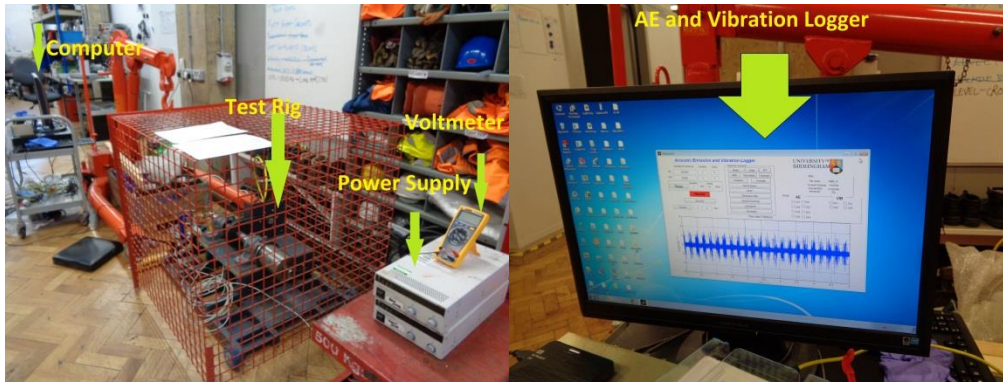
Figure 6-5 and Figure 6-6 show the experimental configuration employed at laboratory experiments using the test rig 2. The photographs on Figure 6-5 present the experimental instruments used at the Laboratory trials. A customised Acoustic Emission and Vibration logger developed by Dr Arash Amini was used for data acquisition. AE and vibration measurements were recorded and saved for further processing. The AE sensor and accelerometer installed at the test bearings are shown in Figure 6-6.

Figure 0-0-0-5: Customized bearing test rig 2 at the University of Birmingham. The photograph on the right shows the AE and Vibration data logger.

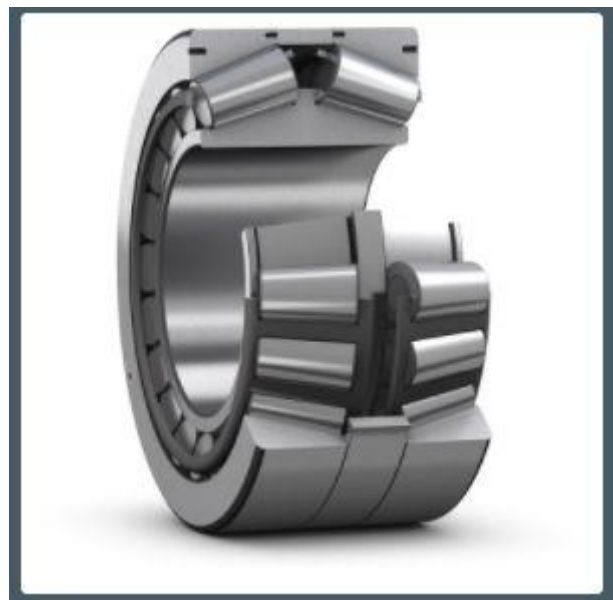
F0

circumference.
F2	Minor damage to one small area of one roller in each cage, again consisting of surface roughening by electrical discharge engraver. Fault length 10% of circumference.
F3	Similar to F1 above, but damage is a little larger and deeper, inflicted by means of a small rotary grinder. Fault length 2.9% of circumference.
F4	Similar to F2 above Single faulty roller in each cage. Small rotary grinder. Fault length 50% of circumference.
F5	Single ground and roughened fault, same position on each outer race. Damage inflicted by small cutting wheel and engraver. Fault length 6.6% of circumference.
F6	Significant damage, both races. Damage inflicted by small cutting wheel and engraver. Fault length 35% of circumference.
F7	Significant damage, both races and 6 rollers on each side. Debris from grinding left in bearing. Fault length 35% of race circumference, 12% of roller circumference.

Figure 0-0-0-7: Induced bearing faults used during the test rig experiments

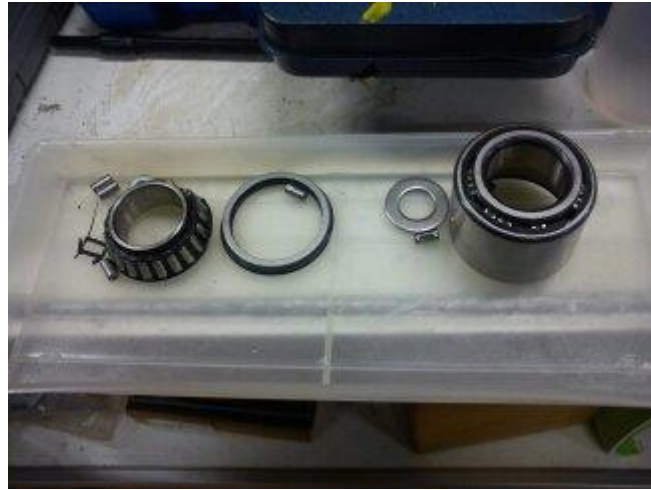
A power tool was used to generate the bearing defects on its surface. Tapered roller bearings have been used as test bearings on laboratory experiments. An example of a rig double raw tapered roller bearing is shown in Figure 6-8.

Figure 0-0-0-8: A rig double raw tapered roller bearing disassembled

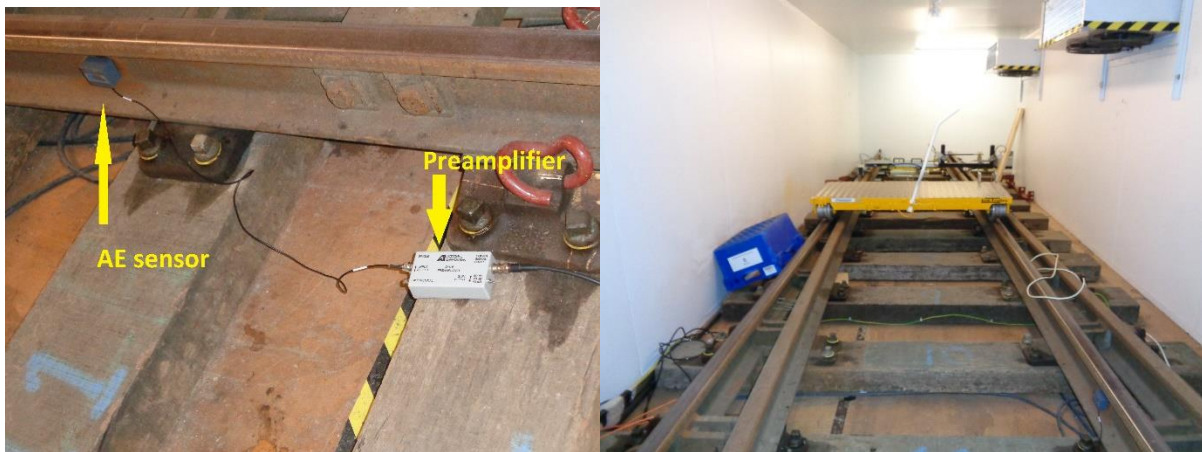
Figure 0-0-0-9: Wayside installations (left figure) and motorized trolley (right figure)

Photographs on Figure 6-9 shows the accelerometer installation wayside and the motorized trolley used at the experimental trials. Wheel flat length illustrated on photograph on Figure 6-10.

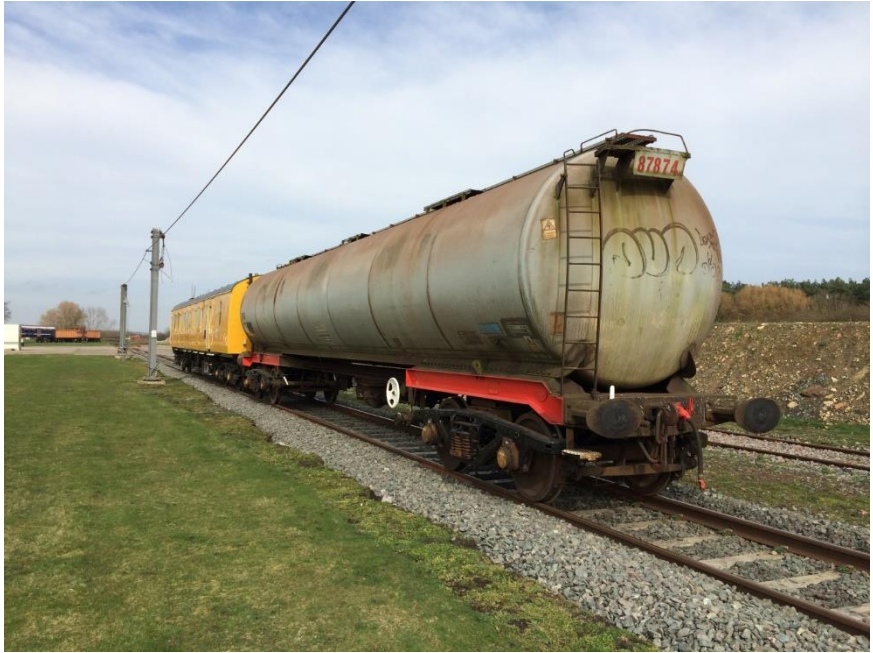
Freight tanker wagons with no artificially induced fault have used at experimental trials. A locomotive with no wheelsets faults provided by Motorail Logistics used to pull or push the test train depending on the direction of movement is shown in Figure 6-11. The train was moved forward and backward over the rails with constant speed of 48Km/h and 32Km/h

Figure 0-0-0-11: Photograph showing the yellow locomotive and the freight test wagons (Amini 2016b)

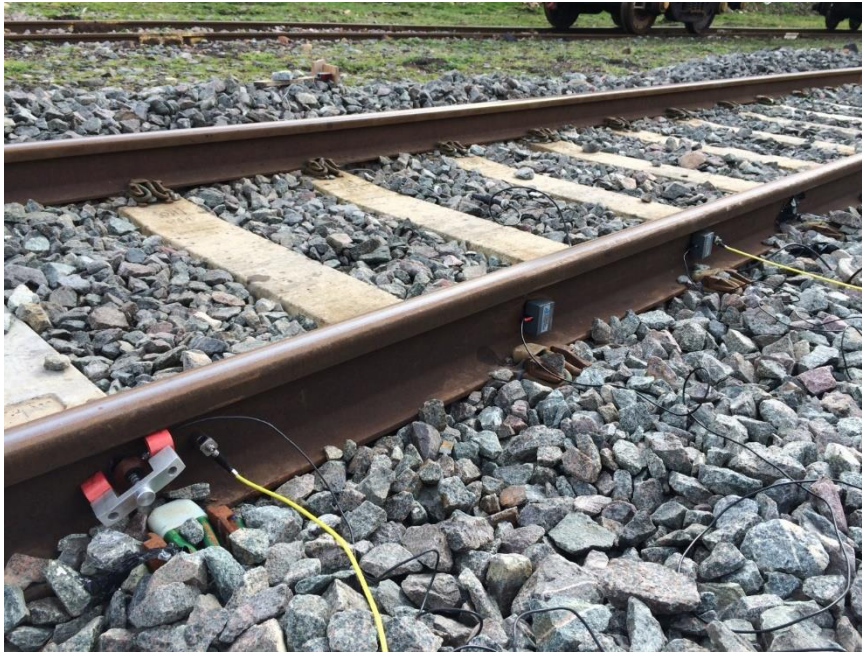
Figure 0-0-0-13: Photograph showing the AE sensors and accelerometers installed on the web rail at Long Marston, UK (Amini 2016b)

sleepers in order to reduce the noise effect on the signal acquired due to rail bending moments. The installation of AE sensors and accelerometers is shown in Figure 6-13. Four R50a AE sensors and two Wilcoxon 712F accelerometers were used during the field trials. The sampling rate was set up to 500 kHz and 25 kHz for AE and vibration acquisition respectively. The time duration of the captured signals was 12 sec.

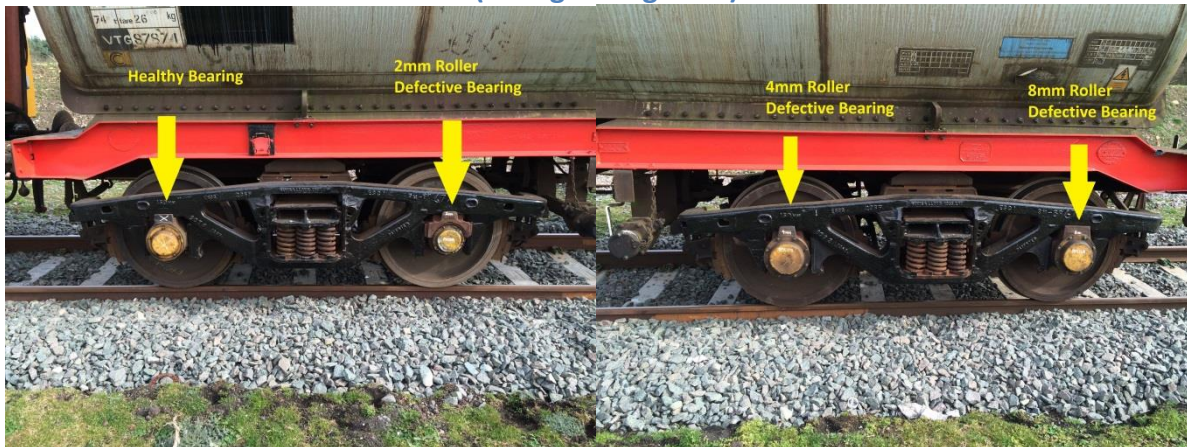
Figure 0-0-0-15: Photographs showing the first wagon of the test vehicle. The tanker contains a healthy and three fault axle bearings

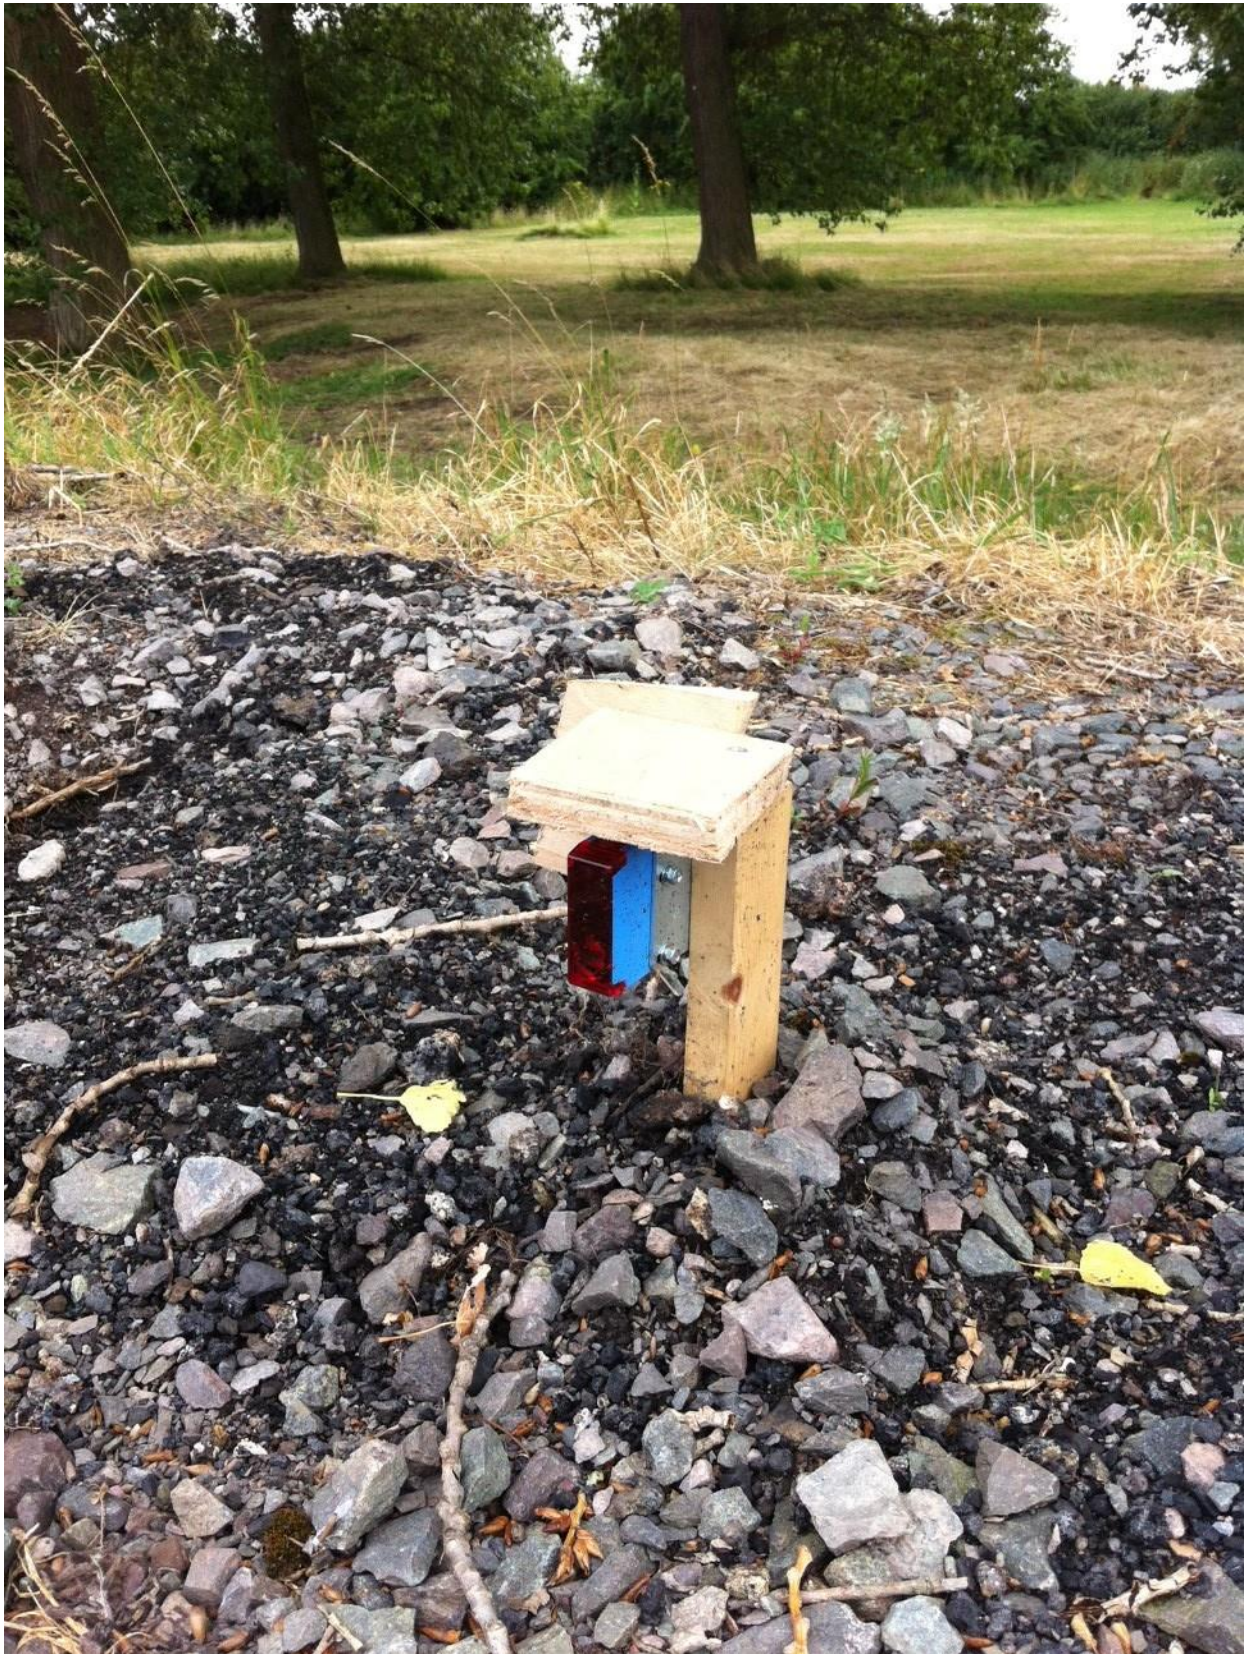
An optical infrared triggering system was also used in order to trigger automated the data acquisition system when the test vehicle pass over the detection zone. Two pairs of infrared sensors were employed in the form of optical gates. Train speed can be calculated when distance between the sensors is known. When the wheelsets pass through the detection zone, the AE and vibration activity arising from the train is captured. The meaningful signal can be truncated in order to increase data storage and reduce computational time. The advantage of multiple sensors on the experiments is redundancy in case of sensor failure. Signals from multiple sensors can also be fused into a signal with the same information and less data

storage. Figure 6-16 shows the optical trigger system used for activating the data logging system at Long Marston measurements.

Figure 0-0-0-16: Photograph showing the optical trigger system used at Long Marston trials

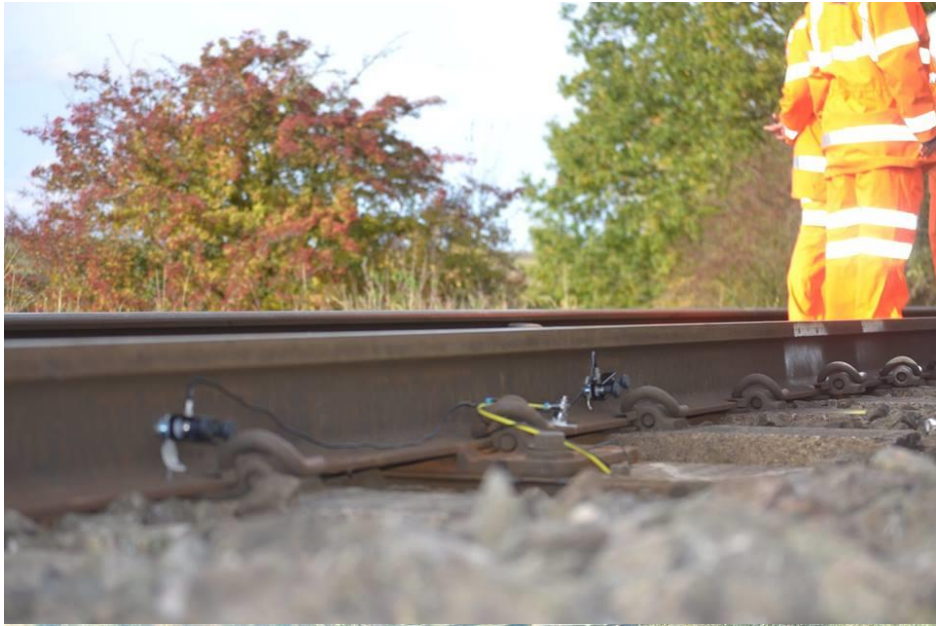
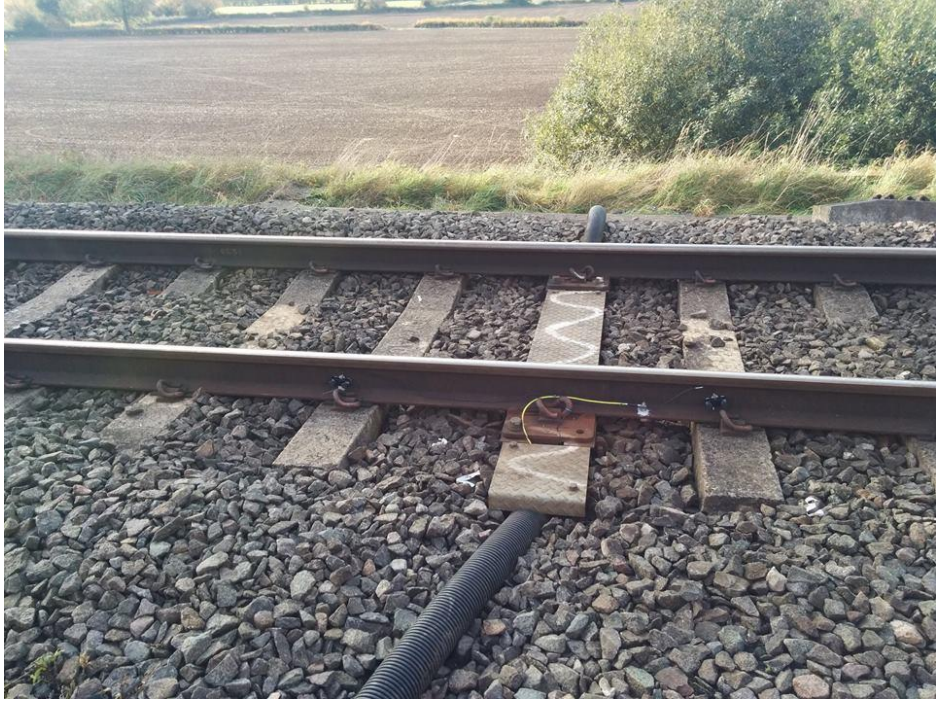
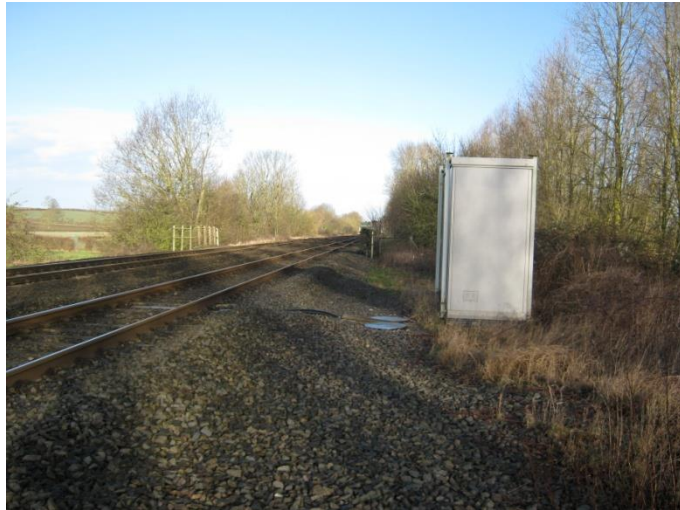
No interference on the track circuits is the main advantage of the proposed monitoring system. The ceramic face of the AE sensors isolates electrically the sensor from the rail track enabling the installation of the system in electrified lines without obstacles. Furthermore, the installation was simple and no time-consuming (less than 1h). Figures 6-18 shows different aspects of the system's installation including the AE resonance sensors and associated pre-amplifiers and amplifiers procured from PAC, two industrial accelerometers procured from Wilcoxon, the computer logging and data storage system (2 U2531A Agilent USB DAQs) and the special cabinet.

Figure 0-0-0-18: RCM system installation at Cropredy

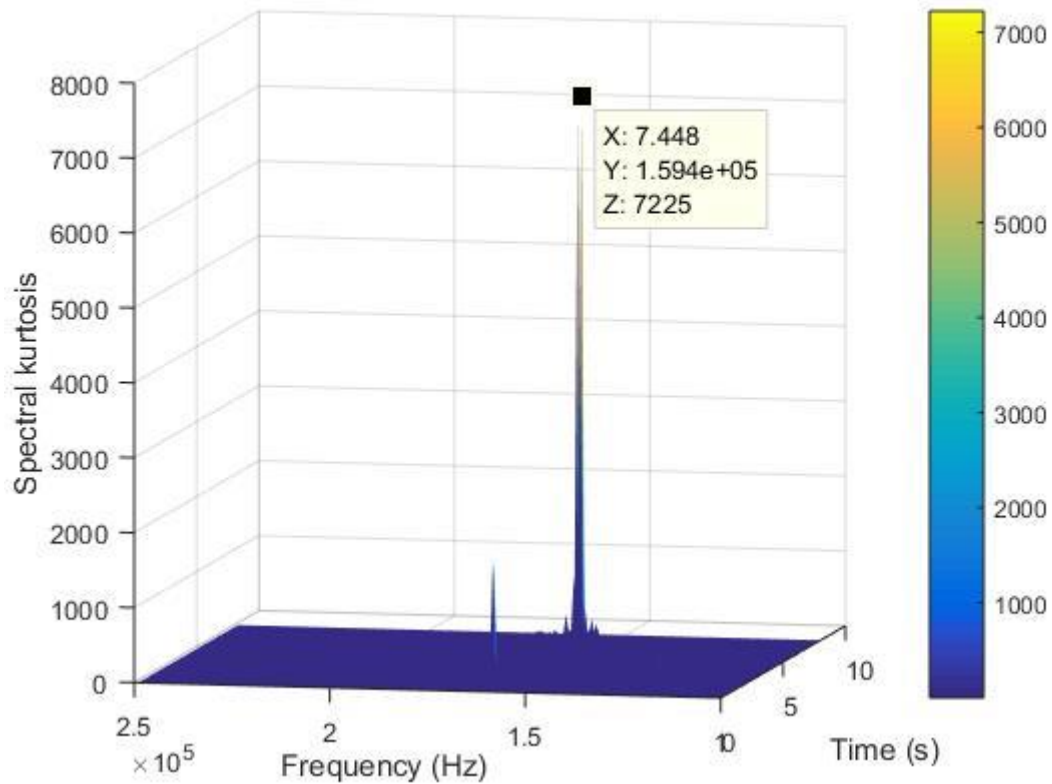
Figure 7-0-77: TSK results. High Kurtosis value at 1.59 kHz indicating the presence of a fault

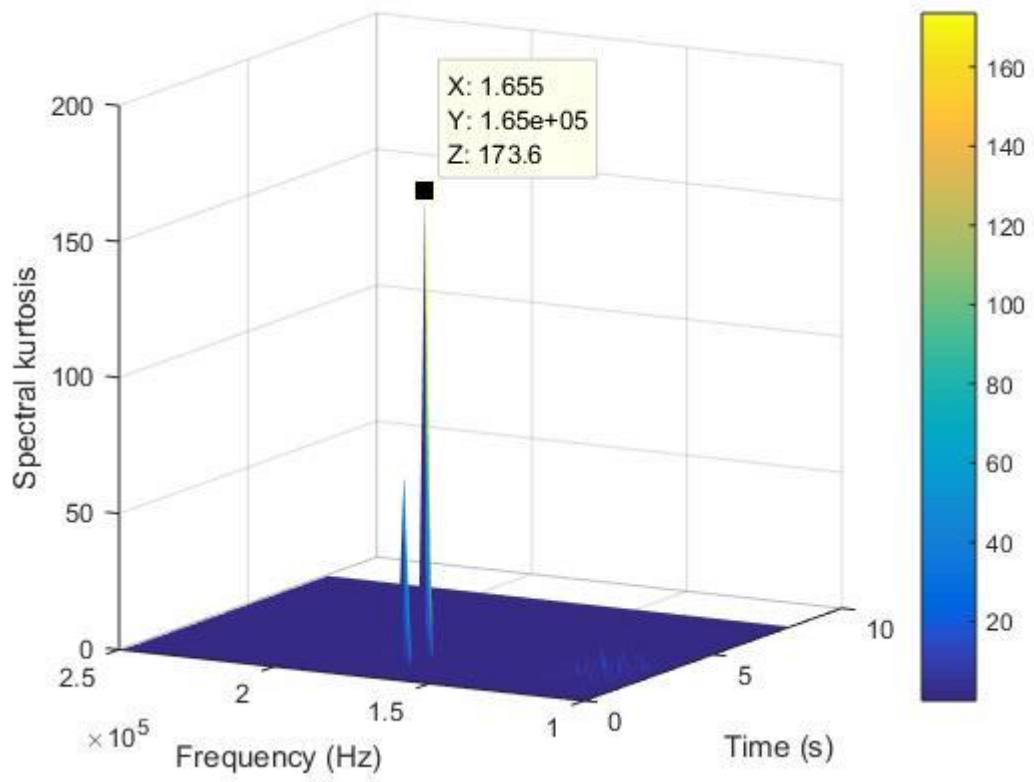
TSK results. High Kurtosis value at 165 kHz indicating the presence of a fault
