## Multidisciplinary Researches in Cultural Heritage Studies: An Approach on Akkale Cistern in Erdemli, Mersin

## 1.1. Description of Akkale Cistern

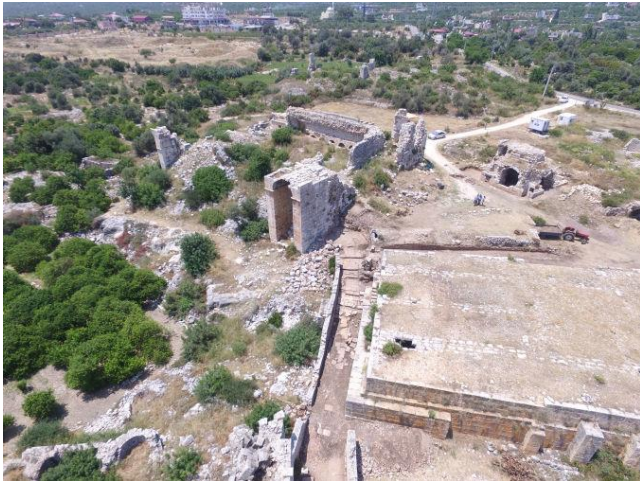
**Figure 2.** Akkale Cistern and buildings in Akkale

There were harbour bath, accommodation facility (inn), public cistern, monumental tomb and remains of religious buildings (Aydınöğlü & Mörel, 2017). Archaeological surveys have also revealed remains of water channels leading from Elauissa-Sebaste Korykos water work towards Akkale. Moreover, there are remains of additional water structures excavated nearby Akkale cistern indicating that there was an integrated water distribution network through the settlement (Figures 2 and 3).

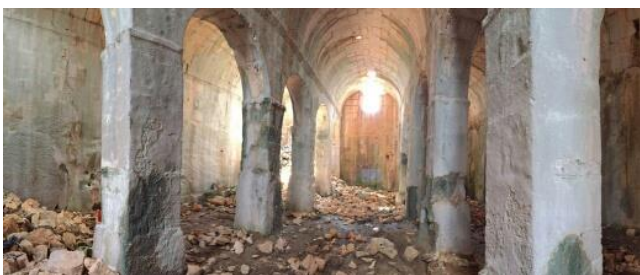
**Figure 3.** Interior view of Akkale Cistern

Akkale cistern is one of the remarkable and well preserved buildings of the whole site. It has a rectangular size with 21.53 m × 36.40 m dimensions and 9.80 m interior height. The main construction technique of the cistern is cut-stone masonry walls, with two rows of arcades supporting the vaulted superstructure. The cistern finishes with flat roof located onto the three rows of barrel vaults. There are top windows and remains of cut-stone roof claddings on the cistern roof. The roof top might have been utilized for additional rainwater harvesting into to the cistern, since there is remarkable catchment capacity with its roof size. Each arcade has 7 arches supported on stone pillars (Figures 2 and 3). There are 3 windows located on each east and western wall, which were probably used to control, to provide daily light and fresh air for interior.

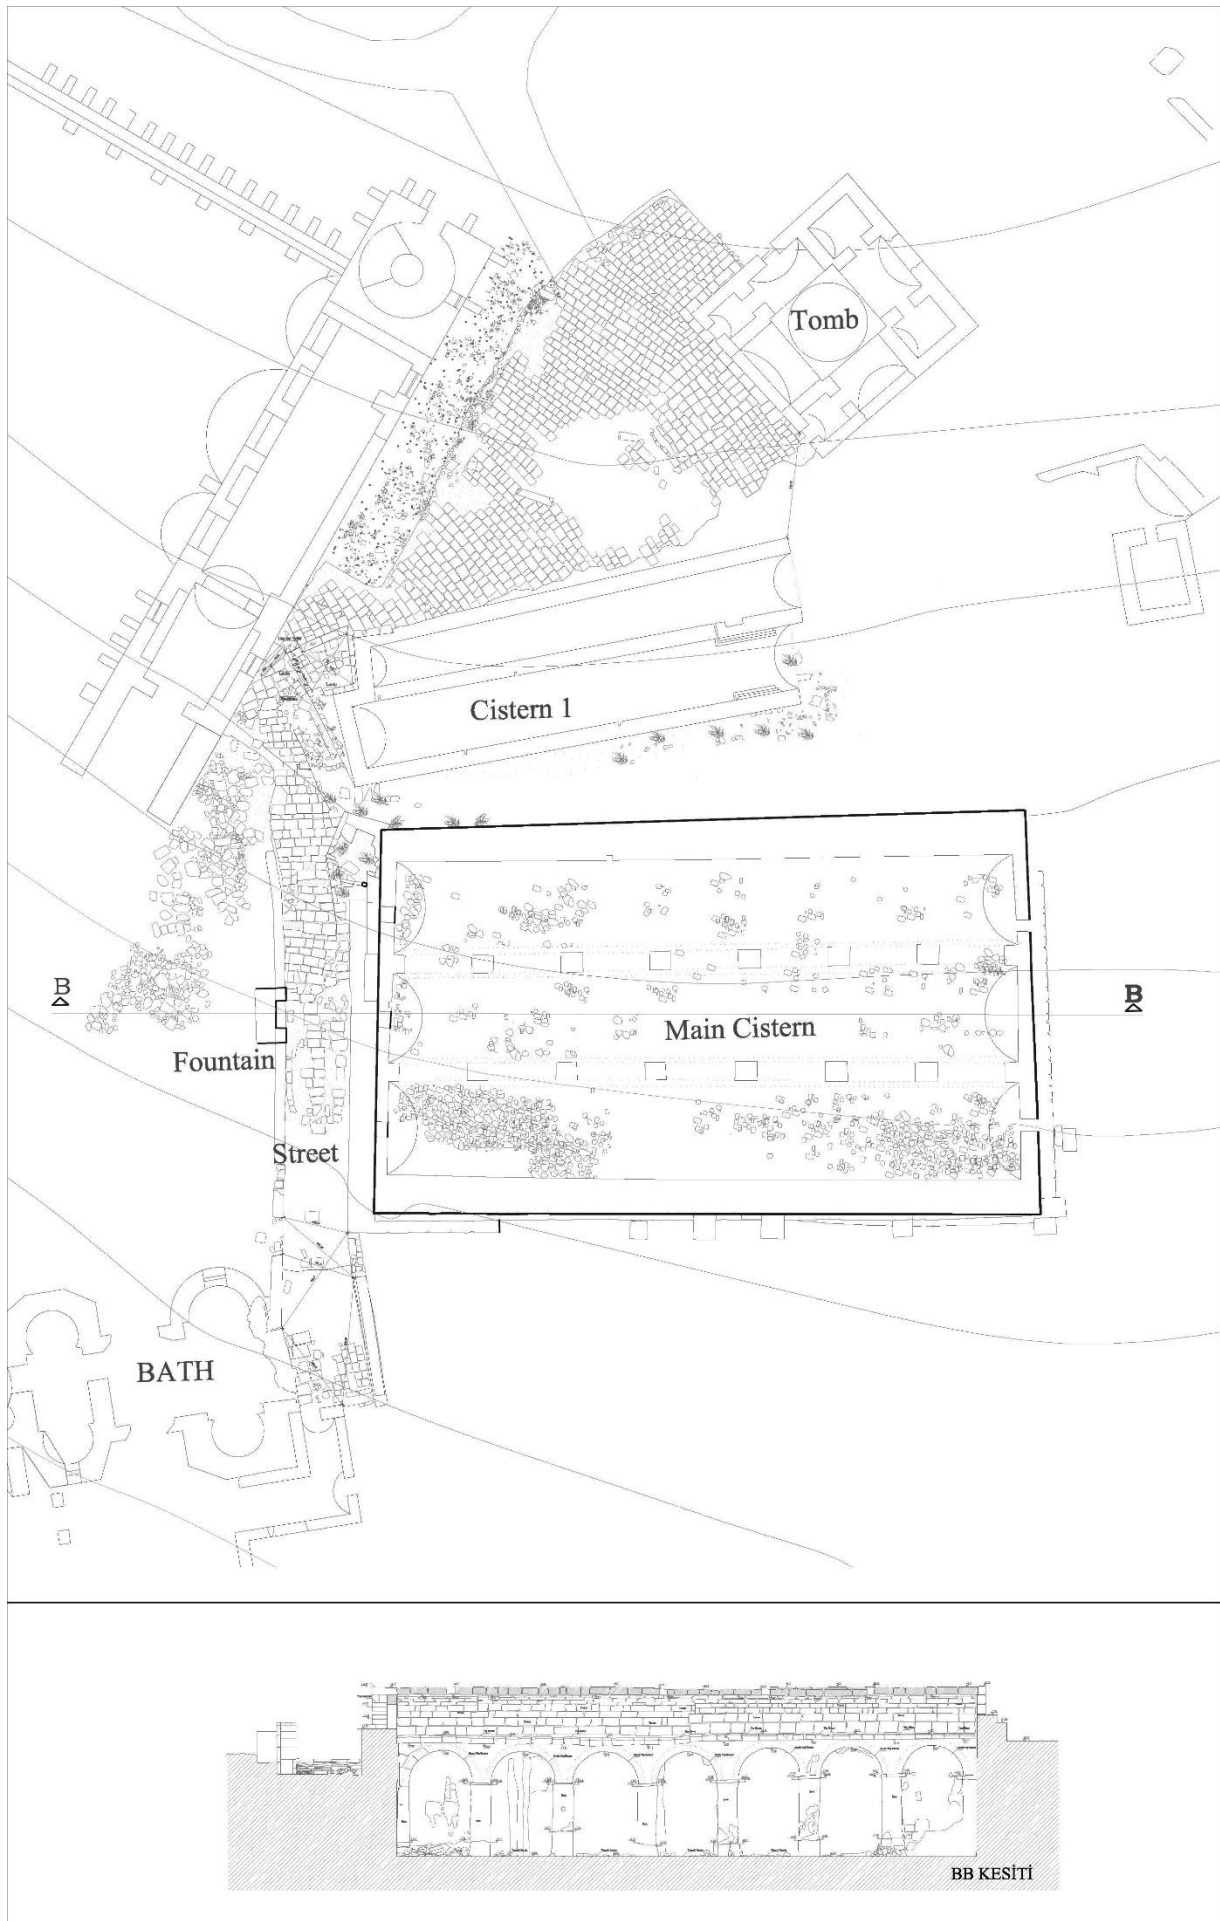
Figure 4. Survey drawings of the cistern

**- Architectural Documentation and Building Surveys:** Archaeological excavations around the cistern revealed important architectural information and traces related to original condition of the building. Following, detailed measured surveys including architectural plans, cross sections, internal and external elevations and documentation studies related to site maps have been conducted by using optic measurement and aerial photogrammetric techniques. Survey drawings are utilized to evaluate architectural details, material use and construction techniques of the cistern. They also provide base maps for restitution proposals and condition assessments studies in further stages (Figure 4).

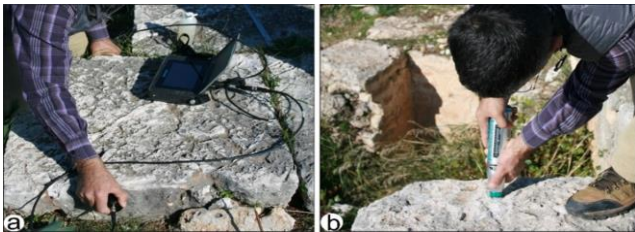
**Figure 7.** Sonic velocity and Schmidt Hammer tests applied on rocky ground (Tağa & Güler, 2018)

**-Geological and Geotechnical Surveys:** Further site investigations related to geological aspects of the site have been conducted in order to compare geomechanical properties of limestone used in masonry construction of the cistern with rocky formation of its close environment and to understand its relationship with the terrain it was constructed into. Non-destructive techniques (NDT) have been preferred for geological and geotechnical researches, since the cistern is located in an archaeological site (Figures 7 and 8). Sonic velocity and Schmidt hammer resistivity tests were performed on the locations chosen on the building. Samples from rocky ground showing similar lithological aspects with stone material used in construction of cistern building were examined through laboratory tests to provide geological data during structural analysis works. Since the cistern was settled into the topography, another NDT method of Vertical Electrical Sounding (VES) technique was applied in order to scan ground resistivity of the cistern and its environs. Ground Penetrating Radar (GPR) method was applied around the cistern to understand boundary of lateral walls inside the rock bed and how much it was buried into the ground (Tağa & Güler, 2018).

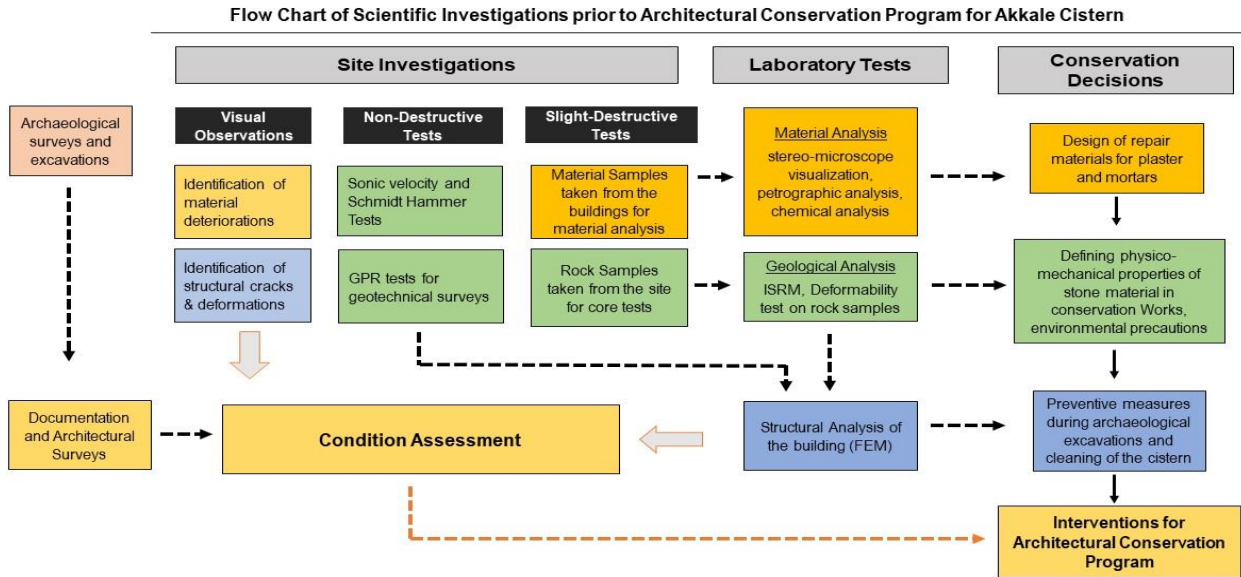
**Figure 10. Flow chart of scientific investigations prior to architectural conservation program for Akkale Cistern**
