Article

Estimators for Structural Damage Detection Using Principal Component Analysis

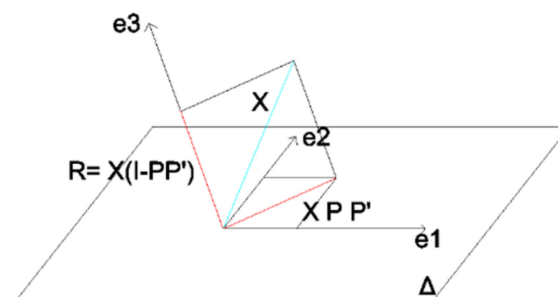
Figure 1. Geometric interpretation of Principal Component Analysis.

Formulas (5) and (6) have a geometric interpretation. The first step is to define the space made by the r first eigenvector of the matrix $X'X$. In Figure 1, this space is the plan Δ . The second step is to compute the projection (XPP' , red lines in Figure 1) of the matrix X in the space (Δ) defined previously. These steps are repeated for $r = 1, 2, \dots$ (one principal component, two principal components, \dots) in order to obtain a graph with the estimator values versus PC number used.

Finally, T^2 is the squared of the vector norm of the projection in the plan weighted by the inverse of the eigenvalue. The T^2 values are calculated for each subspace $r = 1, 2, 3, \dots$ (One principal component, two principal components \dots).

Q is the square of the norm of the residual vector (R). R is the subtraction between the data vector and its projection in the space made by the r first eigenvector (the subtraction between the vectors X and XPP'). The Q values are calculated for each subspace $r = 1, 2, 3, \dots$ (One principal component, two principal components \dots).

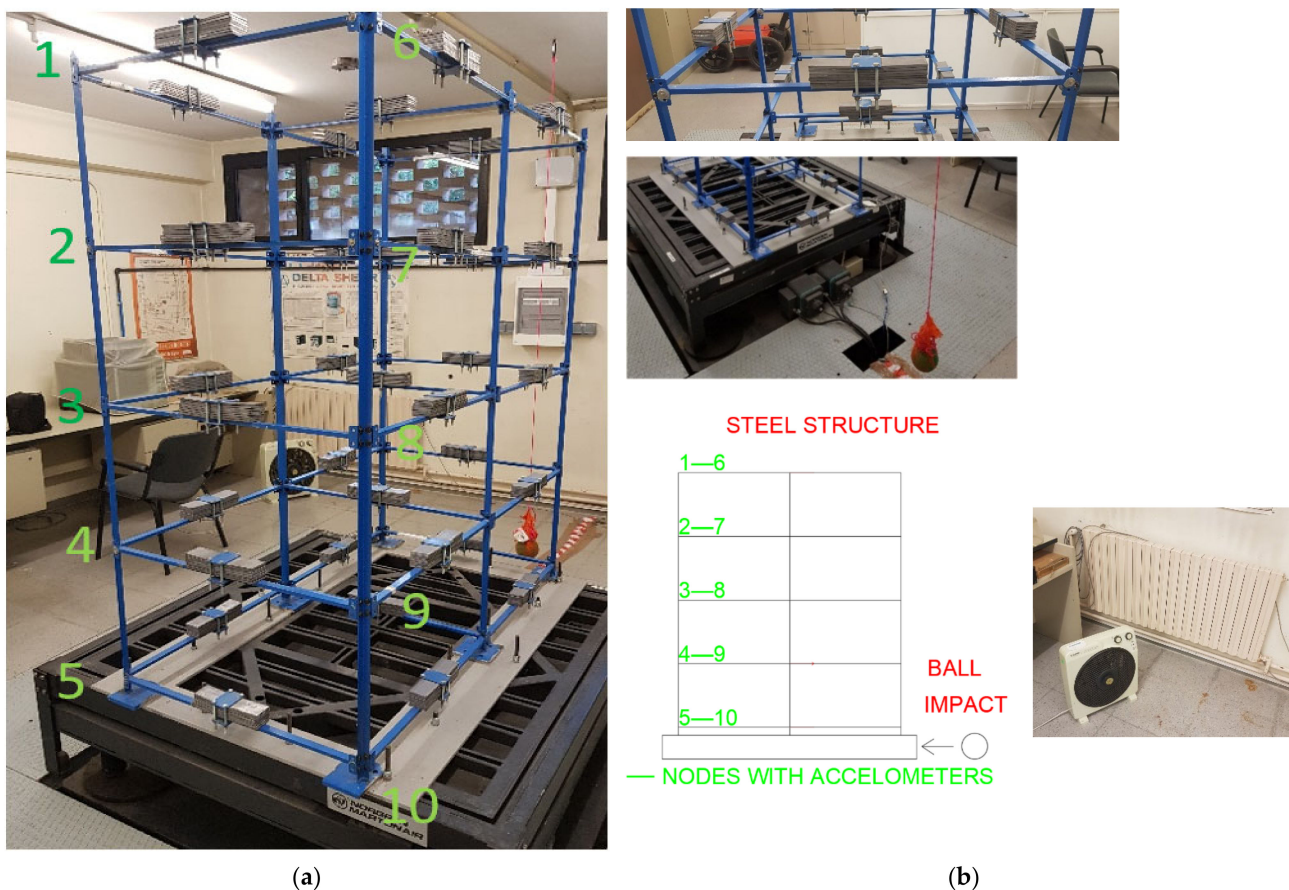
Figure 2. (a) Scaled steel model structure with the number nodes (green); (b) The added load, the ball, schema representing the structure, the monitored nodes (green), and the heaters.

A reduced steel model structure has been used to apply a set of different experimental tests, which are aimed at studying the behavior of the modal frequencies under thermal ambient variations. The scaled steel structure has been modified so that the undamaged and different damaged configurations have been considered in the experimental tests. Numerical models representing the damaged and undamaged structure configurations have been designed and calibrated to complement the experimental tests. The structural model consists of six columns and 35 beams made of steel (Figure 2a). The columns are continuous L shaped $20 \text{ mm} \times 20 \text{ mm} \times 2 \text{ mm}$ profiles, and the beams are $20 \times 10 \text{ mm}$ rectangular shaped bars. The length of each beam is approximately 72 cm for the two-bay frames, and 77 cm for the one-bay ones. Approximately 4.5 kg of lead weight was added in the middle of each beam representing the permanent loads. These added loads consisted of eight $200 \text{ mm} \times 50 \text{ mm} \times 3 \text{ mm}$ lead thick plates connected to the model with a steel plate and four bolts.

the test is performed by using a 2 kg ball and hitting the base of the structure (Figure 2b). The kinematic response of the structure is therefore analyzed by recording, with a set of accelerometers, the acceleration time history of the nodes (Figure 3a,b). The impact force and its corresponding momentum are homogeneous for all the tests because the ball is raised to the same height in each test. Regarding the emulation of the damage conditions of the structure, the impact procedure is performed for five different structure conditions. A first test is performed on the undamaged structure, and four additional tests are undertaken on the structure modified with different damaged configurations. As described above, for each damaged configuration, a range of different ambient temperatures is applied. Then the acceleration is monitored on some specific nodes. The test procedure consists of hitting the structure once every minute. Ten tests were applied successively for each fixed ambient temperature. During the laboratory experiments, the temperature is controlled with a thermometer. However, in order to measure the actual temperature of the structure, a thermographic image was taken by an infrared camera. The joints (Figure 3a) are two vertically positioned bolts at the ends of the beams.

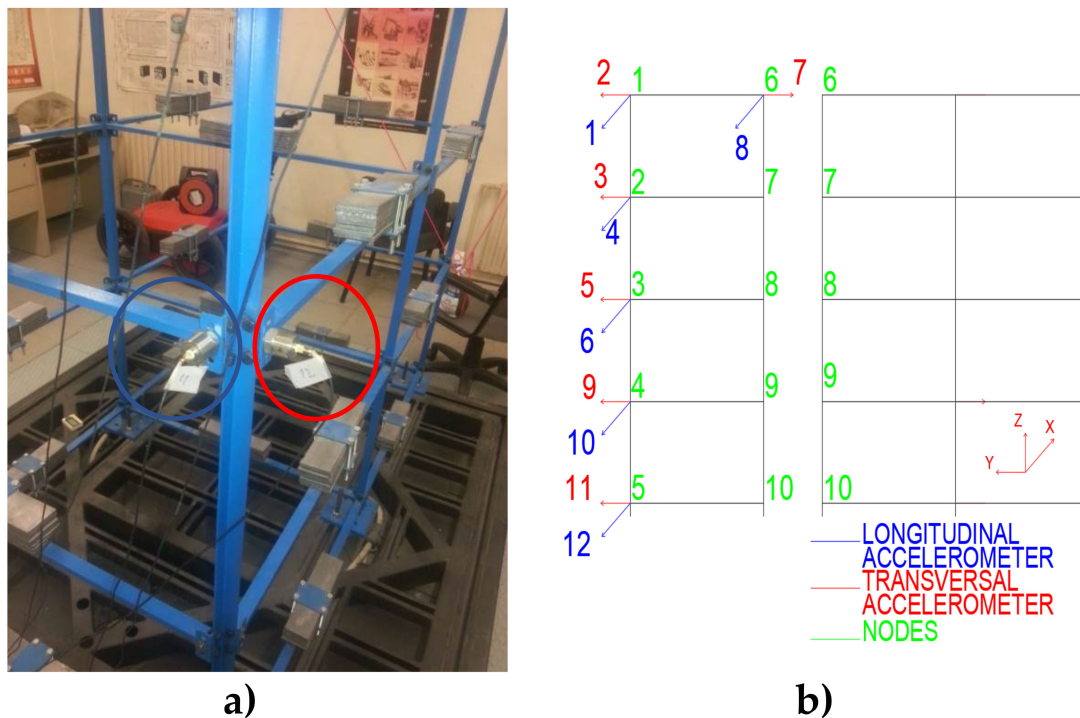
Figure 3. The scaled model and the experimental setup (a) Longitudinal (blue circle) and transversal (red circle) distribution of accelerometer; (b) Location of the nodes (green) and the accelerometers (red and blue).

The experimental setup involves 12 Brüel & Kjaer accelerometers (model 4371) placed in the nodes located in positions 1 to 6 (Figures 2b and 3b). In Figure 3b, the two directions of the accelerometer are detailed in each monitored node with red and blue arrows. The direction of the arrow indicates a positive direction. Accelerometers in positions 1, 4, 8, 10 and 12 were placed in the longitudinal direction (X), while in the transverse direction (Y), the accelerometers were located in positions 2, 3, 5, 7, 9 and 11 (Figure 3b).

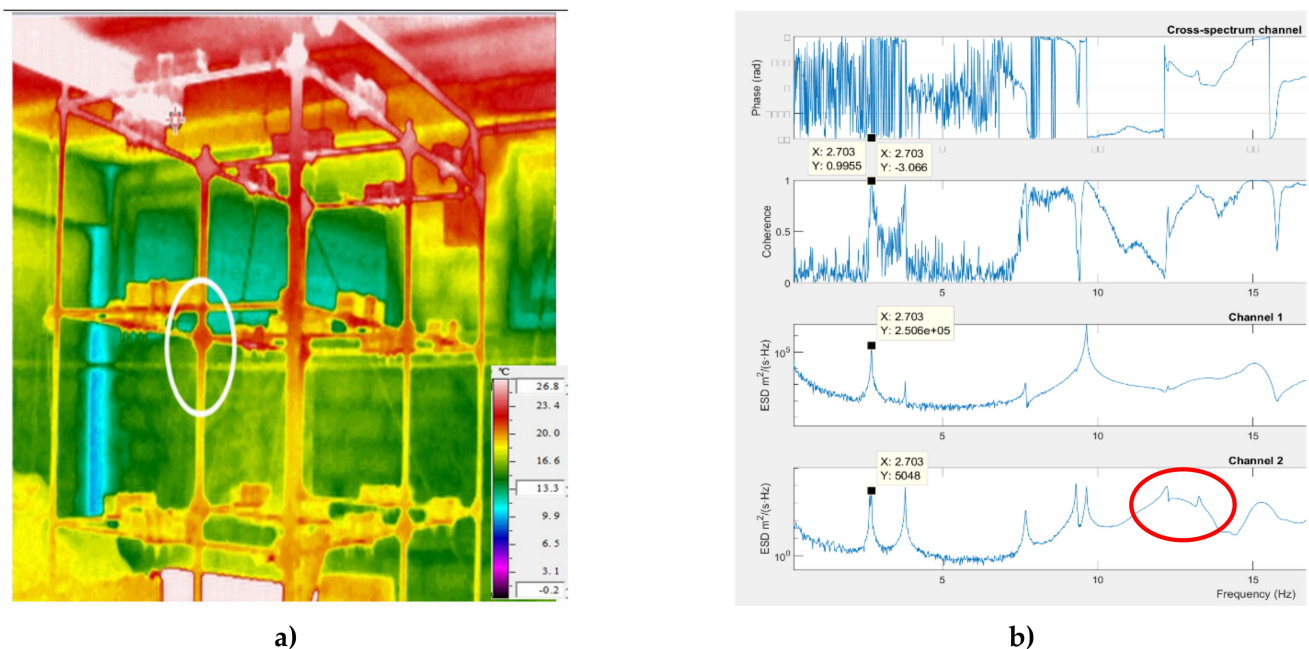
Figure 4. (a) Thermal image of the scaled structure for test 1 at 20.5 °C; (b) Phase, Coherence and ESD of Channels 1 and 2 for test 1 at 20.5 °C between 0 and 18 Hz.

For each monitored damaged configuration, the temperature was measured by a thermal camera (Figure 4a). The post-process signal treatment and analysis were carried out with the Infrec Analyser program. For each test, the temperature is controlled with the help of electric stoves, in the case of increasing the heat, and to lower the temperature with the help of an air conditioning device, as commented above. Table 1 shows the temperature range applied in the five tests.

Figure 4a shows the image obtained with the thermal camera for test 1 at 20.5 °C. The colored picture indicates a heterogeneous distribution of the temperature. The upper part of the structure reached a higher temperature while the bottom of the structure remained cooler. For all tests, the same point is used to measure the temperature (highlighted circle in Figure 4a) and is located at the intermediate height of the structure.

In longitudinal accelerometers, higher modes present a non-symmetric peak related with a non-linear behavior (red circle in Figure 4b).

In ESD, the frequency peak patterns are similar between channel 1 and 2 for modes 2 to 13. However, mode 1 only appears in the longitudinal channel (Figure 4b). It is also important to highlight that, for the tests performed on high damaged configurations and for all the temperatures in the range of study, the first mode, which is orthogonal to the direction in which the structure is excited, was not clearly detected and, consequently, it has not been used in the PC analyses.

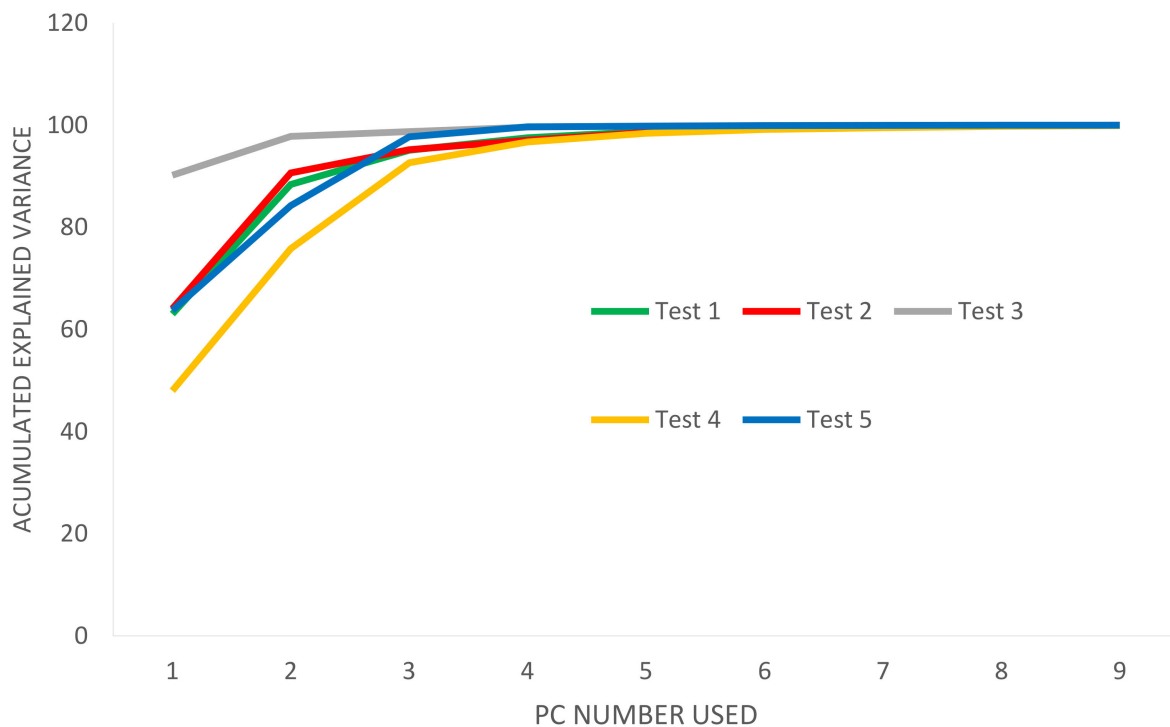
Figure 5. Cumulative explained variance (%) vs. principal component number.

The variance explained is studied for all the damaged configuration tests. Each principal component is associated to a percentage of variance explained. Figure 5 represents the cumulative variance explained vs. the number of principal components used for each of the damaged tests.

The test that has the highest cumulative variance explained for almost all the principal component numbers chosen is the high damaged configuration test 3 (damage in two nodes). The test that has the lower explained cumulative variance is the high damaged configuration test 4 (damage in three nodes). For the undamaged configuration test, three principal components are enough to explain 95% of the data variance and have a flat curve slope. The medium damaged configuration test 2 (damage in two nodes) also needs three principal components before the change of the curve slope in order to explain 95.5% of the total variance. Test 3 (high damage in two nodes) and test 5 (high damage in four nodes) also needed three principal components in order to explain 98% of the data variance. Test 4 (high damage in three nodes), the only damage configuration that includes an asymmetric damage distribution pattern, needed four principal components to make the cumulative variance curve flat and explain 97% of the variance of its data.

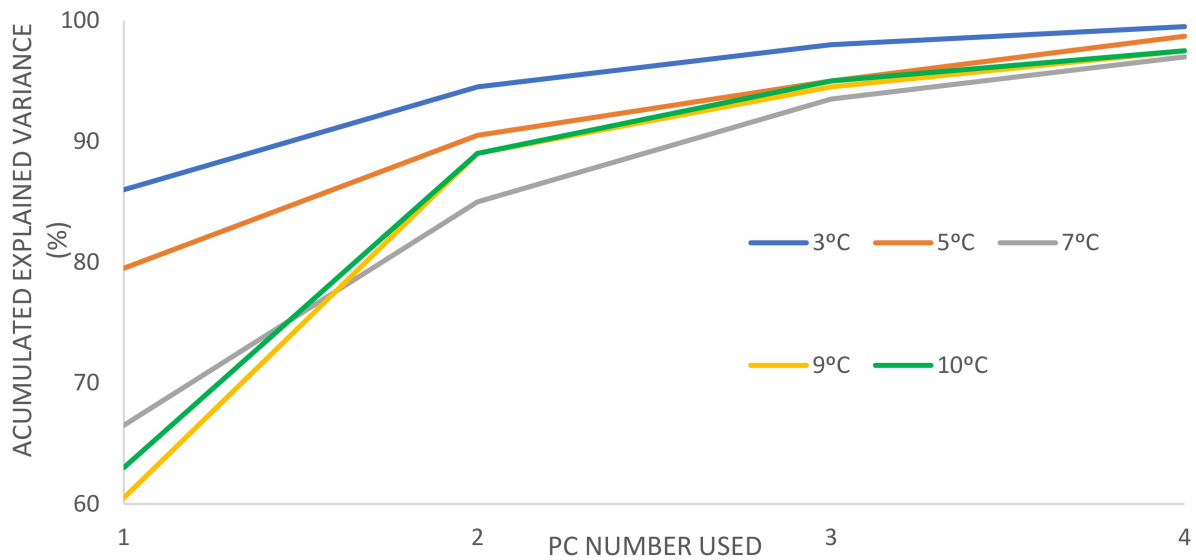
Figure 6. Thermal variation of the cumulative variance for the first four principal components used for the undamaged configuration test.

The evolution of the principal components with the temperature for the undamaged configuration test shows a minimum of 9 degrees of temperature range to assure the stability of the cumulative explained variance of the PC (Figure 6). Similar results occur in the other tests.

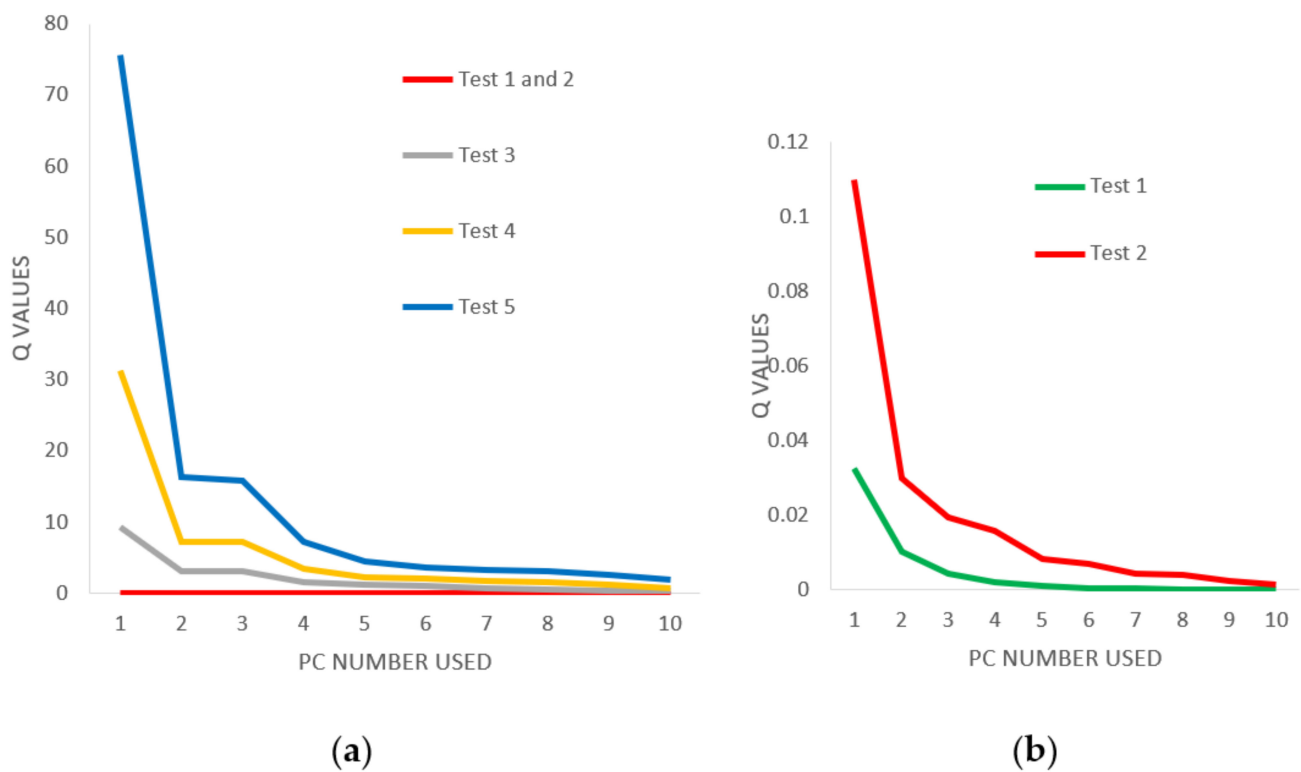
Figure 7. (a) Q values vs. principal component number for all damaged tests. (b) Q values vs. principal component number for tests 1 and 2.

For each damaged configuration test, the Q value is computed as explained in Section 2.2 Equation (6). Figure 7 shows the results of Q values vs. principal component number related to the damaged configuration tests performed in this study.

The undamaged configuration test (test 1) shows the lower Q values for all the principal component number, while the test with higher Q values, is the high damaged configuration test 5 (damage in four nodes).

The Q values derived from the tests are ordered according to the increasing damage level (Figure 7a). The Q values in the undamaged and medium damaged configurations (tests 1 and 2) are smaller than those calculated for the high damage configuration structures (tests 3, 4 and 5). The Q values of the high damaged configuration test 5 (damage in four nodes) are higher than those of the high damage configuration test 4 (damage in three nodes). In addition, the Q values of the high damage configuration test 4 (damage in three nodes) are bigger than the high damage configuration test 3 (damage in two nodes).

In tests 3, 4 and 5 (structures with high damaged configurations), the Q values increase monotonically after the fifth principal component. The fifth principal component is the inflexion point (Figure 7a). However, for the tests 1 and 2 (undamaged and medium damaged structures), Q values increase monotonically since the first principal component. Therefore, in these two cases, only one principal component is needed to reach the inflexion point (Figure 7a).

Although tests 1 and 2 do not indicate a significant shape difference (Figure 7a), when increasing the resolution of the graphic in Figure 7b, it is evidenced that Q values in the undamaged configuration structure (test 1) are smaller than the medium damaged configuration structure (test 2). Not only the Q values are sensitive enough to evaluate the difference between the high damaged, medium damaged and undamaged tests, but it can also differentiate the medium damage configuration (damage in two nodes) from the undamaged configuration structure.

The Q estimator is arranged according to the damage intensity (Figure 7a). The Q estimator is sensitive enough to establish that values in the undamaged structure (test 1) are smaller than those calculated in the medium damaged structures (test 2).

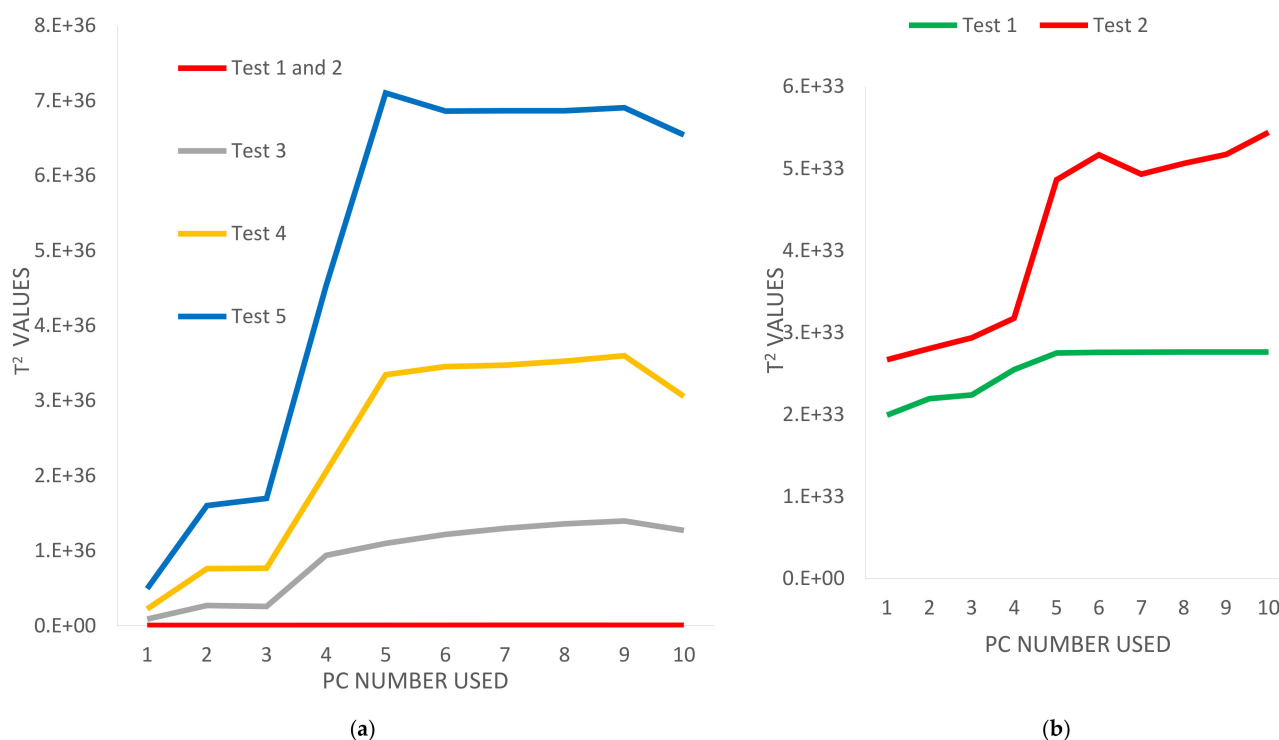
Figure 8. (a) T^2 values vs. principal component number for all damaged tests. (b) T^2 values vs. principal component number for tests 1 and 2.

For each of the damaged tests, the T^2 value is computed as explained in Section 2.2 Equation (5). Figure 8 shows the T^2 values graphic vs. principal component number for each of the damages.

The T^2 values of the tests are arranged in increasing order of damage (Figure 8a). The T^2 values in the undamaged and medium damaged structures (tests 1 and 2) are smaller than the three high damaged structures (tests 3, 4 and 5). The T^2 values of the high damage four nodes structure (test 5) are bigger than the high damage in three nodes structure (test 4). In addition, the T^2 values of the three nodes high damage structure (test 4) are bigger than the two nodes high damage structure (test 3).

In tests 3, 4 and 5 (high damaged structure), the T^2 values increase monotonically after the fifth principal component. The fifth principal component is the inflexion point (Figure 8a). However, for the tests 1 and 2 (undamaged and medium damaged structure), the T^2 values increase monotonically since the first principal component. Thus, in these two cases, only one principal component is needed to reach the inflexion point (Figure 8a).

When increasing the resolution of the graphic (Figure 8b), it can be observed that T^2 values in the undamaged structure (test 1) are bigger than those obtained for the medium damaged structure (test 2).

The T^2 estimator is sorted according to the intensity of the damage (Figure 8a). However, the T^2 estimator seems not to be sensitive enough because T^2 values in the undamaged structure (test 1) are bigger than the medium damaged structure values (test 2). The main causes that may explain these results are the reduced resolution and the short range of temperatures.
