MY PROSTHETIC KNEE IS BECOMING UNSTABLE

¹LH Ong; ²Sabaruddin A; ²Rutel A; ²Jaffar MSA, ²CH Bong; ²KT Tan, ²P. Rao, Reuben, ²Kamaruddin F

¹ Faculty of Medicine & Health Sciences University Malaysia Sarawak Kota Samarahan Sarawak.

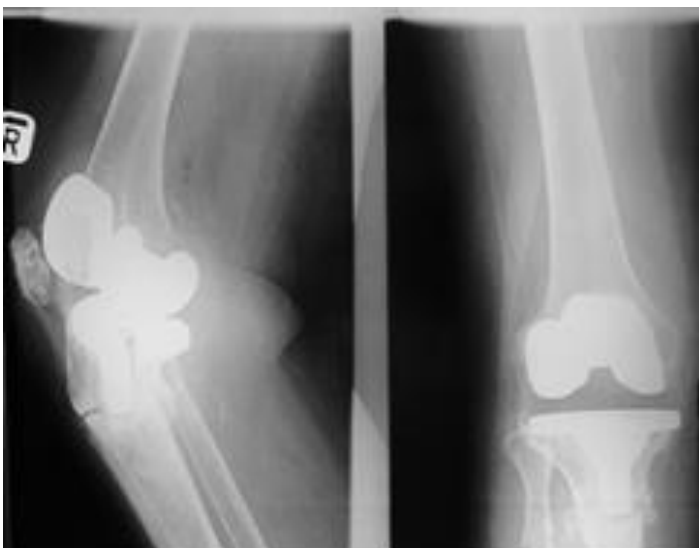
Figure 1: Right knee radiographs

65-year-old lady presented with 2 weeks history of insidious right knee pain, swelling and instability 5 years post total knee replacement. Examination noted patient was able to weight bear with walking frame in pain with varus/valgus laxity. Range of movement of the right knee is 0 – 135 degrees with no evidence of infection. Radiograph noted loosening and peri-prosthetic fracture of the right tibia component associated with fibula neck fracture with no evidence of biochemistry markers of infection.
