Safety and sustainability of school buildings

Doctoral Dissertation  
Doctoral Program in Civil Engineering (34<sup>th</sup> Cycle)

# **Safety and sustainability of school buildings**

**Oscar Mancinelli**

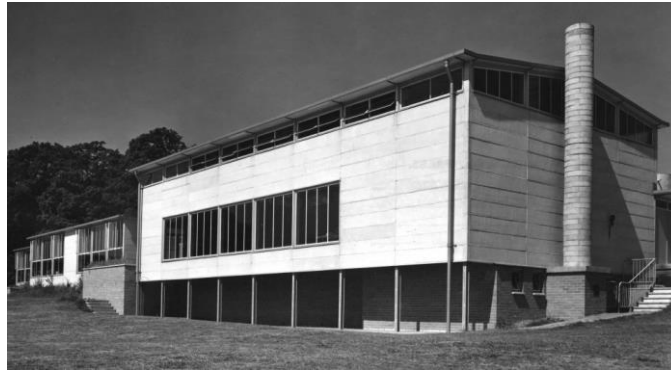
Fig. 5: Essendon Primary School, Hertfordshire: an early example of prefabrication in school buildings, made of light steel-framed system [13]

was promoted by the *School Construction Systems Development Program* (SCDS), a joint effort by university researchers. This programme, which aimed at developing more economical building technologies by importing industrial standardization and techniques, played a key role in building experimentation in the 60s [11, 12].

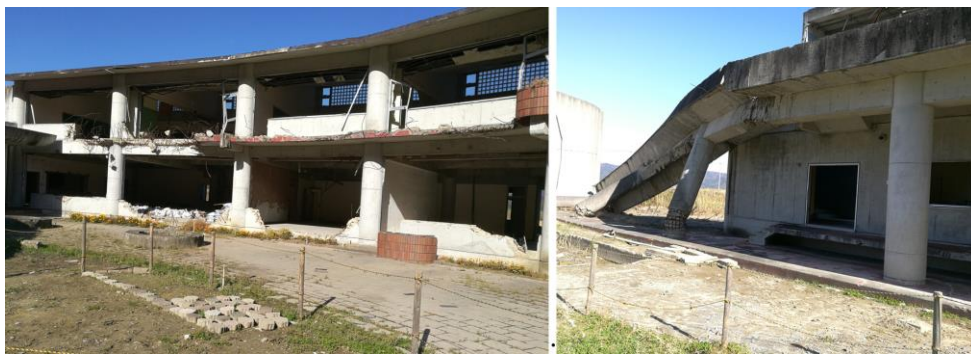
Fig. 11: Okawa Elementary school after being damaged by 2011 tsunami.

However, the *Great East Japan Earthquake* of 2011 highlighted two fundamental points. On the one hand, it showed the key role played by schools as shelters for the population, further emphasising the need to make them safe. On the other hand, it revealed a vulnerability towards the tsunami according to their structural materials, number of floors, distance from the coast and local topographical characteristics [46]. For instance, the two primary schools of Okawa and Kodowaki in the Miyagi Prefecture, were barely damaged by 2011 tsunami disaster. At the Okawa Elementary School, there were 84 casualties [47]. The low-rise two-storey school building, while suffering limited direct damage due to the earthquake, turned out to be very vulnerable to the tsunami. The level of water reached 8.6 m due to the school's unfavourable location in relation to the orography of the surrounding area. Conversely, in the Kodowaki elementary school students and staff escaped in time and survived. However, the school,

which did not suffer any major direct damage from the earthquake, was hit hard by the tsunami and a fire that broke out from debris dragged into the building by the ocean. The heavy legacy of the disastrous events of 2011 is a key lesson that shows how not all the risks can be tackled by acting on a simple building level. Indeed, the fundamental safety measures (e.g. against earthquakes or fire) must be combined with effective Disaster Risk Reduction (DDR) strategies, which include prevention and information for pupils and teachers [48]. The two school buildings have been decommissioned, but the Japanese authorities want to preserve them as a reminder of what happened for future generations. (Fig. 11 and Fig. 12).

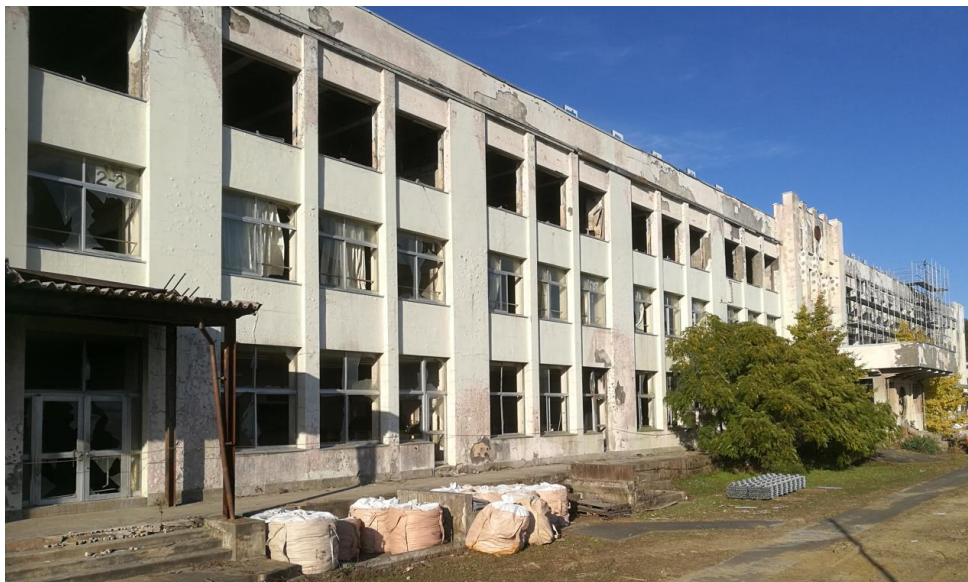
Fig. 12: Kodowaki Elementary school after being damaged by tsunami (November 2019)

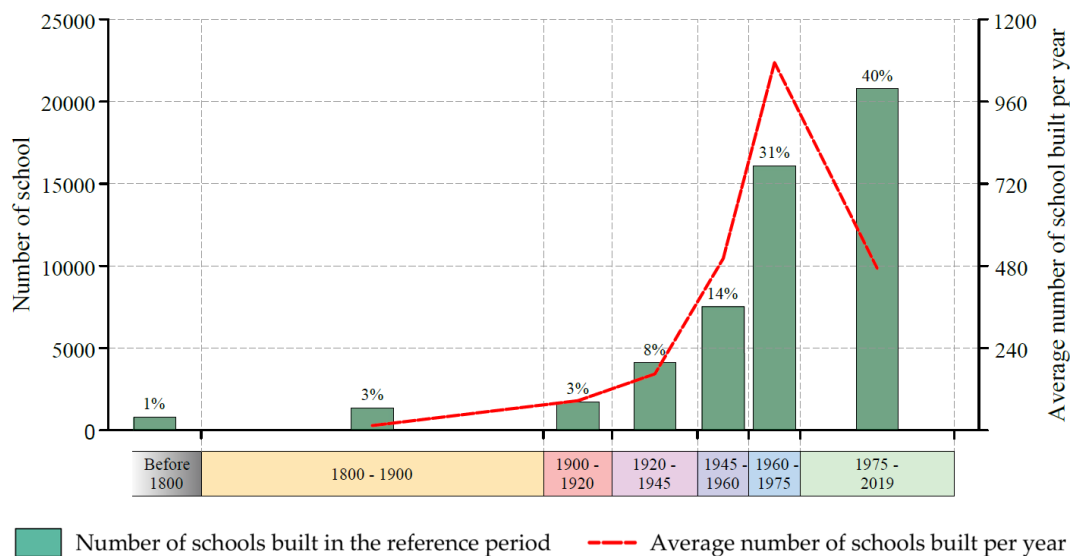
Fig. 16: Construction trend of new school buildings over the time [74].

Approximately 60% of the schools are more than 45 years old. In other words they were built in periods when no seismic standards existed, except in very restricted areas recognised as highly seismic. It is also worth noting that although the last period 1975 - 2019 has the highest percentage of schools built (40%), the most prolific period for school construction was 1960-1975 with more than a thousand schools built every year. As a result, even though 46% of schools are located in medium or high seismic zones (Fig. 17a), only 25% and 20% of schools were seismic-resistant designed in high and medium seismic zones, respectively (Fig. 17b). Beyond seismic risk, more than half of schools have a certificate of static sustainability (Fig. 17c), whereas about 55% of schools do not have a certificate of use and occupancy (Fig. 17d). On the other hand, a survey carried out by the Agnelli Foundation in 2019 reported that almost 10% of schools revealed structural problems, with an estimated cost of around € 200 billion to renovate and reinforce the entire Italian school building stock. [75].

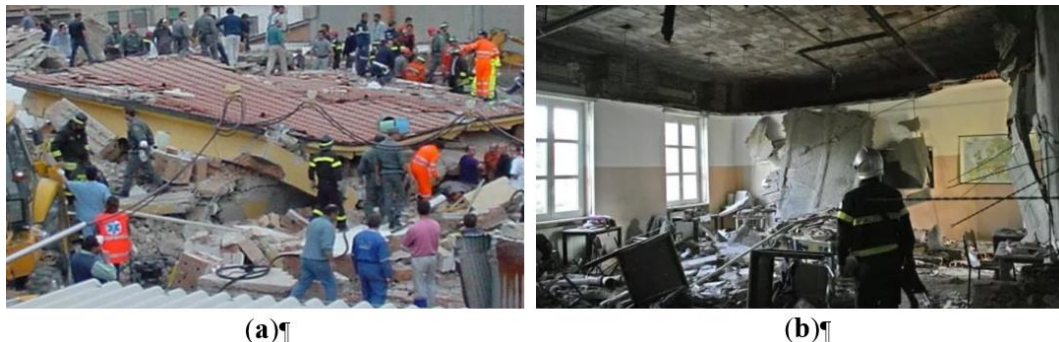
Fig. 18: Some school collapses in Italy: (a) "*Francesco Iovine*" Primary School in San Giuliano di Puglia [77]; (b) "*Darwin*" High School in Rivoli [78].

at the 'Darwin' High School in Rivoli on November 22, 2008, which caused Vito Scafidi's death and one student was seriously injured (Fig. 18b). In particular, these two cases show the tragic effects of two different aspects of the safety deficiency. On the one hand, the collapse of the school in Molise, after an earthquake of magnitude 6 Richter, was caused by the lack of anti-seismic measures in the design of the school, which was not addressed despite being aware that the school was in an seismic-prone area. On the other hand, the collapse of the brick ceiling in the Darwin High School is not caused by a triggering factor, but rather by both a lack of knowledge about the type and mechanical performance of the ceiling and by the heavy debris rested upon it. These tragic events show that the safety of schools depends not only on design and safety aspects, but also on a thorough knowledge of school buildings, which includes construction techniques, as well as all the events and interventions that occurred during their lifetime, along with their constant monitoring. These disastrous events have prompted the authorities to increase their efforts on the school safety issue in recent years, with funding lines being created for seismic retrofitting and, in general, for increasing the safety of schools. However, according to the report of "*Cittadinanza Attiva*", during 2020/2021 academic year there were 35 collapses in schools, showing that the road ahead is still long [76].

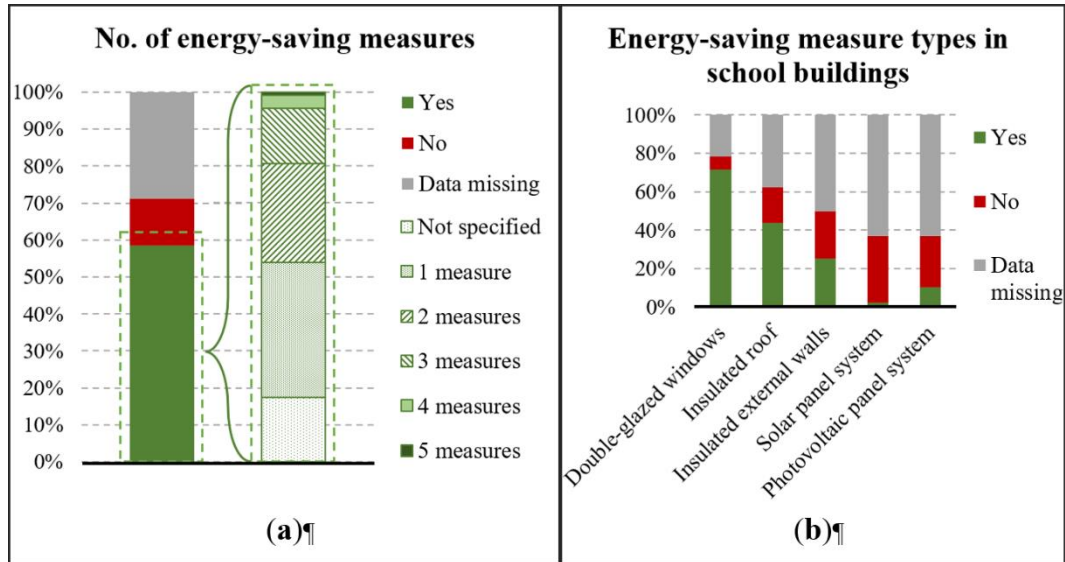
Fig. 19: Energy saving measures; (a) number of schools with one or more measures; (b) types of measures and their implementation in schools

photovoltaic panel systems are absent in almost all the schools (Fig. 19b). Only in around 300 schools, i.e. less than 1% of the total building stock, all the five measures considered are implemented. (Fig. 19a).

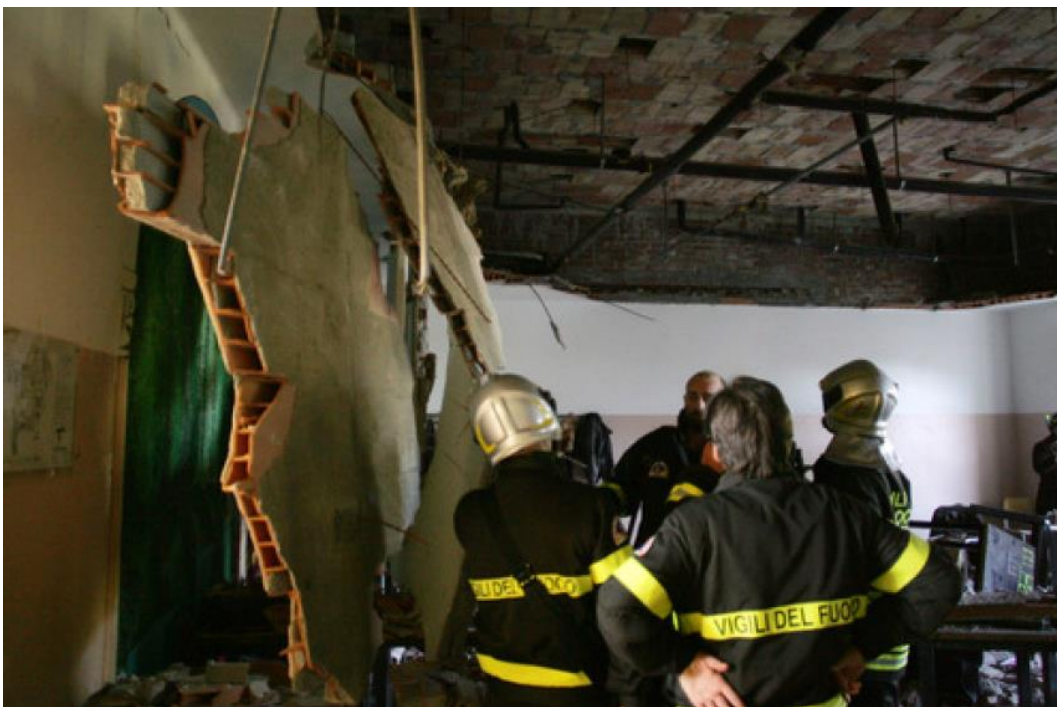
Fig. 25: Illustration of the ceiling collapsed at the Darwin High School in Rivoli, Turin, Italy.

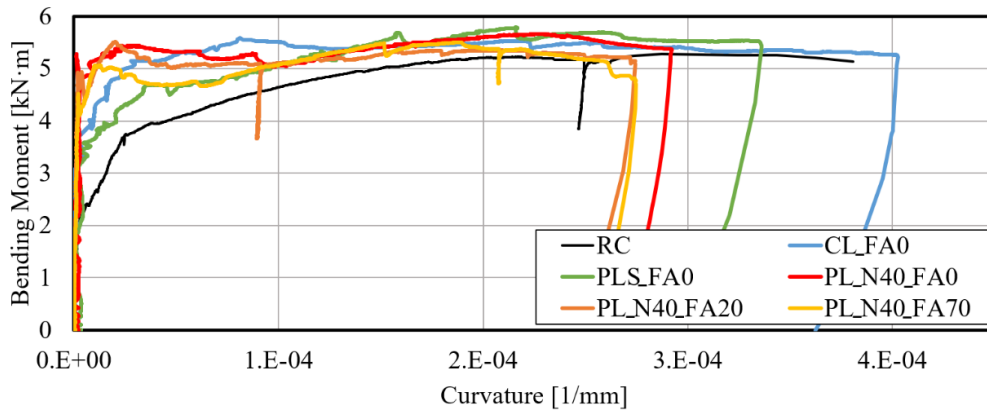
Fig. 39: Moment–curvature relationship measured in the constant moment zone of the beams tested in the experimental campaign 2

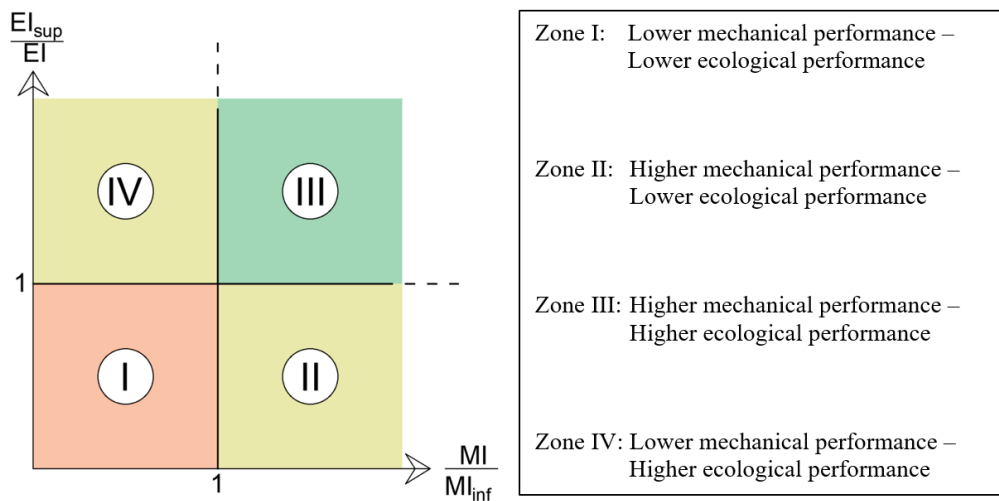
Fig. 44: non-dimensional diagram for evaluating the eco-mechanical performance of concrete manufactures.

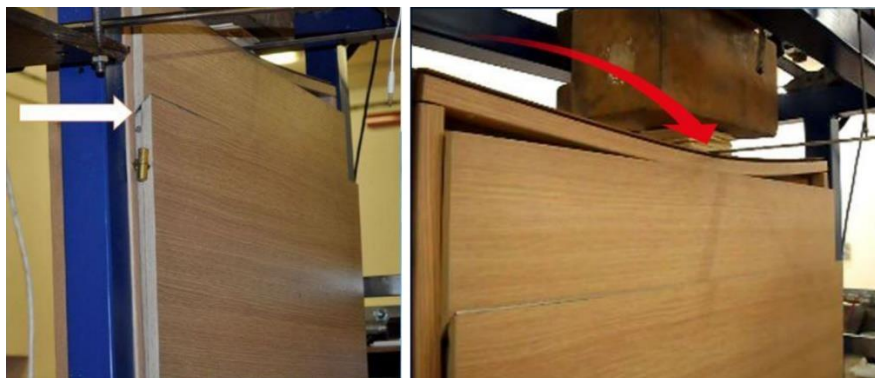
Fig. 49: Emergency System for door opening in critical condition proposed by LF System Italia s.r.l.s. [150].
