Rock Mass Characterization by UAV and Close-Range Photogrammetry: A Multiscale Approach Applied along the Vallone dell'Elva Road (Italy)

Maria Migliazza ¹, Maria Teresa Carriero ^{1,*}, Andrea Lingua ²

Abstract: Geostructural rock mass surveys and the collection of data related to discontinuities provide the basis for the characterization of rock masses and the study of their stability conditions. This paper describes a multiscale approach that was carried out using both non-contact techniques and traditional support techniques to survey certain geometrical features of discontinuities, such as their orientation, spacing, and useful persistence. This information is useful in identifying the possible kinematics and stability conditions. These techniques are extremely useful in the case study of the Elva valley road (Northern Italy), in which instability phenomena are spread across 9 km in an overhanging rocky mass. A multiscale approach was applied, obtaining digital surface models (DSMs) at three different scales: large-scale DSM of the entire road, a medium-scale DSM to assess portions of the slope, and a small-scale DSM to assess single discontinuities. The georeferenced point c

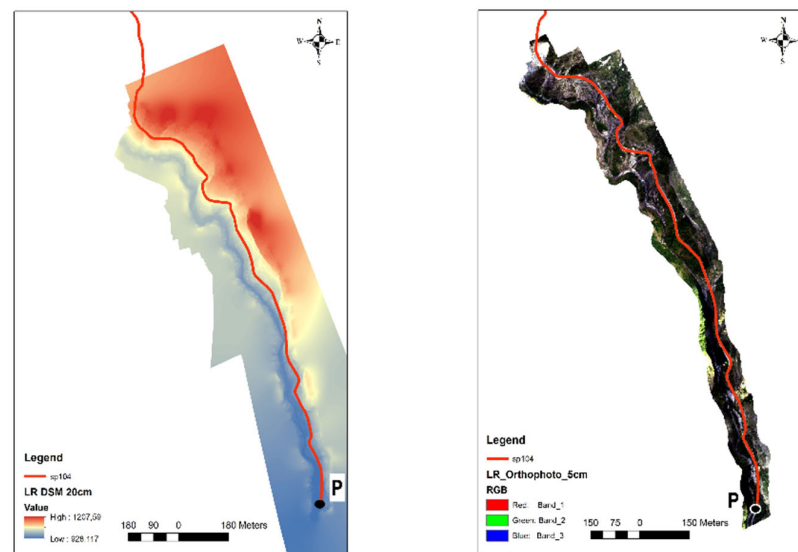
Figure 7. LR example of DSM and orthophoto; coordinates of point P (UTM zone 32T, 349,027.40 m E, 4,938,557.42 m N).

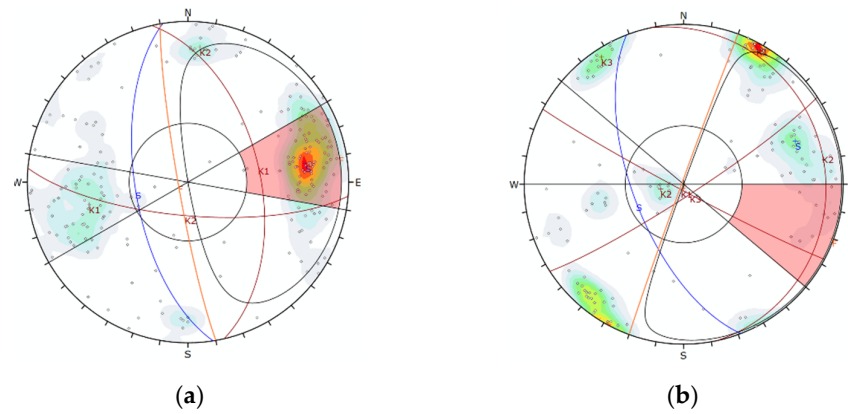
Figure 16. Markland test with Dips 7.0 for sectors (a) A1_b and (b) A3_b.

In each sector, the potential kinematic mechanisms were identified. As previously indicated, the analyses were performed by Dips7.0 [35], identifying the kinematic mechanisms that can occur, on the base of the planes and the slope orientation through the application of the Markland test [43]. Figure 16 shows the Markland test carried out for the A1_b and A3_b sectors; in Table 7 and in Figures 16 and 17, the results obtained in each sector are summarized. The prevailing kinematic mechanism is that of planar sliding but, in some cases, the discontinuity systems can form blocks, which can become unstable due to rockfall or toppling.
