# Determination and Mapping of the Causes of High Risk of Earthquake Hazards Using Geoelectrical Data in Bengkaung, Batu Layar, West Lombok Indonesia

**Abstract:** The Bengkaung area, Batulayar District, West Lombok is suspected to be very vulnerable to the risk of earthquake hazards. However, in this area no scientific research, either geological or geophysical, has ever been carried out regarding this hazard. How are the physical characteristics of the lithology and structure in the area to the risk of earthquake disaster? The purpose of this study was to determine the physical characteristics of the lithology and subsurface structures that were validated by the level of damage. The method used is the geoelectric method and local building damage data. The results of the 2D geoelectric anomaly modeling show the characteristics of the subsurface lithological layers in the form of sand, sandstone, clay, andesite lava faults, fresh andesite lava, and granite. The fault was detected in the center of the study area in a north-south direction. Earthquake hazard analysis shows that the cause of the high risk of earthquake hazard in Bengkaung Village is the presence of faults and cohesiv

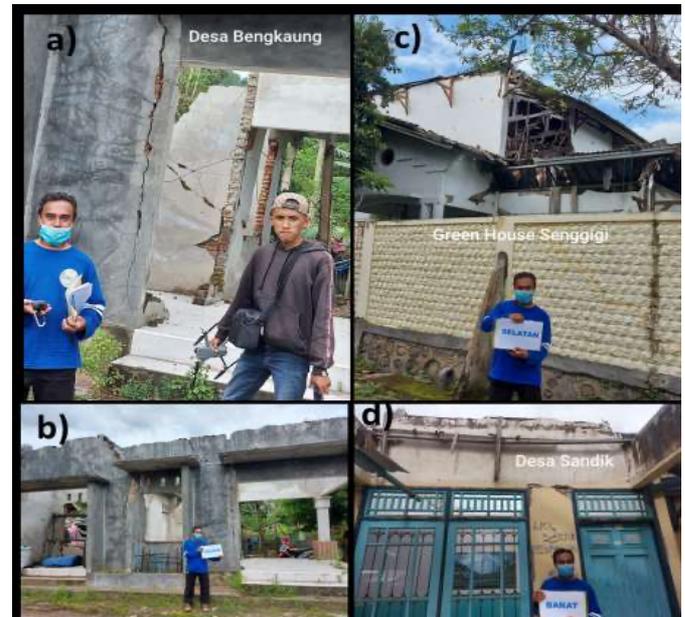
**Figure 1.** Damage photos: a) and b) in Bangkaung Village, c) in Senggigi (Northwest of Bengkaung), d) in Sandik Village (South Bengkaung) (Hyodo et al., 1993)

One of the worst impacts of this third earthquake was in Bengkaung Village, Batu Layar District, West Lombok. Based on data (BPBBD, 2021) this third strong earthquake resulted in 328 houses being heavily damaged, 207 houses being moderately damaged, and 271 houses being lightly damaged. We also found direct damage remnants at the site as shown in Figure 1 (Lavigne et al., 2020). The pattern of damage phenomena in Bengkaung Village approaches a straight line in a north-south direction. We suspect that the phenomenon of damage such as this line is an indication of faults and soft soil that is vulnerable to earthquake hazards.

(depending on the strength of the earthquake and the location of the source) which results in a decrease in the shear modulus. This decrease in shear modulus is caused by the loss of soil stiffness with increasing shear strain. This is consistent with what we observed directly at a location where houses were generally heavily damaged (Figure 1).

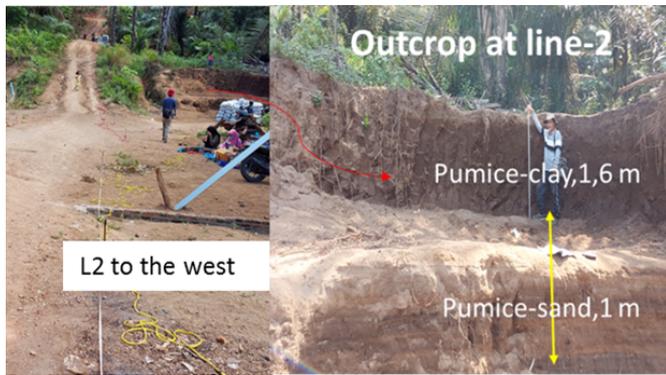
The results of the interpretation of each layer group consisting of clay containing pumice, lapilli pumice, and volcanic breccia sand according to outcrops in the field (Figure 5). The overburden layer fills the elevation of 25 - 40 m, successively the falling pumice layer is 1.6 m thick and the sandy pumice is 1 m thick and weathered breccia sand. The last two layers are alternating, indicating an iterative depositional process.

Figure 5. Outcrop of fallen pumice on line-2

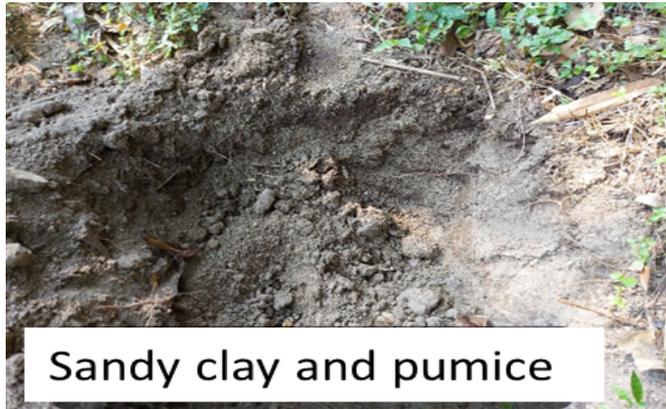
The results of the interpretation of each layer group consist of clay containing pumice, volcanic breccia sand layers containing clay, according to outcrops in the field (Figure 7). This topsoil fills at an elevation of 60 – 85 m, along the line, with resistivity values of 1.17 ohm-m to

Figure 7. Overburden outcrop on Line-3
