Architecture and Planning Journal (APJ)

September 2022

CALCULATING VANDALISM RISK ASSESSMENT FOR ARCHAEOLOGICAL FINDINGS WITHIN HERITAGE BUILDINGS: THE CASE OF AL-ATTAR HISTORICAL MOSQUE IN TRIPOLI LEBANON

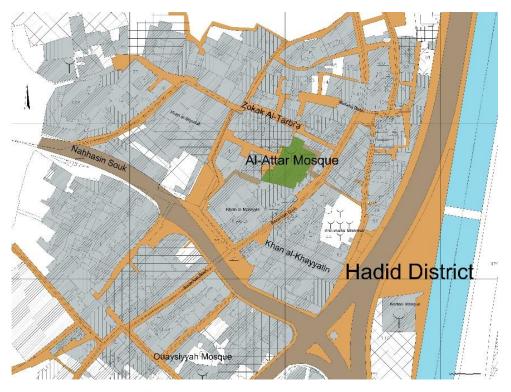
Fig.2: Location of the Attar Mosque, and its surroundings in Tripoli Lebanon

Al-Attar Mosque is located in North Lebanon, Tripoli City. Integrated in the old city, the mosque lies north of the citadel of Tripoli, on the left bank of Abu Ali river, it is located in the Tarbi'a area, Lot no. 1, Hadid district, at an elevation from sea level of approximately 22m.

It is closely surrounded by Souks, Khans, *Hammams* and residential buildings. The mosque has three entrances, where the main east entrance leads to *Souk Al-Bazerkan*, the west entrance leads to *Zoukak AL-Tarbi'aa* and the west entrance leads to *Khan Al-Shawish*.

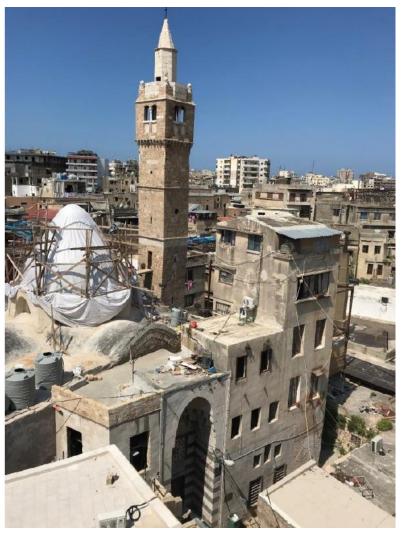
Fig.4: Al-Attar Mosque – Ref: Hazem Aysh

The main prayer hall consisting of barrel vaults, dome and iwans, occupies an area of approximately 400 m2 (25 x 16m). Adding general facilities areas such as toilets located North of the mosque, an ablution room located East of the mosque and adjacent to the East entrance, as well as an open space area, result in a total area of the mosque of 600 m2.

The structure of the mosque consists of pointed barrel vaults, built in a cross shape, having a dome at their crossing, which is a unique prototype in Tripoli. (Salam-Liebich, 1983)
