Case Report

Neglected posterior acetabular wall fracture managed with uncemented total hip arthroplasty with posterior wall reconstruction by femoral head autograft: a case report

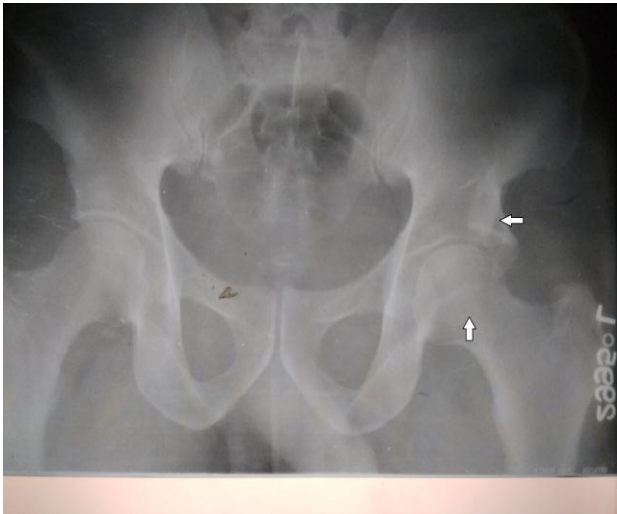
Figure 1: X-ray pelvis with B/L hip showing deficient and displaced posterior wall (arrows).

A forty two year old labourer presented with pain and tenderness in the left hip joint after sustaining a fall while unloading goods from a truck, five months back. Patient was unable to bear weight there on. He had taken treatment at a local hospital in the form of only symptomatic management and longitudinal traction. On examination, the limb was fixed in internal rotation deformity with restricted movement in the two planes. There was shortening of 3 cms on the affected side with high riding trochanter. There was associated nerve palsy presenting as foot drop. The skin traction on which the patient had come was replaced by skeletal traction with increased weight. Preoperative evaluation included x-rays in AP view (Figure 1) and computed tomography both 2D (Figure 2) and 3D reconstruction (Figure 3).

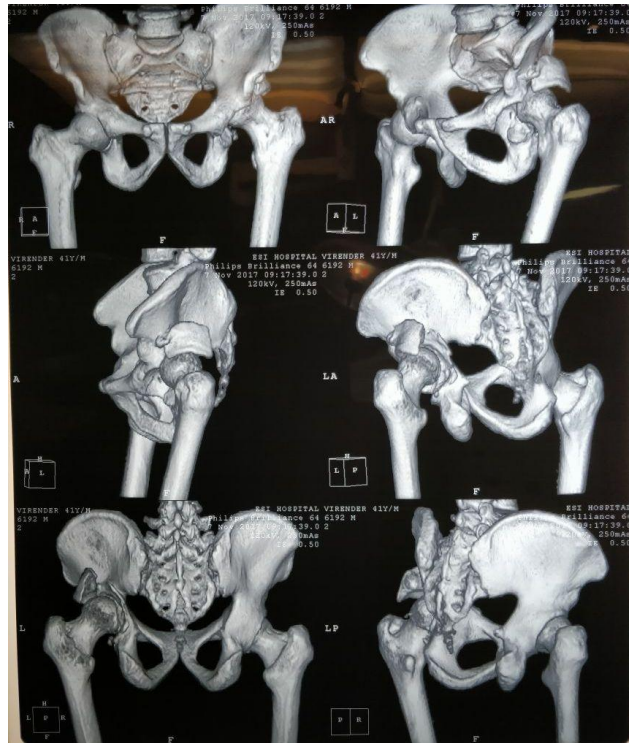
Figure 2: CT scan 2D reconstruction.

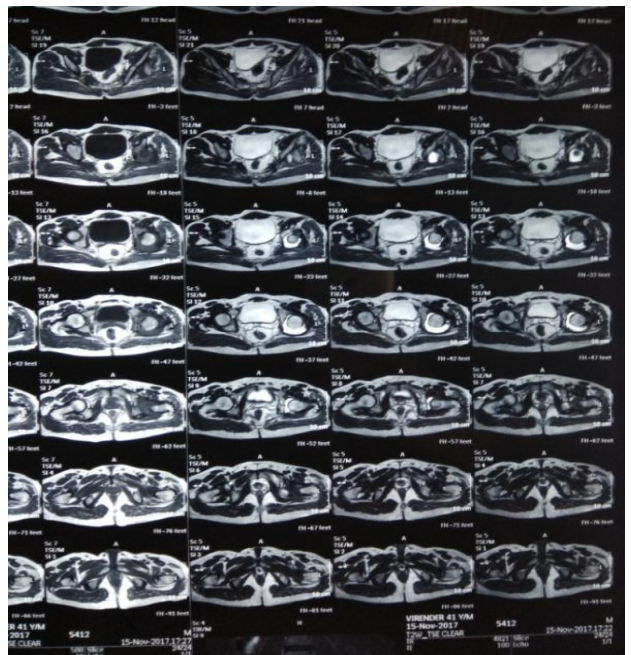
Figure 3: CT scan 3D reconstruction.

3D computed tomography scan provided a clear view about the acetabular and periacetabular bony anatomy. To rule out any arthritic changes in the femoral head, MRI of the hip joint (Figure 4 and 5) was done which revealed flattening of the head, joint effusion bone marrow oedema, confirming the post traumatic injury of the head.

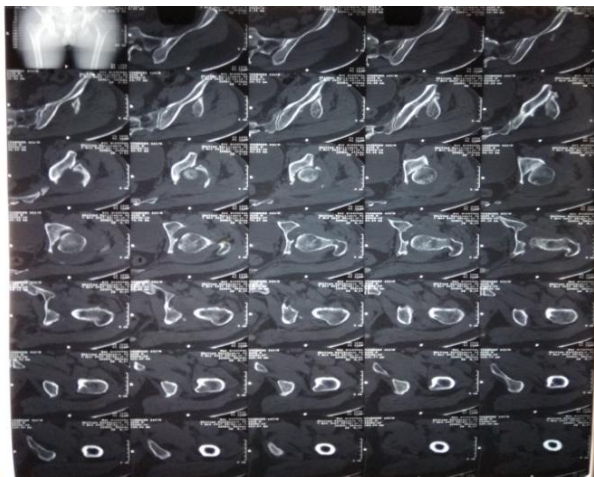
Figure 4: MRI hip joint (axial cut) showing marrow oedema and joint effusion.

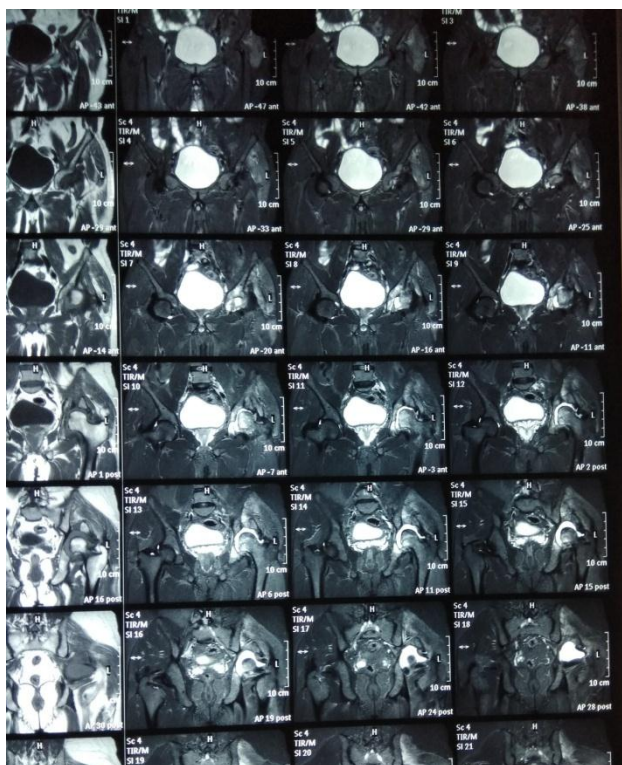
Figure 5: MRI hip (coronal cut) showing flattening of the head, joint effusion, bone marrow oedema.

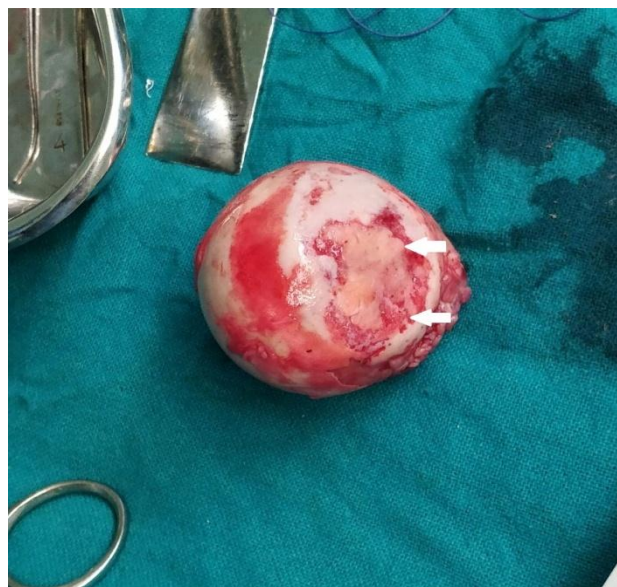
Figure 6: Post traumatic impaction injury showing destruction of the articular surface (arrow).

Patient was placed in the lateral decubitus on the radiolucent table, posterolateral approach was used. After careful dissection into the deeper layers, the head was dislocated. Femoral osteotomy was done in standard fashion and femoral head was saved for later as use of autograft. The head revealed large impaction injury with focal cartilage loss (Figure 6). The acetabular margins were clearly exposed to reveal posterosuperior defect of the wall. The defect was restored by creating a contoured wall support with the help of femoral autograft (Figure 7). The head was denuded from its cartilage and then fixed adjacent to the deficient posterior edge of the remaining acetabular cavity. The graft was secured onto the acetabulum with help of long 4.5 mm cancellous screws.

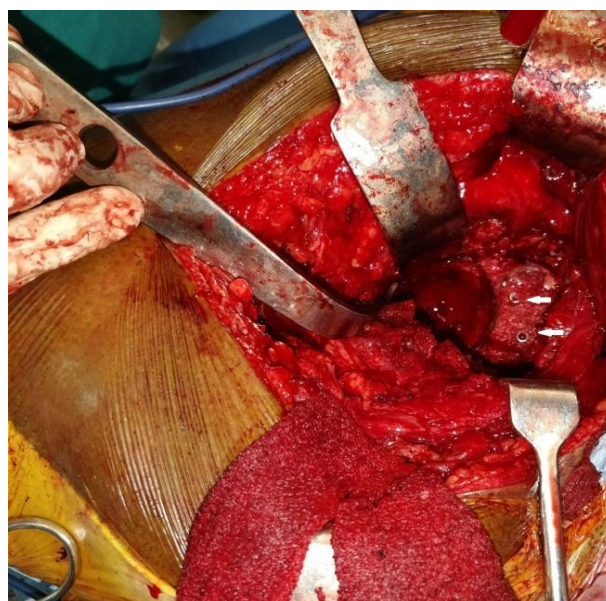
Figure 7: Posterior wall reconstruction after contouring of the femoral head and fixation into the ilium with screws (arrow).

The graft was then gently reamed with the acetabular reamer and the constructed cavity became one unit and was sequentially reamed thereon (Figure 7). The direction of the screw were directed such that they do not interfere with the reaming. After this the porous coated acetabular shell (Pinnacle Hip Solution by Depuy Synthes) of size 46 mm was fixed with cancellous bone screws in the reconstructed cavity. The shell placement was checked with intraoperative fluoroscopy (Figure 8)

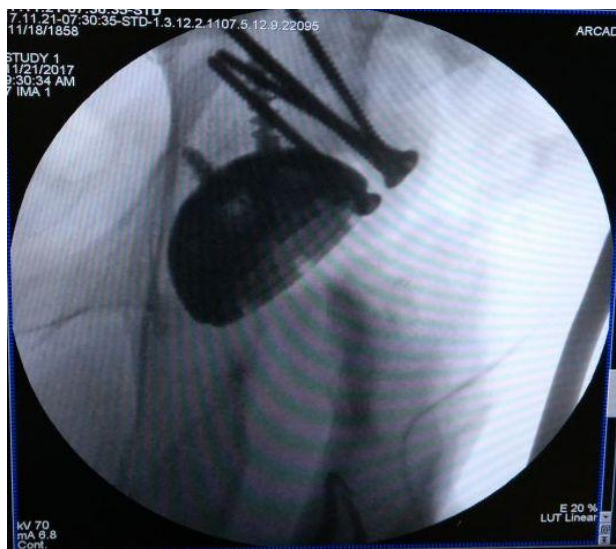
Figure 8: Intraoperative fluoroscopy.

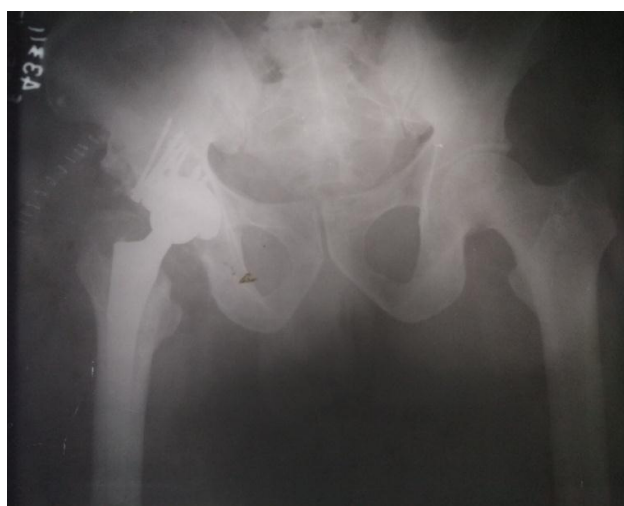
Figure 9: Immediate postoperative X-rays.

28 mm was used and hip was reduced. The hip was stable with a good range of movement. The rotators were reattached to the posterior greater trochanter through drill holes (Figure 9).

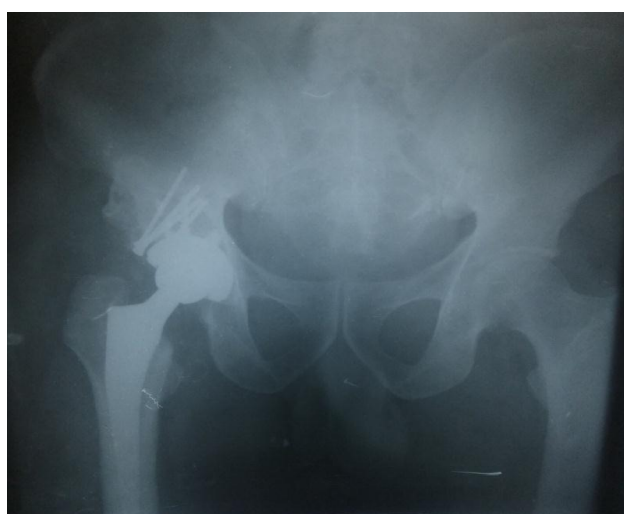
Figure 10: 3 months follow up X-rays, showing good autograft integration.

Range of movement exercises started postoperatively, with non-weight bearing for one month. Toe-touch weight bearing started after one month. By the end of three months, the patient was allowed complete weight bearing. Foot drop was managed by physiotherapy and orthotics. At three months follow up (Figure 10), autograft showed good uptake and patient had good functional outcome with Harris hip score of 76.
