GEOMORPHIC EFFECTS AND HABITAT IMPACTS OF LARGE WOOD AT RESTORATION SITES IN NEW ENGLAND

A thesis

Master of Science

Boston College
Morrissey College of Arts and Sciences
Graduate School

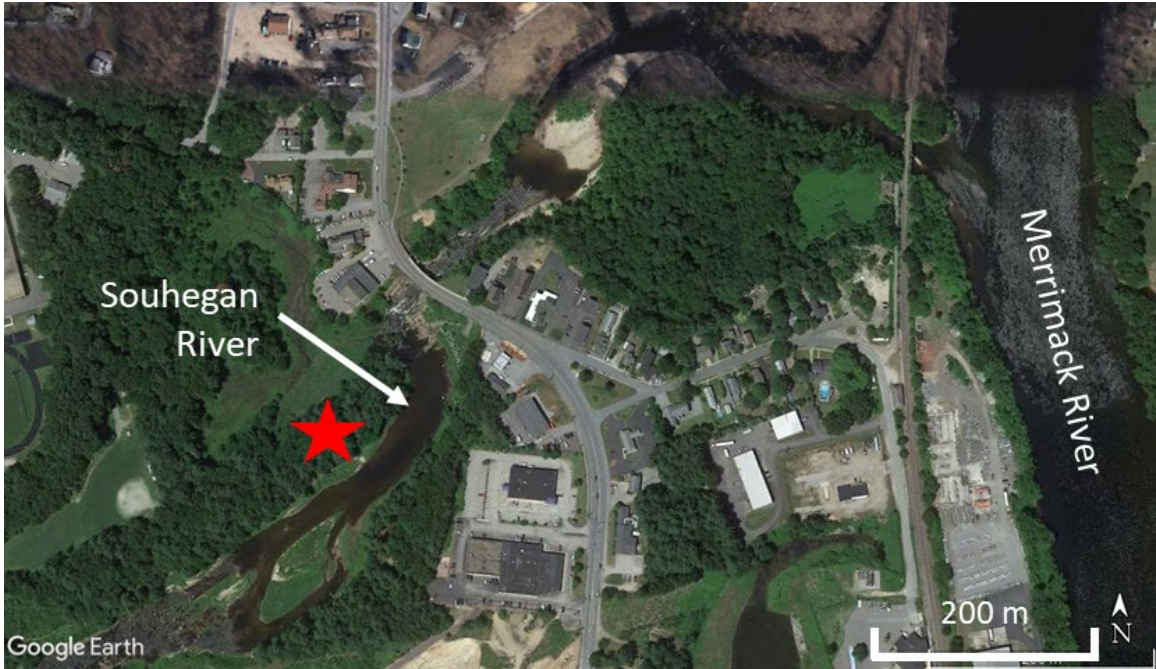
Figure 2. An aerial photograph of the Merrimack Village Dam study site location (Google Earth, 2019). The red star is adjacent to a location on the Souhegan River where instream wood has gathered. The Souhegan river flows from southwest to northeast into the Merrimack River. The Merrimack River is shown along the eastern edge of the photograph, flowing from north to south.

To focus on the implications of instream wood for river restoration and the role that wood can play in establishing a floodplain, I used the site of a previous dam removal as a case study (Figure 2). In 2008, the Merrimack Village Dam (MVD) was removed from the Souhegan River in southern New Hampshire (Collins et al., 2017; Pearson et al., 2011). Conditions at the site while the dam was in place promoted growth of white pine trees along the edge of the impoundment. As the river responded to dam removal,

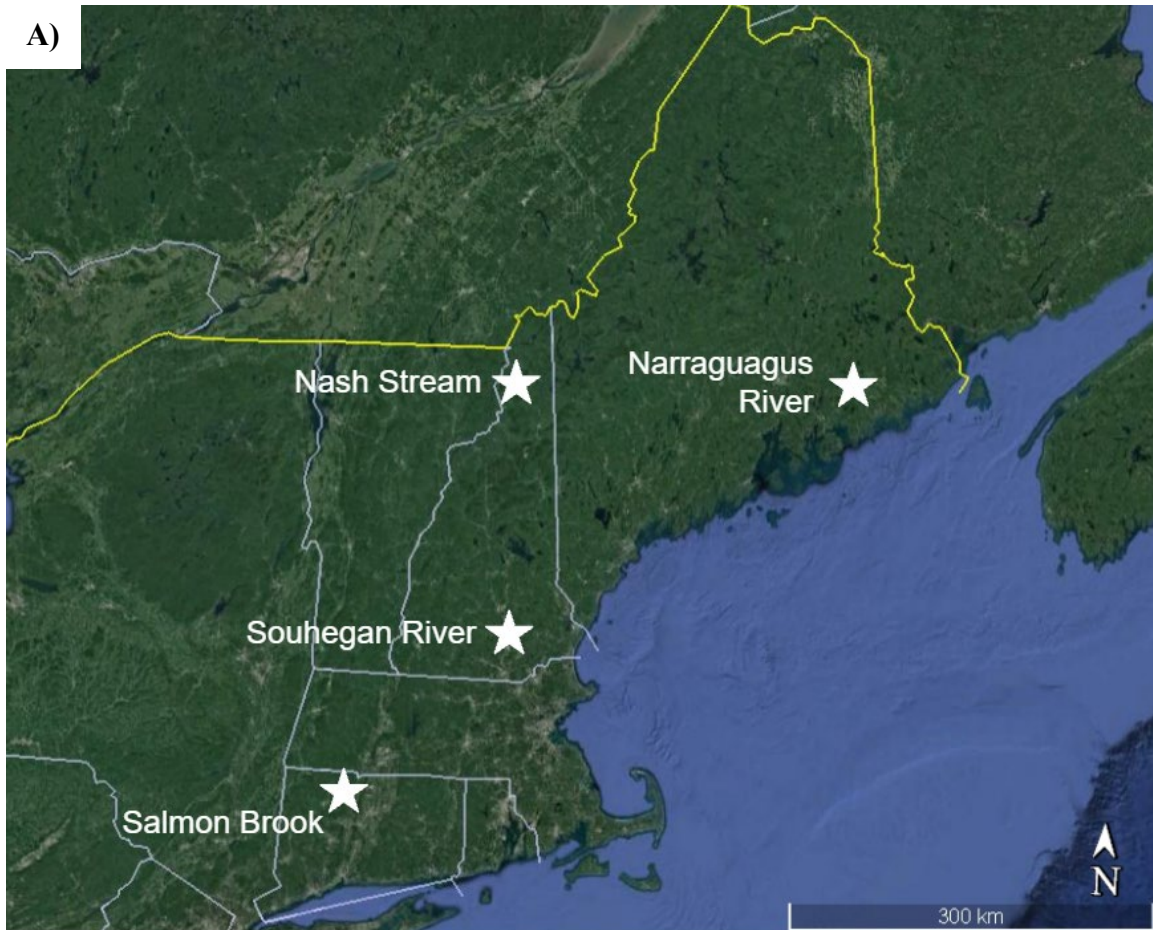
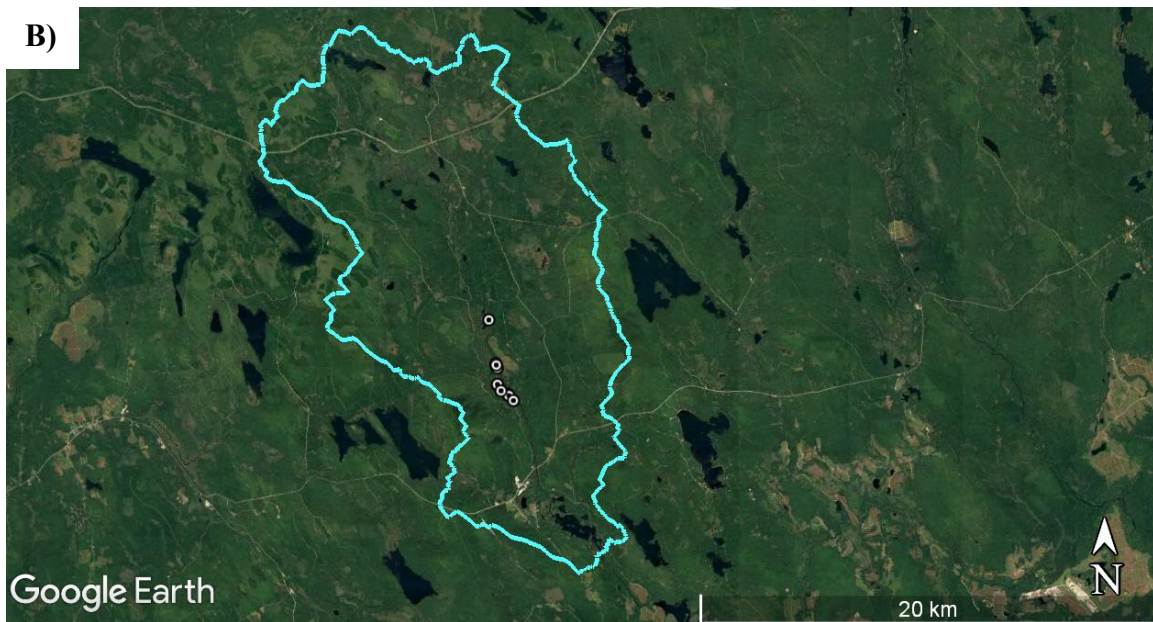
Figure 4. (A) Study sites throughout New England. (B) A closer view of the 10 sites (white dots) within the upper Narraguagus River watershed (cyan line). Due to the scale, some sites appear to overlap.

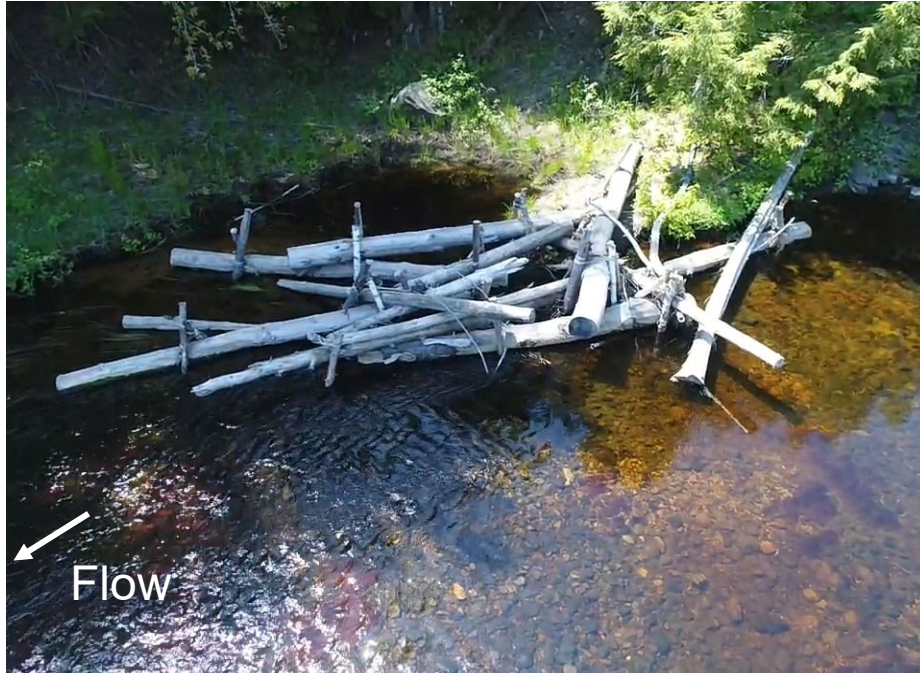
A)

Figure 5. Aerial photographs (sUAS) of two sites on the Narraguagus River in Maine. (A) Post-assisted log structure (PALS) sites include multiple pieces of large wood fixed together to posts driven into the bed, while (B) griphoist (GH) sites include one or multiple trees pulled into the river from a nearby bank.

To specifically evaluate locations where restoration goals involve Atlantic salmon habitats, I surveyed ten sites within the upper Narraguagus River watershed in Maine. I collaborated with a team at the University of Maine investigating macroinvertebrate response at the same sites to obtain complementary data to further understand biophysical linkages. Test reaches included either post-assisted log structures (PALS) or griphoist (GH) trees (Figure 5). PALS are several pieces of large wood secured in the channel by posts driven into the bed and twine. GH sites are those where trees were pulled into the river from a nearby bank.

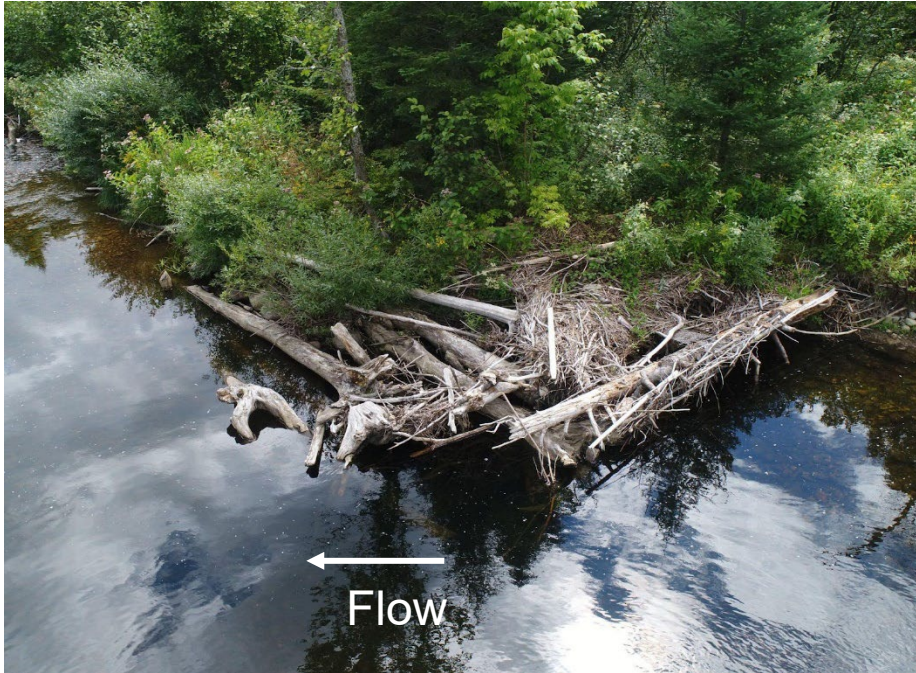
A)

Figure 6. Aerial photographs (sUAS) of two engineered logjams (ELJs) assessed within Nash Stream in New Hampshire. During construction, sediment was placed on top of the ELJs by machinery to provide stability.

Two restoration sites within Nash Stream in New Hampshire were also evaluated. There, restoration efforts positioned large wood so that part of the engineered logjams (ELJs) rested on the adjacent floodplain, while the other portion of the jams extended into the channel (Figure 6).

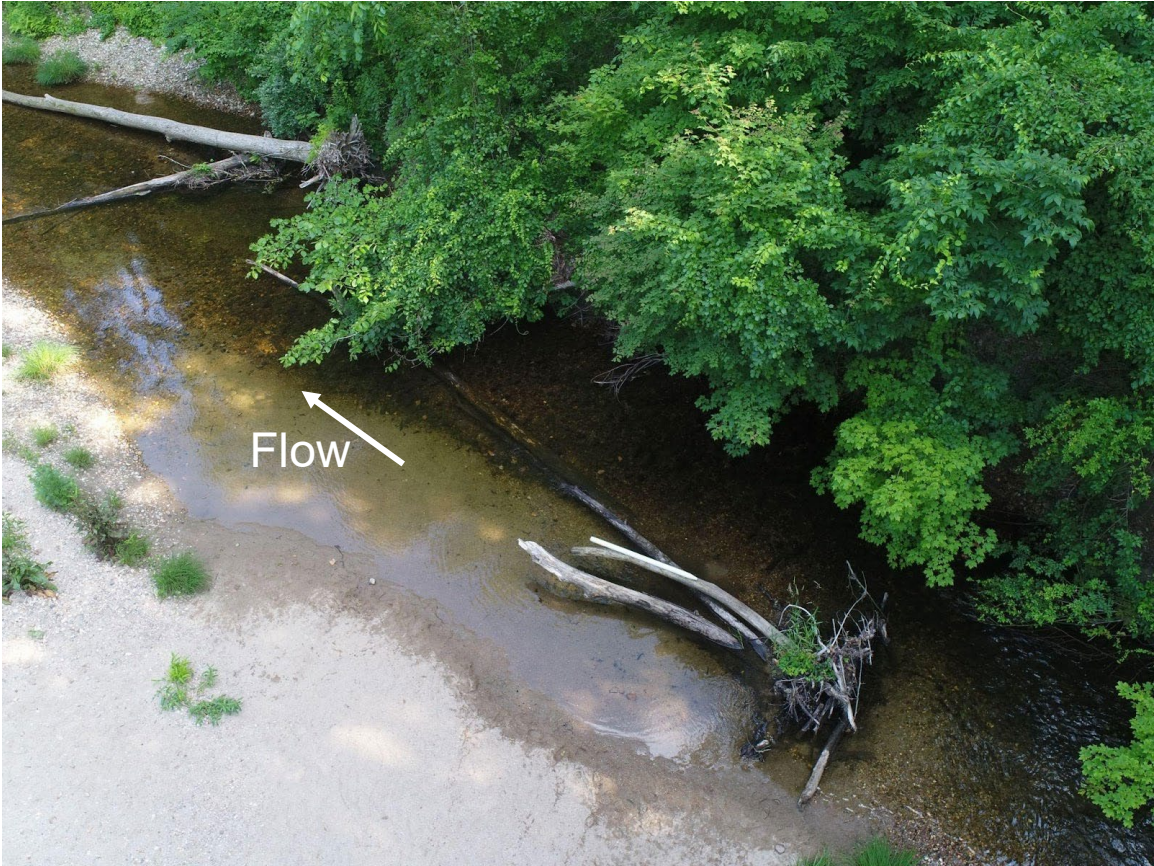
Figure 7. Large wood within the test reach at a field site on the Salmon Brook in Connecticut. Wood trunk is oriented parallel to flow with the rootwad situated upstream.

How the large wood is oriented in relation to river flow within the channel plays a crucial role in the formation of pools and the storage of sediment (Figure 7; Magilligan et al., 2008). The study found that most instream wood pieces were oriented parallel to the flow or angled with rootwads facing upstream. These observed orientations resulted in a

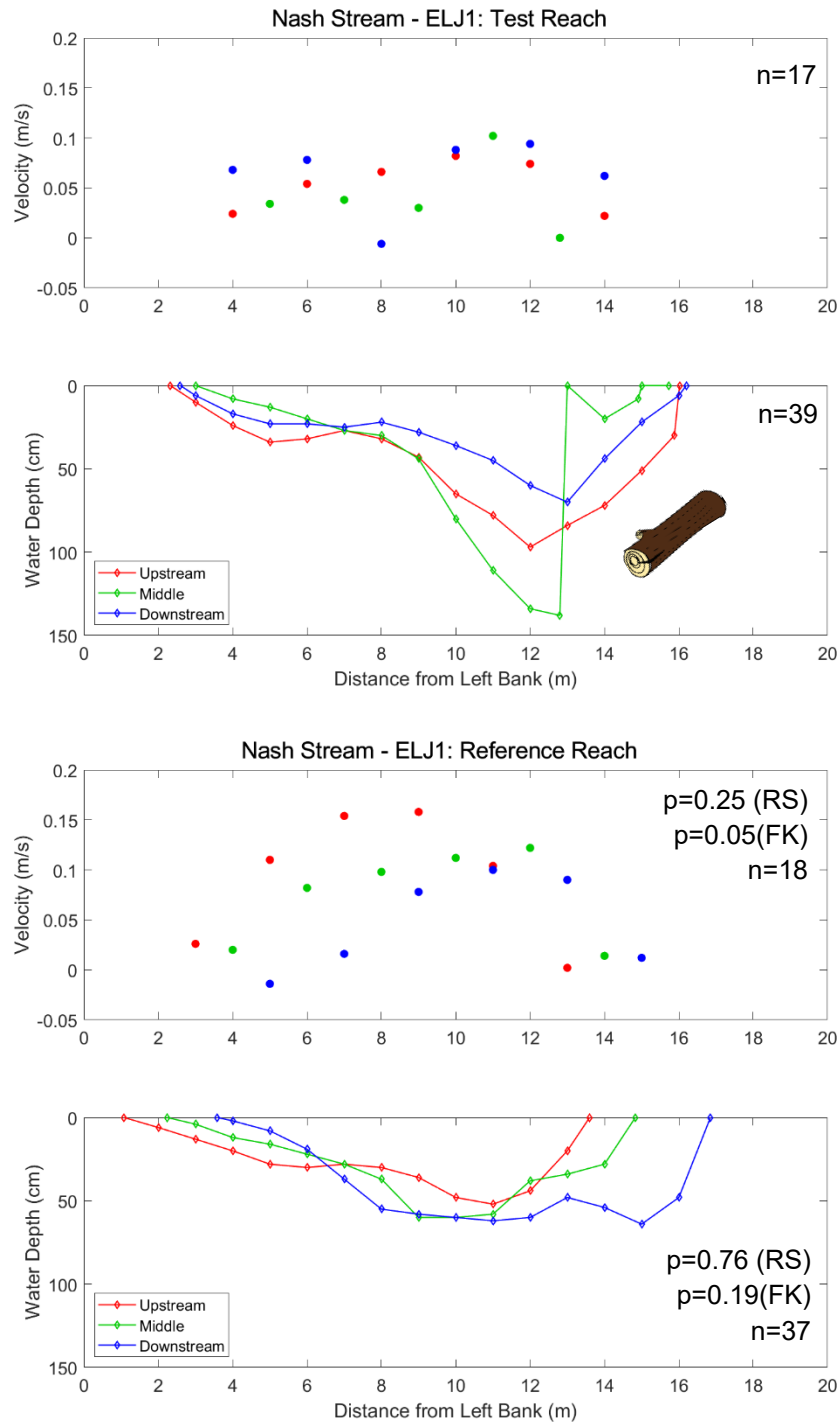
Figure 8. One example of plots that were produced to compare water depths and velocities between surveyed river reaches. The log represents the approximate location of wood placed in the test reach of the channel. Results from the rank-sum (RS) and Fligner-Killeen (FK) statistical tests to compare the medians and variances of depth and velocity data, respectively, between surveyed reaches are shown on the plot along with the number of data points in each sample.

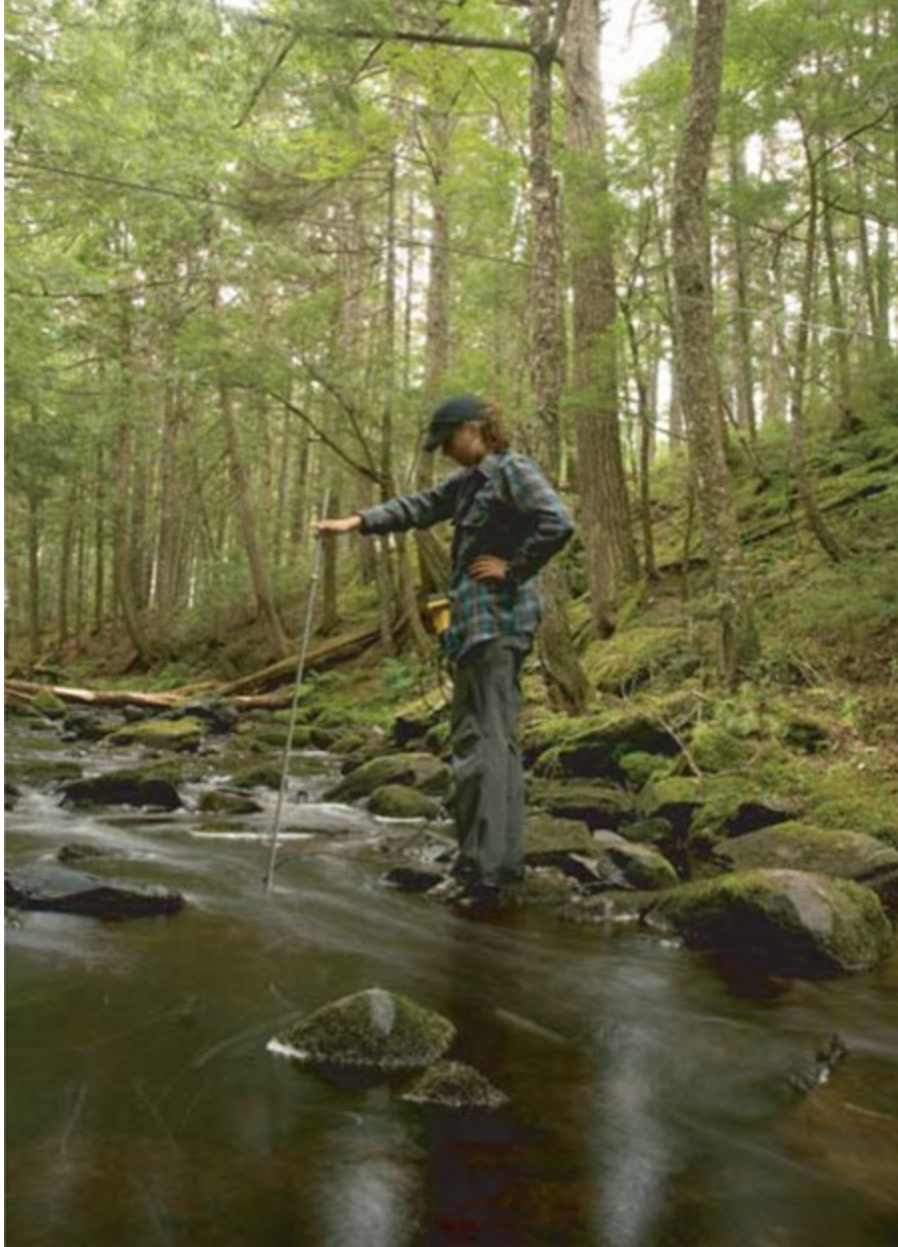
Figure 9. Liz Johnson performing velocity measurements using a Marsh-McBirney flow meter on Baker Brook in the Narraguagus River Watershed, ME (from Johnson, 2009).

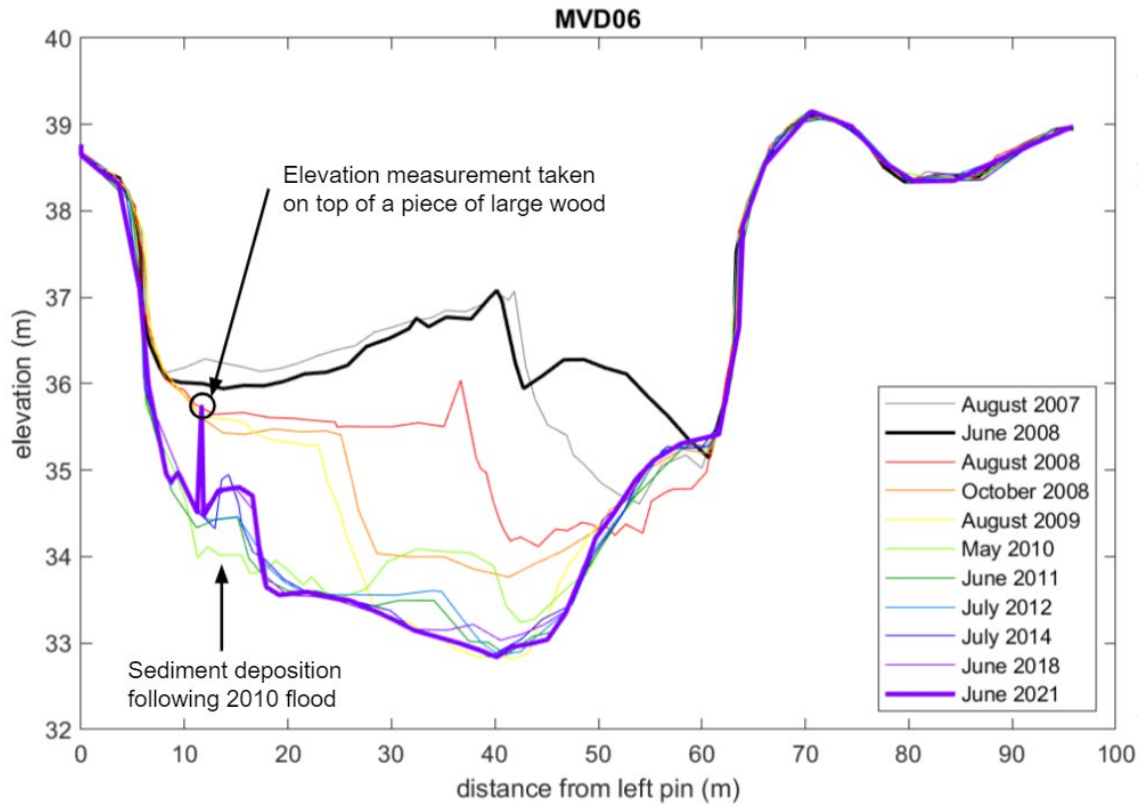
Figure 14. Channel change through time at survey cross-section MVD06, aligned from river left (north) to river right (south). Cross-section locations are shown in Figure 3. Plotted lines represent bed elevations of the Souhegan River during previous surveys. Colors correspond to dates presented in the legend. Survey comparisons shown provide evidence of channel incision in response to dam removal (August 2008-August 2009), as well as left bank erosion following floods in March 2010 (May 2010). Trees recruited during this bank erosion have induced sediment deposition (June 2011-June 2021).

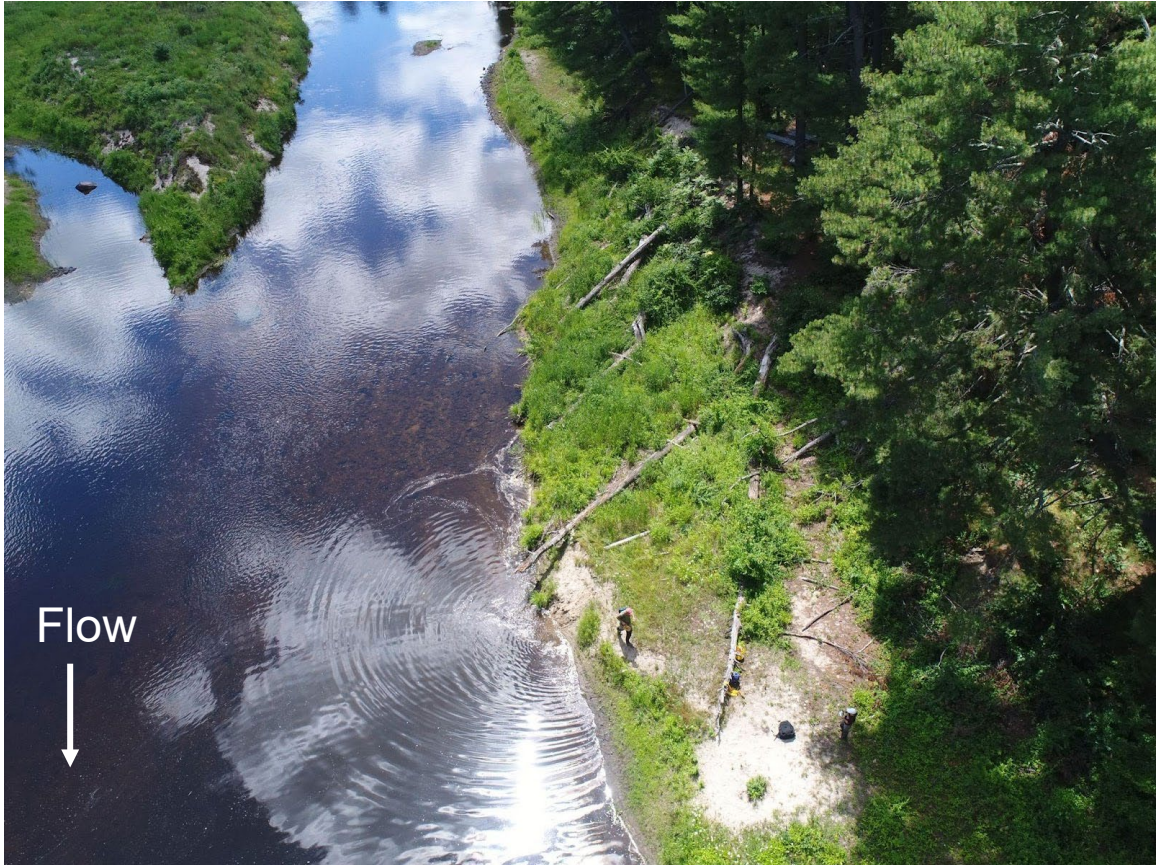
A)

Figure 15. sUAS photographs (A: June 2021; B: August 2021) revealing sediment deposition and subsequent vegetation growth surrounding large wood at the MVD06 cross section.

New surveys collected at the MVD site during the summer of 2021, compared to past surveys from years including, but not limited to, 2007-2012, 2014 and 2018 reveal up to 0.90 m of sediment deposition on top of the surface eroded by a March 2010 flood, surrounding the recruited trees (Figure 14). Photographs and videos from the sUAS flights show the deposition, as well as stable vegetation existing on the newly developing floodplain (Figure 15). In this section, I analyze many of these images in detail.

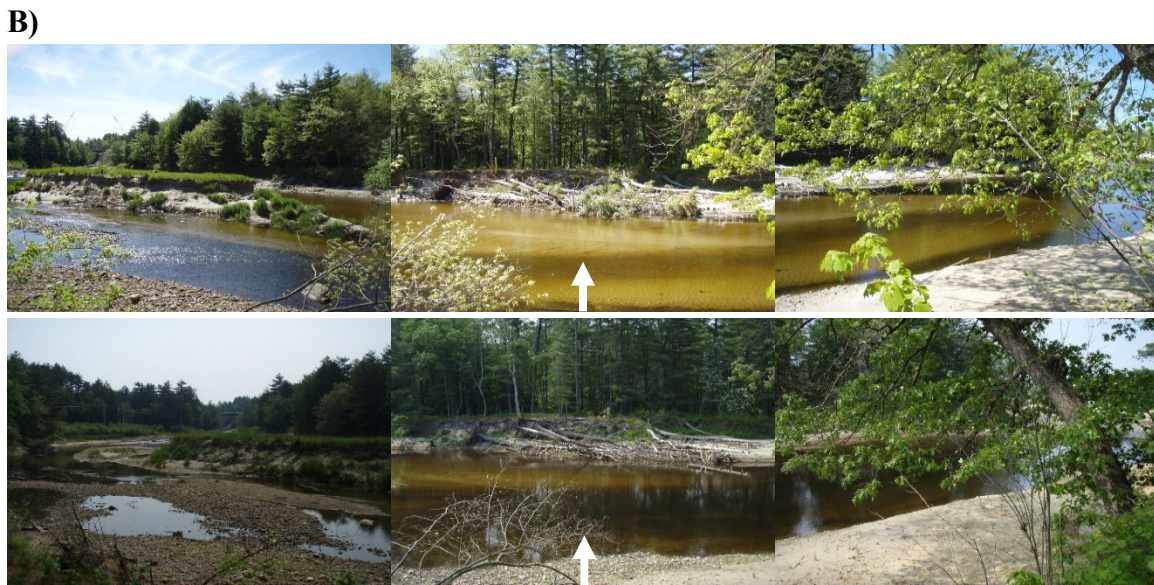
Figure 18. (A) Google Earth aerial imagery from November 2011 and October 2014. The images are centered on the MVD06 cross section. (B) Repeat photographs taken from a photo point (yellow dot) in May 2010 (top row of photographs) and June 2011 (bottom row). Both panels of photographs look at the left bank of the MVD06 cross section in the distance, with the left and right pictures corresponding to upstream and downstream, respectively.

Aerial images from April 2011, November 2011, and October 2014 show sediment deposition and vegetation growth, respectively, around the large wood pieces (Figure 17B; Figure 18). Sediment deposition is also evident in the repeat photographs taken in 2010, 2011, 2012, 2014 and 2018. A sparse amount of vegetation on the extended floodplain is evident in the July 2012 photograph, while more abundant vegetation is present by the time of the July 2014 repeat photographs (Appendix B). The large wood pieces stabilized by sediment and vegetation are also seen in the same orientation in all the later aerial images.

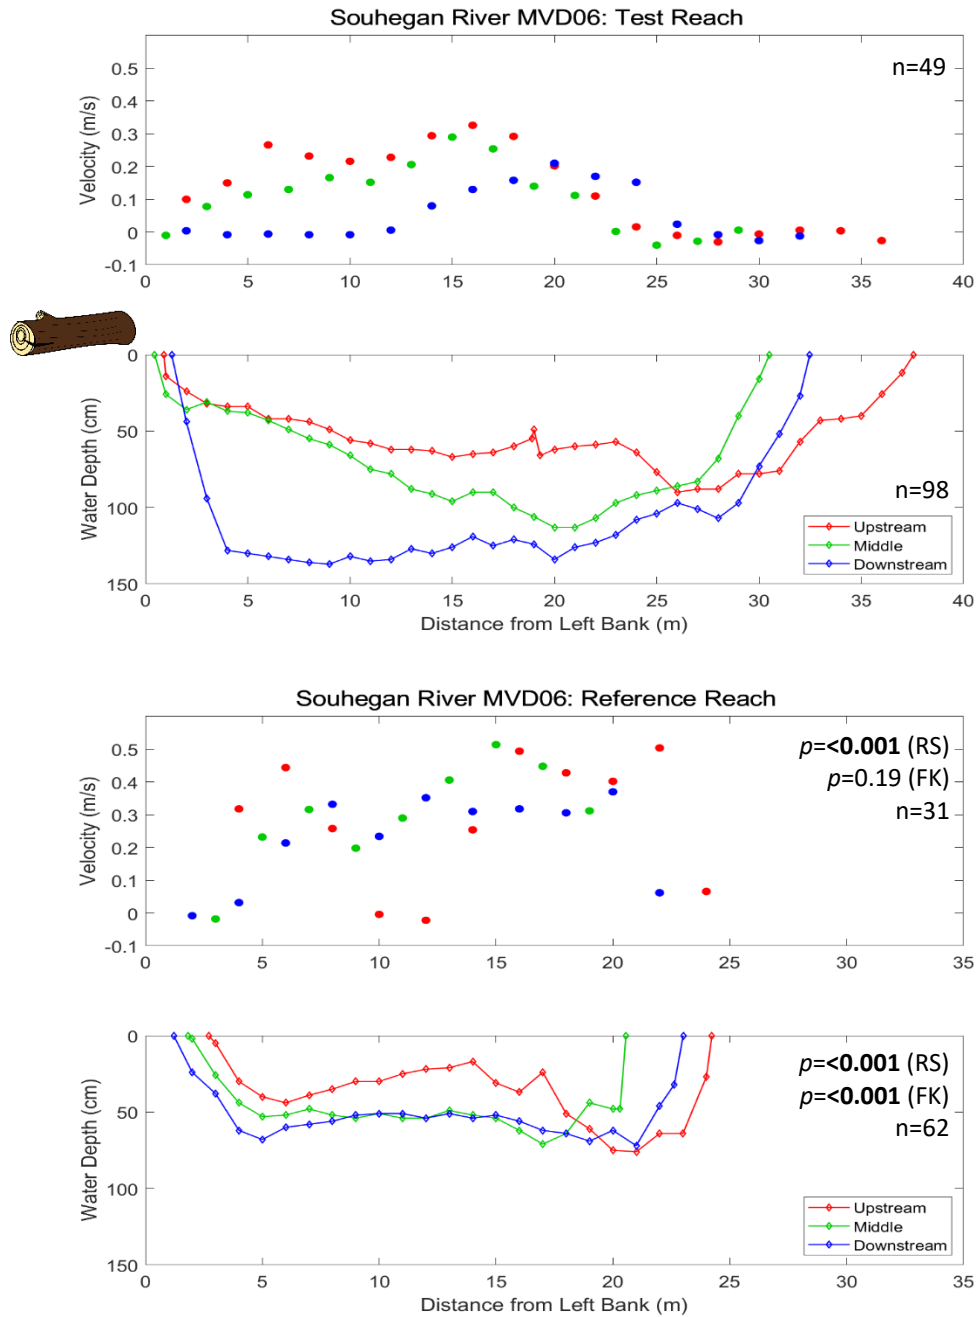
Figure 20. Water depth and velocity data measurements taken at the MVD site on the Souhegan River, NH. The log represents the approximate location of wood that was passively recruited to the test reach of the channel in March, 2010. Results from the rank-sum (RS) and Fligner-Killeen (FK) statistical tests to compare the medians and variances of depth and velocity data between surveyed reaches are shown on the plot along with the number of data points in each sample.

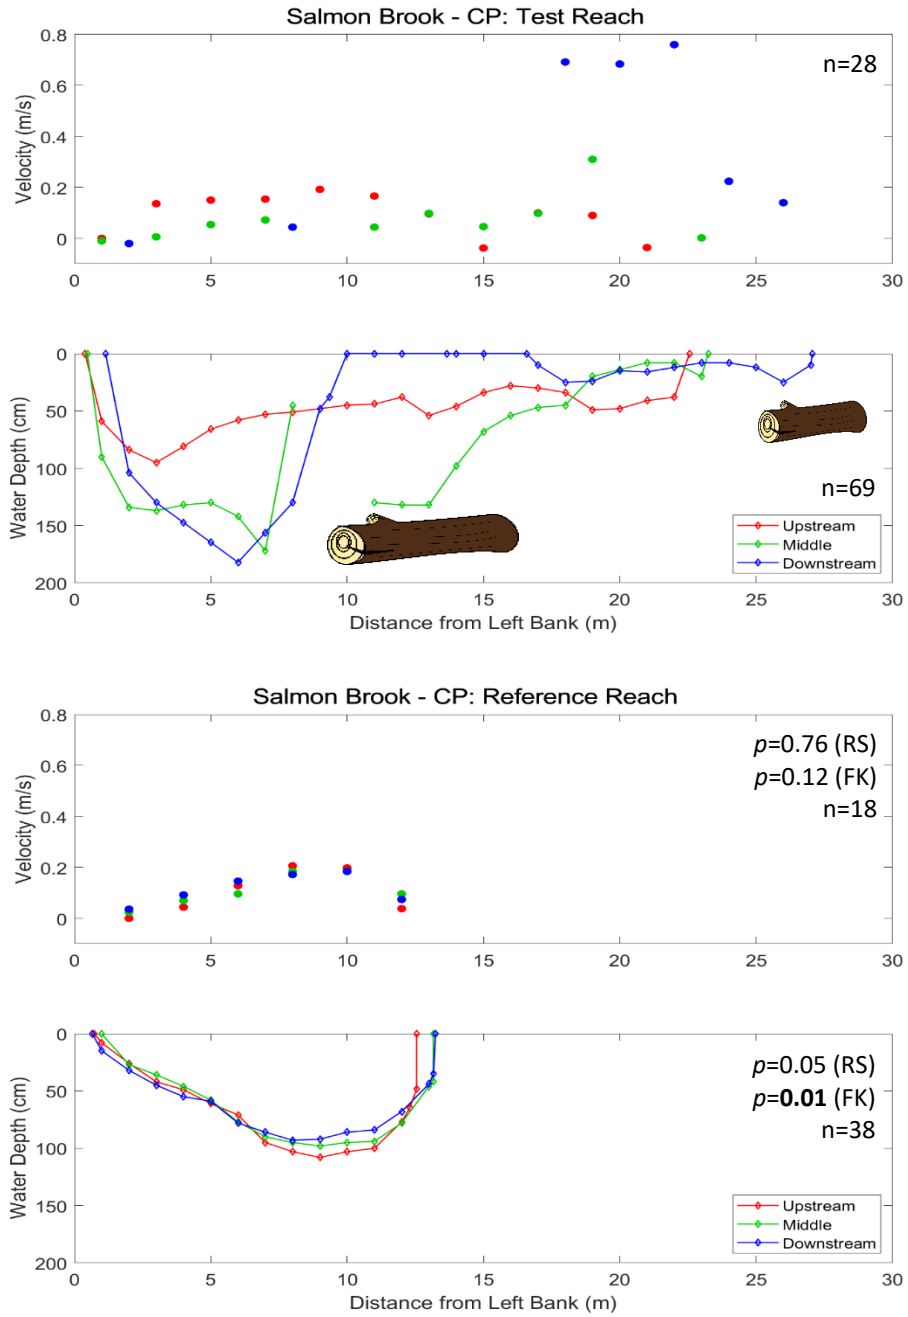
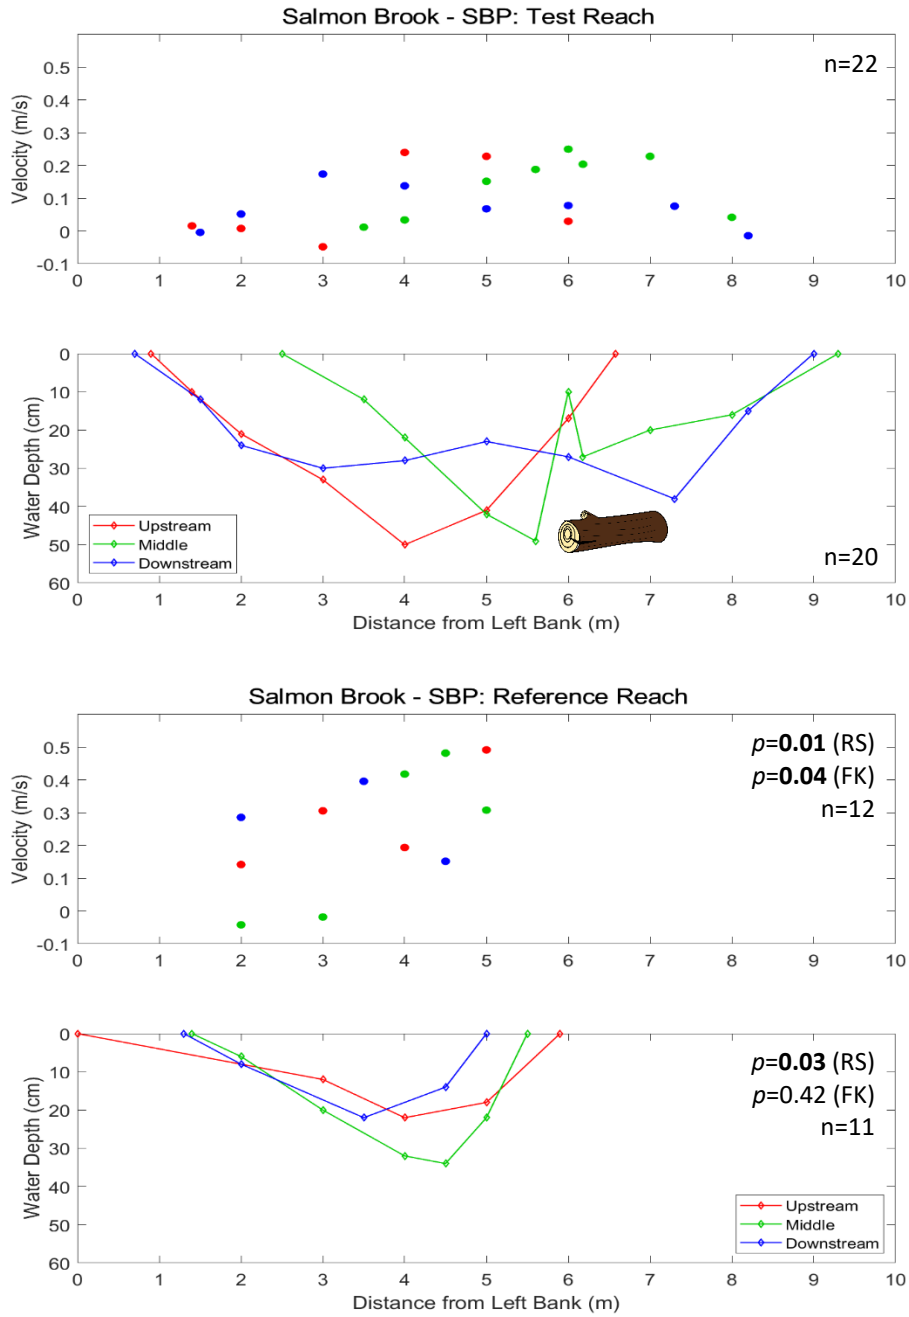
Figure 21. Water depth and velocity data measurements taken at the (A) CP and (B) SBP sites in Salmon Brook, CT. The log represents the approximate location of wood passively recruited to the test reach of the channel. Results from the rank-sum (RS) and Fligner-Killeen (FK) statistical tests to compare the medians and variances of depth and velocity data between surveyed reaches are shown on the plot along with the number of data points in each sample.

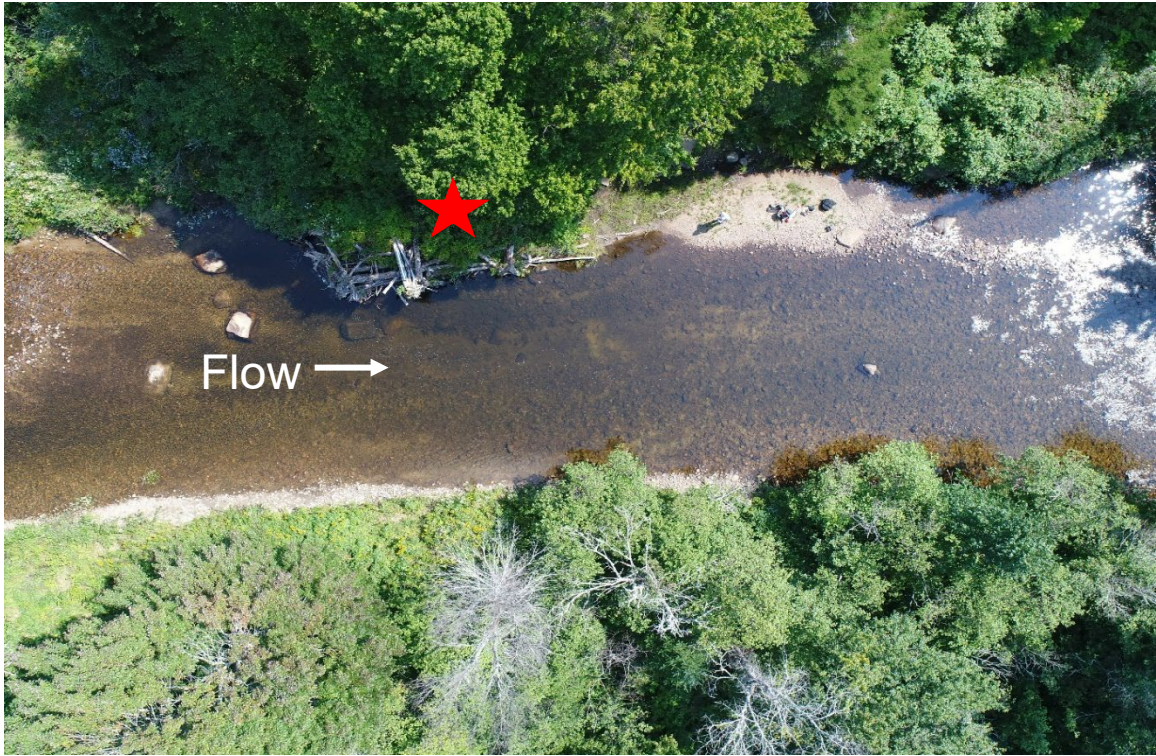
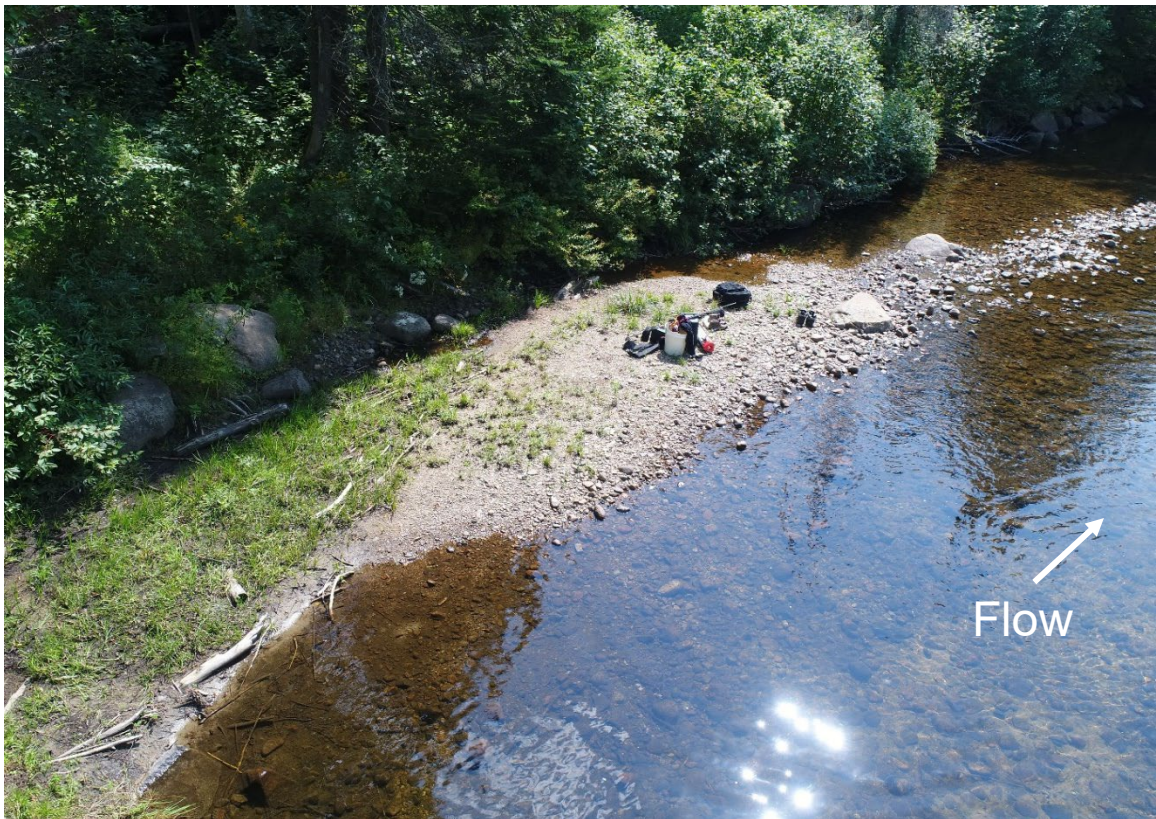
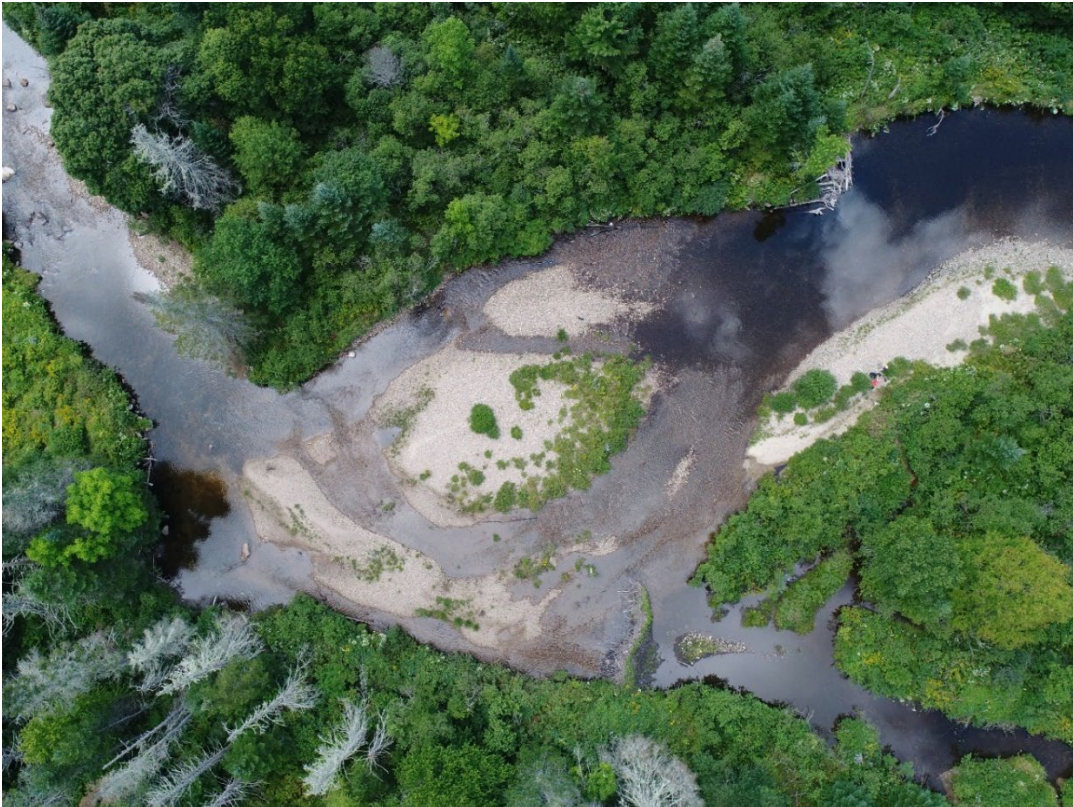
Figure 25. (A) A sediment bar downstream of ELJ2, Nash Stream, present in current sUAS photographs (2022), but apparently absent in historical Google Earth aerial imagery (2013). The engineered logjam (ELJ) is denoted by a red star. The yellow arrow indicates the location of sediment deposition seen in the sUAS photographs. (B) Sediment bars on Nash Stream, much of which are unvegetated. (C) sUAS photographs (2022) showing vegetation and sand adjacent to the SB PALS site on the Narraguagus River.

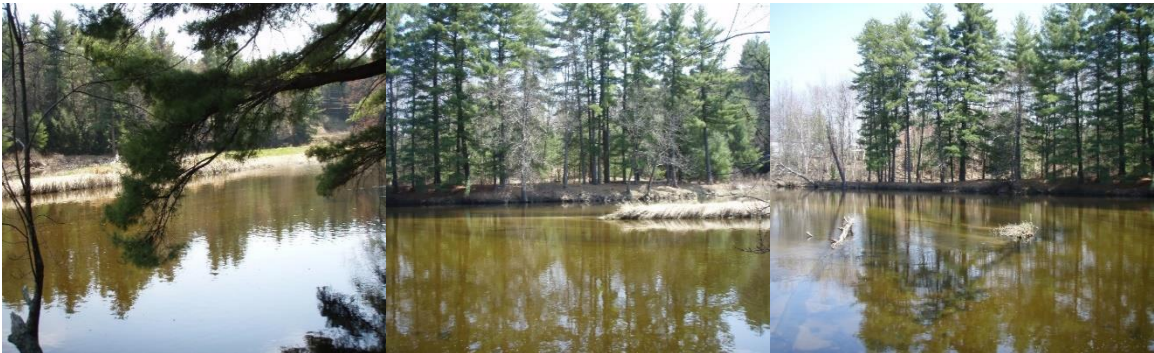
April 2008 – Left bank

All sets of repeat photographs are from the MVD06 cross section. Image sequences progress from upstream to downstream as you read from the left to right side of the page. “Left bank” and “Right bank” indicate the side of the stream from which the photos were taken.

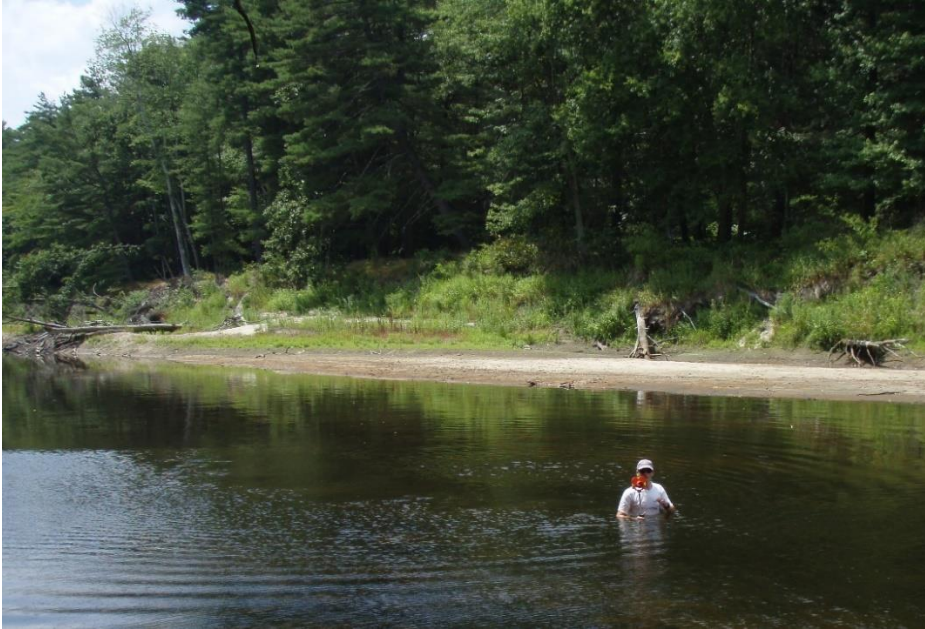
July 2012 – Right bank, individual photograph

The following photograph was taken from the right bank, downstream of cross-section MVD06.

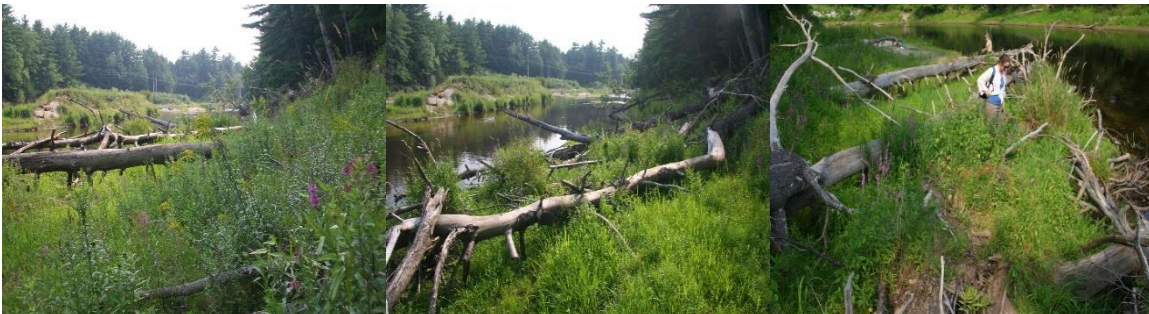
July 2014 – Left bank, individual photographs

The following photographs were taken from the left bank, on the MVD06 extended floodplain.

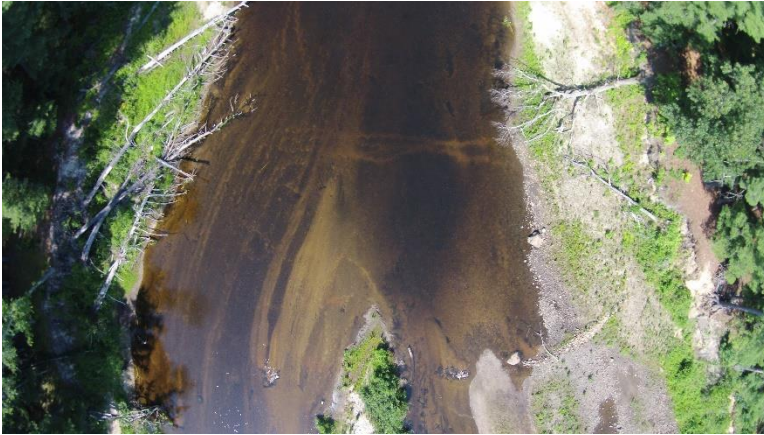
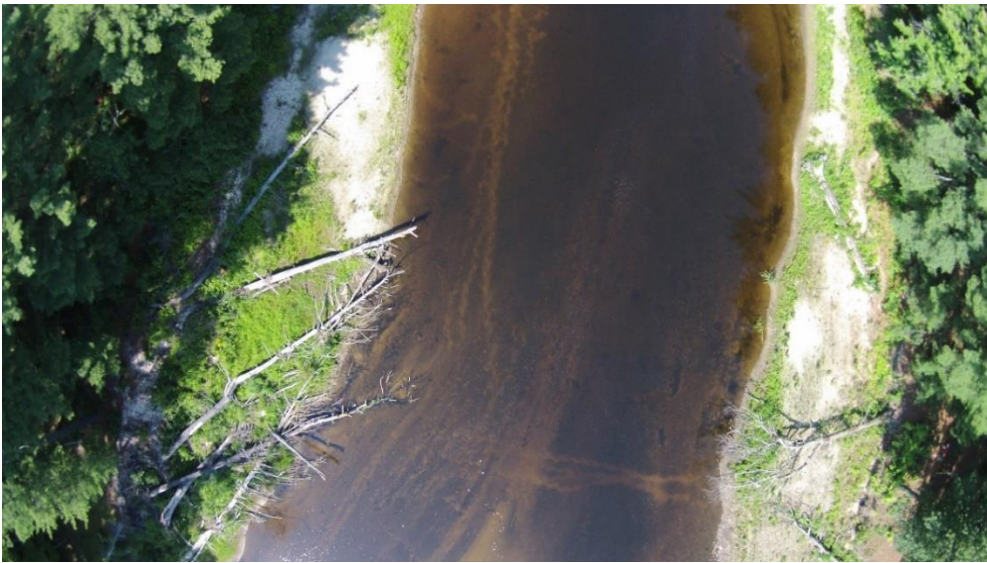
July 2014

Aerial images of MVD06 cross section with the top of the images corresponding to downstream.

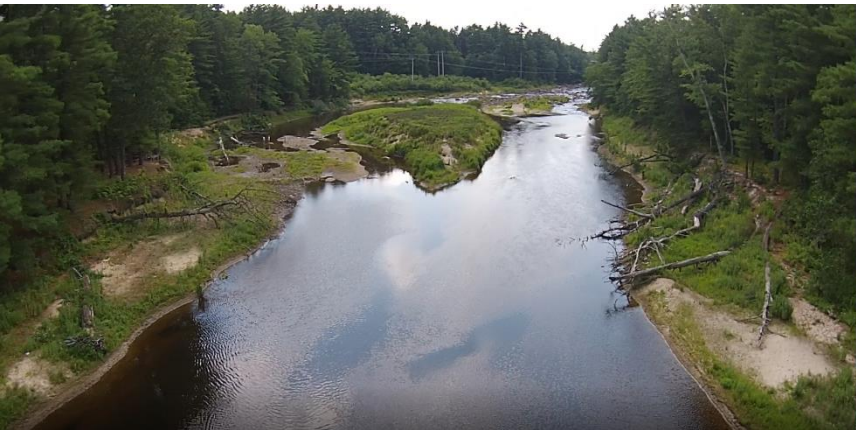
Looking upstream toward the MVD06 cross section.

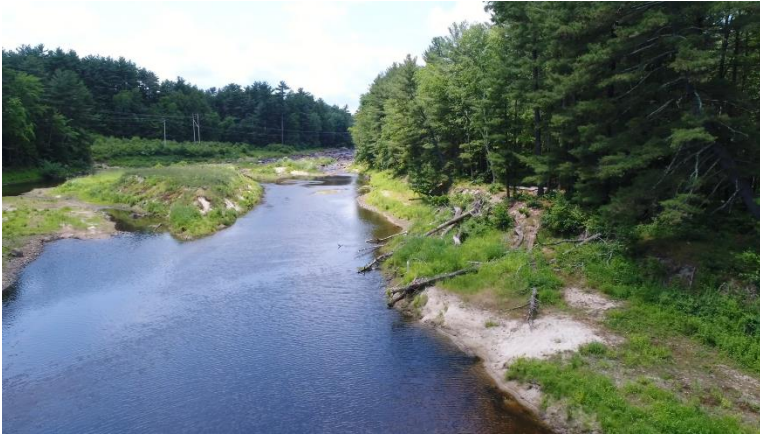
June 2018

Looking upstream toward
the MVD06 cross section.

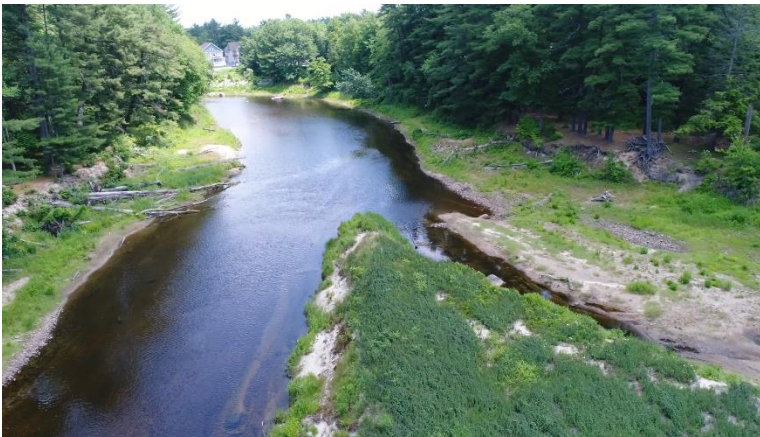
Looking downstream
toward the MVD06 cross
section.

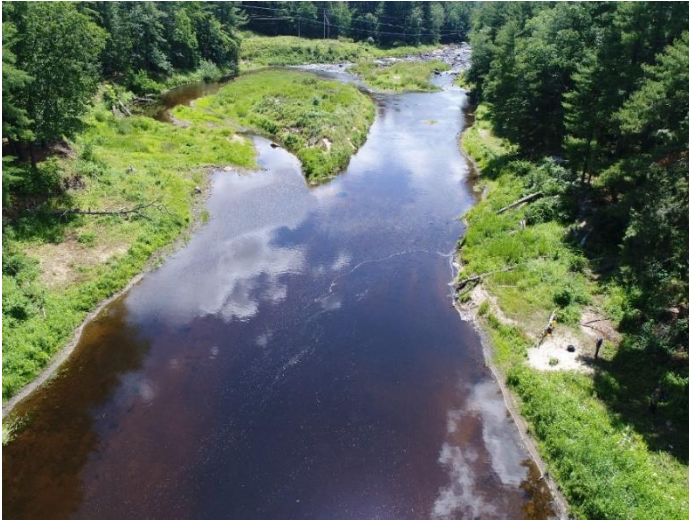
June 2021

Looking upstream toward the MVD06 cross section.

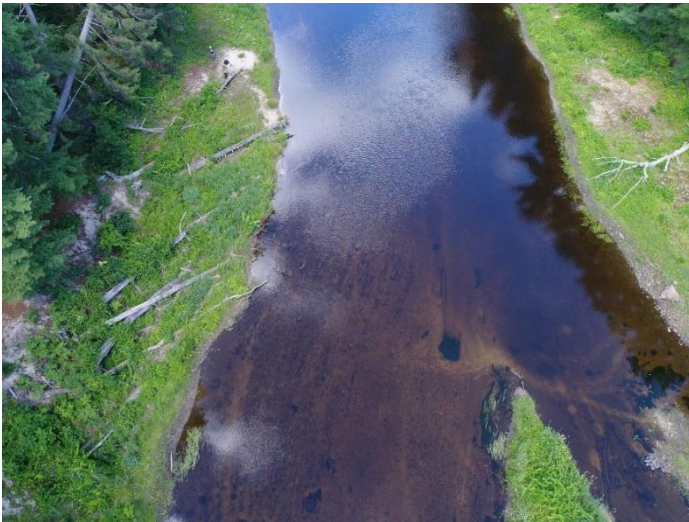
Aerial image of MVD06 cross section with the top of the image corresponding to downstream.

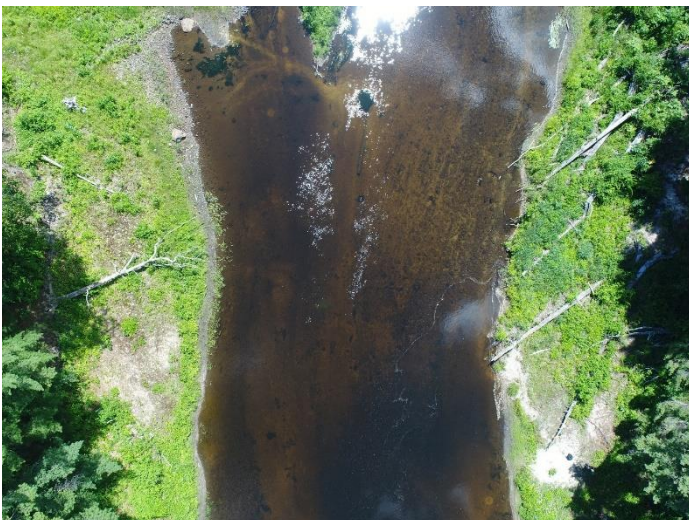
Aerial image of MVD06 cross section with the top of the image corresponding to upstream.
