GEOMORPHIC EFFECTS AND HABITAT IMPACTS OF LARGE WOOD AT RESTORATION SITES IN NEW ENGLAND

A thesis

Master of Science

Boston College
Morrissey College of Arts and Sciences
Graduate School

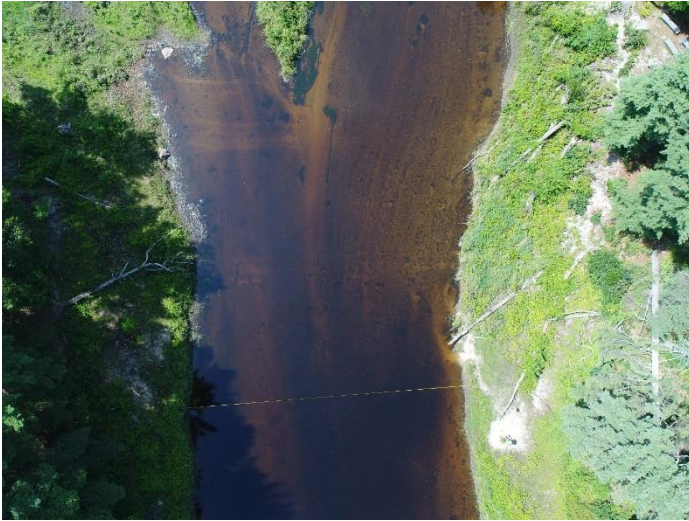
August 2021

Aerial image of MVD06 cross section with the top of the image corresponding to upstream.

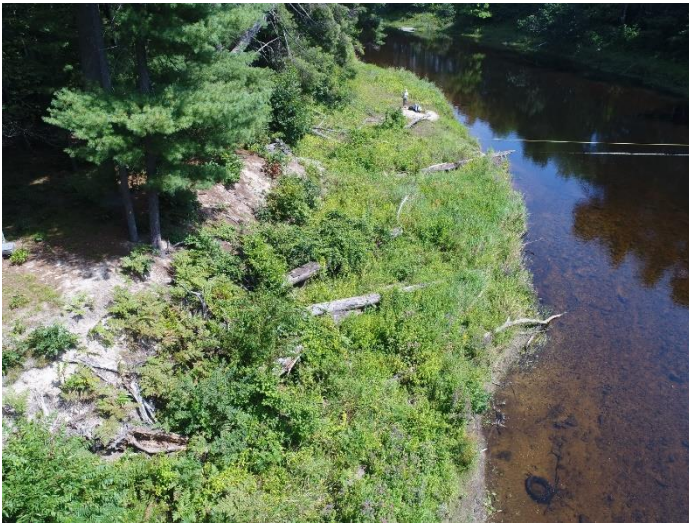
At the left bank for the MVD06 cross section, looking downstream from the upstream end of the extended floodplain containing large wood.
