## Large scale travelling fire tests with open ventilation conditions and their effect on the surrounding steel structure– The second fire test

Journal of Constructional Steel Research

# Large Scale Travelling Fire Tests with Open Ventilation Conditions and Their Effect on the Surrounding Steel Structure– The Second Fire Test

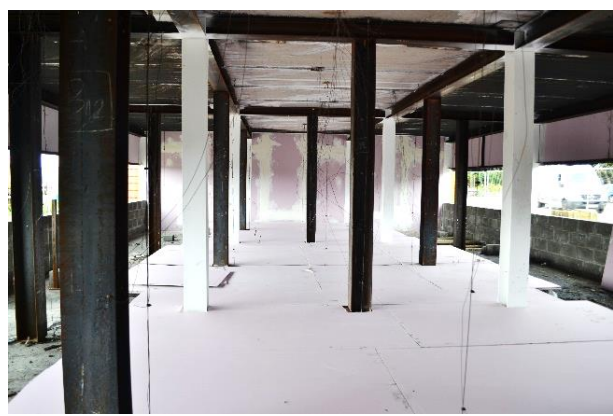
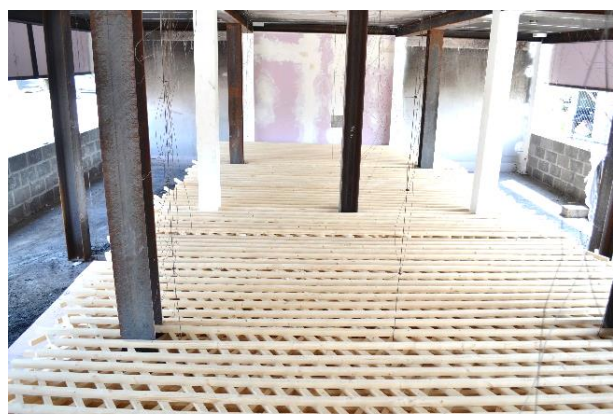
Figure 2: Fire fuel details; (a) platform for providing fuel wood; (b) fuel wood provided in 9 layers

1 level of the platform was 325 mm from the floor finish level as shown in Figure 2 (b). The first layer of the wooden  
 2 sticks was laid at 60° angle from gridline ④ while the second layer was laid at an angle of 120°. The third layer was at  
 3 0° or 180° and the process was repeated in such a way the 6<sup>th</sup> layer of the sticks laid at 0° or 180° had a lateral offset of  
 4 60 mm with respect to the third layer as shown in Figure 2 (c). The final layer, the ninth layer of the fuel wood, was at  
 5 0° or 180°, which helped to visually observe the travelling behaviour of fire from one stick to another. For each test, the  
 6 ignition was defined at a point located along the centreline at 0.5 m from its edge, i.e., at 1.0 m distance from the back  
 7 wall.

4 A significant number of thermocouples were employed to record the gas temperatures within the compartment during  
5 the test. Temperatures were recorded at the ceiling levels using individual thermocouples, while temperatures at different  
6 levels along the height of the compartment were recorded using thermocouple trees. Thermocouple trees used for  
7 temperature recording purposes were categorised into two groups, the small thermocouple trees (TRS) which consisted  
8 of three thermocouples and the large thermocouple trees (TRL) which consisted of six thermocouples each. The small  
9 thermocouple trees were provided outside the fuel bed while the large thermocouple trees were provided within the fuel  
10 bed as shown in Figure 2 (a). This paper will focus on the temperatures recorded within the fuel bed along the centreline  
11 of the test compartment using TRL-4 through TRL-8 which have been specifically identified in Figure 2 (a).

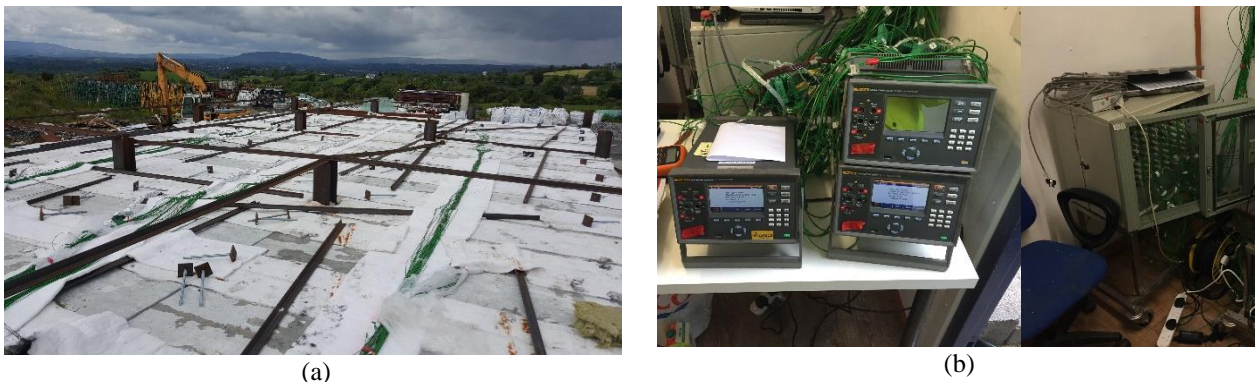
Figure 4: (a) Extension cables used for data recording purposes, (b) Multiple data loggers used

All the thermocouples were labelled and provided in the designated positions. As the length of the thermocouples used during the test was 3000 mm, extension cables were used to connect the thermocouples with the data acquisition system. The extension cables were stretched over the roof of the test compartment which connected the thermocouples and the data loggers. To protect the extension cables from direct exposure to heat during the fire test, a layer of fire blanket was provided between the cables and the roof slabs as shown in Figure 4 (a). As the number of thermocouples and other sensors used to record data was high, multiple data loggers had to be used for data recording purposes, Figure 4 (b).

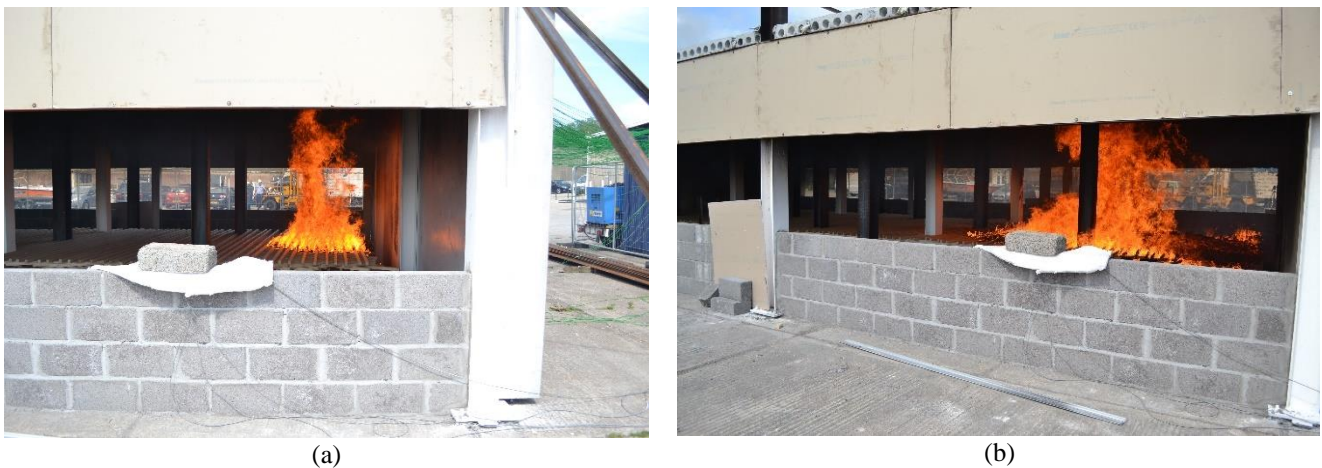
Figure 5: Fire development and temperatures recorded at different intervals along the length of the test compartment: (a) early fire development; (b) fully developed fire in the middle of test compartment

The point of ignition being 500 mm from the edge of the fuel bed near gridline ①, the initial spread of the fire was in all directions forming a circle as shown in Figure 5 (a). After 6 min from ignition, the fire reached the backend of the fuel bed (the edge adjacent to gridline ①). The flames touched the ceiling level after 8 minutes from ignition. After 23 minutes from ignition, the width of fire-band was 4.2 meters as it reached to ends of the firewood parallel to gridlines ③ and ⑤. After 24 minutes, the fire started to travel as the backend of the fire started to move along the length of the compartment. After 29 minutes from ignition, TRL-4 was fully engulfed in flames. The fire travelled ahead and entered Zone 2B after 32 minutes from the start of the fire test. The firewood provided on the platform to measure the mass-loss started to burn after 38 minutes from ignition as the platform was provided in Zone 2B. The thermocouple tree TRL-5 was fully engulfed after 42 minutes from the start of the fire test. At the same instance, the fore end of the travelling fire reached the centre of the test compartment while the centre of the travelling fire band reached the middle of the test compartment after 51 minutes from ignition engulfing the thermocouple tree TRL-6 as seen in Figure 5 (b). It should be noted that the fore end of the fire had also entered the Zone 3B at the same time after 51 minutes from the start of the test. With the fire travelling towards the fore end of the test compartment, majority of the fuel wood supported by the platform to measure the mass-loss was consumed after 59 minutes from ignition. This was the time when the thermocouple tree, TRL-7, was fully engulfed in flames. It was observed that majority of the fuel wood in Zone 3B was burning after 64 minutes from ignition and the thermocouple tree TRL-8 was found to be fully engulfed. The fuel wood continued to burn in Zone 3B until the 82<sup>nd</sup> min, the time when all combustible materials were consumed.

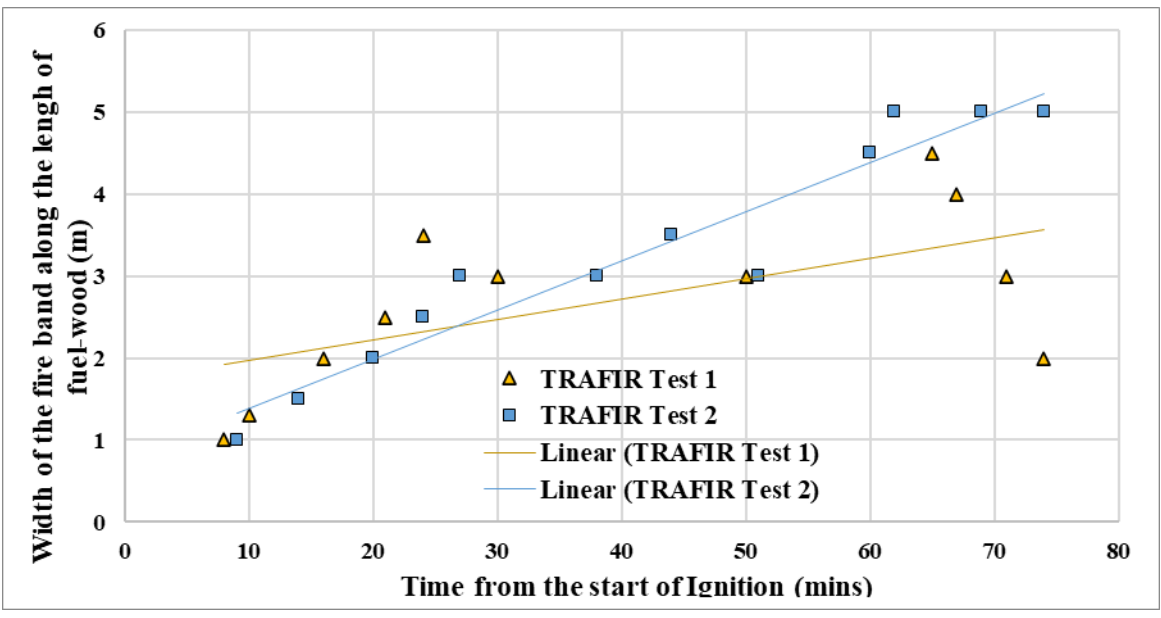
Figure 7: Fire-band width evolution during the fire Test 2 in comparison to fire Test 1

22 between 3 meters and 3.5 meters in the middle of the test compartment in Zone 2B from the 30<sup>th</sup> minute until the 50<sup>th</sup>  
 23 minute as presented in Figure 7. Once the fire band entered Zone 3B, an increase its width was recorded which reached  
 24 5 meters after 62 minutes from ignition. At this point, most of the available fuel wood was burning, and it continued to  
 25 burn for 12 more minutes over the same length as presented in Figure 7. With the consumption of the fuel wood, the  
 26 intensity and width of the fire reduced. It was after the 82<sup>nd</sup> minute from ignition that all combustible materials were  
 27 consumed, and no flames were visible. In addition to the observed fire band width, the trendline is also shown in Figure  
 28 7.

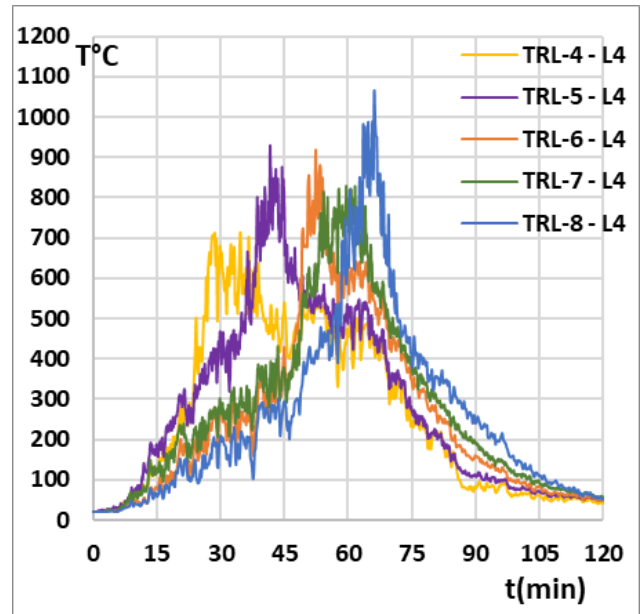
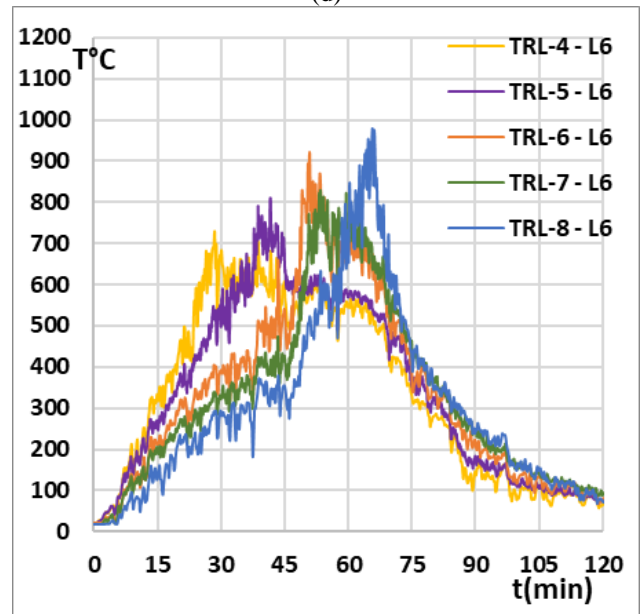
Figure 8: Gas temperatures recorded at different levels via thermocouple trees: (a) Level 1, (b) Level 2, (c) Level 3, (d) Level 4, (e) Level 5, (f) Level 6

- 8 • The rise in temperature at upper level is earlier as compared to intermediate and lower levels. This can be seen  
 9 in Figure 8 (e) and (f) where an increase in gas temperatures is recorded for level 5 and 6 within 5 minutes from  
 10 the start of the test. This was expected as the hot gases rise and accumulate closer to the ceiling level which  
 11 results in a rise of temperatures at upper levels of the test compartment.

- 12 • The rise in gas temperatures at level 4 also initiates at an earlier stage of the test, after 10 minutes from ignition.  
 13 The initial rise in gas temperatures recorded at different thermocouple tree locations is very similar only with 5  
 14 minutes difference as shown in Figure 8 (d). This rise however is different at level 3. The rise in gas temperature  
 15 at level 3 for thermocouple tree TRL-4 and TRL-5 initiates much earlier as compared to that recorded using  
 16 TRL-6, TRL-7 and TRL-8, refer to Figure 8 (c).

- 17 • The rise in temperatures at the two bottom levels; level 1 and level 2, initiates late but this rise is sudden. It is  
 18 seen in Figure 8 (a) and (b) that for the initial 30 minutes, the rise in temperatures at these levels is very low.  
 19 However, after 30-32 minutes from the start of the test, a sudden rise in temperatures is recorded. This rise could  
 20 have initiated at an earlier stage for levels 1 and 2 at TRL-4, however, the data could not be recorded as  
 21 thermocouples at these levels in TRL-4 were found faulty. None-the-less, the rise in gas temperatures at these  
 22 levels is directly related to the positioning of the travelling fire band. When the travelling fire band is away from  
 23 these thermocouple trees, the rise in temperatures at lower levels is slow. As the travelling fire band gets closer  
 24 to the thermocouple trees, a sudden rise in temperatures is recorded. It should be noted that the thermocouples

- For upper levels, the increase in gas temperature is steady and slow while the decay phase is comparatively sharp as shown in Figure 8 (e) and (f). On the other hand, the rise in gas temperatures at lower levels is sharp while the decay part of the curve is uniform and slow as shown in Figure 8 (a) and (b).
- The gas temperatures recorded at different levels using thermocouple trees shows significant variations in the test compartment, highlighting a transient heating both longitudinally (i.e., along the path of the travelling fire) and vertically (i.e., along the height of the compartment).

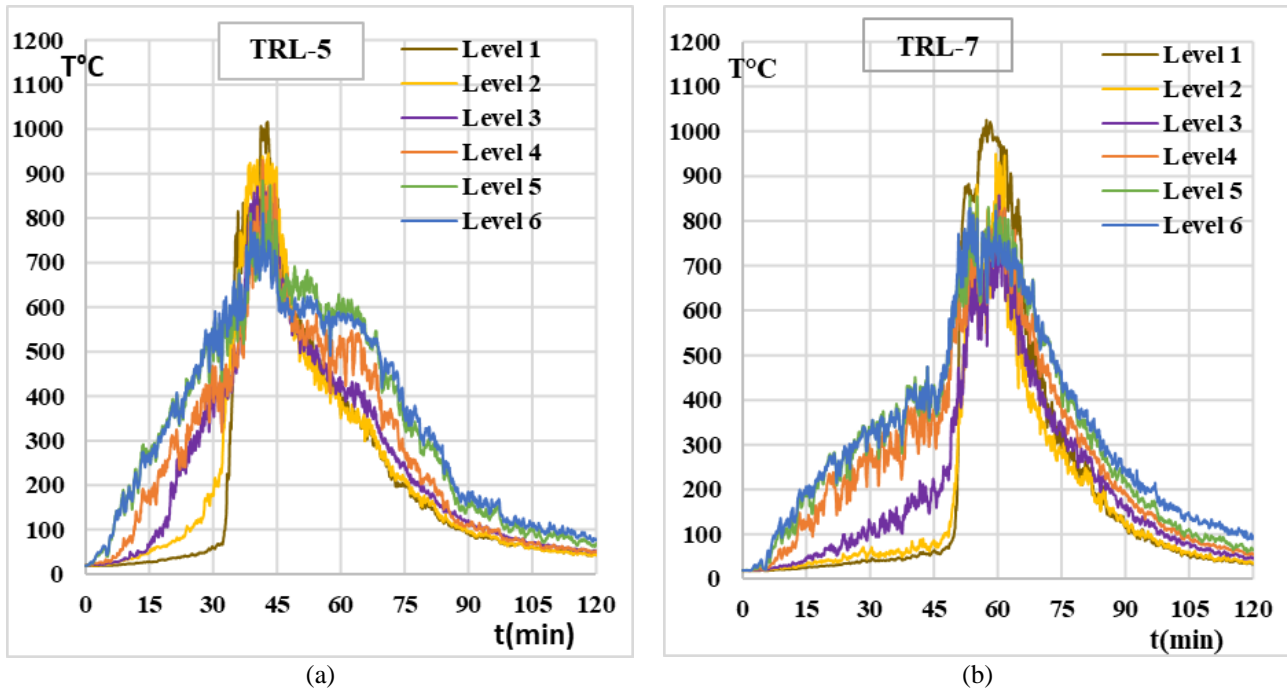
Figure 9: Gas temperatures recorded using; (a) TRL-5; (b) TRL-7

(i.e., in TRL-5 and TRL-7) are presented in Figure 9 (a) and (b) respectively. The gas temperatures recorded at level 6 provide the compartment temperatures in the surroundings of the beams.

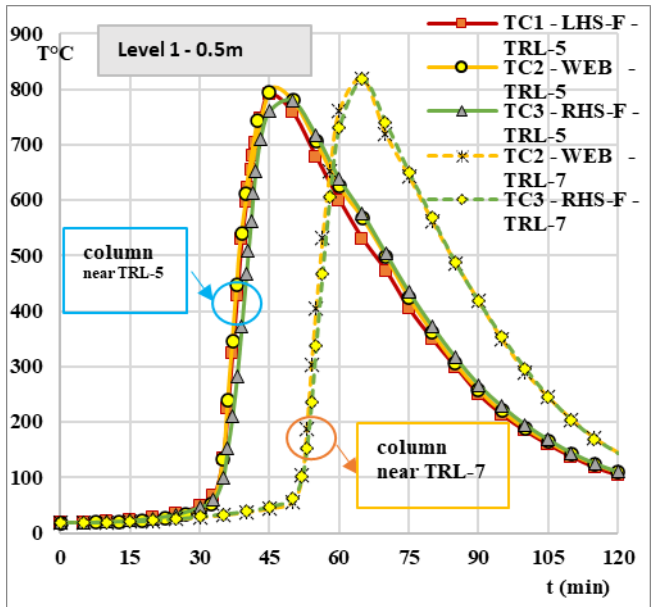
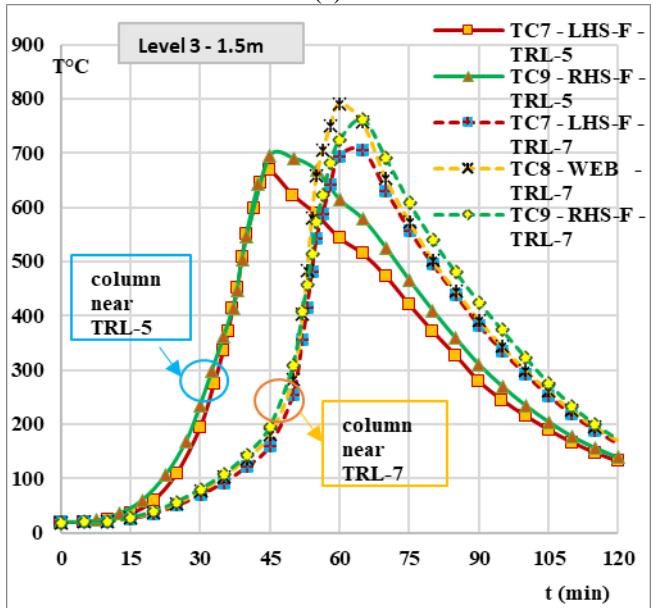
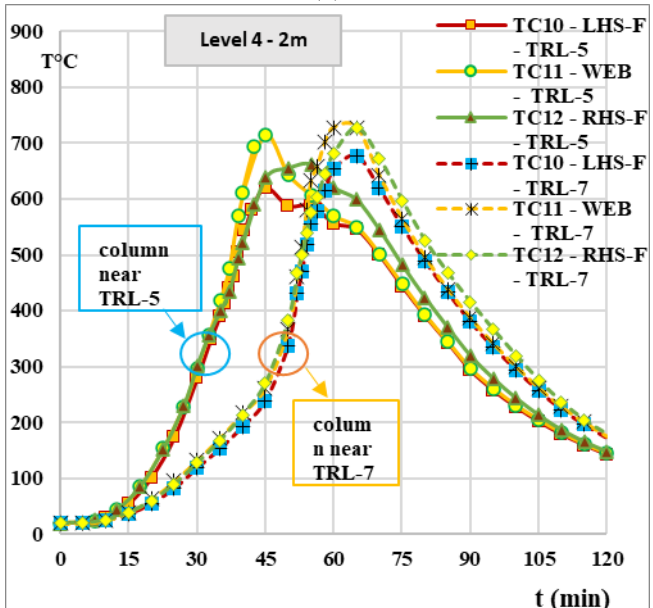
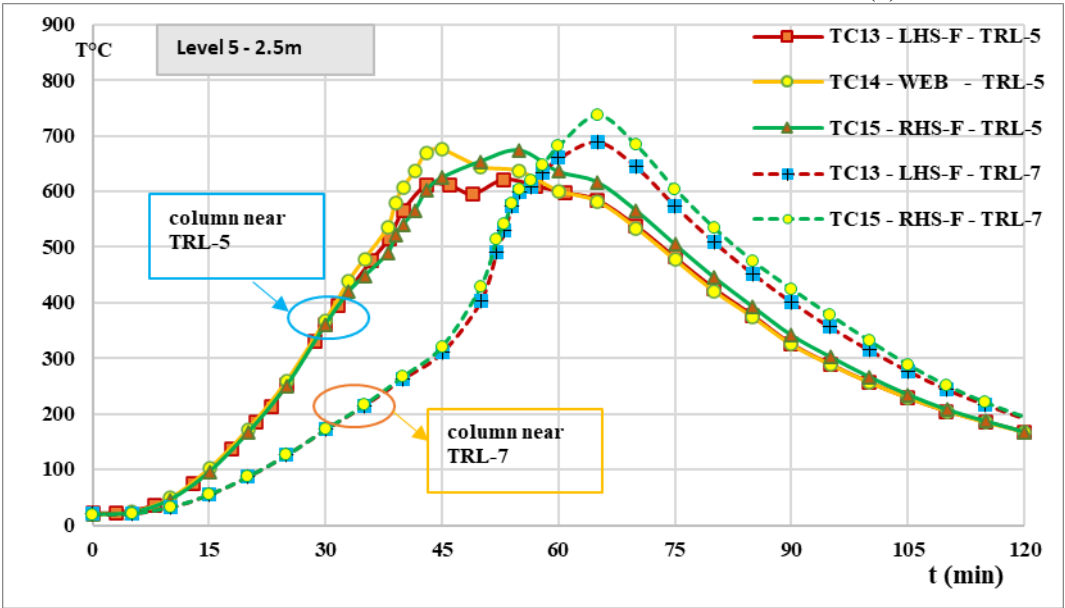
1 Figure 10: Steel temperatures recorded in dummy columns adjacent to TRL-5 and TRL-7 at; (a) Level 1: (b) Level 2: (c) Level 3:  
2 (d) Level 4: (e) Level 5.

Steel temperatures recorded in the dummy columns (C11) adjacent to TRL-5 and TRL-7 are presented in Figure 10 for all five levels (i.e., Level 1 to Level 5). It should be noted that temperatures in the steel column were recorded at 5 levels as shown earlier in Figure 3. Three labels shown in Figure 10 corresponds to different positions of the thermocouples. The label “LHS-F” corresponds to the flange of the column facing gridline ©. These thermocouples are identified as 1, 4, 7, 10 and 13 in Figure 3 (c). Similarly, the thermocouples identified as 3, 6, 9, 12 and 15 labelled as “RHS-F” are the ones provided on the flange facing the gridline ⓑ. The remaining five thermocouples identified as 2, 4, 6, 8 and 10 are provided in the web and have been labelled with “WEB” in Figure 10. The thermocouples which were found faulty have been omitted from the data presented in Figure 10. The trend of the steel temperatures recorded in the columns present similarities to those recorded within the test compartment as the rise in temperatures at upper levels initiates earlier as compared to lower levels. In case of column adjacent to TRL-5, the rise in steel temperatures initiates after 33 minutes from the start of ignition at level 1. The column adjacent to TRL-7 is at a farther distance from the point of ignition, hence the rise in steel temperature at level 1 is recorded after 53 minutes from the start of the test. For both columns, the rise in steel temperature at level 1 is rapid once the travelling fire gets closer as shown in Figure 10 (a). The rise in steel temperature at level 2, 3 and 4 initiates after 18, 15 and 13 minutes from ignition for column adjacent to TRL-5. The rise in steel temperature is relatively rapid for level 2 while this is relatively slow for level 4 as shown in Figure 10 (b), (c), and (d). The rise in temperatures for column adjacent to TRL-7 at levels 2, 3 and 4 is similar to that for column adjacent to TRL-5. As the column adjacent to TRL-7 is at a higher distance from the point of ignition, the rise in temperature at level 2 is rapid and more pronounced after 30 minutes from ignition as shown in Figure 10 (b). On the other hand, the rise in temperature for column adjacent to TRL-7 at level 3 and 4 initiates after 22 and 15 minutes respectively as presented in Figure 10 (c) and (d). The gas temperatures recorded in the test compartment presented earlier in Figure 9 showed that the rise in gas temperatures at upper levels earlier as compared to that at lower levels. The steel temperatures recorded in the columns present a similar pattern.

At lower levels, the rise in temperature initiates after a longer time from the start of ignition while at upper levels, the rise in temperatures starts at earlier stages of the tests irrespective of the positioning of the column. It is seen in Figure 10 (e) that the rise in steel temperature at level 5 initiates after 10 minutes from the start of the test for both columns. This is comparatively faster for column adjacent to TRL-5 being closer to source of ignition while the same is slower for column adjacent to TRL-7. None-the-less, the rise in temperatures at level 5 initiates earlier as compared to the lower levels. It is also noticed in Figure 10 that steel temperatures across the section of the columns are quite uniform. It should be noted that higher maximum steel temperatures are recorded in column adjacent to TRL-7 as compared to those recorded in column adjacent to TRL-5.

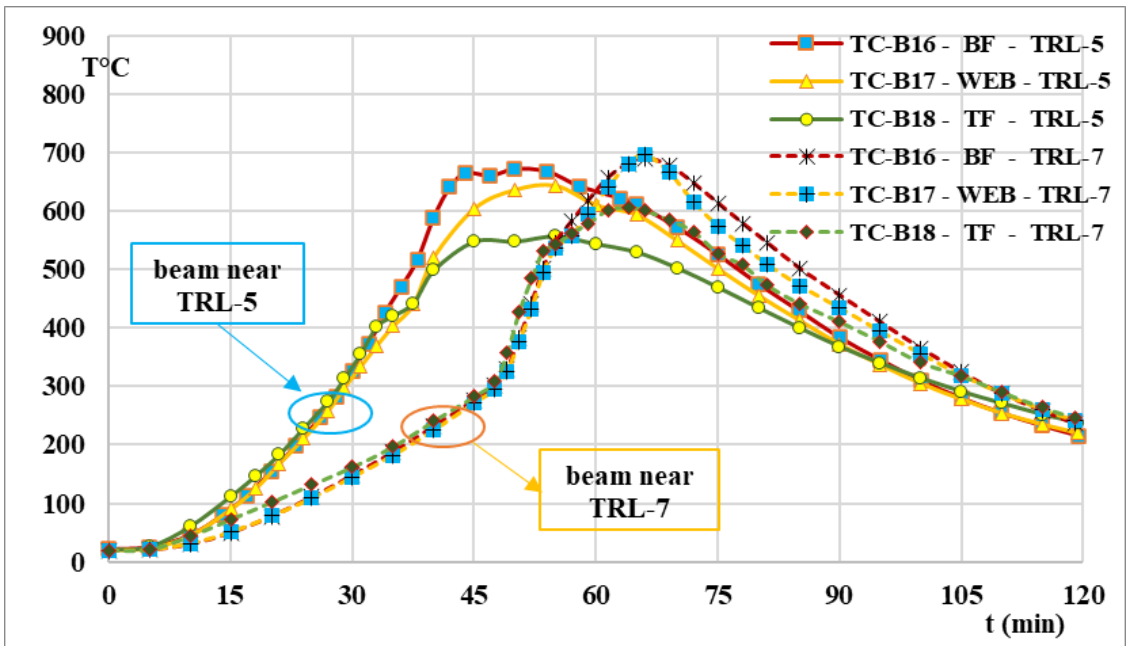
Figure 11: Evolution of temperatures in beams along gridlines ② and ③ adjacent to TRL-5 and TRL-7

The beams considered for data presentation purposes consist of the hot rolled steel profile HEA160 provided along gridlines ② and ③ and located between gridlines B and C. The selected beams were instrumented with three thermocouples, one on each flange and one in the middle of the steel web, shown previously in Figure 3 (d). The gas temperatures in the compartment close to the beam thermocouples were recorded via thermocouples provided at level 6 in TRL-5 and TRL-7. The recorded gas temperatures at level 6 using TRL-5 and TRL-7 are presented earlier in Figure 9. For each beam, the recorded steel temperatures are presented using three curves in Figure 11. The labels “TC - B16 - BF” corresponds to bottom flange while the label “TC - B17 - WEB” corresponds to the middle of the beam web. The last label “TC - B18 - TF” corresponds to the top flange in Figure 11. The temperatures in the beam adjacent to TRL-5, being closer to the point of ignition, increase at an earlier stage of the test after 09 minutes from ignition. This increase in the recorded temperatures is relatively quick. However, for beam adjacent to TRL-7, a slower increase is recorded from the 13<sup>th</sup> minute until the 45<sup>th</sup> minute. As the travelling fire band moves across the compartment and gets closer, a sharp increase in steel temperature is recorded in the beam adjacent to TRL-7 as shown in Figure 11. In case of temperatures recorded across the section of the columns, it was found that the temperatures were fairly uniform, However, in case of beams, it is interesting to note that the temperatures measured in the flanges and the web are non-uniform. The temperatures recorded in the top flange in both steel beams are significantly lower as compared to those recorded in the bottom flange. The maximum steel temperatures recorded in the bottom flange, the web and the top flange are 675°C, 640°C and 550°C respectively for beam adjacent to TRL-5. Similarly, the maximum temperatures recorded in the bottom flange, web, and top flange for beam adjacent to TRL-5 are 700°C, 690°C and 600°C respectively as shown in Figure 11. The temperatures recorded in the steel columns and beams show the transient heating of the surrounding structure for travelling fire scenarios.

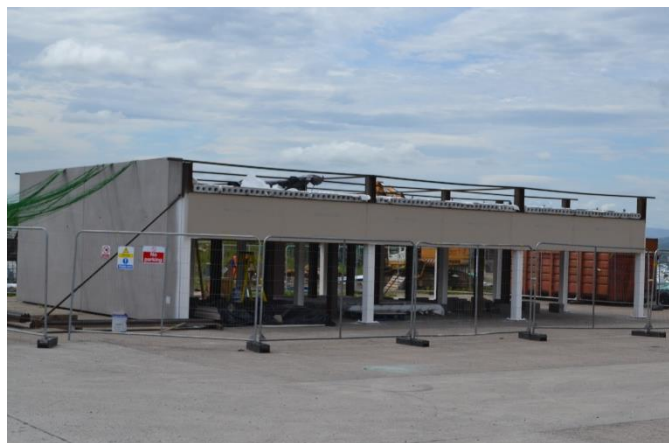
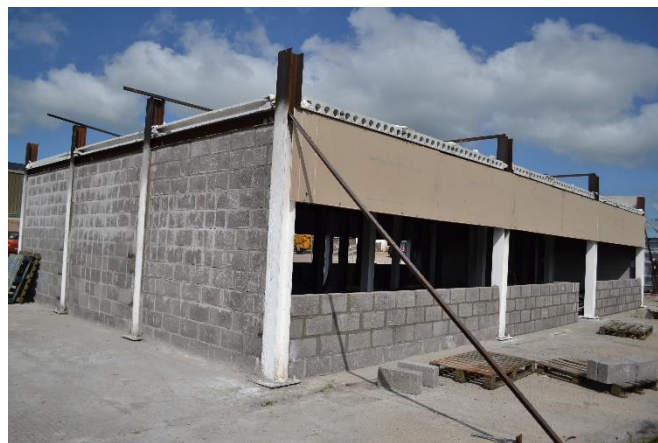
Figure 13: Boundary arrangements for (a) Test 1 – Only the back wall is constructed; (b) Test 2 – Additional front wall and 1 m deep concrete walls along the longer dimension

The data recording arrangements during Test 1 and Test 2 were kept similar. These include the arrangements to record the gas temperatures in the compartment, the steel temperatures recorded in the steel structure and the arrangements for the mass-loss recording. In addition, the back wall constructed along the gridline ① and the down-stands provided along the longer dimension, gridlines ① and ④, were also similar. During Test 1, no walls were constructed along the gridline ④ as shown in Figure 13 (a). However, during Test 2, a concrete wall with no openings was constructed along the gridline ④. In addition to the down-stands provided along the longer dimension, along gridlines ① and ④, during Test 2, a 0.9 m high concrete wall (soffit) was constructed which further reduced the size of the openings along the longer dimension of the test compartment as shown in Figure 13 (b). The total size of openings during Test 1 was 87 m<sup>2</sup> which was reduced to 30 m<sup>2</sup> during Test 2.

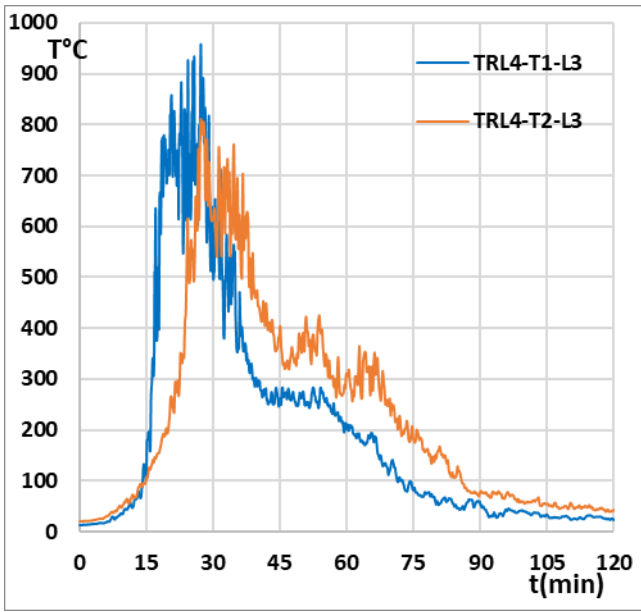
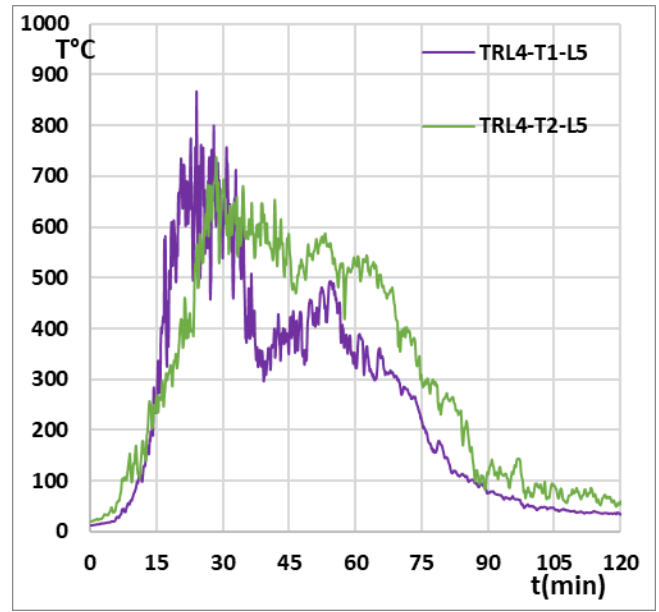
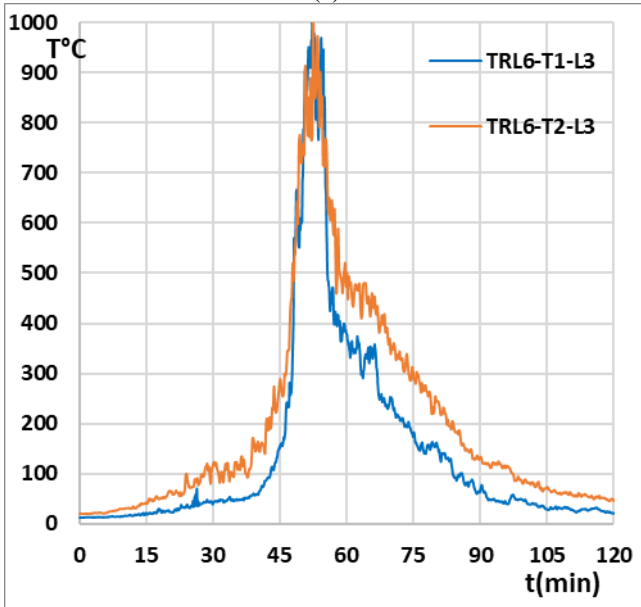
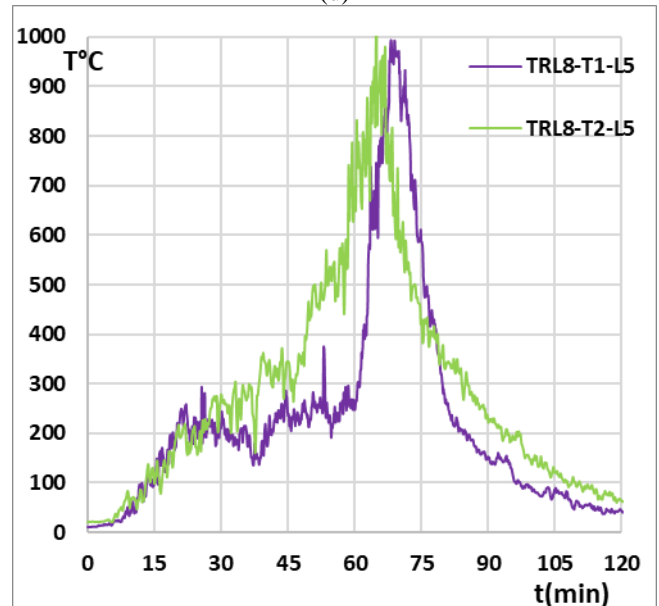
During Test 2, it was observed that the growing phase was relatively slower as compared to that observed during Test 1. This can be observed in Figure 14 (a), where the rise in gas temperatures is faster at level 3 in TRL-4 for Test 1 while the same is relatively slower for Test 2. It is also interesting to note that higher gas temperatures were recorded for Test 1 as compared to Test 2 at the same location. The gas temperatures recorded at level 5 in TRL-4 are very similar for Test 1 and Test 2 for the evolving phase, but differences exist for the phase when the fire travels away towards the fore

1 end of the compartment as shown in Figure 14 (b). During Test 2 a gentler drop in temperatures was recorded at level 5  
2 in TRL-4 as compared to sharp drop recorded during Test 1.

The gas temperatures recorded in the middle of the test compartment (referring to TRL-6) are very similar for Test 1 and Test 2: the similarities in the growing phase of the fire are closer to each other as compared to the decay phase as shown in Figure 14 (c) and (d). During the temperature reducing phase of Test 2, the decrease in gas temperatures is relatively slow as compared to that recorded during Test 1.

The temperatures recorded in the last zone of the test compartment, Zone 3B, are presented in Figure 14 (e) and (f). Differences during the growing and decay phases of the fire can be clearly seen. These differences are more dominant at level 3 as shown in Figure 14 (e). It is seen that the rise in gas temperatures at level 3 initiates at earlier stages during Test 2 as compared to Test 1. During Test 1, no concrete wall was provided along the gridline ④, which allowed the hot gases to escape. However, during the Test 2, due to the presence of the wall, the rise in temperatures was recorded at earlier stages as the hot gases were trapped within the test compartment. During Test 1, the increase in gas temperatures was only recorded once the travelling fire reached the area surrounding TRL-8, however during Test 2, increase at level 3 was recorded at earlier stages as shown in Figure 14 (e). It is also interesting to note that the decrease in gas temperatures during Test 1 was more rapid as compared to that recorded during Test 2 from the 80<sup>th</sup> minute onwards. Although for the initial 30 minutes the rise in temperatures at level 5 is similar for both tests, the rise in temperatures is more significant for Test 2 as compared to that recorded for Test 1, refer to Figure 14 (f). Again, this is the influence of the reduced openings of the test compartment by constructing additional walls along the gridline ④ and along the longer direction of the compartment. Similar to level 3, the reduction in temperatures at level 5 during Test 1 is more rapid as compared to that recorded during Test 2.

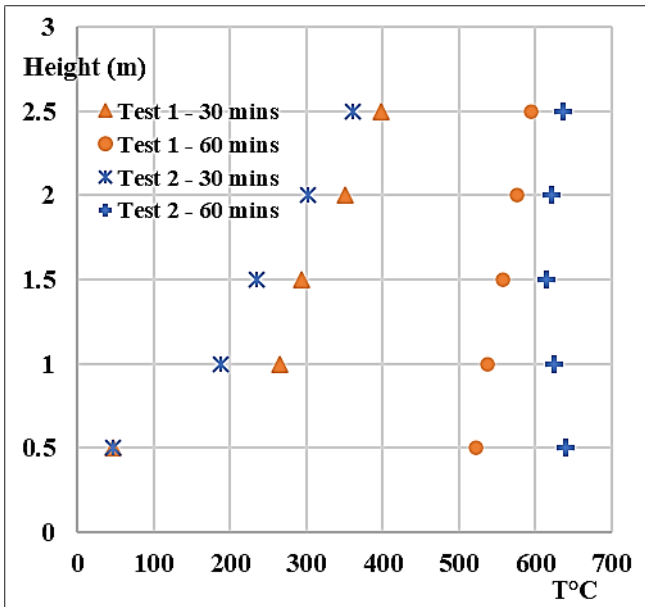
For the steel columns adjacent to TRL-5, after 30 minutes from the start of the test, temperatures recorded at level 1 (at 0.5 m) are similar during both tests as shown in Figure 15 (a), while the temperatures recorded at upper levels, level 2 through level 5, are higher during Test 1 (even though a similar trend is observed). This is related to the developing phase of the fire at earlier stages of Test 2 which was slower for Test 2 as compared to Test 1. The situation reverses after 60 minutes from the start of the test. Steel temperatures recorded at all levels during Test 2 were higher as compared to those recorded during Test 1, refer to the right part of the graph given in Figure 15 (a). The size of openings during Test 2 were significantly smaller as compared to Test 1, more heat was retained within the test compartment as a result, higher temperatures were recorded in the column adjacent to TRL-5.

In case of column adjacent to TRL-7, temperatures recorded after 30 minutes are similar for Test 1 and Test 2, as shown in Figure 15 (b). The recorded temperatures after 60 minutes are higher for Test 2. During both tests, temperatures recorded in the columns after 30 minutes were lower than those recorded after 60 minutes from ignition.

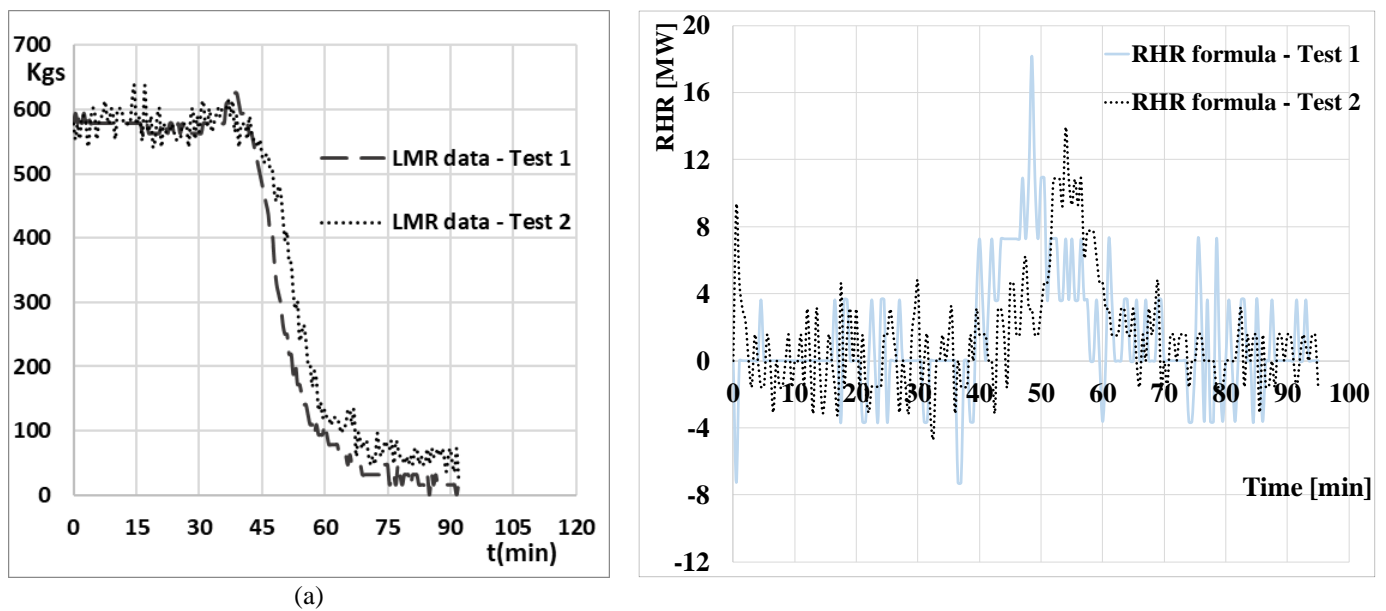
Figure 17: Comparison for Test 1 and Test 2; (a) Recorded mass-loss; (b) Approximation of the RHR derived from the mass-loss measurements

3 The mass loss arrangements for Test 1 and Test 2 were similar as was the fire load. The burning of the fuel wood  
 4 supported by the steel platform used to measure the mass loss started after 37 and 38 minutes respectively for Test 1  
 5 and 2. This can be seen in Figure 17 (a) where a reduction in the weight of the fuel wood supported by the steel platform  
 6 was recorded at these times during the tests. The fuel wood supported by the platform was consumed after 64 minutes  
 7 from ignition in Test 1. In case of Test 2, majority of the fuel wood was also consumed at the same instance, however,  
 8 the burning continued for the remainder duration of the test. The approximated RHR derived from the mass loss  
 9 measurements are fairly similar for Test 1 and Test 2, as it can be seen in Figure 17 (b). The only noticeable difference  
 10 is a time shift for the whole curve which is delayed for around 5 minutes for Test 2 (which is in line with the temperatures

11 observations described previously). Since the only significant change concerns the time occurrence, the applying of the  
 12 Savitzky–Golay filter as described above leads to fairly similar results for Test 1 and Test 2: the filtered RHR with  
 13 parameters 10 and 20 show maxima values of 8140 kW and 5850 kW for Test 1 and of 8100 kW and 5505 kW for Test  
 14 2, respectively.
