THE CASE OF THE ORATORY OF SAN ROCCO IN SORAGNA (PARMA): FROM ABANDONMENT TO HEALTH FACILITY.
AN INTEGRATED RESTORATION PROCESS

THE CASE OF THE ORATORY OF SAN ROCCO IN SORAGNA (PARMA): FROM ABANDONMENT TO HEALTH FACILITY. AN INTEGRATED RESTORATION PROCESS

Cristian BARBIERI¹, Sofia CELLI² Federica OTTONI³,

Keywords: Integrated restoration; reuse; consolidation; oratory; health facility

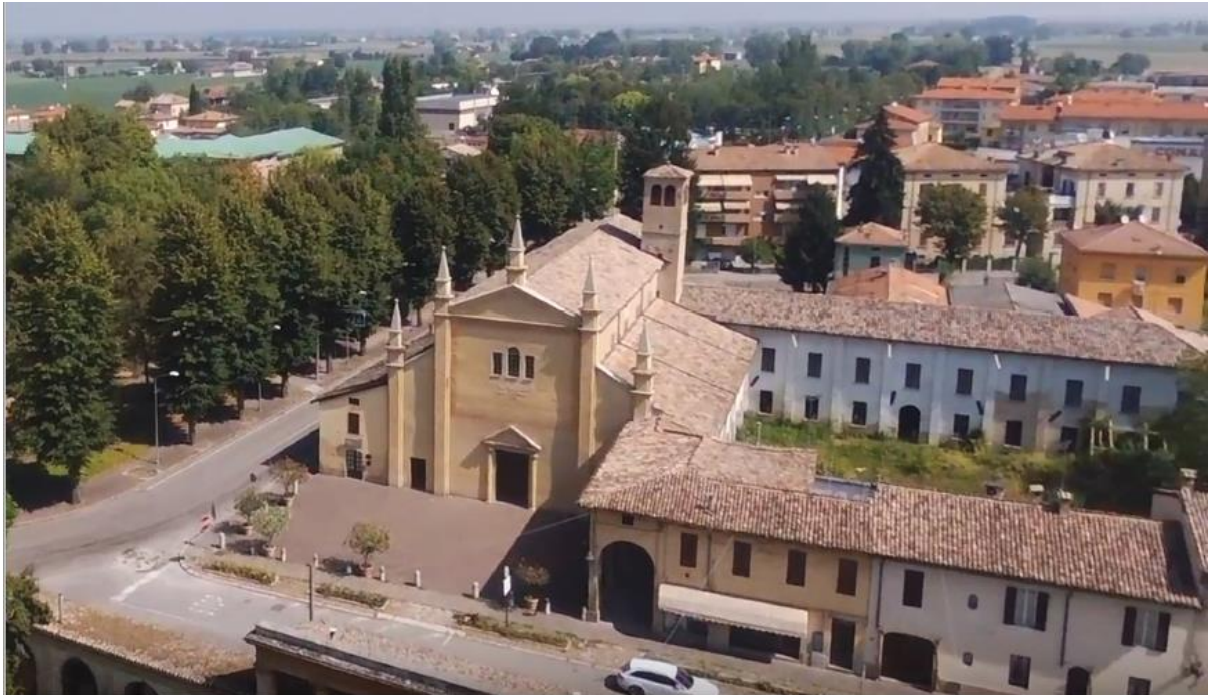
Fig. 1: Aerial photo of the complex.

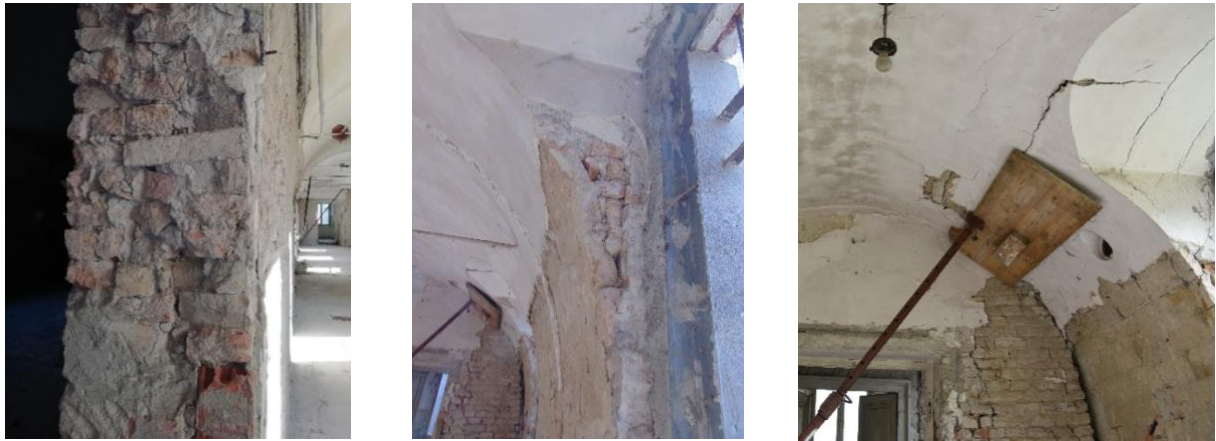
Fig. 3: On the left the masonry of poor build quality. The center photo show the bad construction quality of the vault. On the Right the the north-eastern corner with the collapse of the vault which has led to the insertion of a temporary prop.

In particular, from the geometrical and damage analysis, the masonry emerged as the main critical issue: the poor quality of the original materials and arrangements has been indeed worsened by an harmful intervention of integration - with the insertion (from the ground level up to -150 cm) of perforated brick on the external walls and on part of the main spine wall – in the mid of 1970. (Fig. 3 on left)

In the north-eastern corner the poor construction quality of the vault, which presents an incorrect texture precisely in correspondence with the shutters (Fig. 3 central) was certainly aggravated by subsequent interventions, such as the enlargement of the windows, and by some changes to the general conformation of the plan building.

In particular, the barrel vault presents important deformations and the collapse of the final part of the vault and the damage of the external wall, which has led to the insertion of a temporary prop (Fig. 3 on right). It clearly shows the activation of a thrust mechanism in correspondence to the graft of the transverse body in which there is an evident bending mechanism, combined to a mechanism of corner failure. An interesting interpretation of the described mechanism has been given basing on some historical drawings of the building (Fig. 4). In particular, the documents testify to the former existence of an additional wing of the complex leaning against the façade that is currently bending, as well as of a stream of water in proximity of the subsiding corner. The demolition of such historic portion combined

with the horizontal thrust of the barrel vault, the occasional seismic activities and the subsiding earth could very well justify the seriousness of the identified mechanisms.

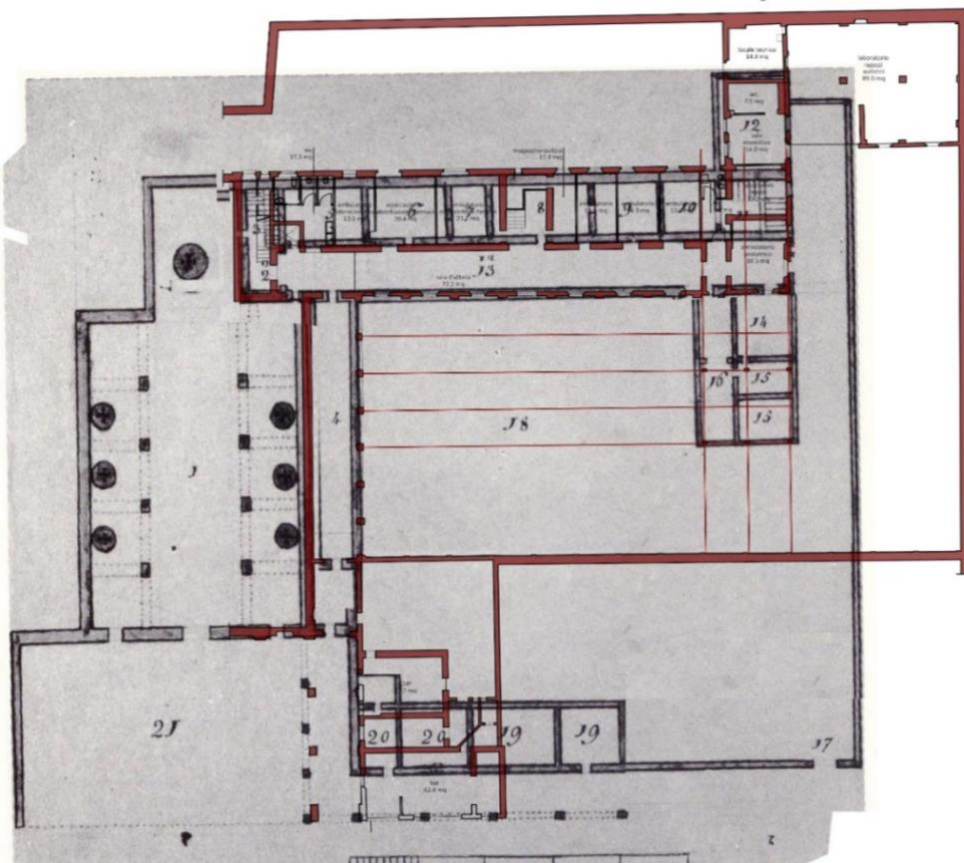
Fig. 4: The main transformations can be seen from the overlapping of the reliefs. In particular, the complete demolition of the wing that separated the court can be observed. This wing held back the thrust of the vault, currently heavily damaged and propped up both on the extrados and in correspondence with the ancient wing.

The horizontals and spine walls in this portion are in fact not well clamped to the surrounding walls, which are in fact subject to possible overturning. To complicate the static situation of the vault was the construction in 1958 of a reinforced concrete slab above the vault itself and above the lateral wooden floors.

To complete the description, the roof of body B, which was originally asymmetrical and pushing, saw the insertion of trusses following the demolition of the spine wall that continued up from the corridor below. The truss chains are currently weighed down by rafters and tiles of the false ceiling which cause an evident bending mechanism, punctually aggravated by the rotting of some beam heads (due to lack

of maintenance of the roof). In addition, the pushing hip rafter of the east elevation have generated deep cracks in the corner walls visible in the fronts, aggravating the tilting mechanism evident in the corner. Less interesting, from the point of view of instability and conservation, is block C: while the original part (north wing of the original complex) deserves an in-depth study and conservation, presenting similar problems to the rest of the building (lack of masonry quality and heavy transformations of the floors), the more recent leaning building does not present relevant architectural and historical characteristics, thus allowing its demolition.

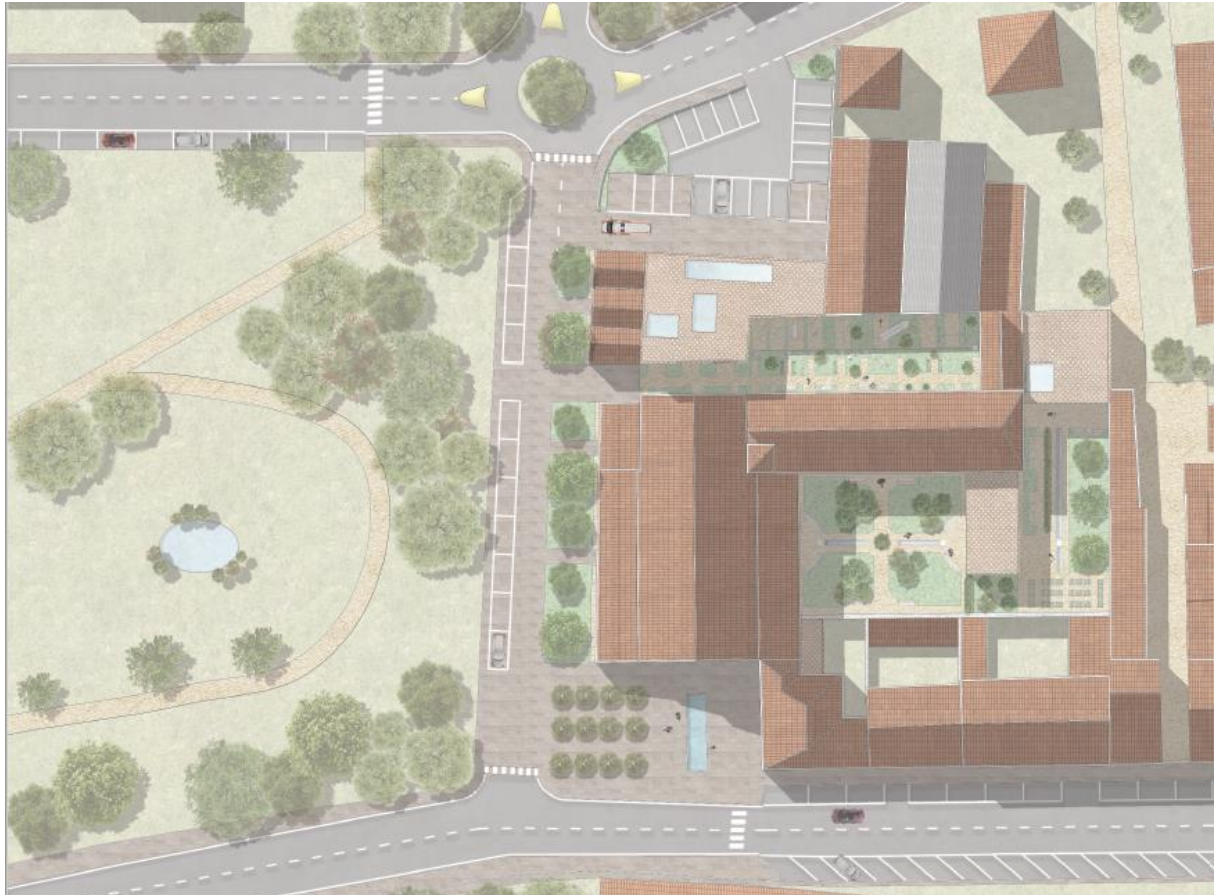
Fig. 6: Project masterplan showing the changes in urban planning.

The insertion of all these functions, strongly linked and complementary, has required an urban reorganization, with the rethinking of the road layout able to ensure better viability and urban quality and better connect the complex to neighboring countries (thus increasing their use and attractiveness). As stated before, the strategies adopted are derived from an historical and social analysis, aimed at enhancing the complex through the re-appropriation, by the community, of the identity spaces.

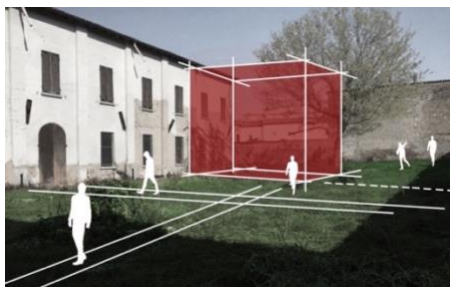
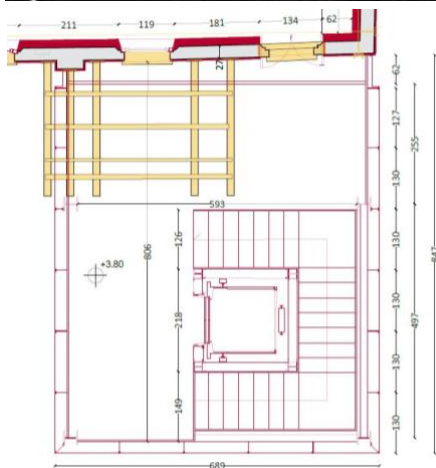
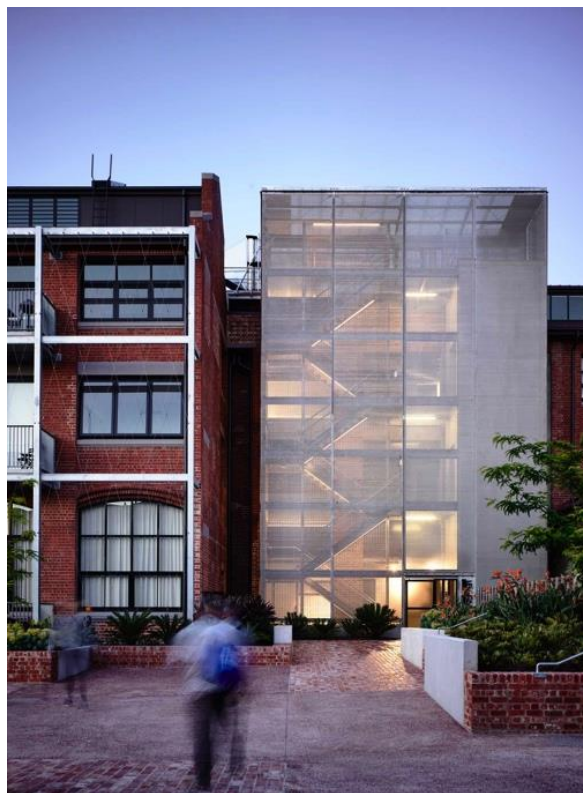
Figure 9: On the left: first floor plan of the new stair case, inserted in the new volume at the north-eastren corner of the block B, recovering the ancient sedime of the court configuration. On the right: the perforated steel panels employed by Kerstine Tompson Architects at Wertheim Factory (Melbourne), which suggest the hypothesized materials for the new volume.

Walking along the long portico can be reached the public space of the Health facility (the barrel vaulted corridor) which hosts the waiting room for surgeries. The services and reception are located at the entrance of the corridor, while nursing and observation therapy clinics and the specialistic ones, are respectively located on the west and the east side of the central stairs, conserved in this central position for functional reason, but completely redesigned with new structure and materials (in virtue of the previous historical analysis). At the same floor, the pediatric and psychiatric clinic are located in a more secluded position, equipped with a special waiting room to accommodate children, with the insertion of a new volume at the north eastern corner of the block B, to recall the original court configuration (Fig.9)

Indeed, the historical and structural analysis, has represented the pretext for the restoration process which, attempting to balance the structural, historical and functional needs, as seen the insertion of a new block in place of the original demolished one.

This solution has multiple positive outcomes: from a structural perspective, the replacement of the provisional props – that are currently supporting the south façade – with permanent steel ones incorporated in the new construction, would effectively contrast the ongoing dangerous bending mechanism previously described. Moreover, the added block would facilitate the positioning of a further vertical connection (stair and elevator) between the two levels of the complex, granting an overall better fruition of the complex: through this structure, the new multipurpose room would have an independent entrance, also helping in managing the different flows of users moving within the complex on a daily basis at different times. Finally, as already underlined, this new volume helps in creating a pediatric waiting room directly overlooking the garden, thus allowing to separate the kids from the other patients, with facility granting benefits both in terms of general comfort of the users and epidemic control.

However, the relevance of the new path is also related to the achievement of full compliance with the current regulations in terms of accessibility and fire prevention. On one hand, the positioning of an elevator allows to address the issue of architectural barriers, on the other, the whole stairway configures as an exit route, meeting the safety requirements for public halls.
